National Transportation Safety Board

Safety Recommendation

In reply refer to: A-00-46 through -50

Fatigue Cracking in the BK117 Vertical Fin

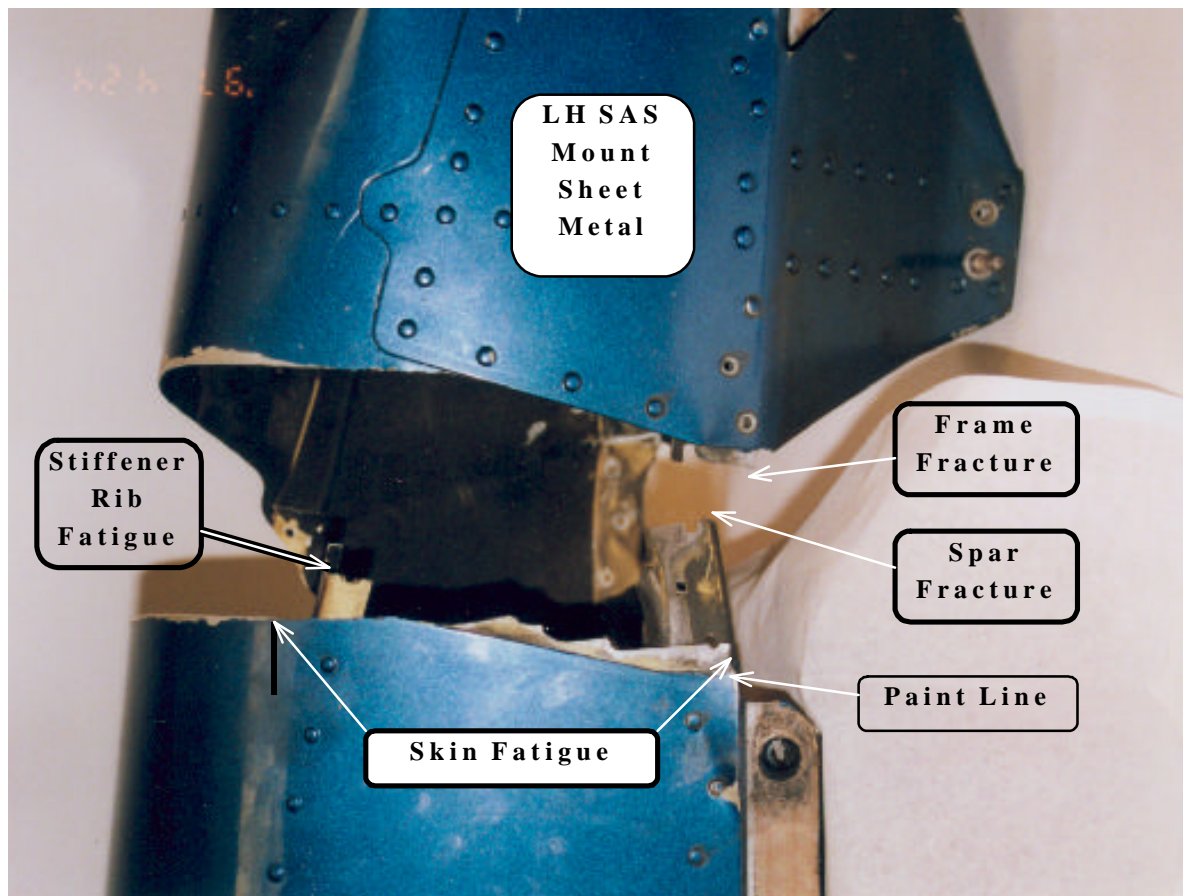
Metallurgical examination of the wreckage established that the separation was caused by fatigue cracking in multiple components of the vertical fin structure, including the skin and spar. Fatigue cracking was discovered at five locations in the vertical fin skin beneath the lower edge of the left-hand yaw stability augmentation system (SAS) servo mount support.³ Fatigue cracks were also discovered in the vertical fin spar, which in effect partially severed the spar immediately adjacent to the noted skin cracks. The fatigue cracking in the skin originated at rivet holes common to the yaw SAS servo mount support and grew undetected to a length of approximately 5 1/2 inches before the ultimate separation of the vertical fin. The fatigue crack propagation in the skin was concealed by the installation of the yaw SAS servo mount support (see figures 1 and 2).

Figure 1. A left-side view of the fatigue area with the individual component fractures denoted. “Paint Line” arrow denotes the original position of the lower edge of the left-hand sheet.

Perform a fatigue evaluation/damage tolerance analysis of the Eurocopter BK117 vertical fin structure to ensure that the inspection requirements of Airworthiness Directive (AD) 98-24-13 are adequate to detect crack growth in the underlying

areas of the modified spar and leading-edge skin and to verify that the BK117 vertical fin spar is not susceptible to fatigue failure beyond those areas specifically identified by AD 98-24-13. If the susceptibility is not so limited or the inspection requirements are not adequate, the AD should be superseded to ensure that all fatigue cracks will be detected. (A-00-46)

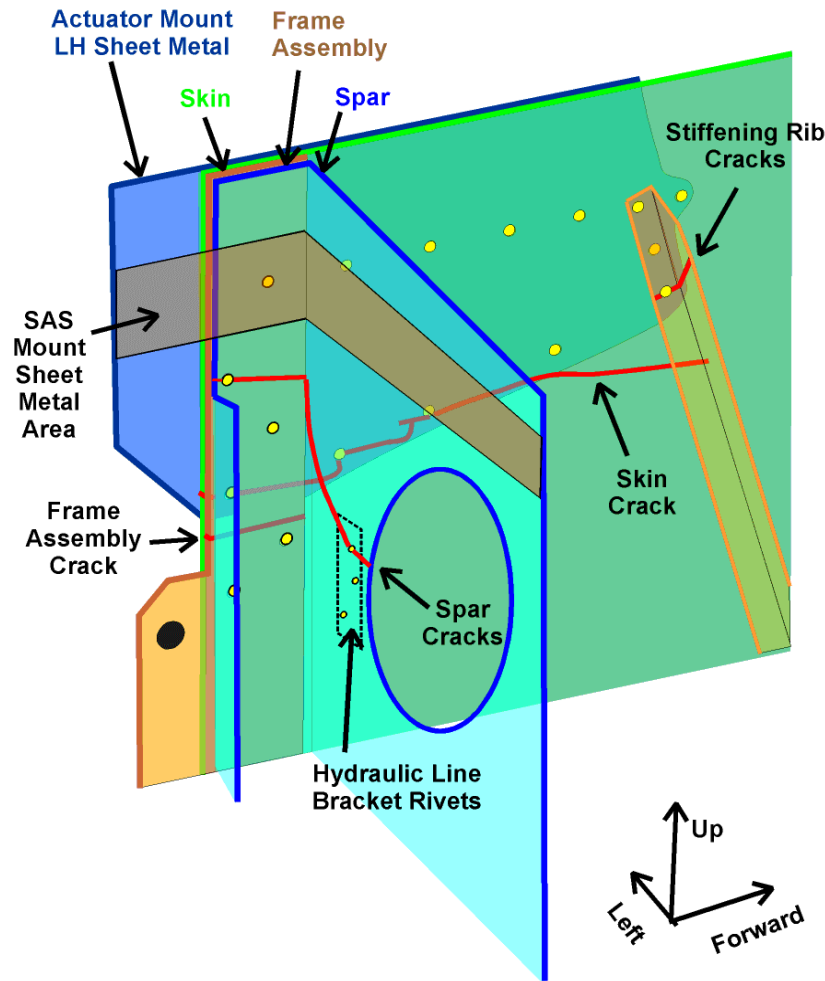
Figure 2. An illustration of the fin components in the area of the preexisting cracks. Of particular interest are the relative positions of the cracks in each member. Overlapping members are shown partially transparent to expose hidden detail. (Not to scale.)
