National Transportation Safety Board

Safety Recommendation

Date: July 6, 2000

In reply refer to: A-00-66 through -71

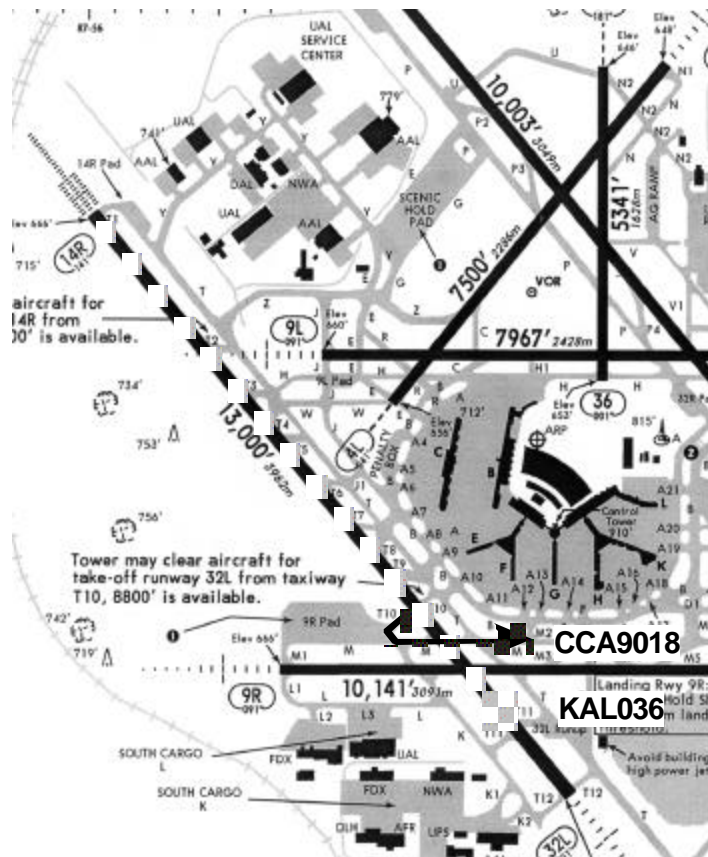
Figure 1. ORD Airport Diagram.

On April 1, 1999, about 0210 central standard time, Air China flight 9018 (CCA9018), a Boeing 747 (747), Chinese registration B2446, and Korean Air flight 036 (KAL036), a 747, Korean registration HL7493, were involved in a runway incursion on runway 14R at O'Hare International Airport (ORD), Chicago, Illinois. (Figure 1 shows a diagram of ORD with references to both airplanes' positions.) CCA9018, a cargo flight, had just landed and was rolling out on runway 14R when the ORD local controller instructed KAL036 to taxi into position and hold on runway 14R. After CCA9018 exited runway 14R at taxiway T10, the local controller cleared the flight to taxi to the cargo

ramp, and the flight crew acknowledged the instructions. The local controller then cleared KAL036 for takeoff. The flight crew of CCA9018 inadvertently deviated from its assigned taxi route and reentered runway 14R at taxiway M. As KAL036 approached rotation speed, the captain saw CCA9018 crossing the runway ahead. The KAL036 captain abruptly rotated the airplane, banking to the left. KAL036 reached 9° of left bank shortly after takeoff, passing directly over CCA9018 within 3 seconds and clearing CCA9018 by about 75 feet. The incident occurred in visual meteorological conditions (VMC) at night. No injuries were reported, and neither airplane was damaged.

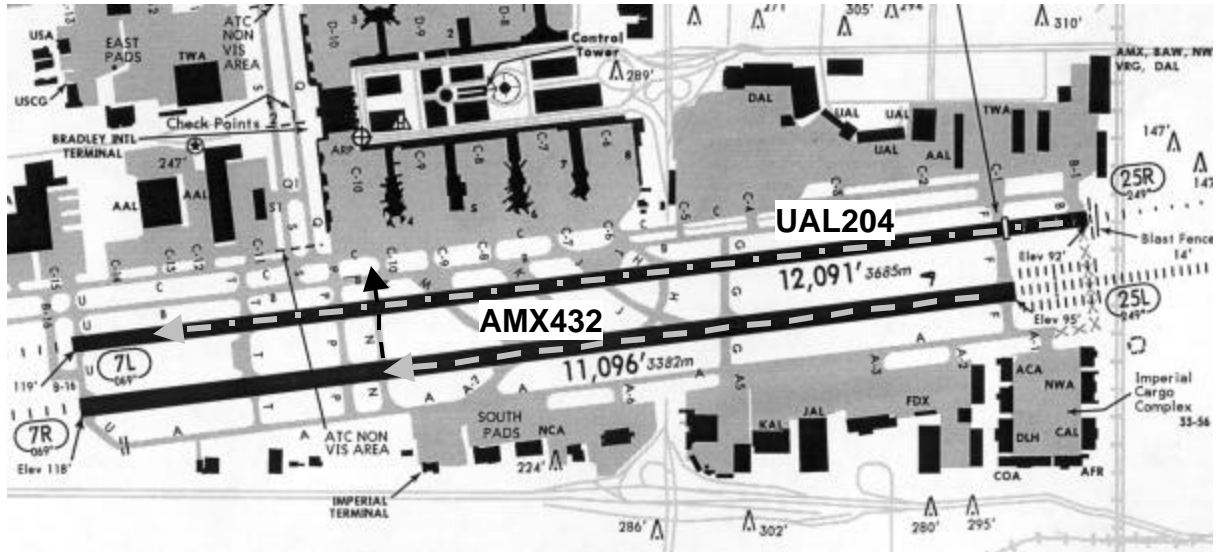
Figure 3. LAX Airport Diagram.

controller stated that she thought that the flight crew read back “short 25R.” The controller stated that AMX432 turned on taxiway N but then accelerated toward runway 25R. The controller restated the hold short instruction, but UAL204 had already flown over AMX432 by about 100 feet. The incident occurred in VMC at night. No injuries were reported, and neither airplane was damaged.
