National Transportation Safety Board

Safety Recommendation

In reply refer to: A-07-113 through -116

On November 15, 2004, a fire occurred in the electrical/electronic equipment center compartment of a Boeing 777-200ER airplane (operated by British Airways as flight BA239) shortly after arrival at Boston-Logan International Airport, Boston, Massachusetts. Ground maintenance personnel observed smoke coming from the airplane after a ground electrical power unit was plugged into the airplane's external power panel. Maintenance personnel notified the flight crew of the smoke and helped deplane all passengers and crew from the aircraft. No injuries to any passengers or flight crewmembers were reported.

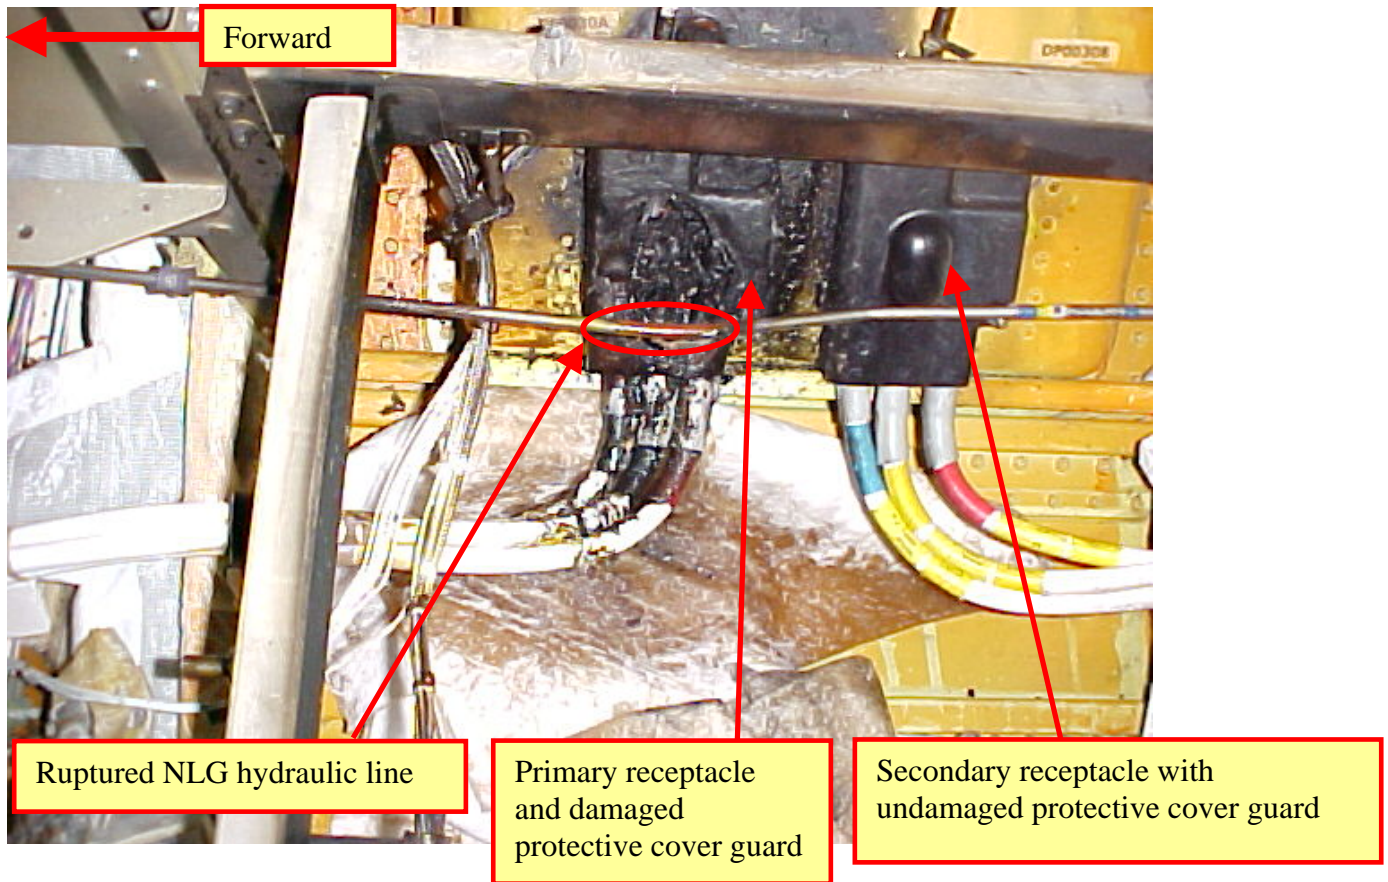
Postincident examination of the airplane revealed that the fire resulted from a combination of electrical arcing between the lower terminal studs at the primary power receptacle¹ and misting hydraulic fluid from a ruptured nose landing gear (NLG) hydraulic line, which is located about 3 inches from the primary and secondary external power receptacles. The primary power receptacle, its protective cover guard, attached wiring, adjacent wire bundles, and the NLG hydraulic line all sustained extensive thermal damage (see figure 1).

Figure 1. Damaged external power connector receptacles and the surrounding compartment.

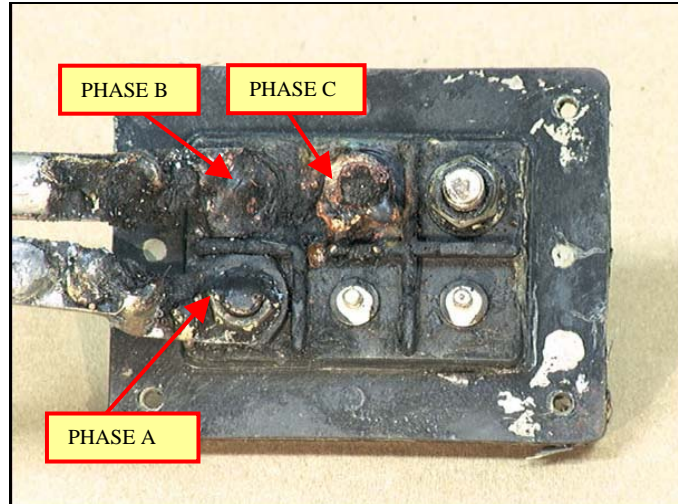
Examination of the primary power receptacle terminal block from the airplane involved in the November 15, 2004, event identified evidence of electrical arc damage between three of the phase studs (A, B, and C in figure 2) installed on the back of the terminal block, as well as melted inner surfaces due to the arcing. Additionally, the terminal lug that connects to the phase C stud showed evidence of oxidation and electrical arc erosion. Several of the contact pins exhibited overheating damage, extensive pitting, and considerable corrosion. Metallurgical analysis of the ruptured NLG hydraulic line revealed that it failed due to exposure to molten copper plasma. Examination of the protective cover guard revealed that a portion of its surface had melted as a result of exposure to plasma.

Figure 2. Primary power receptacle (internal to the aircraft) from the incident airplane showing evidence of electrical arc erosion between phase studs A, B, and C.
