National Transportation Safety Board

Safety Recommendation

Date: October 24, 2007

In reply refer to: A-07-70 through -86

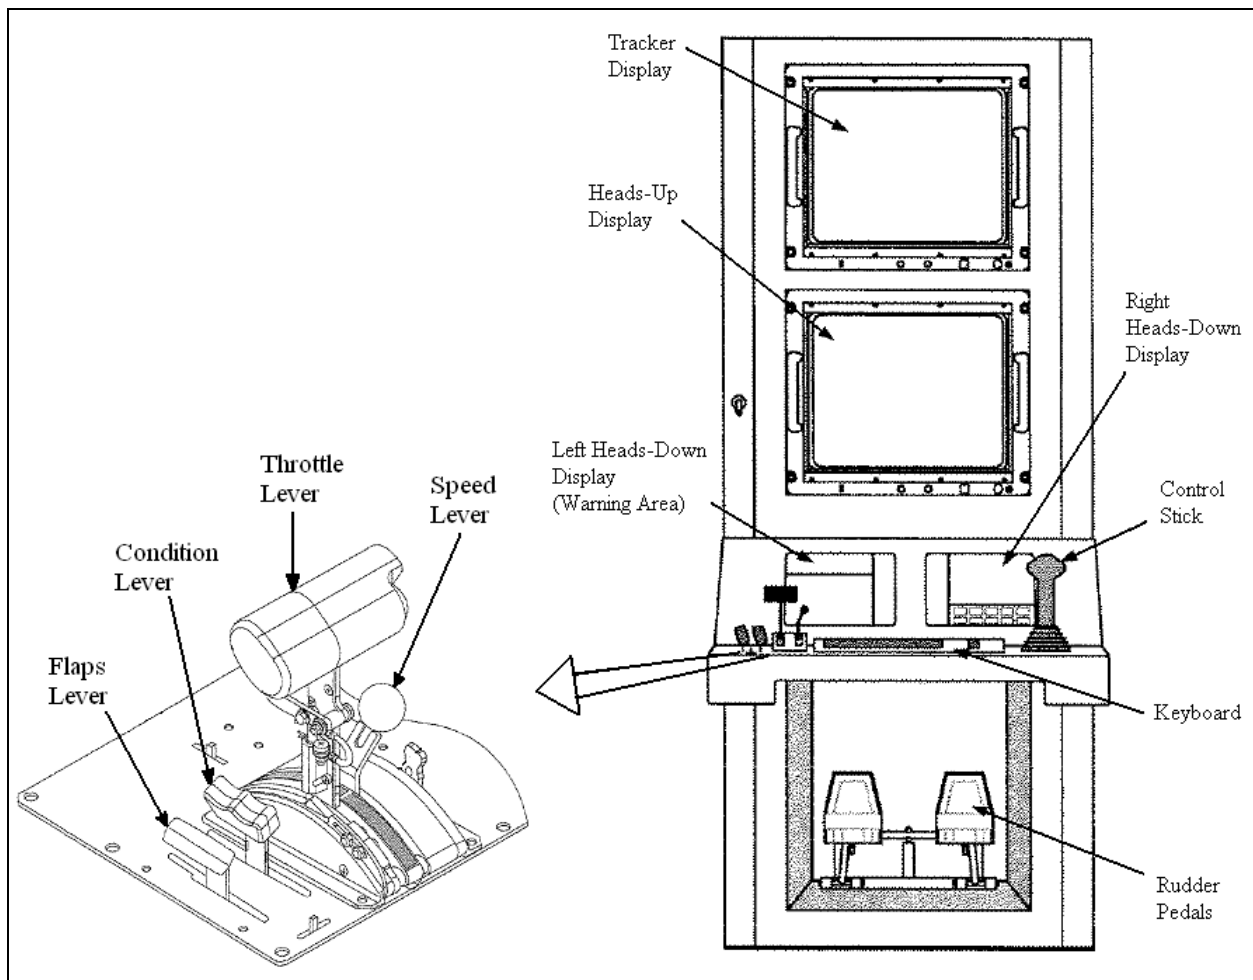
The GCS at FHU, from which the accident flight was controlled, contains two nearly identical control consoles: PPO-1 and PPO-2 (see figure 1). During a routine CBP mission like the accident flight, the pilot (provided by GA-ASI) controls the UA from the PPO-1 console, and a payload operator (a U.S. Border Patrol agent) controls the camera mounted on the UA from the

PPO-2 console. Although the aircraft control levers (flaps, condition lever, throttle, and speed lever) on PPO-1 and PPO-2 appear identical, they may have different functions depending on which console controls the UA. When PPO-1 controls the UA, the condition lever controls the engine via movement to one of three positions, as follows:

When the UA is controlled by PPO-1, the condition lever at the PPO-2 console controls the camera’s iris setting. Moving the lever forward increases the camera’s iris opening, moving the lever to the middle position locks the iris setting, and moving the lever aft decreases the opening. Typically, the lever is set in the middle position.

Figure 1. Diagram of a Control Console Installed at the CBP’s Ground Control Station

Operational control of the UA can be transferred from PPO-1 to PPO-2 in the event of a malfunction of PPO-1. Console lockup checklist procedures indicate that, before switching operational control between the two consoles, the pilot must match the control positions on PPO-2 to those on PPO-1 by moving the PPO-2 condition lever from the middle position to the forward position, which keeps the engine operating. The pilot⁴ stated in a postaccident interview that, during the accident flight, the console at PPO-1 “locked up,” which prompted him to switch control of the UA to PPO-2, as allowed by the system design. However, he did not consult the console lockup checklist. He stated that he did not position the PPO-2 levers to match the PPO-1 levers before the transfer of control, as defined in the console lockup checklist. As a result, the condition lever of PPO-2 was in the middle position when the transfer of control occurred, and the engine fuel shutoff valve was commanded to close when control of the UA was transferred from PPO-1 to PPO-2. Safety Board investigators later confirmed, through a review of parameters recorded during the event, that the condition lever of PPO-2 was in the fuel cutoff position when the switch from PPO-1 to PPO-2 occurred. As a result, fuel to the UA’s engine was cut off, and its engine stopped operating.

Findings thus far in the CBP accident investigation and information about a similar U.S. Coast Guard event⁵ demonstrate that the current design of the control consoles (that is, the dual functions assigned to a single lever) can cause an unsafe condition that can result in an unintended engine shutdown if proper procedures are not followed. The Safety Board is aware that, as a result of the accident, design changes were proposed for the GCS to inhibit transfer of control between PPO-1 and PPO-2 when the control levers are in disagreement (including the condition lever). However, Board investigators have been unable to assess the progress and outcome of these changes in preventing inadvertent engine shutdowns because the CBP and GA-ASI have not yet released the pertinent design details requested. Until the Board can obtain a more comprehensive understanding of this system change, concerns remain regarding the potential for inadvertent engine shutdown during the operation of the Predator B. Therefore, the Safety Board believes that the CBP should require GA-ASI to modify the UAS to ensure that inadvertent engine shutdowns do not occur.

Engine data and fault annunciations are also normally displayed and highlighted in the left heads-down display on the PPO-1 and PPO-2 consoles (see figure 1). However, a significant amount of information is presented in this display, including several highlighted warnings other than engine performance data that are not prioritized; therefore, it may be difficult to sort through information quickly in an emergency situation. Adding to this difficulty is the absence of a unique aural annunciation associated with the engine-out indication; only one tone is used for all fault conditions. Without an obvious indication of the engine-out condition, the pilot was unable to quickly evaluate the situation and recognize that the fuel had been cut off to the engine during the transfer to PPO-2.

Require General Atomics Aeronautical Systems, Inc., to modify the unmanned aircraft system to ensure that inadvertent engine shutdowns do not occur. (A-07-70)

Require General Atomics Aeronautical Systems, Inc., to modify the unmanned aircraft system to provide adequate visual and aural indications of safety-critical faults, such as engine-out conditions and console lockups, and present them in order of priority, based on the urgency for pilot awareness and response. (A-07-71)
