National Transportation Safety Board

Safety Recommendation

Date: January 29, 2010

In reply refer to: A-10-1 through -9

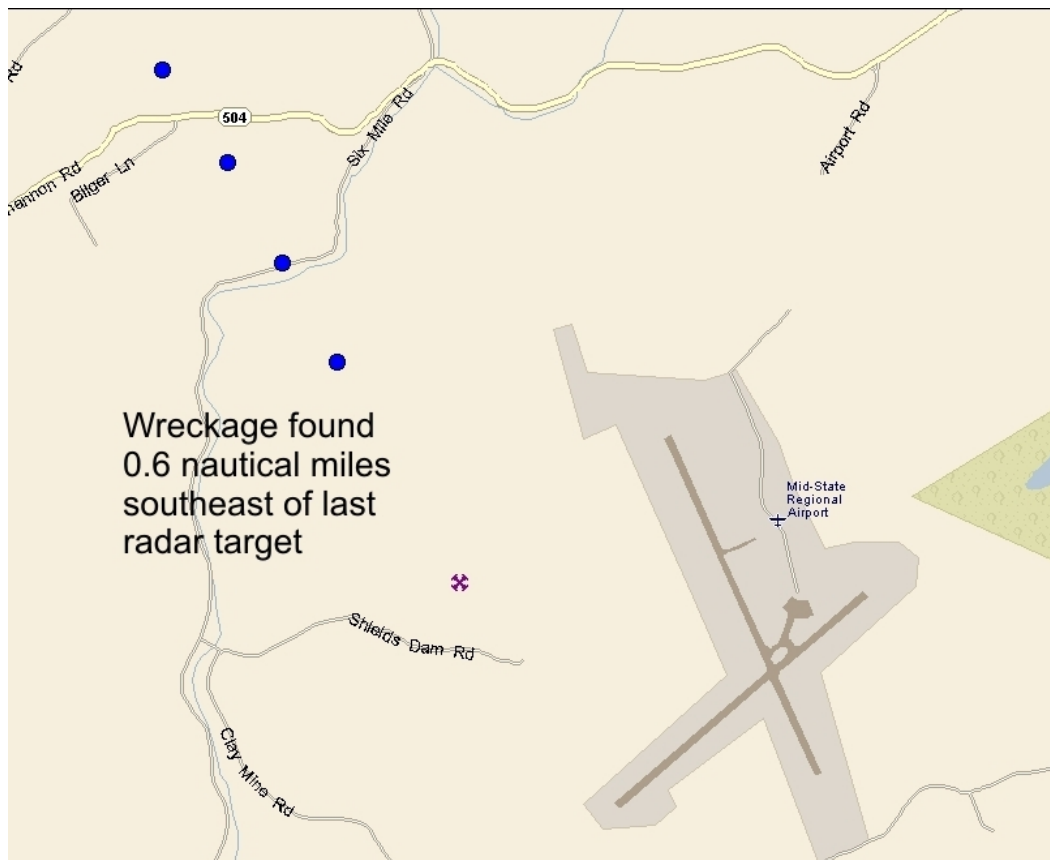
An NTSB review of recorded radar data showed that the last position recorded by ZNY for the airplane was 5.6 nm south of the outer marker, not 2 nm south as reported in the ALNOT. The last few radar targets tracked directly toward the crash site. (See figure 1.) The airplane was eventually located about 0.6 nm south of the last radar target and about 300 yards from the closest road. If the FAA radar data had been immediately evaluated and made available to the AFRCC, as well as the Pennsylvania State Police or other local first responders, the delay in determining the aircraft's last known radar position would have been almost completely eliminated, and searchers could have located the airplane and rescued the survivors much sooner than 8 hours after the accident.

Figure 1. Map of the Philipsburg, Pennsylvania, accident area overlaid with radar targets leading to N56246's wreckage about 0.6 nm southeast of last FAA radar target.

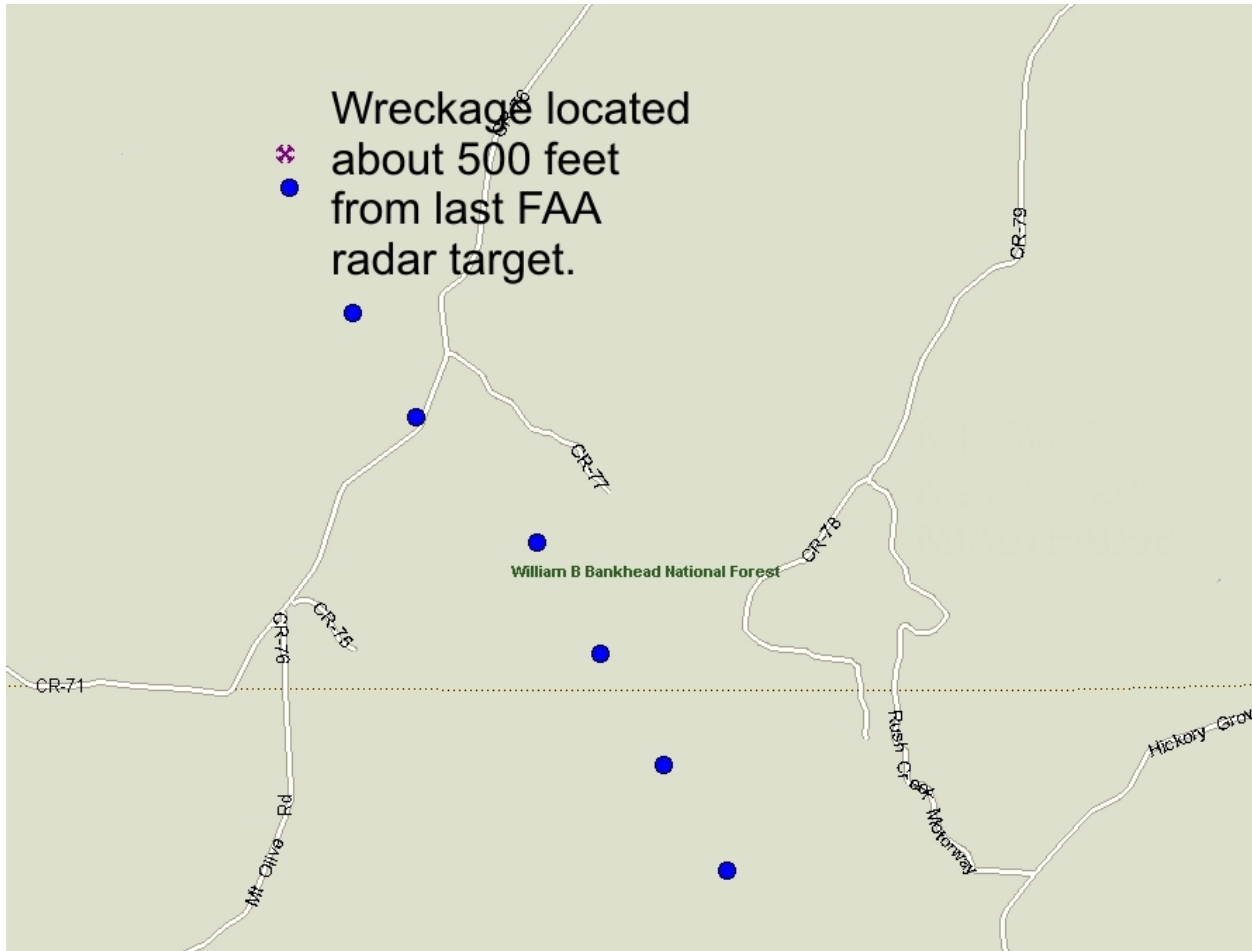
NTSB investigators reviewed the information used to support the search for the helicopter and reviewed AFRCC's efforts to obtain FAA data needed to help locate it. It was immediately apparent that all the information needed to locate the helicopter was recorded at BHM TRACON during and after its contact with the pilot. The controller's instruction to set the aircraft's transponder to 0335 served to positively identify the aircraft. Even though the controller was unable to see the helicopter on his radar display, the targets were recorded by the radar data processing system. After the pilot changed the transponder setting from 0335 to 1200, the target trail continued directly to the accident site. Had the BHM TRACON radio communications and radar data been made available to a trained radar analyst immediately after the facility responded positively to the ALNOT, the crash location likely would have been available within minutes, and search teams likely would have been able to reach the accident site much sooner.

Figure 2. Map of the Moulton, Alabama, accident area overlaid with radar targets leading to N468WE's wreckage about 500 feet from the last FAA radar target.

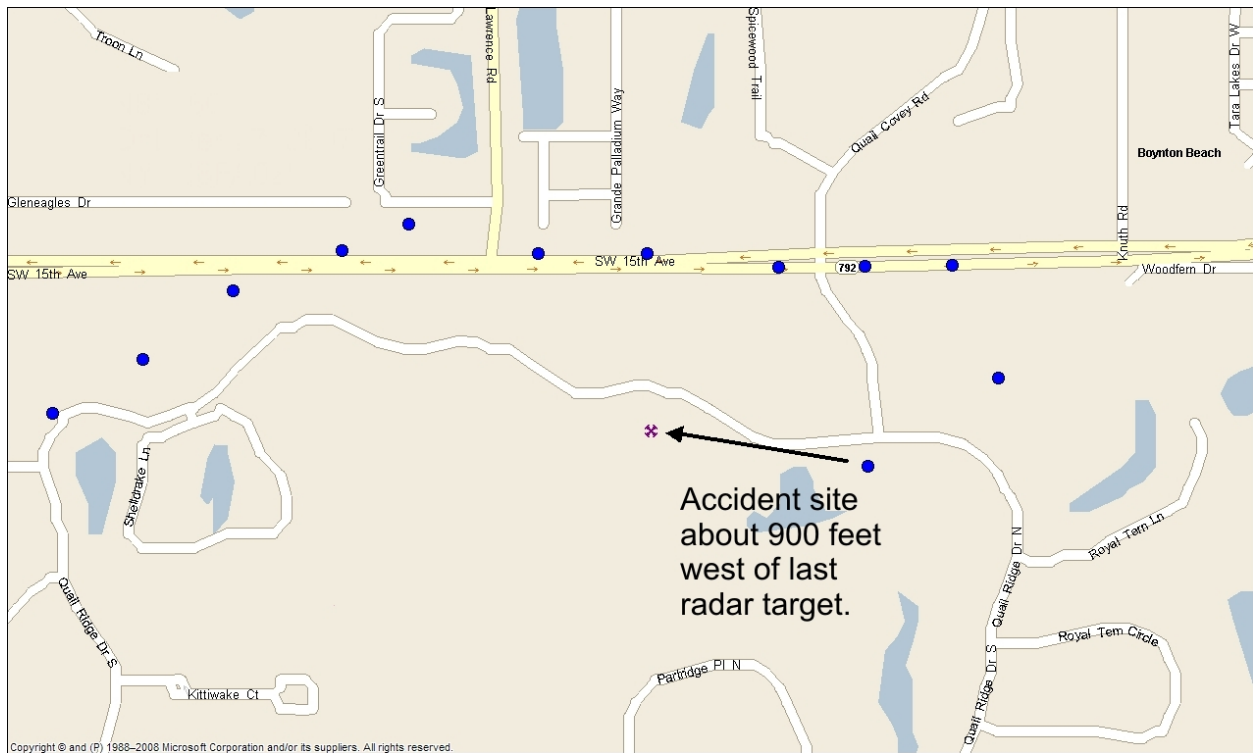
Figure 3. Map of the Boynton Beach, Florida, accident area overlaid with radar targets leading to N8155C's wreckage about 900 feet west of the last FAA radar target.

Postaccident review of FAA radar data recorded at PBI showed that the aircraft was last observed about 2011, westbound and descending through 100 feet. The wreckage was located on a residential golf course about 900 feet west of the last radar target. The NTSB is concerned that, even though the PBI controller noticed the accident immediately and solicited assistance in locating the aircraft from nearby pilots and a local law enforcement helicopter, it still took an hour and 18 minutes to find the wreckage and the surviving passenger. Because of the dark night conditions, accurate location information would have helped guide responders to the correct location. FAA radar data contained a direction of flight and last known position very close to the location of the wreckage; however, that information was not made available to local responders to assist in the search. According to information provided by PBI, no technically qualified persons were available when the accident occurred to search the radar data recordings and produce the needed radar data. The NTSB believes that if the last recorded radar latitude and

longitude position and direction of flight had been supplied to local responders, the time needed to find the aircraft and rescue the survivor would have been substantially reduced.

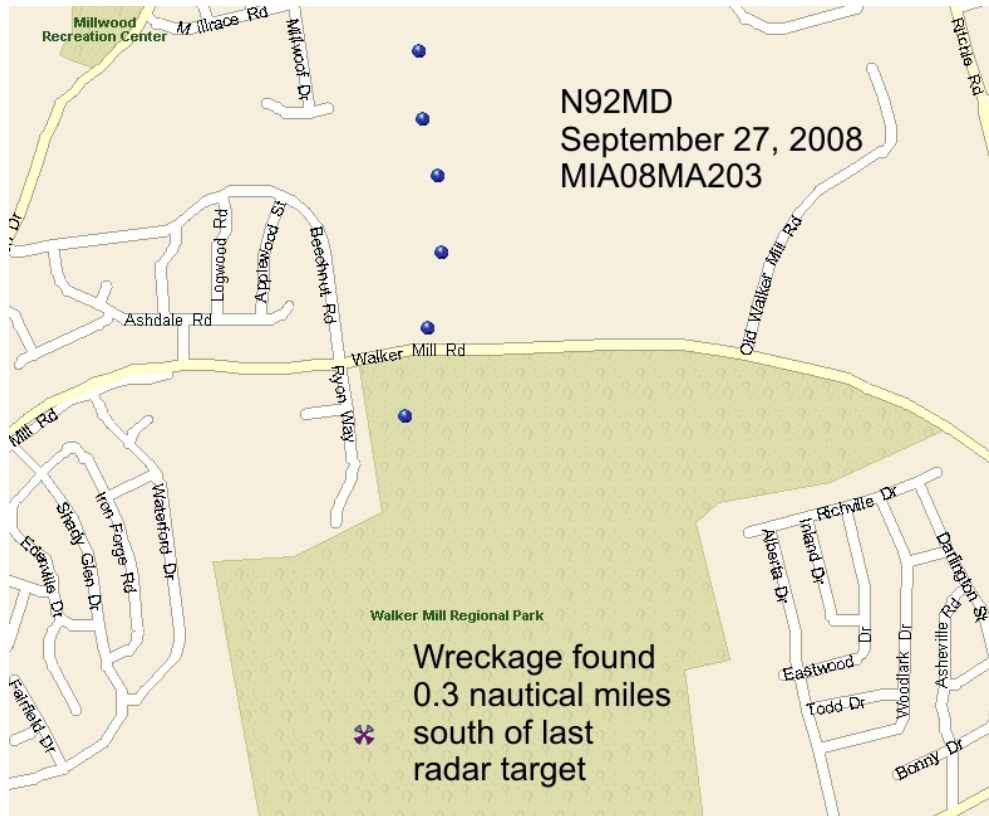
Figure 4. Map of the District Heights, Maryland, accident area overlaid with radar targets leading to Trooper 2's wreckage about 0.3 nm south of the last FAA radar target.

The PCT operations manager did not obtain or refer to any recorded PCT radar data after he was advised of the accident. The FAA provided no assistance in locating the crash other than the ADW controller's recollection of the last position shown on the tower radar display. Following the accident, ground searchers were provided with conflicting and inaccurate information from various sources about the helicopter's last known position. Had FAA radar data been used to provide a location to the search teams, the confusion would likely have been reduced, and the searchers could have immediately gone to the correct area. The wreckage was eventually located about 0.3 nm south of the last target, approximately 2.5 nm from ADW.
