National Transportation Safety Board

Safety Recommendation

In reply refer to: A-10-44 and -45

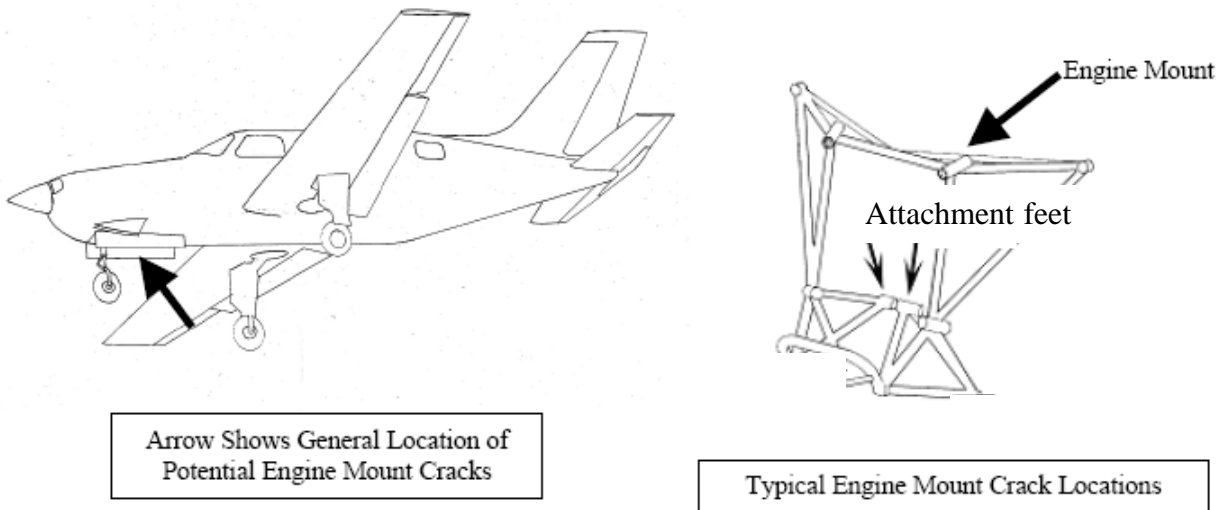
The NLG actuator on Piper PA-46-350P airplanes is bolted via two attachment feet to the lower aft engine mount, which is constructed of welded tubes (see figure 1). The NLG actuator extends down and forward from the attachment feet and attaches to the NLG. During taxi,

takeoff, and landing, the attachment feet transmit loads from the NLG to the engine mount, thus creating repetitive tensile stress in the engine mount attachment feet areas and, in some cases, leading to fatigue cracking.⁴

Figure 1. Piper PA-46-350P crack locations on engine mount

The airplane in the Sanford, Florida, accident was equipped with a redesigned engine mount that was installed at the time of manufacture. The NTSB's postaccident examination of N548C revealed that the right attachment foot had fractured at the engine mount support tube. The NTSB materials laboratory's examination of the fractured foot revealed a fatigue crack emanating from multiple origins at the exterior of the joint where the attachment foot was welded to the support tube. At the time of the accident, the airplane was 8 years old and had accumulated 711 flight hours with 878 cycles since new (CSN).

The airplane in the Fishers, Indiana, accident had a redesigned engine mount that was installed on March 21, 2003. The airplane had accumulated 542 flight hours and an estimated 1,400 cycles since then. At the time of the accident, the airplane was 7 years old and had accumulated a total of 772 flight hours.⁶ The NTSB's postaccident examination of N411MD revealed that the right attachment foot had separated from the rest of the engine mount due to fatigue cracking⁷ where the attachment foot was welded to the support tube.

Require repetitive inspections for fatigue cracking of the nose landing gear actuator attachment foot areas on all Piper PA-46-310 and -350P engine mounts and require replacement, if necessary. (A-10-44)

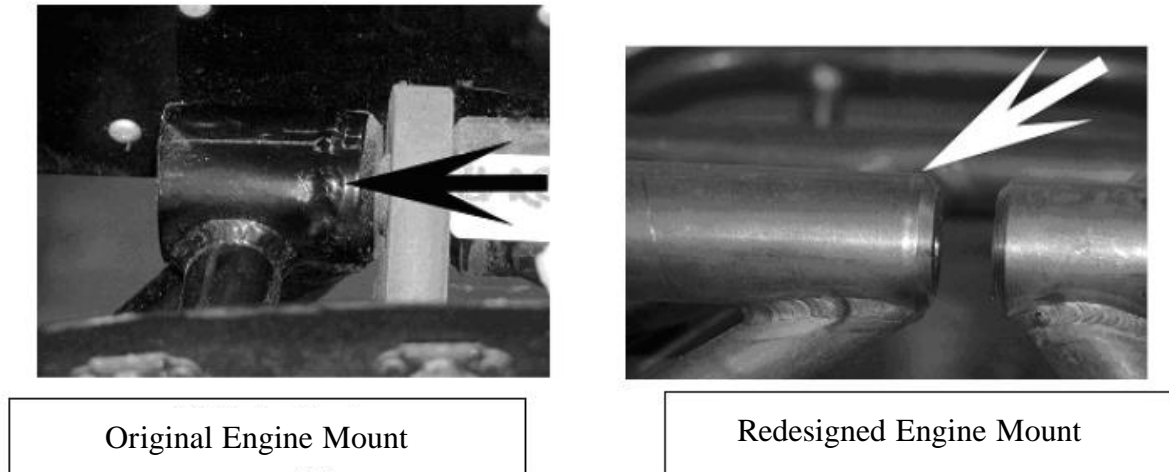
Piper PA-46-310 and -350P airplanes have either an original engine mount or a redesigned engine mount (see figure 2).⁵ In the original design, each attachment foot is a two-piece part consisting of a metal disk welded to the end of a metal tube, which is then welded to the engine mount support tubes. In the redesigned engine mount, each attachment foot is a one-piece machined part made from a single piece of steel, eliminating the welding within the feet themselves. However, on both the original and redesigned engine mounts, the attachment feet are welded to the engine mount support tubes, which is where fatigue cracking has been identified by the NTSB.

Figure 2. Original engine mount with two-piece foot and redesigned engine mount with one-piece machined foot

The NTSB is concerned that the redesigned engine mounts on Piper PA-46-310 and -350P model airplanes have attachment foot areas susceptible to fatigue cracking similar to the fatigue cracks identified by Piper on the original engine mounts. The NTSB concludes that the tensile stresses applied to the redesigned engine mounts could lead to fatigue fractures in the NLG actuator attachment foot areas. However, redesigned engine mounts are not currently subject to the inspection provisions of SB 1103, nor is compliance with SB 1103 required.¹⁰ Although the NTSB is not aware of incidents or accidents involving original engine mounts that have not been inspected, the NTSB believes that inspections of the original engine mounts should also be mandatory in order to detect fatigue cracking. Therefore, the NTSB recommends that the FAA require repetitive inspections for fatigue cracking of the NLG actuator attachment foot areas on all Piper PA-46-310 and -350P engine mounts and require replacement, if necessary.

Require Piper to redesign the PA-46-310 and -350P engine mounts so that they are not susceptible to fatigue cracking in the attachment foot areas. (A-10-45)
