# National Transportation Safety Board

## Safety Recommendation

**Date:** October 20, 2010

**In reply refer to:** A-10-129 and -130

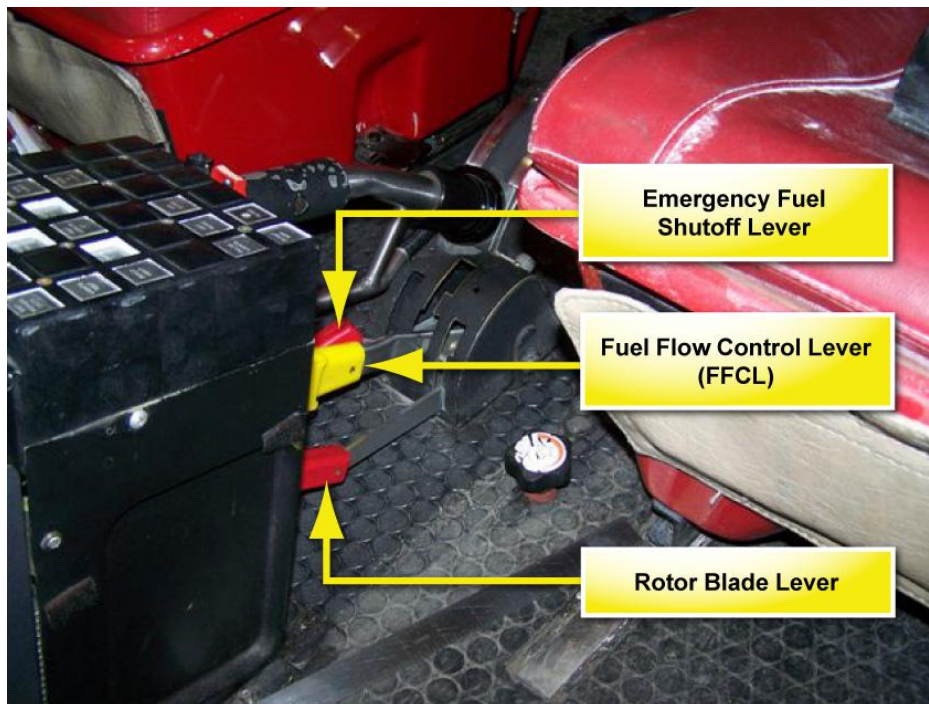
comprised of the FFCL and its detent track, an emergency fuel shutoff lever, and the rotor brake lever (see figure 1).<sup>2</sup> The FFCL, which is the center lever, controls fuel flow to the engine and operates the main and emergency fuel flow control valves. The FFCL moves in a detent track that has three positions, which include two detents. The first position is the stop (aft) detent, the second position is the flight (forward) detent, and the third position is an emergency-valve-opening-travel position, which is forward of the flight detent and is only used for emergency operation (see figure 2). When the FFCL is in the stop detent, the main and emergency fuel flow control valves are closed. When the FFCL moves from the stop detent to the flight detent, it progressively opens the main fuel flow control valve. When the FFCL is in the flight detent, fuel to the engine is automatically metered based on power demand. When the FFCL moves from the flight detent to the emergency-valve-opening-travel position, the emergency fuel flow control valve progressively opens to supply the engine directly. Placing the FFCL in the emergency-valve-opening-travel position bypasses the automatic metering of the fuel control and introduces additional fuel into the engine. Movement of the FFCL is readily accomplished by moving the lever slightly to the right out of the detents and moving it forward or aft.

Figure 1. Floor-mounted control quadrant.

Require Eurocopter to review the design of the fuel flow control lever (FFCL) and/or its detent track on AS350-series helicopters and require modification to ensure that the FFCL is protected to prevent unintentional movement out of its detents and that it does not move easily to an unintended position. (A-10-129)

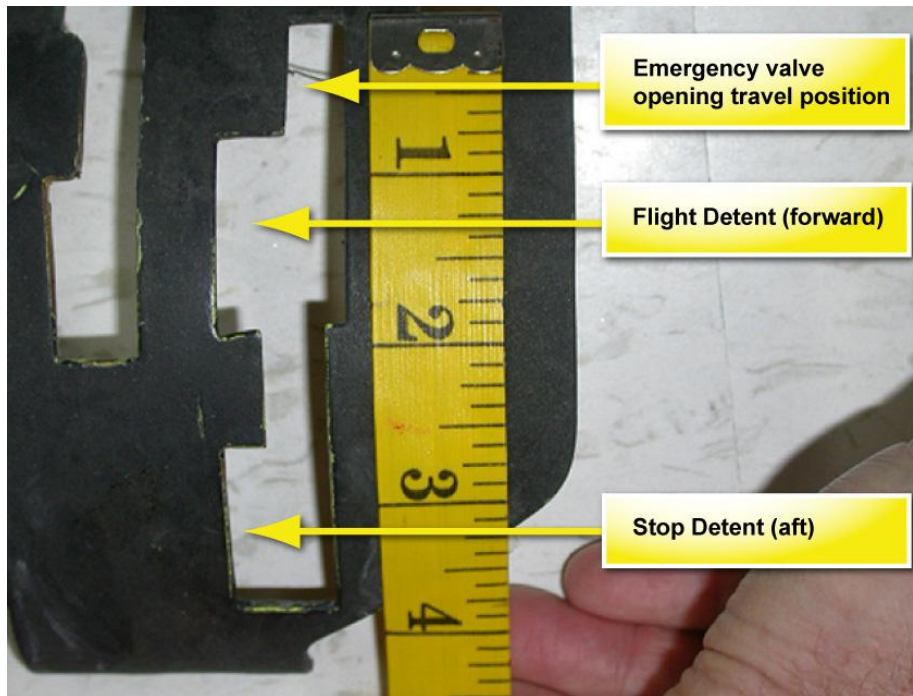
Figure 2. FFCL track and detent/position locations.

The NTSB's investigation of the Chickaloon accident revealed that the FFCL was in the emergency-valve-opening-travel position when the accident occurred. Investigators determined that, due to the close proximity of the passenger's right foot to the FFCL as well as the location of his unstowed backpack in the wreckage, it is likely that either the passenger's right foot or his backpack inadvertently moved the FFCL out of the flight detent and into the emergency-valve-opening-travel position. The movement of the FFCL resulted in an engine overspeed and loss of engine power. Given the rough and uneven terrain in the area and the helicopter's low altitude at the time, a successful autorotation was improbable.

The NTSB concludes that the design and location of the FFCL and its detent track in Eurocopter AS350-series helicopters allows for easy access to and inadvertent movement of the FFCL, which could cause a serious or catastrophic accident if the movement occurs at a critical point during flight or on the ground. Therefore, the NTSB recommends that the Federal Aviation Administration (FAA) require Eurocopter to review the design of the FFCL and/or its detent track on AS350-series helicopters and require modification to ensure that the FFCL is protected to prevent unintentional movement out of its detents and that it does not move easily to an unintended position.

Evaluate other helicopters with fuel flow control levers (FFCL) and detent tracks similar in design to those on Eurocopter AS350-series helicopters and require modification, as necessary, to ensure that the FFCL is protected to prevent unintentional movement out of its detents and that it does not move easily to an unintended position. (A-10-130)
