National Transportation Safety Board

Safety Recommendation

In reply refer to: A-10-131

On April 15, 2008, about 0923 Alaska daylight time, a Eurocopter AS350B2 helicopter, N213EH, experienced a loss of engine power during flight and sustained substantial damage during an emergency descent and impact with terrain about 34 miles east of Chickaloon, Alaska.¹ The commercial pilot and three passengers were fatally injured, and one passenger was seriously injured. The on-demand air taxi flight was conducted under 14 *Code of Federal Regulations* (CFR) Part 135 in visual meteorological conditions.

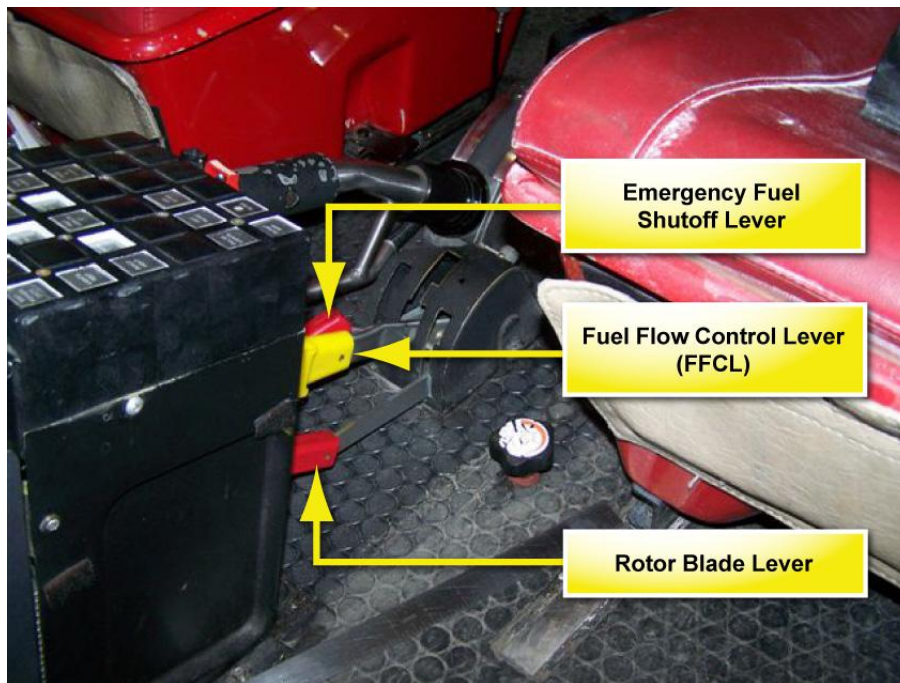
The control quadrant of Eurocopter AS350B, AS350BA, AS350B1, and AS350B2 helicopter models is located on the floor between the pilot's seat and the front left seat and is comprised of the FFCL and its detent track, an emergency fuel shutoff lever, and the rotor brake lever (see figure 1).² The FFCL, which is the center lever, controls fuel flow to the engine and operates the main and emergency fuel flow control valves. The FFCL moves in a detent track that has three positions, which include two detents. The first position is the stop (aft) detent, the second position is the flight (forward) detent, and the third position is an emergency-valve-opening-travel position, which is forward of the flight detent and is only used for emergency operation (see figure 2). When the FFCL is in the stop detent, the main and emergency fuel flow control valves are closed. When the FFCL moves from the stop detent to the flight detent, it progressively opens the main fuel flow control valve. When the FFCL is in the flight detent, fuel to the engine is automatically metered based on power demand. When the FFCL moves from the flight detent to the emergency-valve-opening-travel position, the emergency fuel flow control valve progressively opens to supply the engine directly. Placing the FFCL in the emergency-valve-opening-travel position bypasses the automatic metering of the fuel control and introduces additional fuel into the engine. Movement of the FFCL is readily accomplished by moving the lever slightly to the right out of the detents and moving it forward or aft.

Figure 1. Floor-mounted control quadrant.

The NTSB concludes that the design and location of the FFCL and its detent track in Eurocopter AS350-series helicopters allows for easy access to and inadvertent movement of the FFCL, which could cause a serious or catastrophic accident if the movement occurs at a critical point during flight or on the ground.

Require Eurocopter to review the design of the fuel flow control lever (FFCL) and/or its detent track on AS350-series helicopters and require modification to ensure that the FFCL is protected to prevent unintentional movement out of its detents and that it does not move easily to an unintended position. (A-10-131)

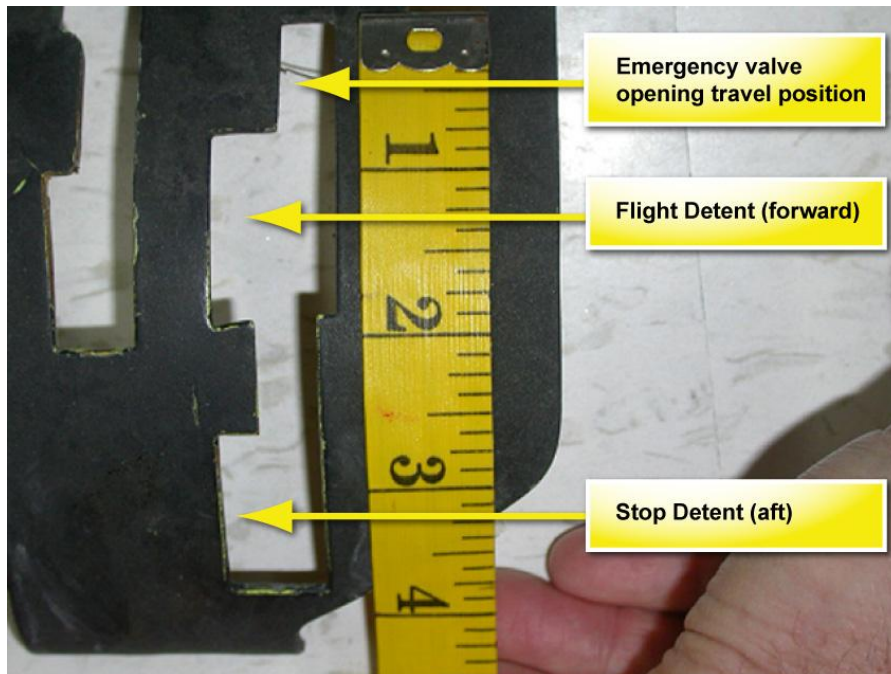
Figure 2. FFCL track and detent/position locations.

The NTSB's investigation of the Chickaloon accident revealed that the FFCL was in the emergency-valve-opening-travel position when the accident occurred. Investigators determined that, due to the close proximity of the passenger's right foot to the FFCL as well as the location of his unstowed backpack in the wreckage, it is likely that either the passenger's right foot or his backpack inadvertently moved the FFCL out of the flight detent and into the emergency-valve-opening-travel position. The movement of the FFCL resulted in an engine overspeed and loss of engine power. Given the rough and uneven terrain in the area and the helicopter's low altitude at the time, a successful autorotation was improbable.

The NTSB is concerned that the FFCLs on Eurocopter AS350-series helicopters can be easily and inadvertently moved out of their detents by objects or persons, including the pilot and passengers, in flight or on the ground. If the FFCL is inadvertently moved to the emergency-valve-opening-travel position during flight, the engine can rev up in seconds (as was the case in the Chickaloon accident), which can result in engine overspeed, engine over-temp, engine over-torque, and drive-train damage. According to Eurocopter's chief test pilot, the placement of the FFCL in the emergency-valve-opening-travel position during cruise flight could cause an engine overspeed within seconds and could potentially result in the shedding of free
