National Transportation Safety Board

Safety Recommendation

Date: November 17, 2010

In reply refer to: A-10-132 through -135

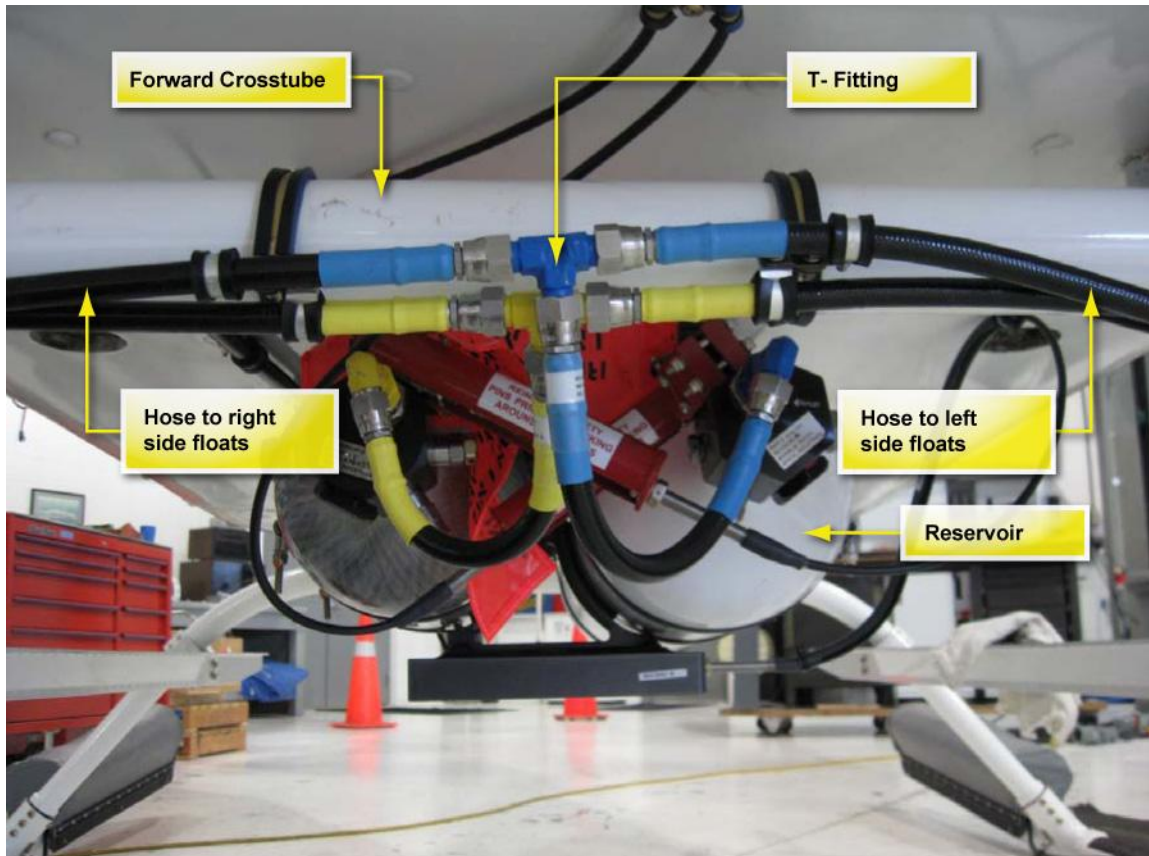
cross-tube of the helicopter. (See figure 1.) The gas then splits off into two 0.30-inch-diameter hoses (left and right) and travels to two Y-shaped port fittings (left and right) mounted to the bottom of the cross-tube. Each port fitting then distributes the gas to all three floats on that side of the helicopter through 0.30-inch-diameter hoses. (See figure 2.)

Figure 1. Apical emergency float system hose connections between the reservoir and the floats.

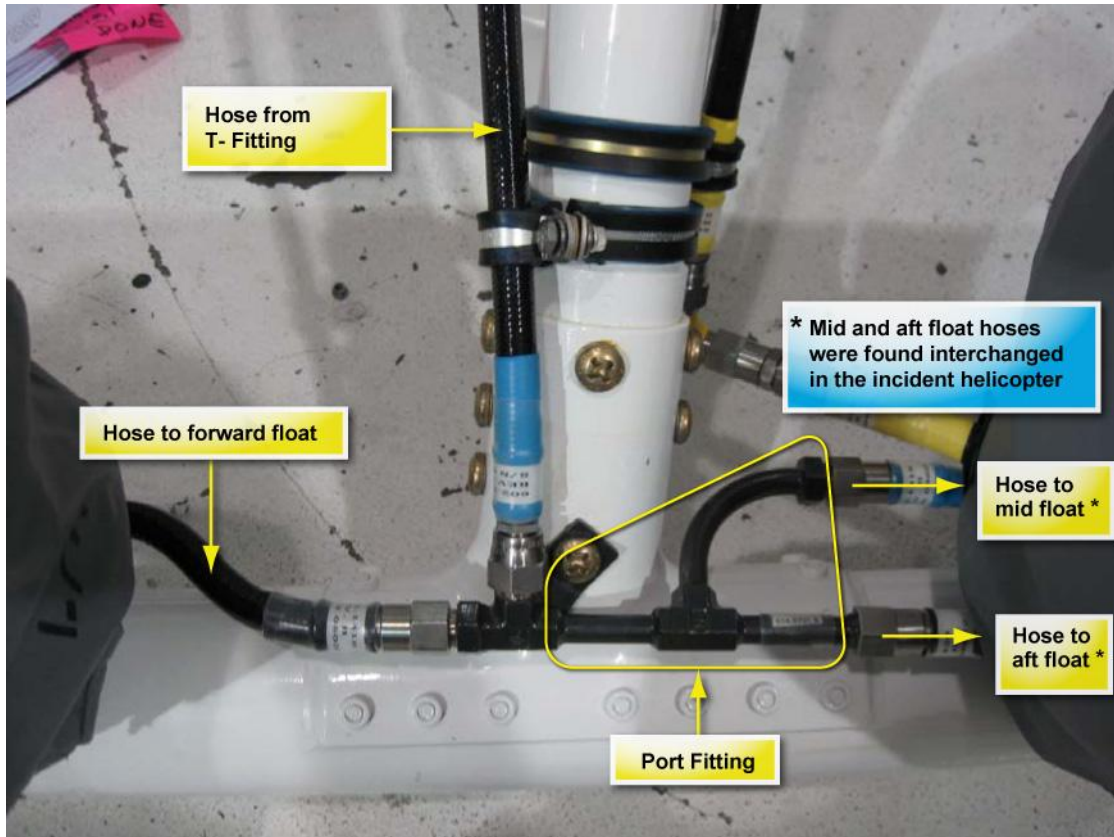
On the inside of the port fitting are two different-sized reducers (0.125 inch for the hose intended to lead to the forward float and 0.145 inch for the hose intended to lead to the mid float) that control the gas flow to the forward and mid floats so that the floats inflate with equal pressure despite their different capacities and distances from the cylinder. The forward float has a smaller gas capacity, thus requiring less gas and a shorter time to inflate and, therefore, has a reducer of 0.125 inch. The mid float is closest to the port fitting but has a larger gas capacity, thus requiring more gas and, therefore, has a reducer of 0.145 inch. The aft float is the farthest from the port fitting with a larger gas capacity, thus requiring more gas and time to inflate and, therefore, has no reducer to allow nonrestricted gas flow.

Figure 2. Apical emergency float system port fitting and hose connections to forward, mid, and aft floats.

As noted, examination of the incident helicopter revealed that the hoses for the mid and aft floats were interchanged, allowing nonrestricted gas flow to the mid float. This mistake is possible because both hoses can connect to either hose connection at the port fitting. According to Apical, if these hoses are interchanged and installed incorrectly to the port fitting, the gas will not distribute properly through the port fitting and the mid float will inflate quicker than the aft float. This error will result in increased pressure beyond the mid float's designed capacity, which can lead to bursting, and reduced pressure and insufficient gas flow to the aft float. This uneven gas distribution can lead to the risk of inversion because the floats will not inflate uniformly.

Based on the similar design and size of the connections of the float hoses to the port fitting and given repetitive findings by PHI and other operators, the NTSB concludes that the hoses that connect the mid and aft float to the port fitting can easily be interchanged and installed incorrectly, resulting in low inflation pressure in the aft float with simultaneous excessive pressure in, and rupture of, the mid float. The NTSB further concludes that a new design is needed to ensure that the required hoses will, in every instance, be connected only to their proper fittings. Such a design could use different sizes of hose-to-port fittings or different design connections so that a float's hose can only be connected to the proper opening at the port fitting and cannot be interchanged. Therefore, the NTSB recommends that the Federal Aviation Administration (FAA) require Apical Industries Inc., to redesign the emergency float system for helicopters such that the hoses for the mid and aft floats can no longer be interchanged and installed incorrectly to the port fitting. Once the redesigned emergency float system described in Safety Recommendation A-10-132 is available, the NTSB recommends that the FAA require operators of all helicopters currently equipped with Apical emergency float systems to install the redesigned system.

Require Apical Industries Inc., to redesign the emergency float system for helicopters such that the mid and aft floats can no longer be interchanged and installed incorrectly to the port fitting. (A-10-132)

Require operators of helicopters equipped with Apical emergency float systems to immediately conduct a one-time, two-person, visual inspection to ensure that the hoses from the mid and aft floats are properly installed to the port fitting. (A-10-134)

Until the redesigned Apical emergency float system is installed as described in Safety Recommendation A-10-133, at every maintenance activity that requires disconnection of the hoses, require a two-person inspection of the re-installation of the hoses from the mid and aft floats to the port fitting and to sign a maintenance checklist attesting to proper installation. (A-10-135)
