National Transportation Safety Board

Safety Recommendation

Date: November 23, 2010

In reply refer to: A-10-136 through -147

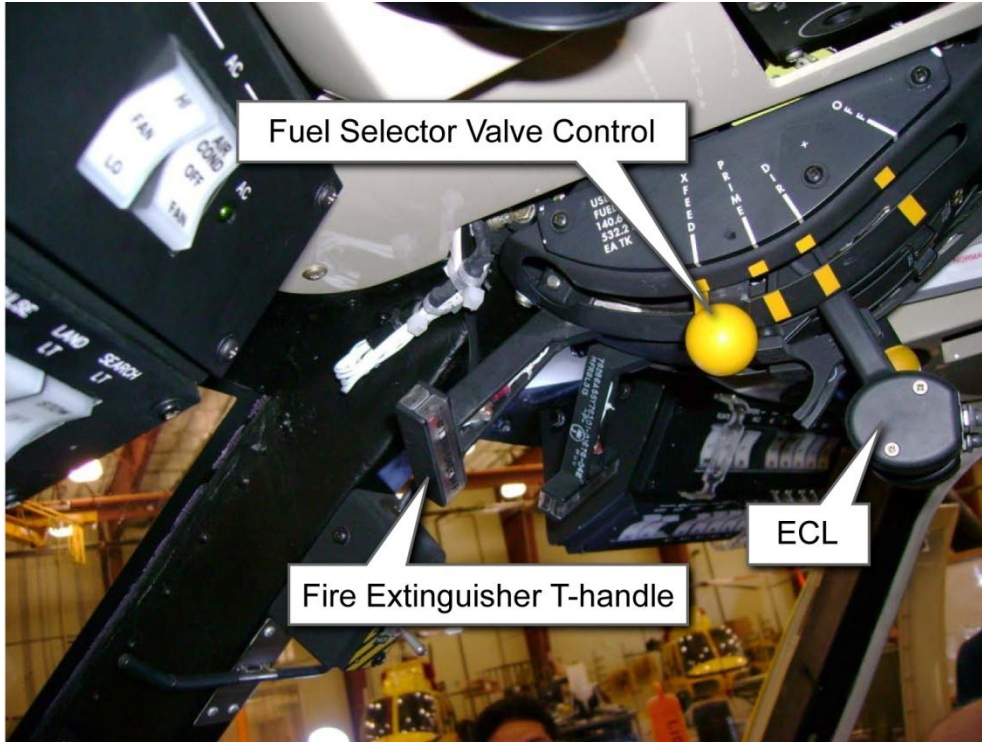
The Sikorsky S-76C++ helicopter has an overhead engine control quadrant that houses two engine fire extinguisher T-handles, two engine power control levers (ECL), two fuel selector valve control levers, and switches for other essential functions (see figure 1). The fire extinguisher T-handles, which are located about 4 inches aft of the captain's and first officer's windshields, are normally in the full-forward position during flight and are held in place by a spring-loaded pin that rests in a detent; aft pulling force is required to move the handles out of their detents (see figure 2). In the event of an in-flight engine fire indication, the flight crew is instructed, in part, to move the affected engine's fire extinguisher T-handle full aft so that a mechanical cam on the T-handle pushes the trigger on the ECL out of the wedge-shaped stop, allowing it to physically move aft with the T-handle (pilot input is required to move the T-handle and ECL aft together); fuel to the affected engine is then reduced. The fuel flow to the engine is eventually shut off as the fire extinguisher T-handle continues aft. The fire extinguisher system is then automatically armed and ready for the pilots to release the fire extinguishing agent into the appropriate engine compartment. Sikorsky S-76C+, S-76D, and S-92A helicopters have engine control quadrant designs similar to the S-76C++ helicopter.

Figure 1. Engine control quadrant on a Sikorsky S-76C++ helicopter.

The NTSB concludes that impact forces on the S-76C++⁶ canopy or windshields near the engine control quadrant and the subsequent movement of T-handles, which may push the ECL triggers out of the stops and allow them to move aft and into or near the flight-idle position, could result in unexpected and substantial loss of engine power. Greater resistance to movement of the fire extinguisher T-handles would ensure that the T-handles do not become dislodged due to impact force on the canopy or windshield and cause unintended movement of the ECLs. The NTSB understands that pilots would then need to use greater force to move the T-handles; however, this resistance can be calculated so that it will not lead to operational problems for the pilots who activate the T-handles when needed and will still provide protection against unintentional movement of the T-handles and ECLs. Therefore, the NTSB recommends that the FAA require that Sikorsky redesign the S-76C++ model helicopter fire extinguisher T-handles and/or engine control quadrant to ensure that the T-handles do not inadvertently dislodge out of their detents due to any external force on the canopy or windshields that could cause unintended movement of the ECLs. The NTSB further recommends that the FAA evaluate other helicopter models with engine control quadrant designs similar to the S-76C++ model helicopter and require modification, as necessary, to ensure that any external force on the canopy or windshields does not cause unintended movement of the ECLs.

Require that Sikorsky redesign the S-76C++ model helicopter fire extinguisher T-handles and/or engine control quadrant to ensure that the T-handles do not inadvertently dislodge out of their detents due to any external force on the canopy or windshields that could cause unintended movement of the engine power control levers. (A-10-136)

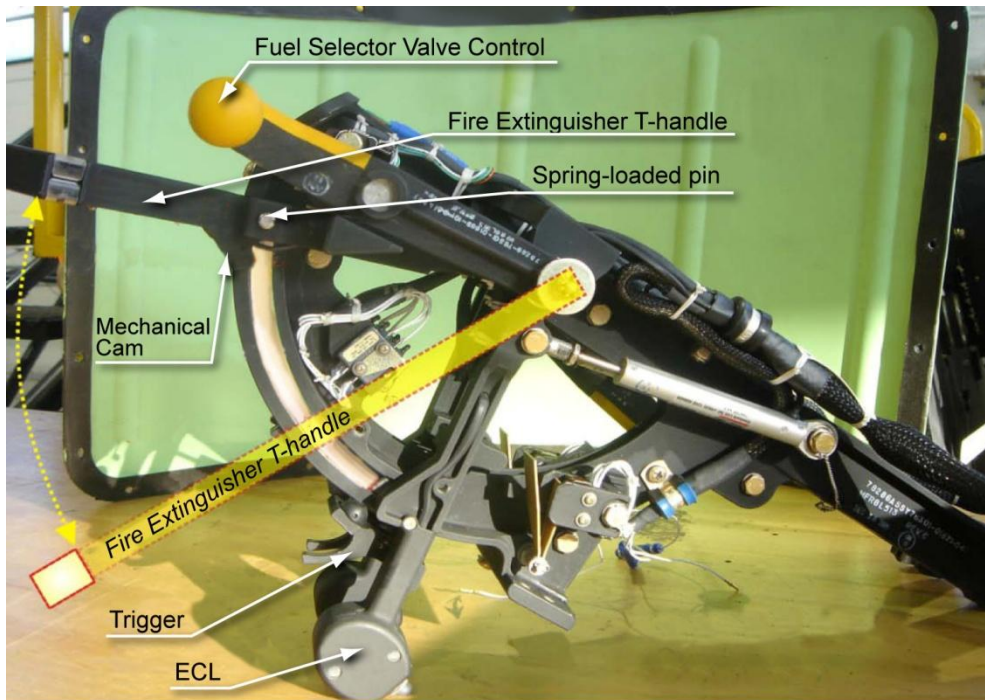
Figure 2. S-76C++ fire extinguisher T-handle and ECL with trigger mechanism.

Based on the impact damage to the canopy, it is likely that the bird impacted the canopy just above the right-side windshield near the fire extinguisher T-handles. As noted, the CVR recorded a loud bang and rushing wind, immediately followed by sounds consistent with a power reduction on both engines; thus, it is likely that the bird impact shattered the windshield and jarred the fire extinguisher T-handles out of their detents and moved them aft. The momentum of the T-handles pushed both ECL triggers out of their stops and allowed them to move aft and into or near the flight-idle position. A similar incident occurred on November 13, 1999, in West Palm Beach, Florida, when a bird struck the windshield of an S-76C+ helicopter, N276TH, operated by Palm Beach County.⁵ The bird did not penetrate the laminated glass windshield, but the impact force of the bird cracked the windshield and dislodged the fire extinguisher T-handles out of their detents; however, in that case, the force was not great enough to move the ECLs.
