# NATIONAL TRANSPORTATION SAFETY BOARD

## PIPELINE ACCIDENT REPORT

Natural Gas Pipeline Rupture  
and Subsequent Explosion  
St. Cloud, Minnesota  
December 11, 1998

**NTSB/PAR-00/01  
PB2000-916501  
Notation 7178A  
Adopted July 11, 2000**

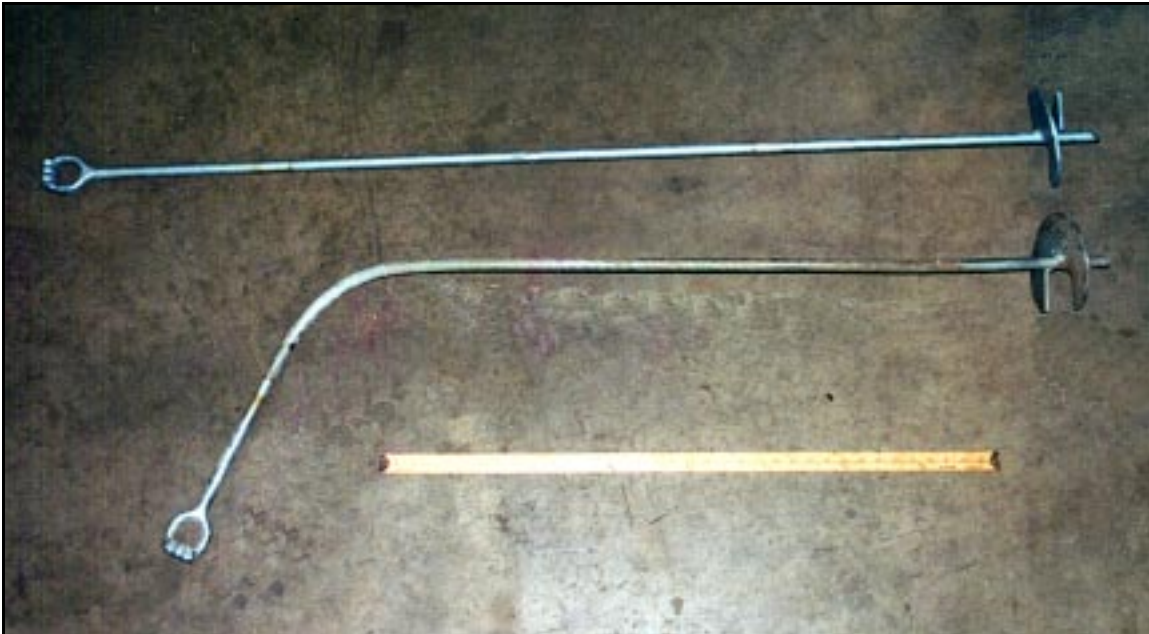
**Figure 2.** Unused anchor (top) and accident anchor after removal from accident site

The CCI crew stated that they intended to install the anchor vertically, and no evidence was found to indicate that the anchor did not enter the ground vertically. But when the anchor struck the buried granite slab, the crewmembers followed their customary practice and struck the top of the anchor with a hammer until they perceived that the anchor had broken through the obstacle or had deflected off to its side. As the investigation later determined, the anchor had not broken through but had bent and deflected. The anchor apparently continued to bend as the four men applied pressure to the anchor cranker in their attempt to complete the installation. The investigation determined and postaccident excavation revealed that the anchor bent and followed along the upper surface of the buried granite slab until the cutting helix on the anchor tip dropped off the end of the slab, thus striking and rupturing the pipeline.

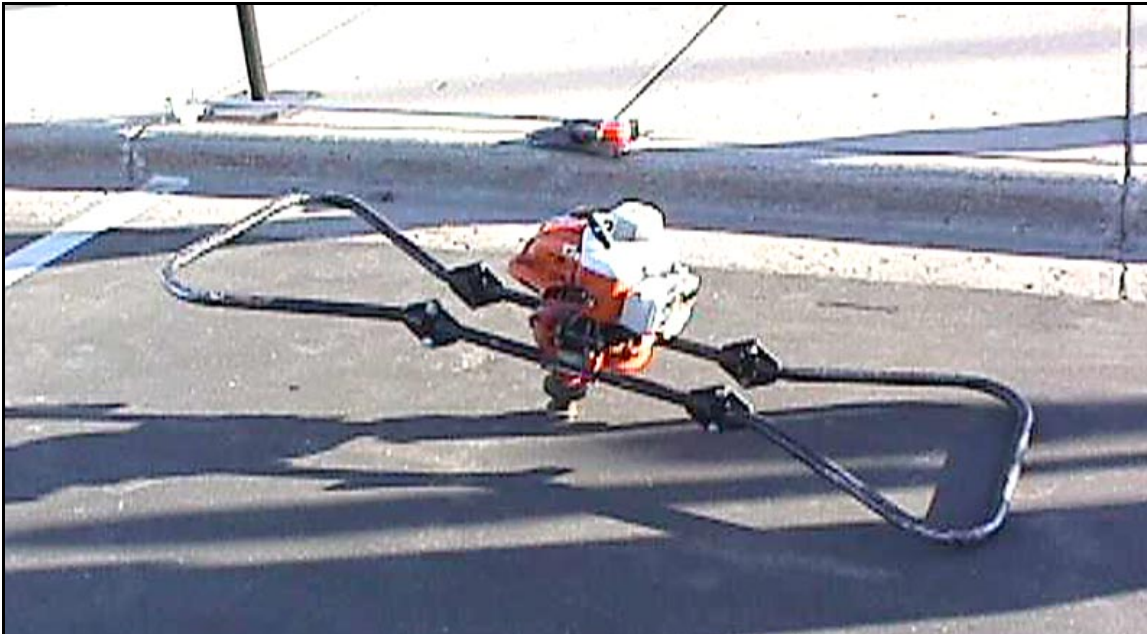
**Figure 3.** The “anchor cranker” auger used to install the anchor that ruptured the pipeline

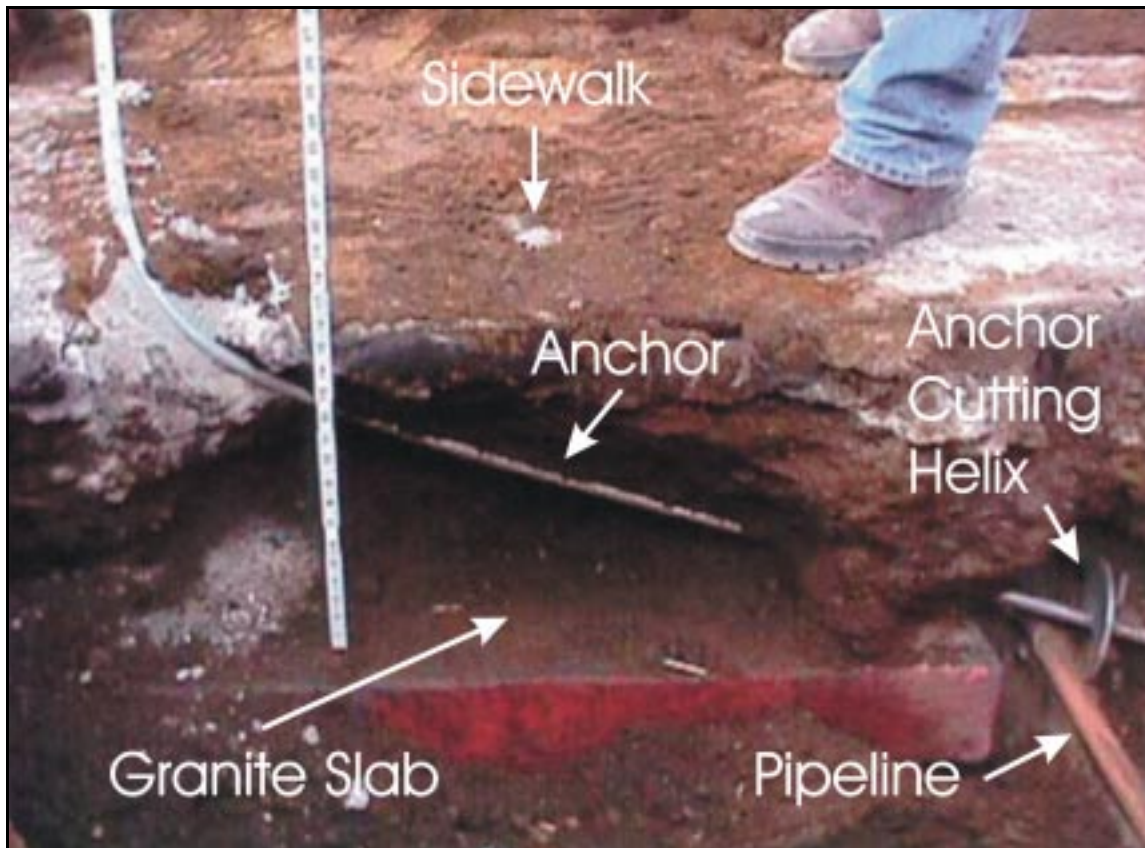
began to smell gas. They then stopped the auger and released it. At that point, according to the foreman, “it [the auger] just laid over towards the [utility] pole.” (See figure 4.)

**Figure 4.** Anchor installation site as revealed by postaccident excavation

NSP marked the location of a nearby gas service line before the CCI construction crew began installing the utility pole anchor through the sidewalk next to the building housing Book-Em's Bar and Bellanti's Pizza. Postaccident excavations confirmed the accuracy of the paint marks that indicated the location of the natural gas line. The Safety Board concludes that the marked location of the ruptured gas line was accurate and was therefore not a factor in this accident.

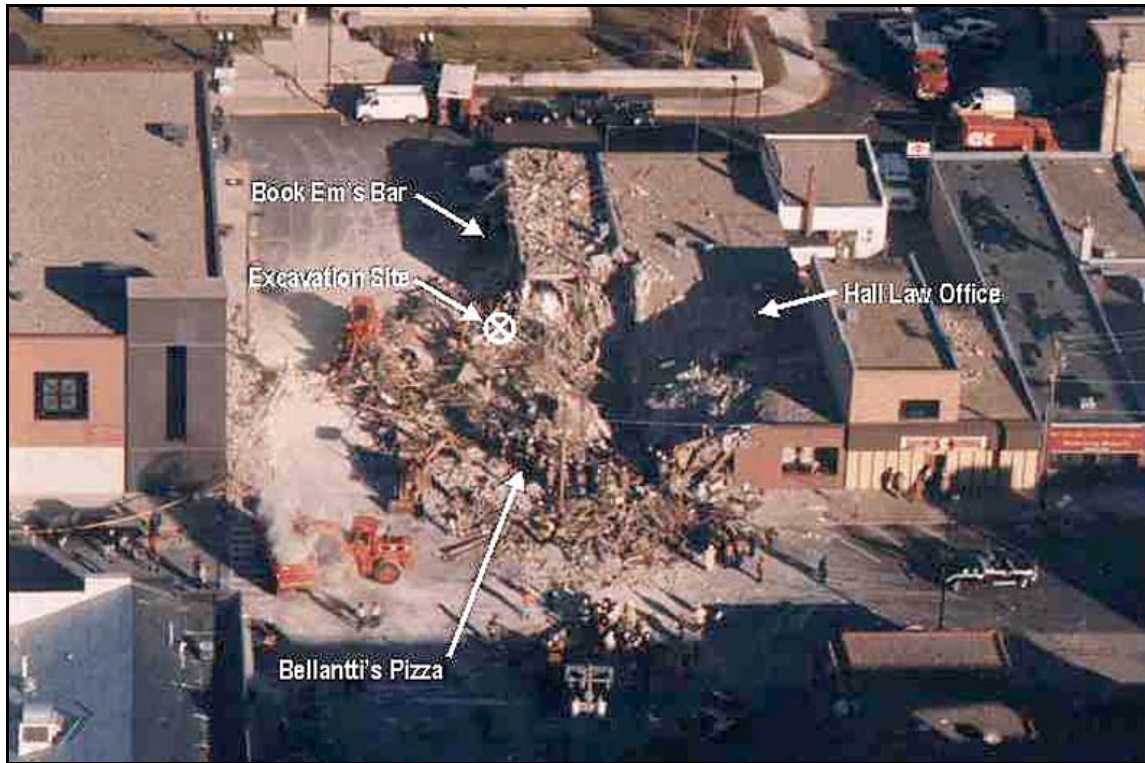
In addition to the building containing Bellanti's Pizza and Deli, the explosion destroyed the buildings containing Book Em's Bar, Tom's Bar, and Bartsh Bail Bonds, and the two buildings containing the Hall Law Offices. The law office buildings were joined with a fire door. The blast also damaged the Stearns County court facilities building and the buildings housing Taco John's and Howies Bar. According to the St. Cloud city assessor, the damage assessment for the buildings destroyed by the natural gas explosion was \$399,000. (See figure 5.)

**Figure 5.** Postaccident aerial view of affected area
