Highway Accident Report

Collision Between Amtrak Train 97 and Molnar Worldwide Heavy Haul Company Tractor-Trailer Combination Vehicle at Highway-Rail Grade Crossing in Intercession City, Florida, on November 17, 2000

**NTSB/HAR-02/02
PB2002-916202
Notation 7480
Adopted July 23, 2002**

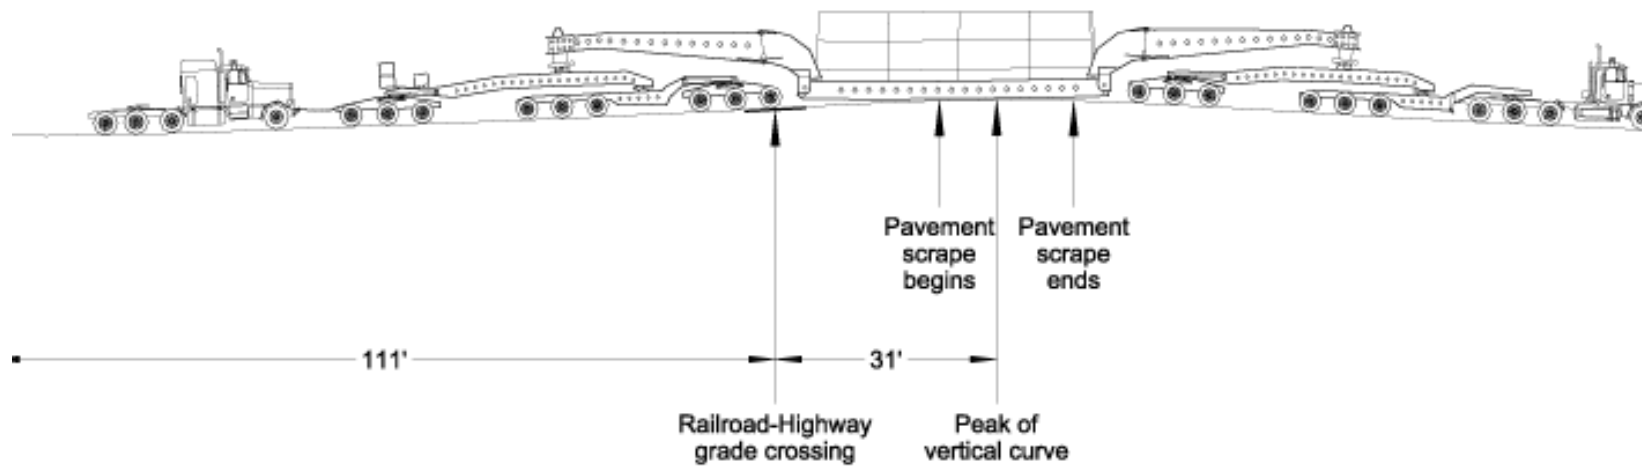
Figure 7. Accident grade crossing profile showing where trailer scraped pavement.

The auxiliary operator stated that as the center portion of the trailer traversed the crossing, the frame rails scraped the surface of the roadway. (See figure 7.) The vehicle did not hang up on the crossing. Convoy crewmembers stated that the crossing lights flashed and the bell activated. The auxiliary operator observed a train approaching from the east and then heard the train horn. The vehicle had not yet cleared the crossing, and the auxiliary operator notified the truckdriver by radio of the approaching train. The auxiliary operator then jumped from the rear control station. The train struck and sheared off the pusher truck tractor, which was located directly behind the rear control station. (At the time of the accident, this truck tractor was being towed.) The rear portion of the trailer swung toward the east, left the paved surface of the roadway, and struck a concrete stanchion supporting an electrical tower, where it came to rest.

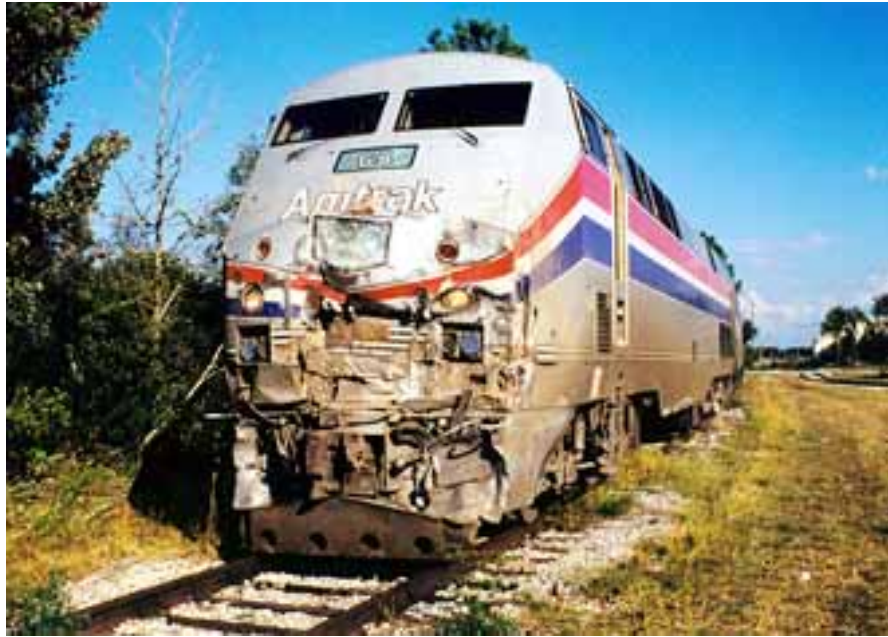
Figure 8. Amtrak locomotive after collision.

The collision resulted in moderate damage to the locomotive (see figure 8) and brake rigging damage to the baggage car. The pusher tractor was destroyed. (See figure 8a.) (See table 2.)

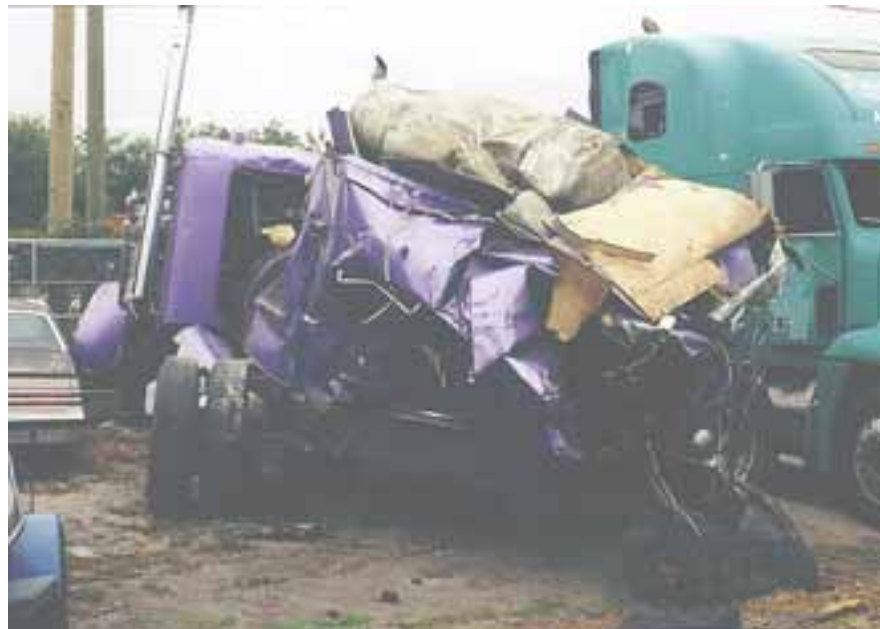
Figure 8a. Rear view of pusher tractor after collision.

No mechanical deficiencies were noted on the truck-tractor combination vehicle during the Safety Board’s postaccident inspection. The 1993 Peterbilt tractor was extensively damaged following impact with the Amtrak locomotive. The right front tire/wheel and the suspension of the rearmost three-axle steerable dolly were damaged when the dolly struck the concrete base of a utility pole. The counterweight separated from the tractor at impact and struck the Amtrak locomotive in the front between the headlight and coupler device.

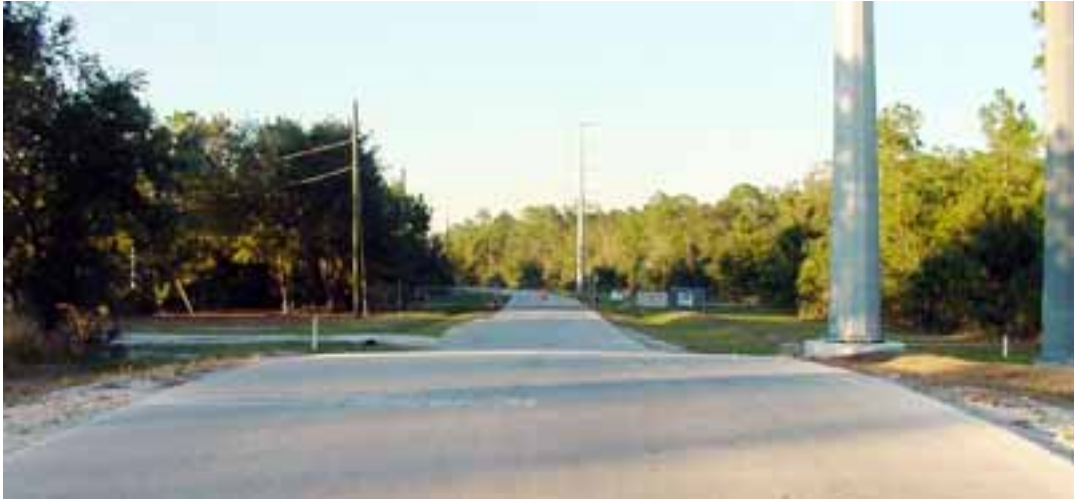
Figure 9. Photograph of accident highway-rail grade crossing.

Acceptable geometrics necessary to prevent drivers of low-clearance vehicles from becoming caught on the tracks would provide the crossing surface at the same plane as the top of the rails for a distance of 2 feet outside the rails. The surface of the highway should also not be more than 3 in. higher nor 6 in. lower than the top of the nearest rail at a point 30 feet from the rail unless track superelevation dictates otherwise.

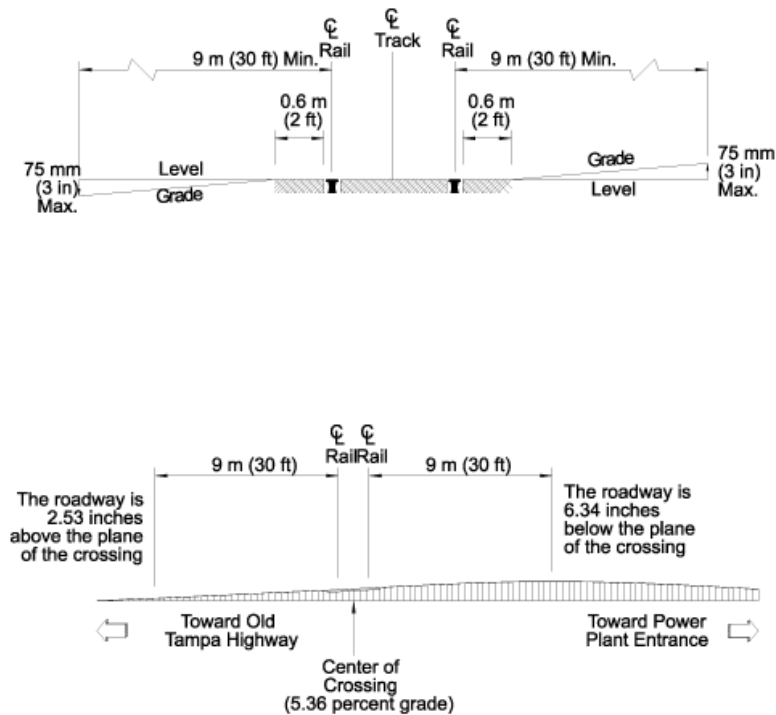
Figure 11. Schematic illustrating AASHTO guidelines and accident grade crossing profile.

Based on the 2001 guidelines, the crossing is a humped crossing.¹⁹ Because it was built in 1993, it is not required to conform to the current guidelines. (See figure 11.)

¹⁹ The *Manual on Uniform Traffic Control Devices* refers to humped crossings as highway profile conditions sufficiently abrupt to create a “hang-up” situation for long wheelbase vehicles or low-ground clearance trailers.

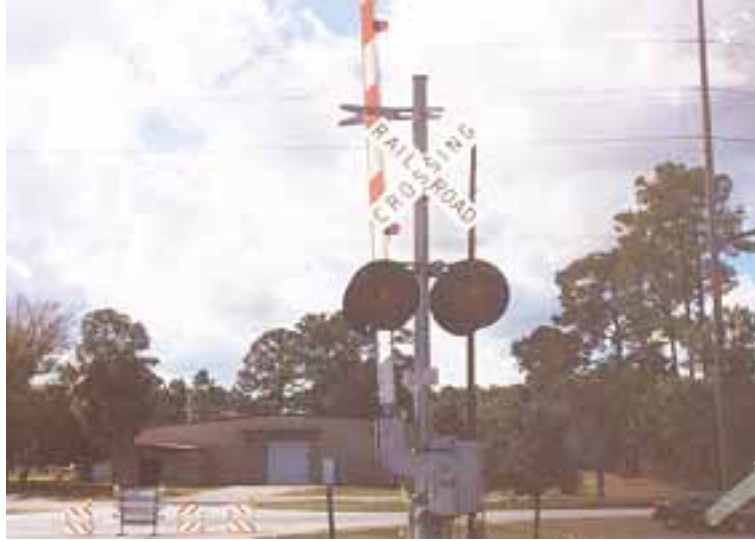
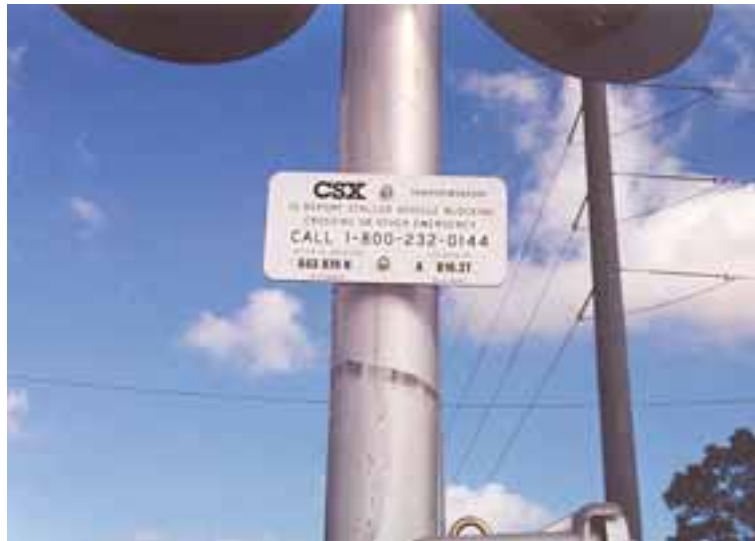
Metal emergency call number signs, approximately 12 by 6 inches, were mounted on each crossing gate vertical pole. (See figures 12 and 13.)

According to CSXT, the signs were installed in 1997. The signs read as follows:

CSX TRANSPORTATION
TO REPORT STALLED VEHICLE BLOCKING CROSSING OR OTHER
EMERGENCY
CALL 1-800-232-0144
Ref. Crossing - ID #643 879N
Located at mile post A 816.27

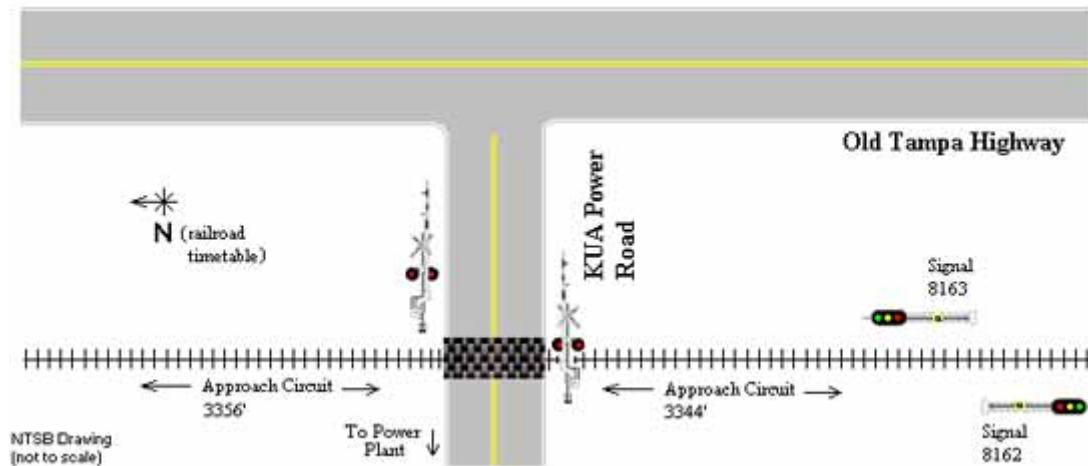
Figure 15. Crossing signals.

The crossing was equipped with gates, eight 12-inch diameter flashing lights, and a bell. The warning devices were controlled by a Harmon phase motion detector designed to provide a minimum of 25 seconds of warning time for trains traveling at the maximum authorized speed of 79 mph. The north approach track circuit (for southbound trains) extended approximately 3,356 feet from the center of the crossing and was terminated with a narrow band shunt (326 hertz [Hz]). A whistle board was positioned by the wayside, approximately 1,898 feet from the center of the crossing. The south approach track circuit (for northbound trains) extended approximately 3,344 feet from the center of the crossing and was also terminated with a narrow band shunt (326 Hz). A whistle board for northbound trains was positioned 2,186 feet from the center of the crossing. (See figure 15.)

After the accident, the Safety Board conducted operational tests on the active crossing traffic control devices (signals, bells, lights, and gates) and found no anomalies.²² The north approach circuit measured 3,356 feet. The testing showed that trains traveling at the maximum authorized speed of 79 mph would take 29 seconds to traverse the approach circuit and occupy the crossing. The train detection equipment required approximately 3 to 4 seconds to recognize an approaching train and activate the warning devices. This configuration provided a minimum warning time of 25 seconds before the arrival of a train at the crossing. Slower trains received longer warning times.
