Aircraft Accident Report

**Loss of Control and Impact with Pacific
Ocean Alaska Airlines Flight 261
McDonnell Douglas MD-83, N963AS
About 2.7 Miles North of
Anacapa Island, California
January 31, 2000**

**NTSB/AAR-02/01
PB2002-910402
Notation 7263E
Adopted December 30, 2002**

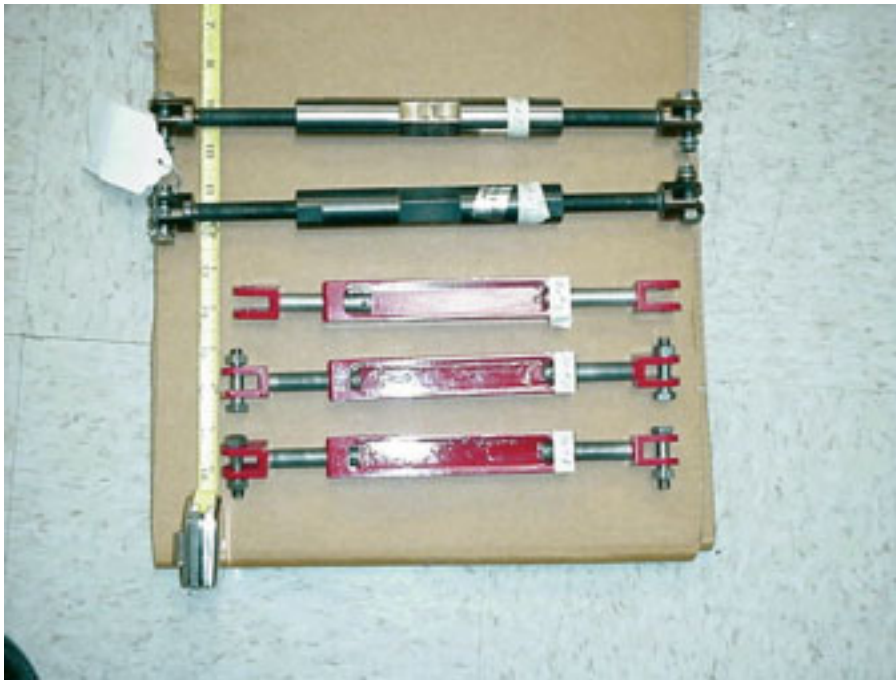
⁹⁰ The Safety Board did not use the actual restraining fixture that was used for the accident airplane’s last end play check because it was not in serviceable condition.

⁹¹ Discrepancies up to a maximum of about 0.005 inch were recorded.

Figure 10. Two Alaska Airlines-fabricated restraining fixtures and three Boeing-manufactured fixtures.

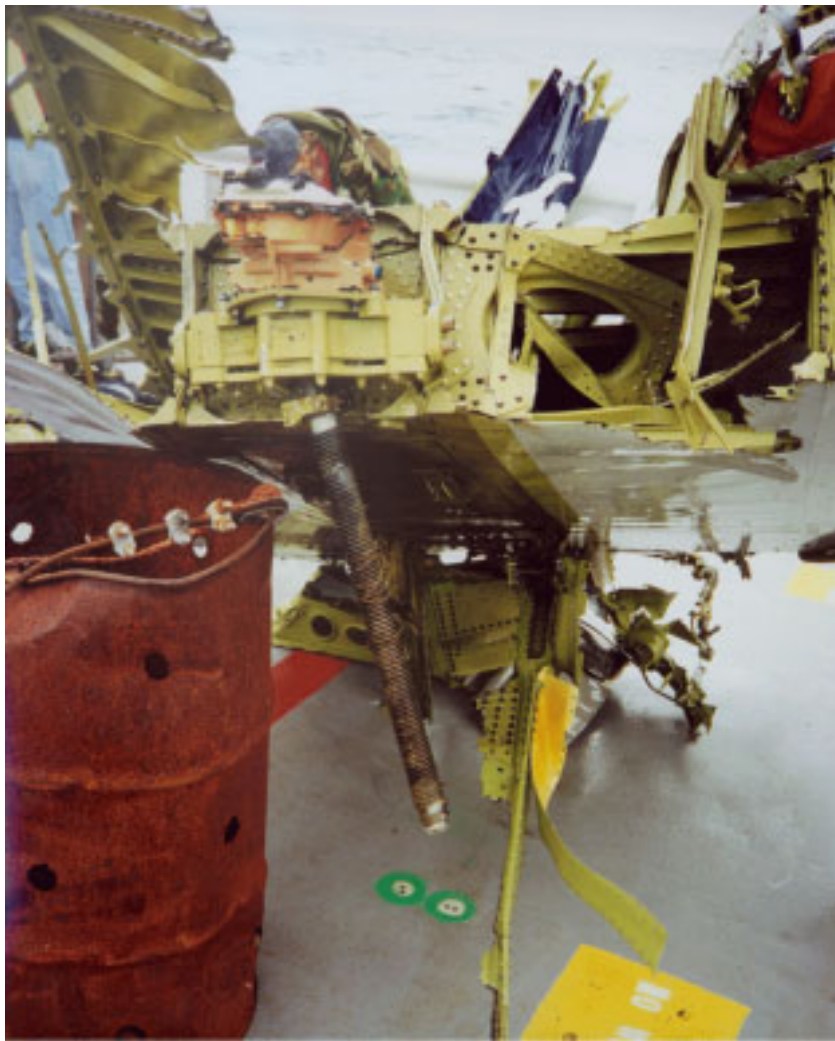
wrapped around the central part of the acme screw.¹¹⁶ (Figures 12a and 12b show the acme screw immediately after it was brought on board the recovery ship and immediately after it was brought to shore, respectively; figure 12c shows the acme screw during initial inspection.) The acme screw was rinsed with fresh water immediately after its recovery by directing the water from a hose similar to a garden hose over the gearbox and allowing the water to flow down over the screw. To preserve the acme screw and the thread remnants wrapped around the screw in their as-recovered condition, the stream of water used to rinse the screw was not directly sprayed on it. The acme screw might have been rinsed again with a garden-type hose after it was brought to shore.

Figure 12a. The acme screw immediately after it was brought on board the recovery ship.

Figure 12b. The acme screw immediately after it was brought to shore.

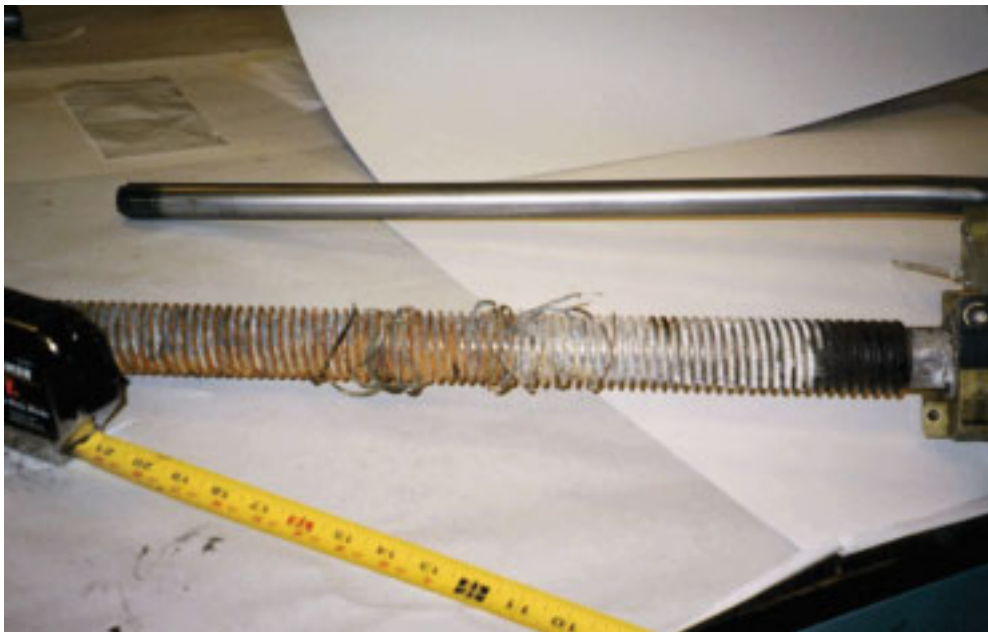
Corrosion pitting and red rust areas were found along most of the acme screw's length, with the heaviest areas of corrosion and rust along its lower half. Large areas of the acme screw were also found covered by white deposits, which chemical analysis determined were consistent with corrosion debris from the magnesium gearbox case attached to the top of the acme screw assembly. Figure 13 shows the acme screw thread remnants wrapped around the screw, the red rust areas, and the white deposits.

Figure 13. A photograph of the acme screw thread remnants wrapped around the screw, the red rust areas, and the white deposits.
