APPENDIX V  
MINE MAP  
ARACOMA ALMA MINE #1, MSHA ID No. 46-08801  
ARACOMA COAL COMPANY, INC.  
9 Headgate Longwall Belt Drive  
Area Fire Protection

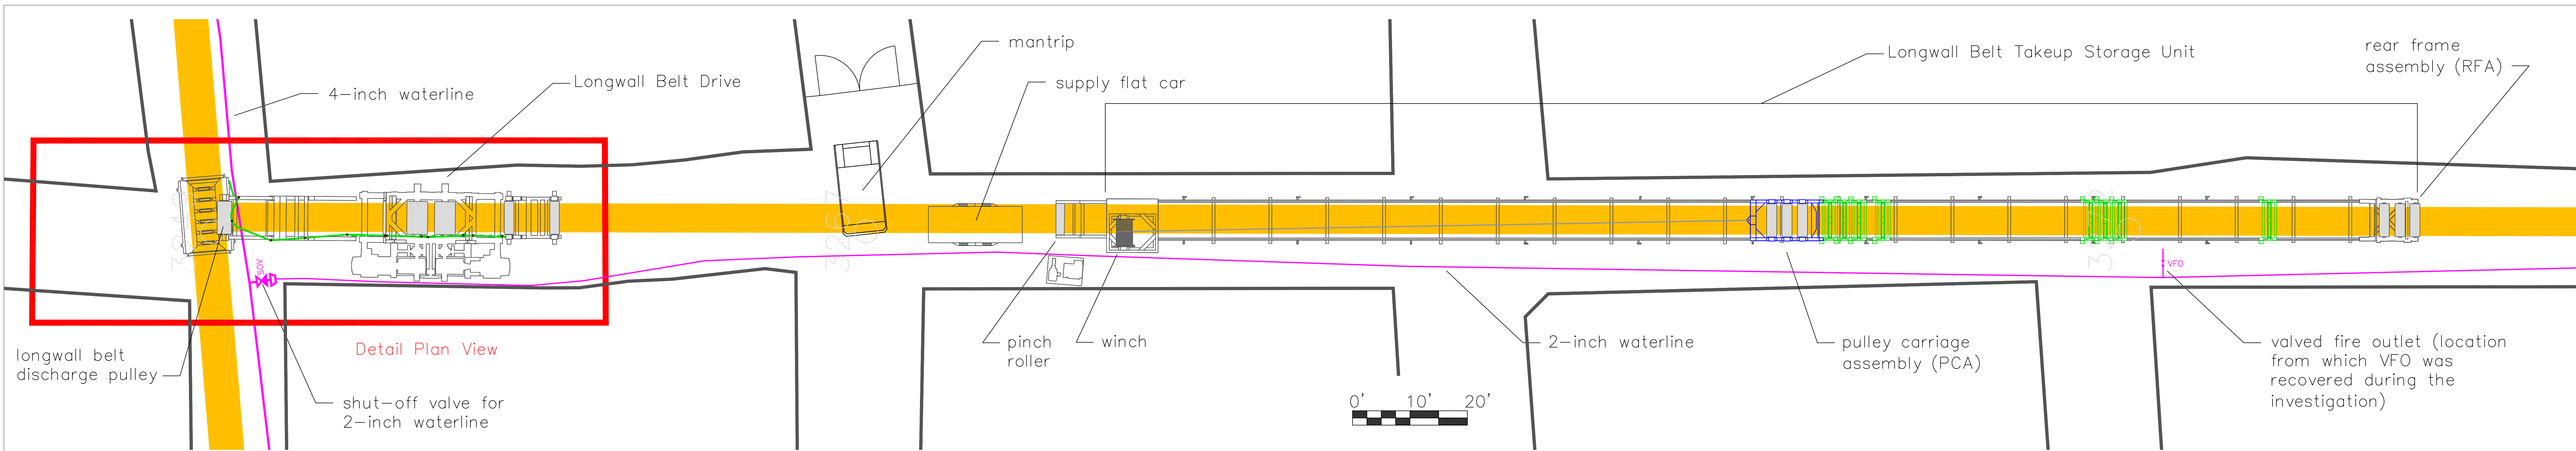
Plan View of Longwall Belt Drive and Takeup Storage Unit Area

Waterline and other objects in the area of the fire were damaged. Approximate location of specific objects depicted as mapped and photographed for demonstrative purposes.

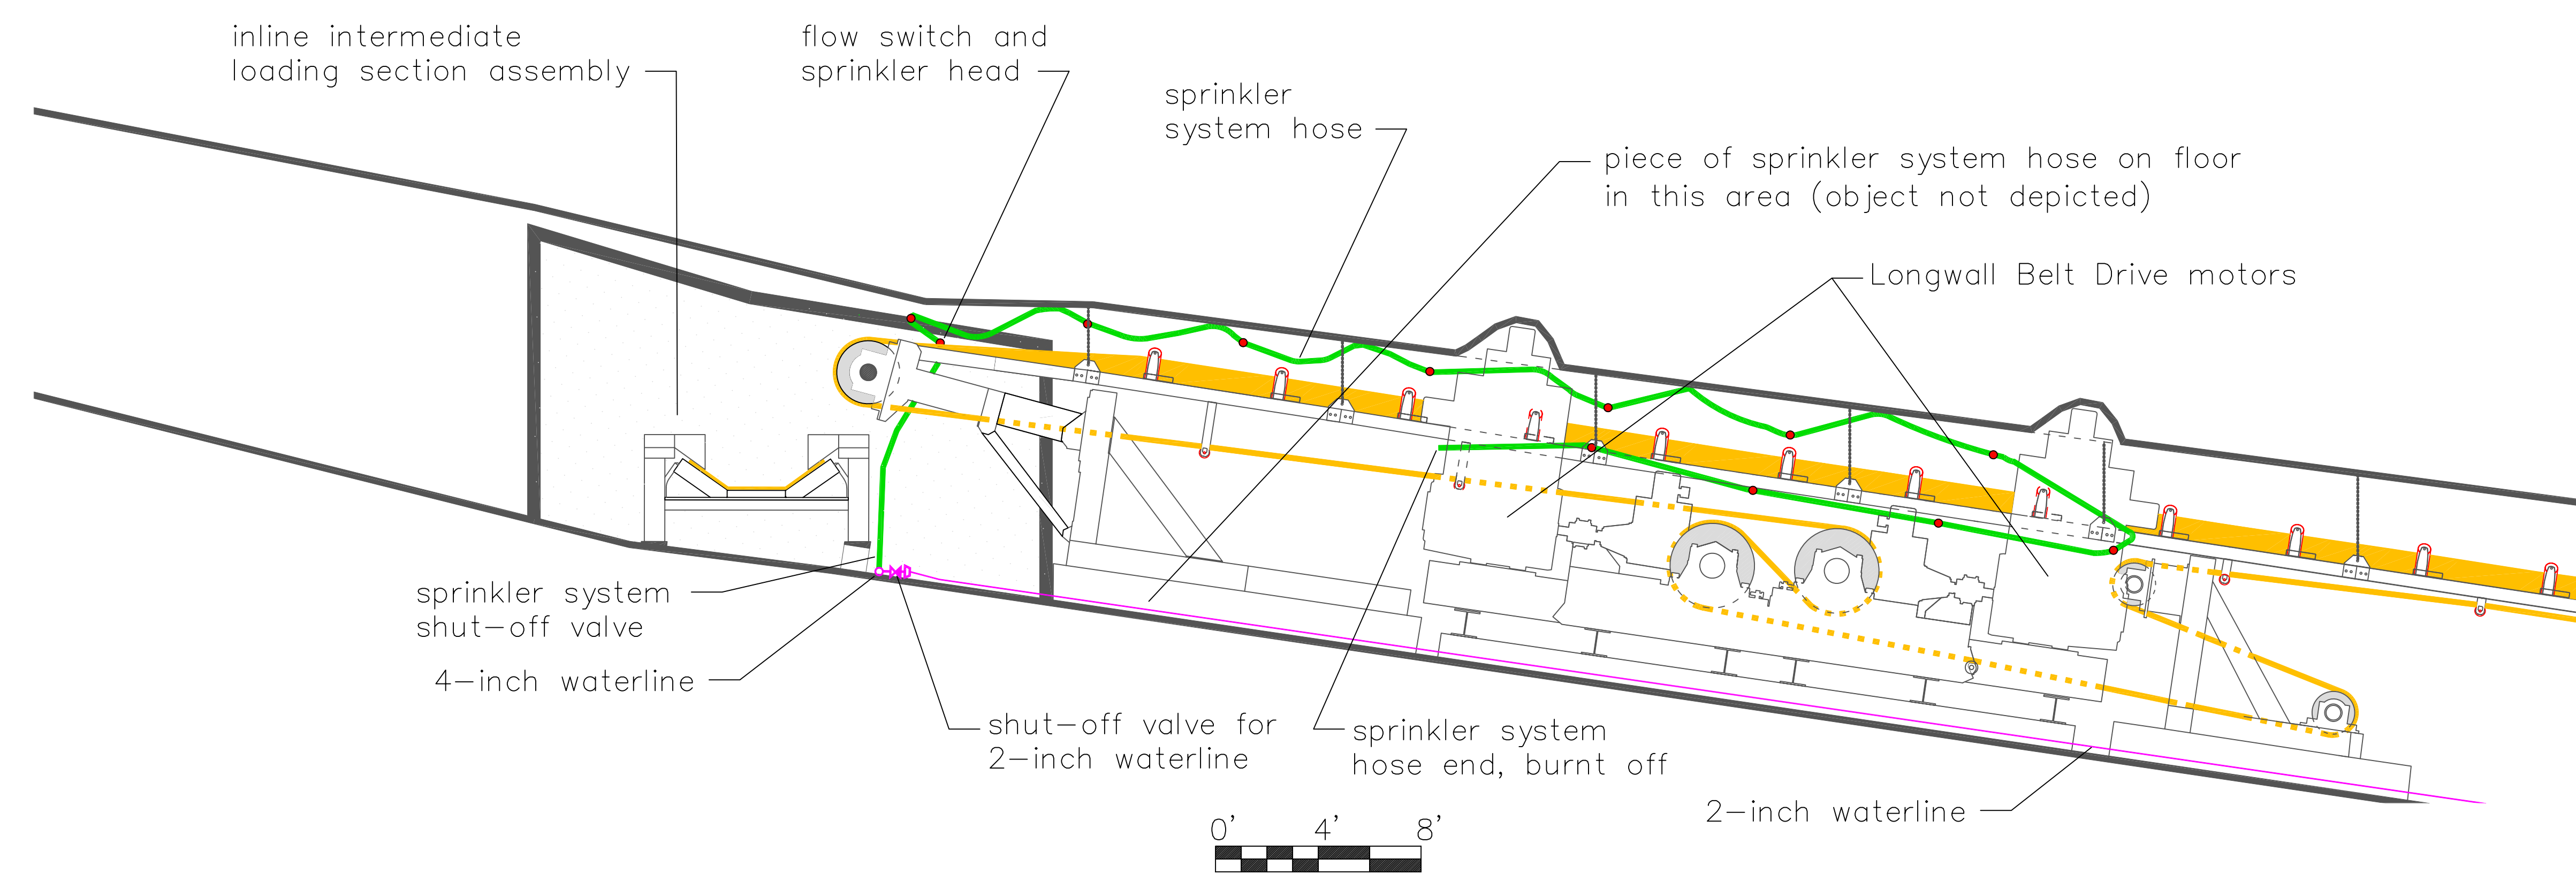
Portions of the suspended belt structure shown in the Section A-A' side view was damaged by the fire and fell from the roof. The belt structure and other conveyor belt system components shown are depicted as similar to how they likely existed, based on information collected during the investigation, before the fire and is for demonstrative purposes only.
