Report of Investigation  
Fatal Underground Coal Mine Fire

U.S. Department of Labor  
Mine Safety and Health Administration  
2007

Aracoma Alma Mine #1  
Aracoma Coal Company, Inc.  
Stollings, Logan County, West Virginia  
I.D. No. 46-08801

Fatal Underground Coal Mine Fire  
January 19, 2006

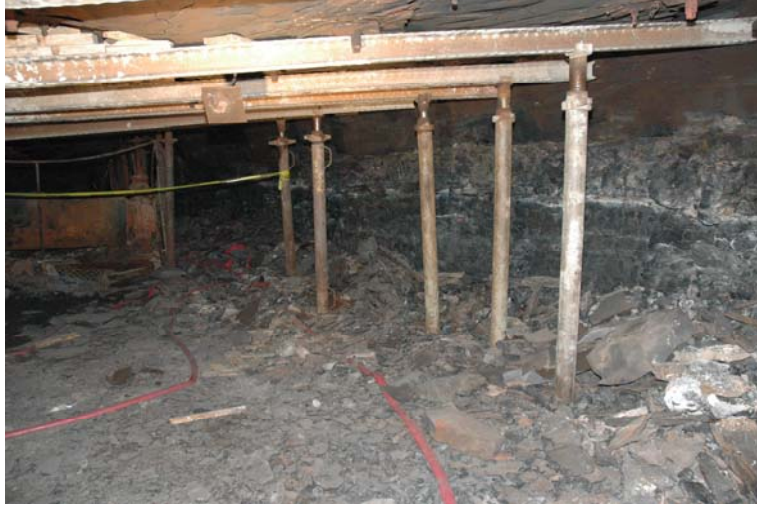
Physical evidence and interview statements indicated that no stopping existed across the No. 7 Belt entry inby the belt tail between SS 3249 and SS 3266 on January 19 (Figures 3 and 4).

**Figure 4. Area inby No. 7 Belt tail pulley.**  
(Roof support was installed post-accident.)

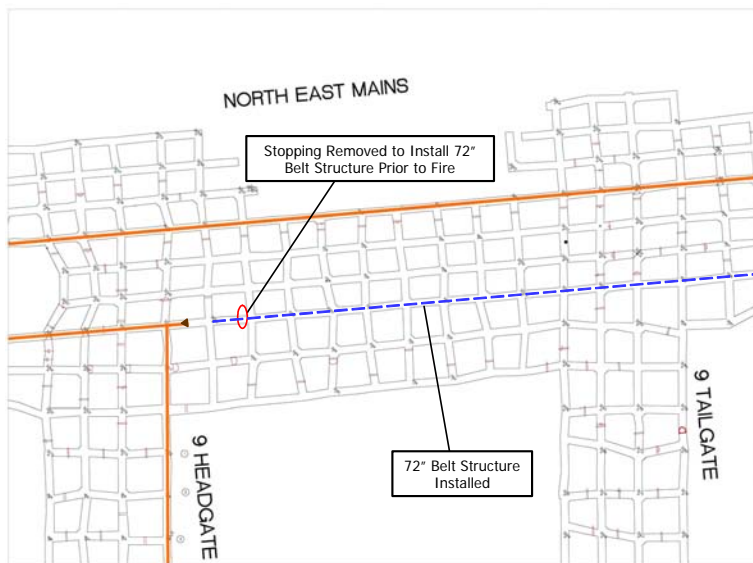
Physical evidence and interview statements revealed a stopping had been constructed in the No. 7 Belt entry between SS 3266 and the intersection with the next inby crosscut. However, there was no stopping in that location on January 19 (Figures 5 and 6). This stopping was removed by a construction crew to facilitate installation of a dual switch house (“splitter box”) during the last week of October 2005. Belt structure was later installed so that the structure extended from near SS 3266 to just outby the intersection at SS 3223. Interview statements revealed the framed curtain had been removed prior to December 29, 2005.

**Figure 5. Critical ventilation control removed prior to fire.**

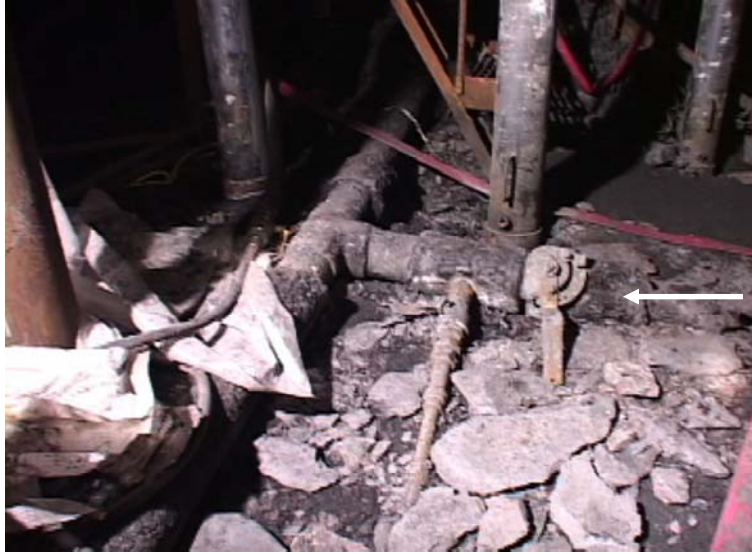
**Figure 14. 4-inch water valve (found in “off” position)**

After the fire, MSHA investigators examined the area of the 4-inch butterfly valve where it connected to the 2-inch PVC waterline (SS 3249). This valve was visually examined and found in the closed position. It could not be determined when, or by whom, the valve had been closed. If this valve was closed at the time the fire started, water would not have been available in the 2-inch PVC waterline. This is the line Cabell initially attempted to use to fight the fire.
