Report of Investigation
Fatal Underground Coal Mine Fire

Aracoma Alma Mine #1
Aracoma Coal Company, Inc.
Stollings, Logan County, West Virginia
I.D. No. 46-08801

January 19, 2006

Fatal Underground Coal Mine Fire
January 19, 2006

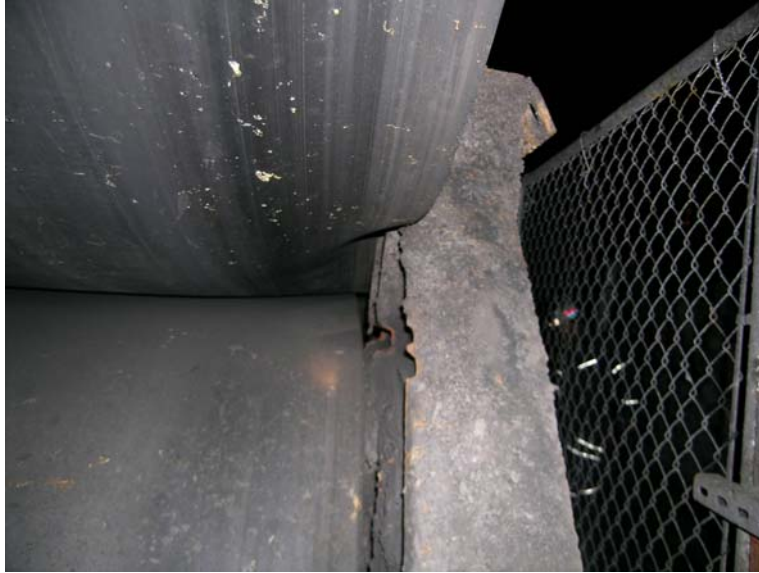
Examining the takeup storage unit, Cabell discovered only one of the two trip latch levers on a drop-off carriage assembly had disengaged and caused the drop-off carriage assembly to become skewed across the center section beams. Appendix D contains information concerning the longwall belt takeup storage unit and its operation. The longwall belt was misaligned and rubbing against a pillow block bearing housing within the pulley carriage assembly (PCA) of the takeup storage unit. Cabell observed light smoke. Evidence of misalignment of the belt within the takeup storage unit is shown in Figure 1.

Figure 1. Evidence of belt misalignment.

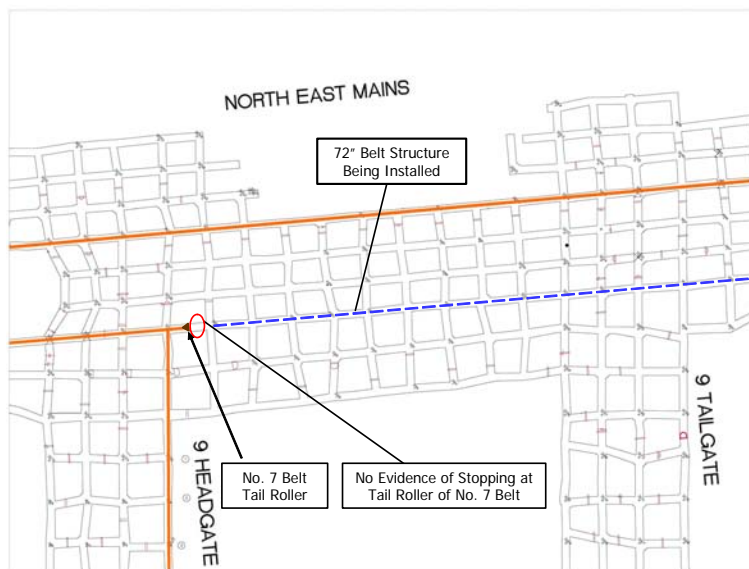
A stopping was depicted at this location on maps posted in mine offices, including the map that was identified by the mine operator representative as the map that § 75.1202-1 required to be kept up-to-date with temporary notations showing permanent ventilation controls constructed or removed. An image of that map is provided in Appendix M. Additional discrepancies existed between the ventilation controls mapped by the investigation team and those depicted on the required map(s).

Figure 3. Absence of critical ventilation control.

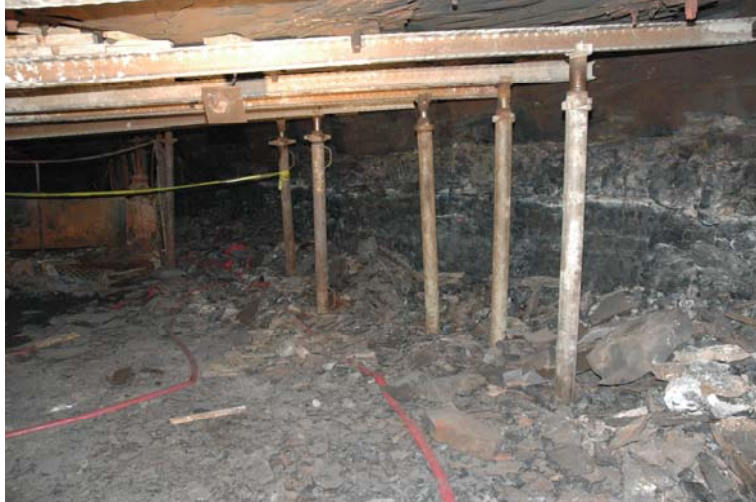
Figure 4. Area inby No. 7 Belt tail pulley.
(Roof support was installed post-accident.)

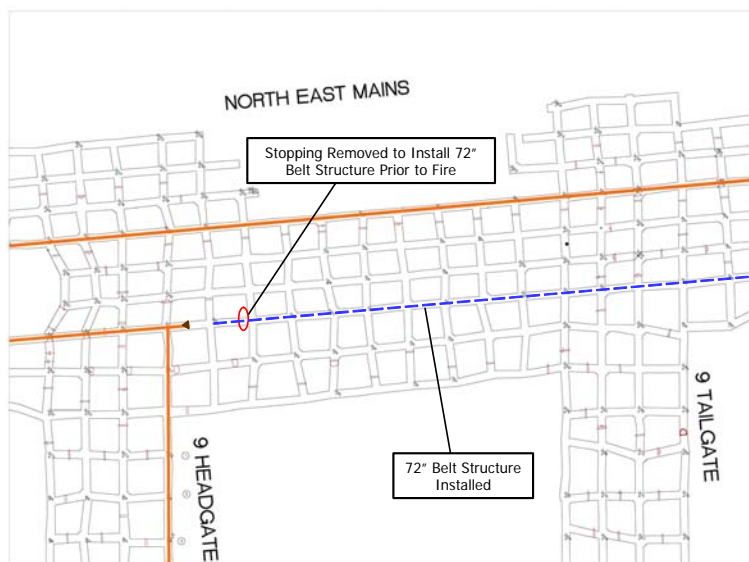
Physical evidence and interview statements revealed a stopping had been constructed in the No. 7 Belt entry between SS 3266 and the intersection with the next inby crosscut. However, there was no stopping in that location on January 19 (Figures 5 and 6). This stopping was removed by a construction crew to facilitate installation of a dual switch house (“splitter box”) during the last week of October 2005. Belt structure was later installed so that the structure extended from near SS 3266 to just outby the intersection at SS 3223. Interview statements revealed the framed curtain had been removed prior to December 29, 2005.

Figure 5. Critical ventilation control removed prior to fire.

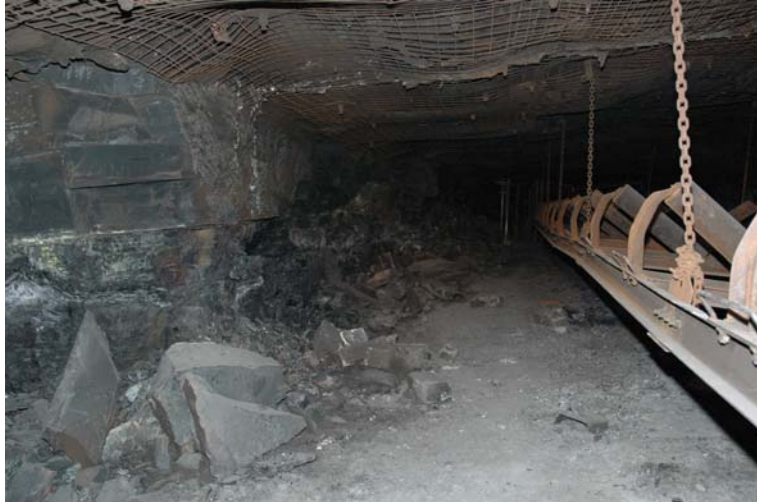
Figure 6. Location where belt structure was installed after removal of a stopping.

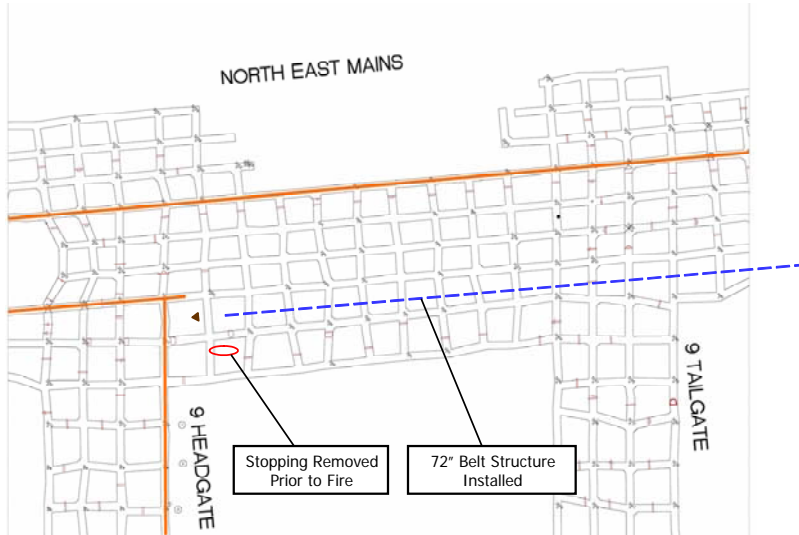
- The installation of another single stopping could have completed the airlock between SS 3267 and SS 3333. The location of that single stopping was in the crosscut on the side of the roadway opposite the longwall belt electrical installations. Alternatively, a series of stoppings in NEM between 9 Headgate and 9 Tailgate could have completed the airlock. Physical evidence and mine rescue and recovery logs and maps revealed neither the single stopping nor several of the individual stoppings in this alternative series were in place on January 19.

Figure 7. Additional critical ventilation control removed prior to fire.

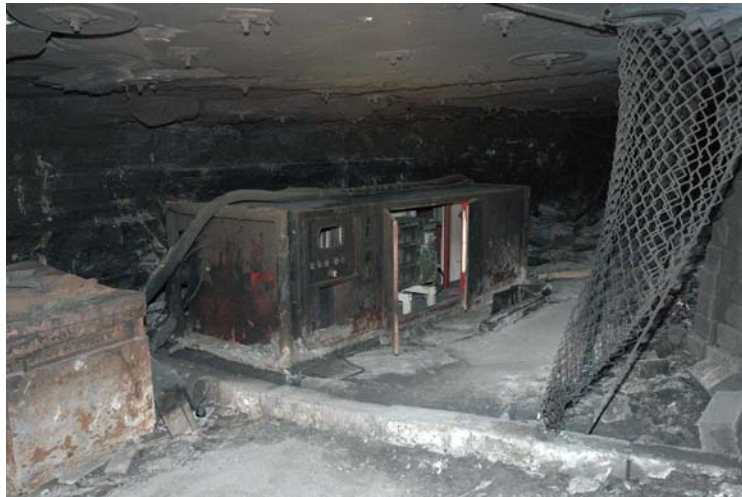
Figure 8. Former location of stopping at the electrical installation.

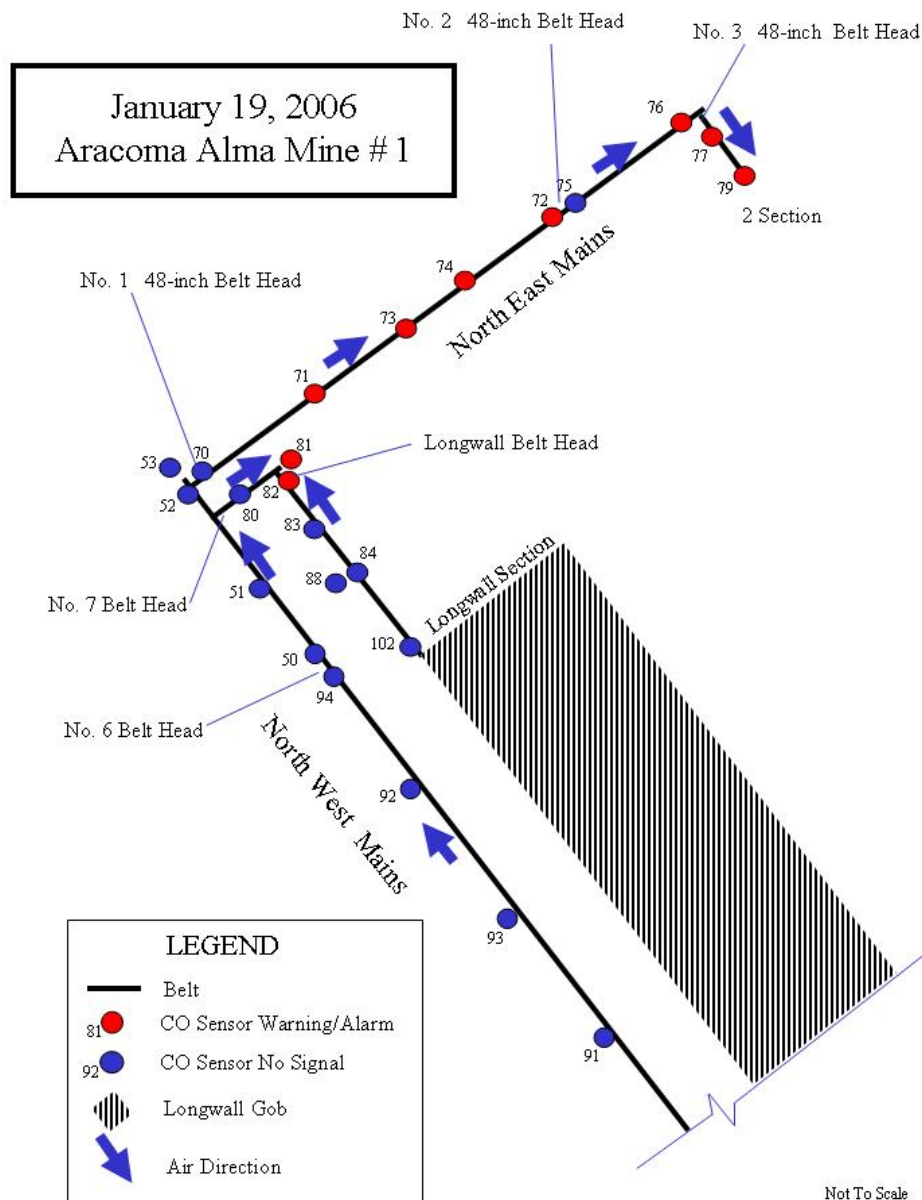
Figure 12 illustrates the location of CO Sensors 82 and 83, which were in the area where the fire originated. According to the AMS event log, the first sensor to detect an alert level of CO was Sensor 82. This indicated the direction of airflow was from the belt takeup storage unit toward Sensor 82 at the time the CO was detected. An alarm level of CO was detected at Sensor 82 at approximately 5:14 p.m., 21 seconds after the alert level. An alarm level of CO was detected at Sensor 81 at approximately 5:16 p.m., also 21 seconds after the alert level.

Figure 12. Relative CO Sensor Locations on January 19, 2006.

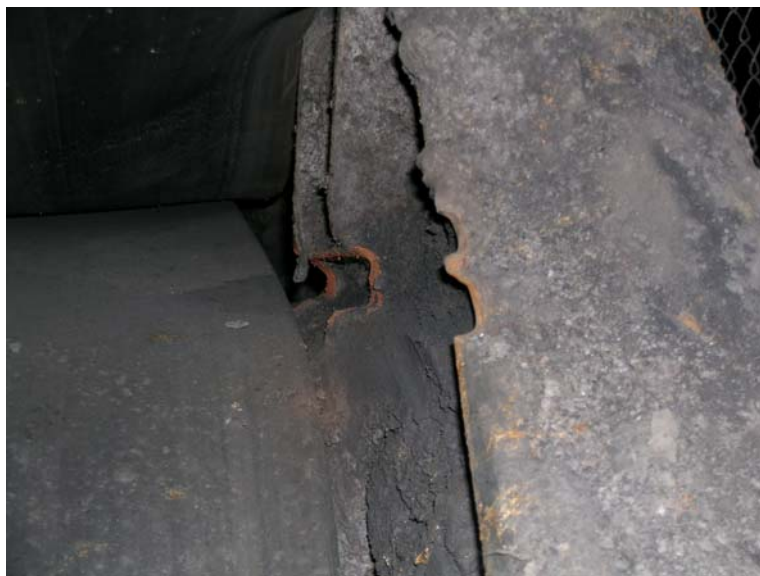
- Damaged belt hangers, some partially cut through and others severed from prolonged rubbing from the misaligned belt;
- Damaged belt takeup storage unit frame components, partially cut through from prolonged rubbing of the misaligned belt (See Figure 13);
- Severed strips of belt on the mine floor and hanging on belt structure;
- Lengths of partially severed strips of belt;
- Shavings of belt on the mine floor;
- Belt cord fibers wrapped around belt roller components; and
- Extended lengths of belt with frayed edges.

Figure 13. Grooves cut into the rear frame assembly.

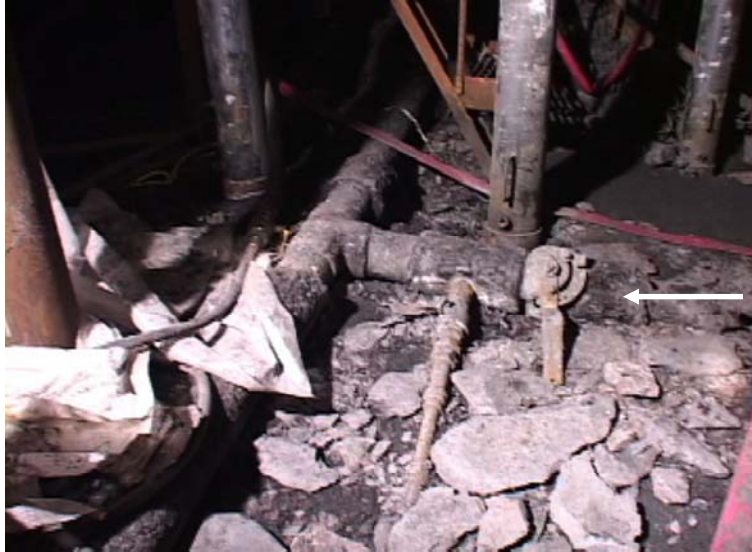
Figure 14. 4-inch water valve (found in “off” position)

After the fire, MSHA investigators examined the area of the 4-inch butterfly valve where it connected to the 2-inch PVC waterline (SS 3249). This valve was visually examined and found in the closed position. It could not be determined when, or by whom, the valve had been closed. If this valve was closed at the time the fire started, water would not have been available in the 2-inch PVC waterline. This is the line Cabell initially attempted to use to fight the fire.
