# Department of Defense Legacy Resource Management Program

PROJECT NUMBER (05-170)

## **Long-Term Management Strategies for USS ARIZONA, A Submerged Cultural Resource in Pearl Harbor**

NATIONAL PARK SERVICE  
SUBMERGED RESOURCES CENTER

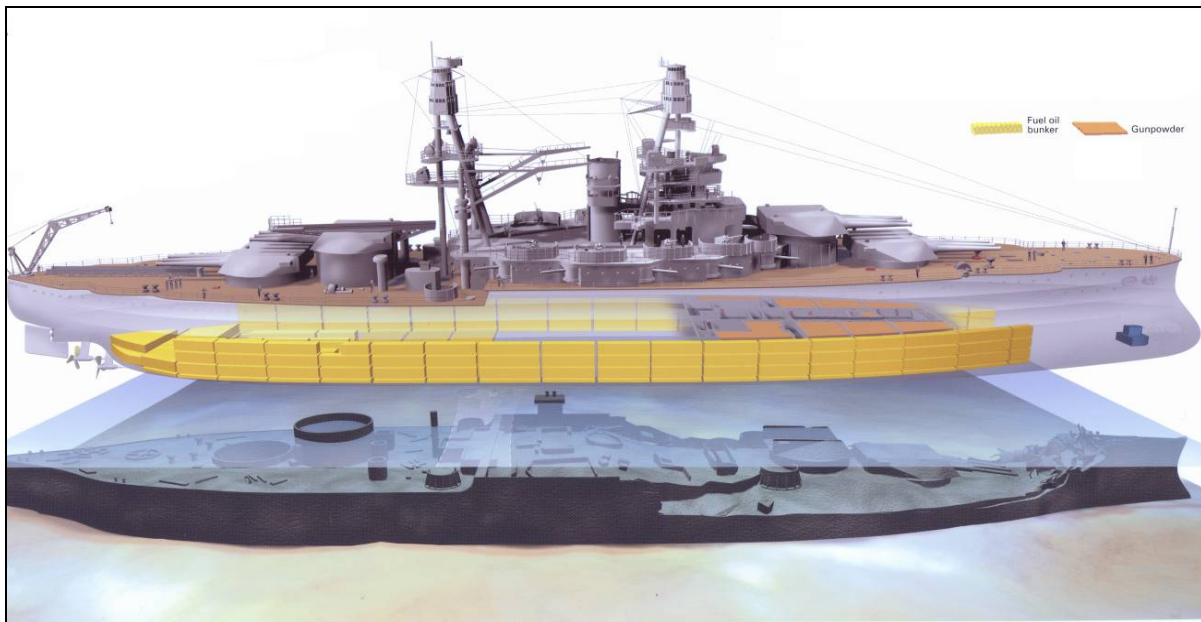
Figure 3.3. Graphic of Arizona showing oil bunker and forward magazine locations in relation to hull damage mapped by SRC in the 1980s (Graphic by National Geographic Society).

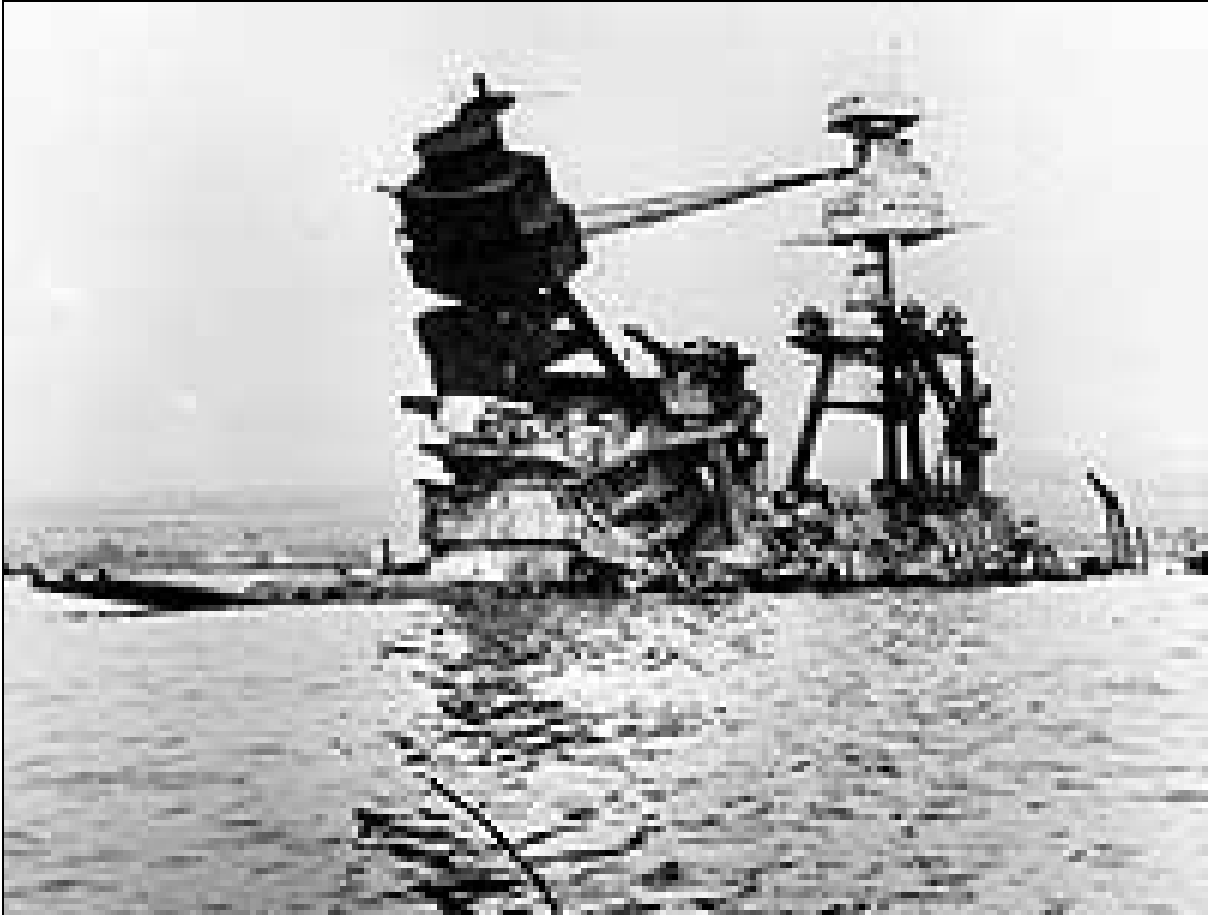
**Figure 3.5.** *Arizona* damage soon after fires were extinguished December 10, 1941 (USS *Arizona* Memorial Photo Archives).

This ship is damaged by enemy action, internal explosions and fire to such and extent as to be valueless except as to the material in the after 40% of length not damaged by immersion in sea water, and as an expensive source of steel scrap. Subject to further diving surveys, it is recommended that work on this ship be limited to removing No. 3 and 4 turrets as practicable with local weight handling equipment and removing other useable material under other Bureaus and to cutting off, as opportunity affords, of the damaged structure above water.

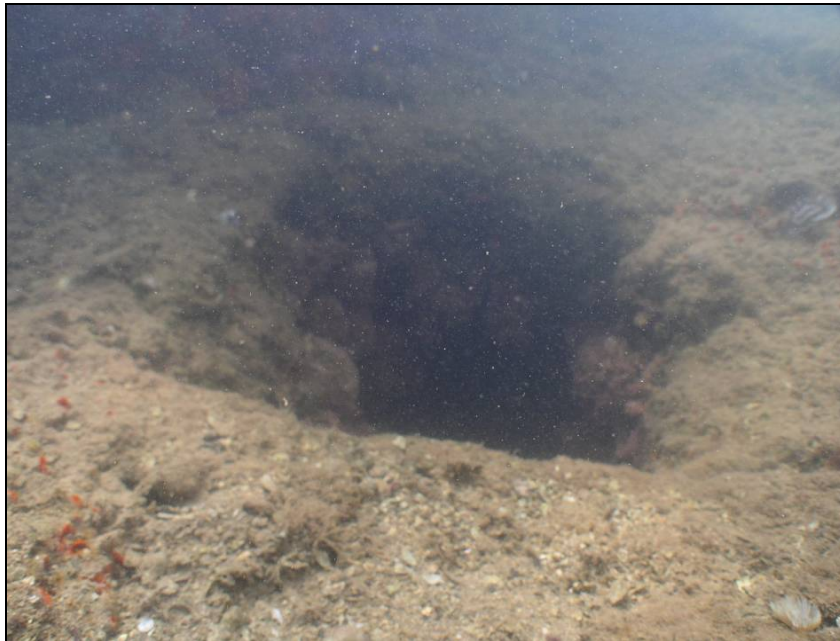
**Figure 3.6.** Bomb hole, forward of the galley, port side, near frame 78 (NPS Photo by Patrick Smith).

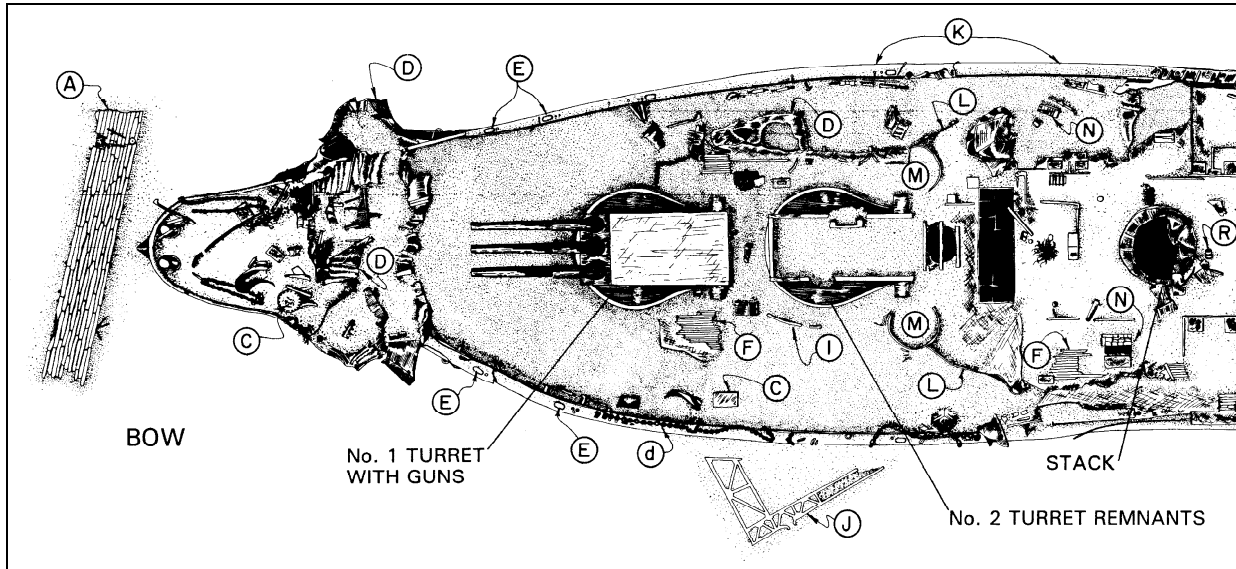
Figure 3.8. Planimetric view of *Arizona* bow damage (Drawing by NPS-SRC).

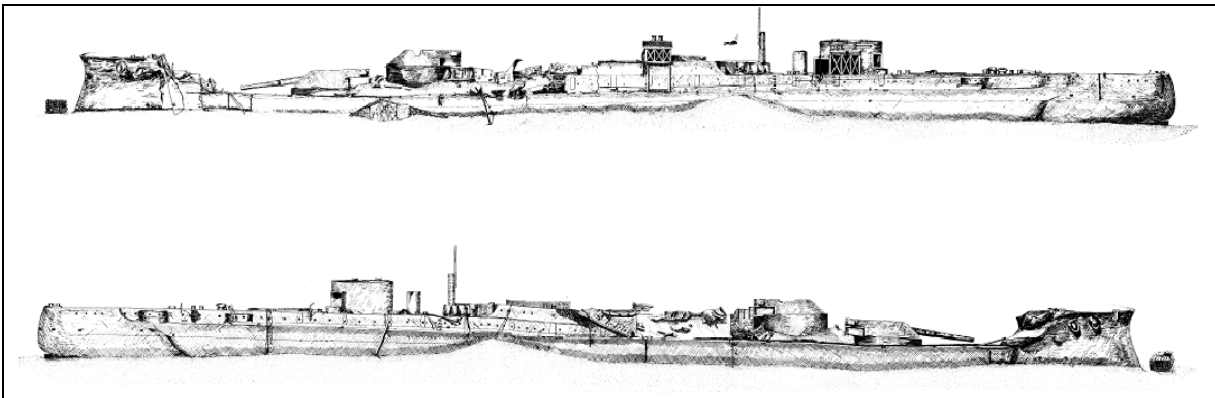
Figure 3.9. *Arizona* profile views port and starboard depicting current condition (Drawing by NPS-SRC).
