CHAPTER 5

Steel-Hull Corrosion Analysis of USS *Arizona*

Donald L. Johnson, Brent M. Wilson, John D. Makinson, Robert De Angelis, William N. Weins, and James D. Carr

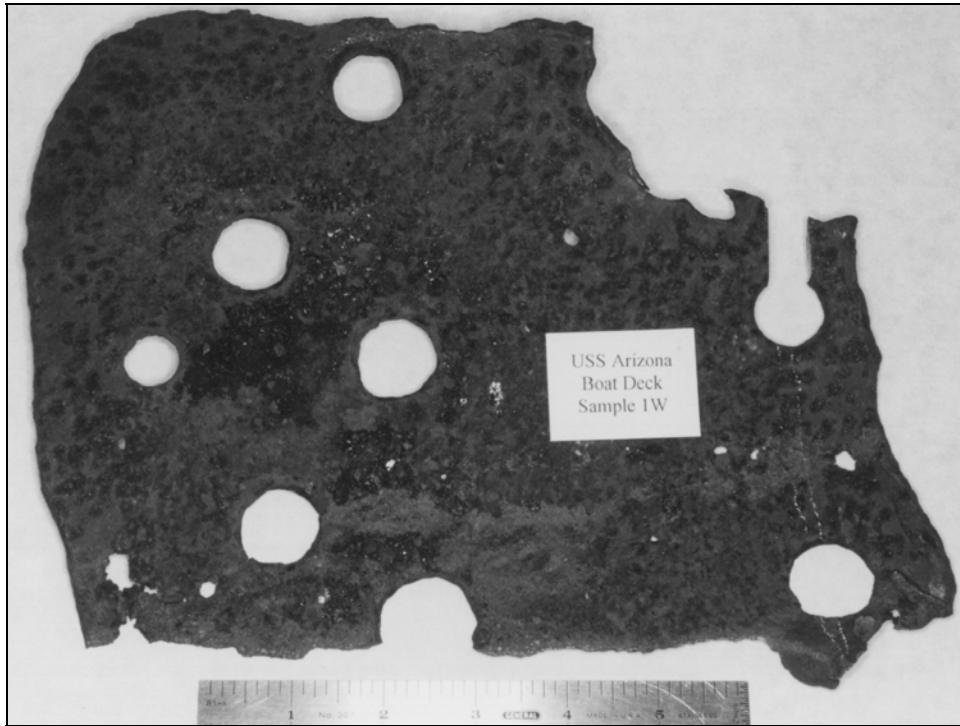
Figure 5.5. Sample W1, plate from boat deck with rivet holes.

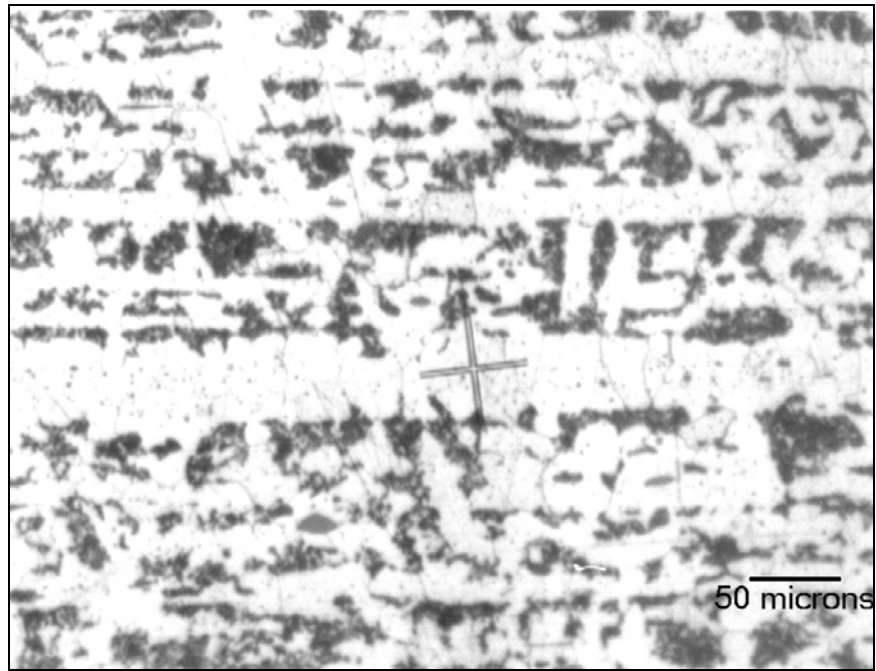
Figure 5.7. Microstructure of W1, 175X, 0.2% Nital etch.

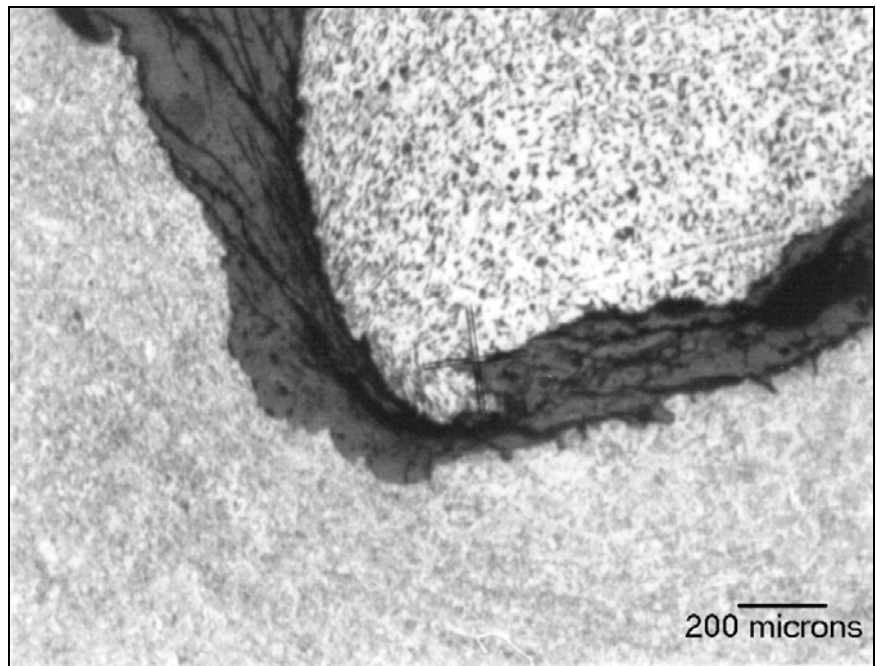
Figure 5.8. Microstructure of W3. Plate is at top right, rivet is at lower left. 45X, 2% Nital etch.

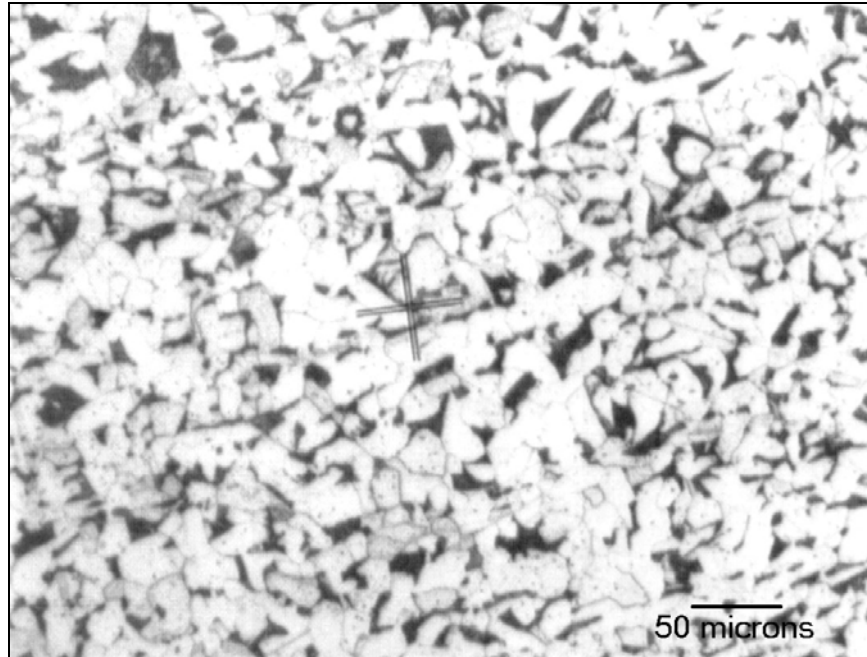
Figure 5.9. Microstructure of plate W3, 175X, 2% Nital etch.

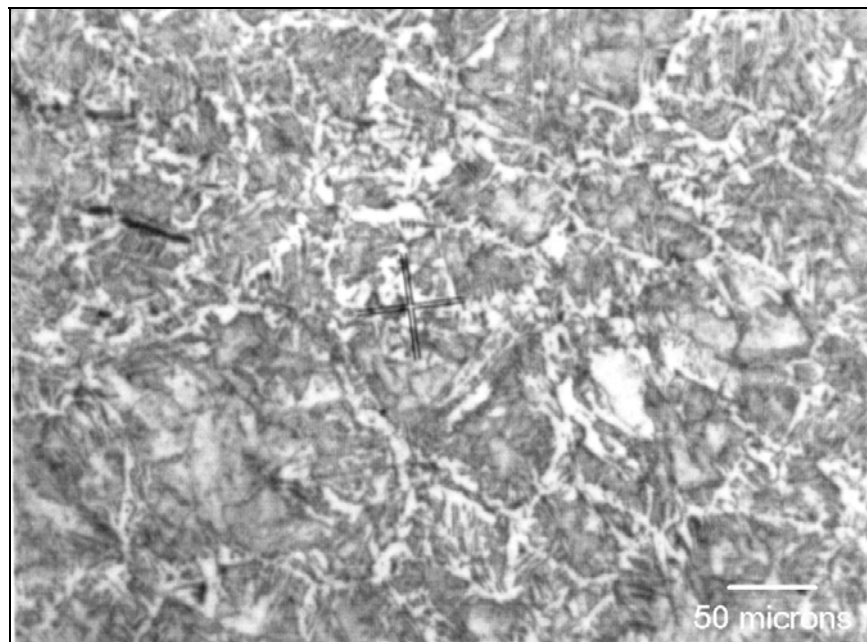
Figure 5.10. Microstructure of rivet in sample W3, 175X, 2% Nital etch.

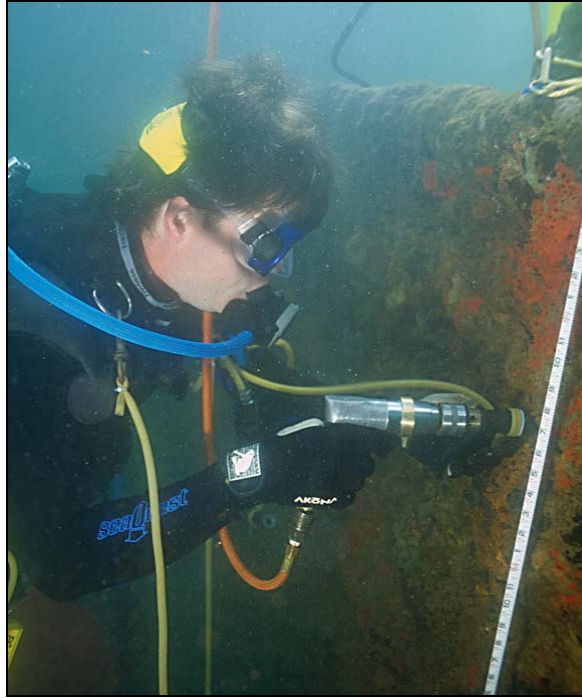
Figure 5.17. Drilling through USS *Arizona*'s exterior concretion in preparation to measuring E_{corr} and pH (NPS Photo by Brett Seymour).

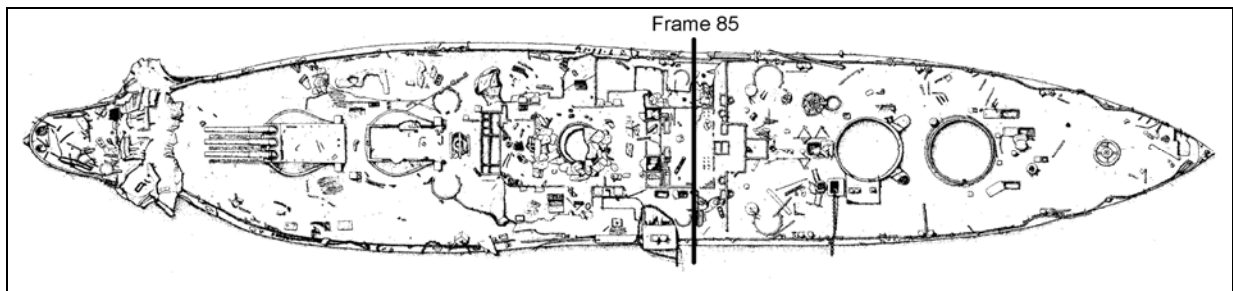
Figure 5.20. Frame 85 on USS Arizona's hull, the focus for much of the corrosion analysis.

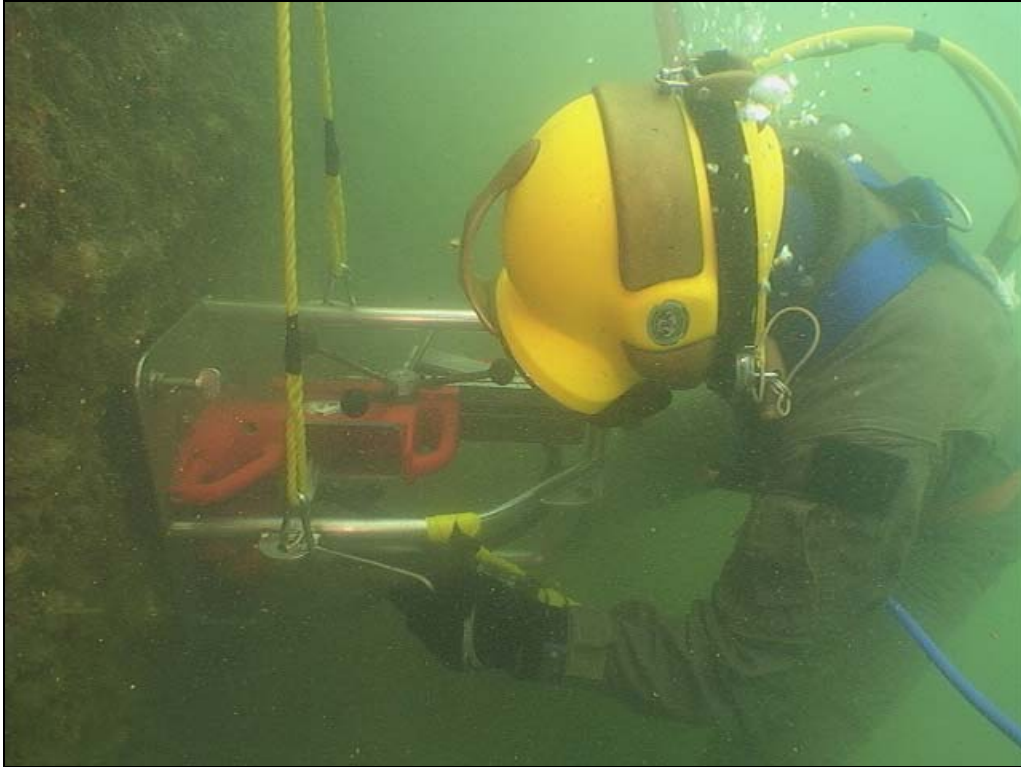
Figure 5.59. U.S. Navy diver using Titan’s hydraulic hole-saw to remove samples from Arizona’s hull (NPS Photo by Brett Seymour).

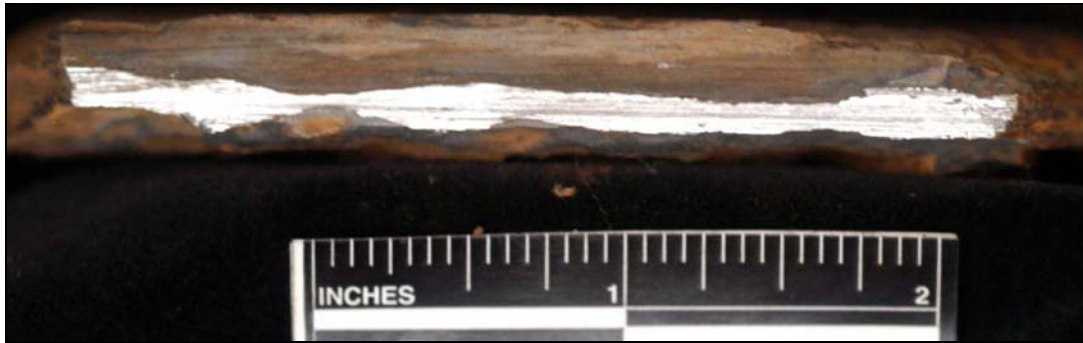
Figure 5.62. Cross section photograph of steel hull sample #USAR-02-001.

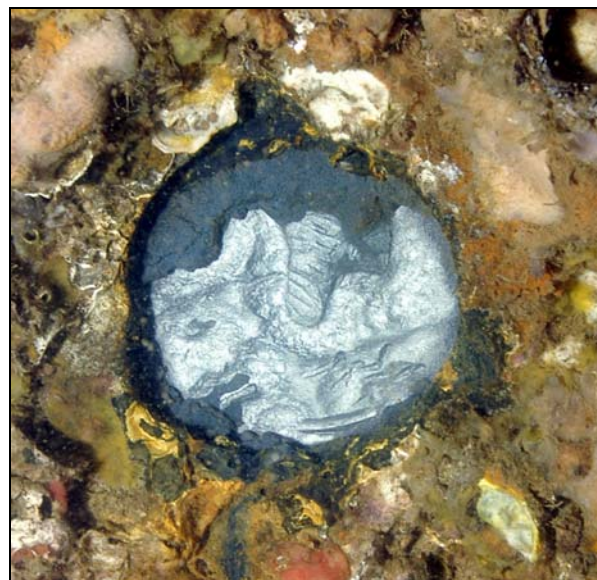
Figure 5.74. Steel surface of Arizona’s hull after extensive preparation. Part of the strongly adhering layer below the concretion remains at top. Uneven steel surface is due to corrosion (NPS Photo by Brett Seymour).
