**NRC Response to
FAQ 12-01 (Withdrawn) re. Columbia DG3 Failure
For August 29, 2012 ROP WG Meeting**

Plant: Columbia Generating Station (CGS)

Date of Event: February 28, 2010

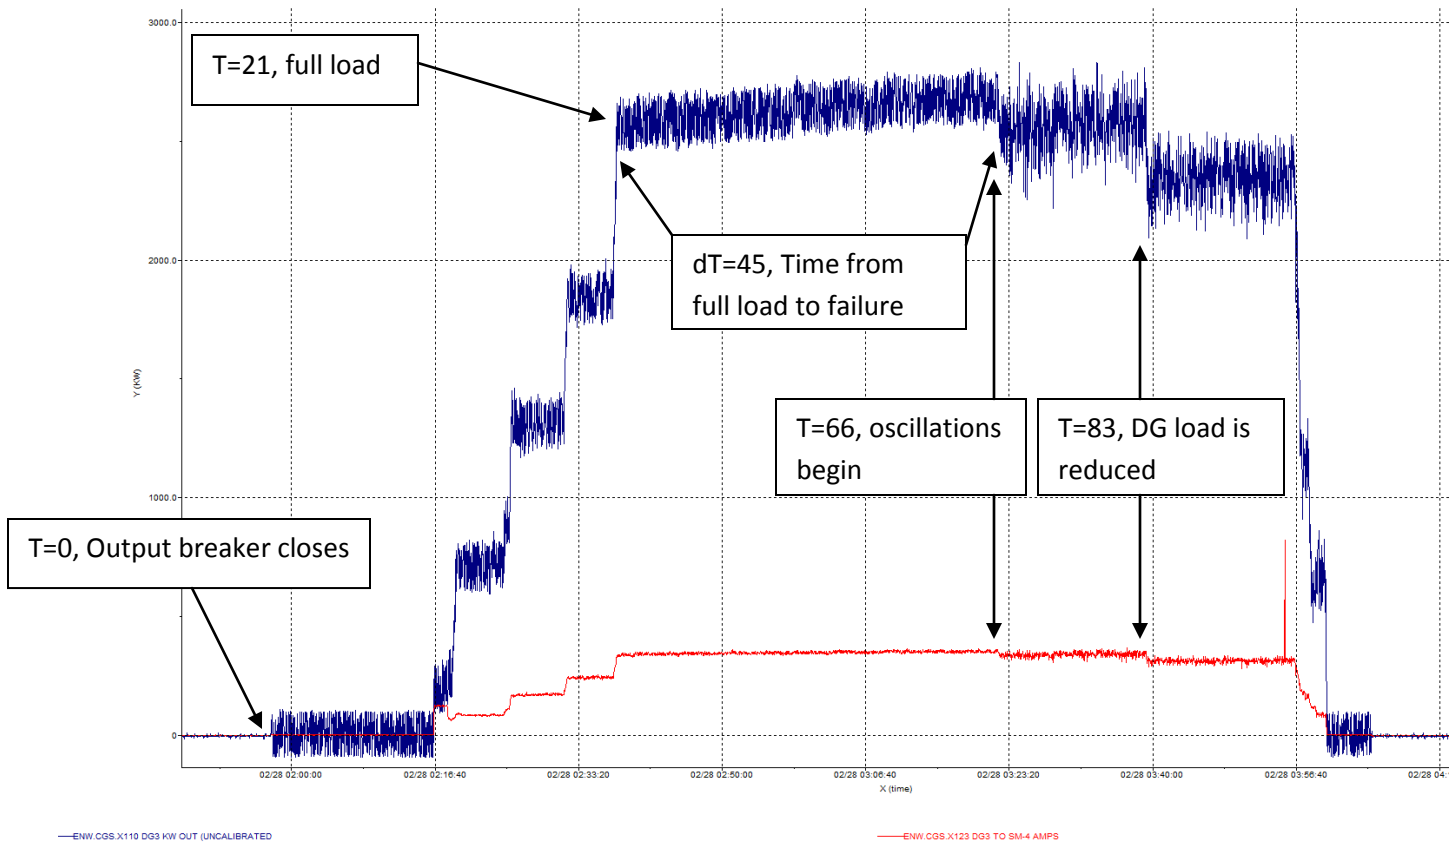
Figure 1, Load and current profile during DG3 Operation on 2/28/10

On February 28, 2010, CGS was testing an Emergency Diesel Generator (EDG). Refer to figure 1 for Load and Current trace of the subject event. The EDG successfully started, the EDG output breaker successfully closed (T = 0 minutes), the EDG successfully load sequenced up to fully loaded (T = 21 minutes), after 45 minutes the EDG experienced unexpected load oscillations of 350 kw (T = 66 minutes), after 17 minutes the load was lowered (T = 83 minutes) and the 350 kw oscillations were observed to continue another 16 minutes of operation until the EDG was unloaded (T = 99 minutes) and shut down.

When the EDG was shutdown, plant staff made a log entry stating, "After running DG3 **fully loaded over an hour** per SOP-DG3-START, observed ... Swings from 300 to 320 amps, Swings from 2200 to 2500 KW ...". Root cause investigation later identified that the governor actuator had failed 45 minutes after reaching full load (T = 66 minutes). At that point the EDG was no longer capable of performing its monitored function. The MSPI Basis Document identifies that the monitored function is to provide 4160 VAC emergency power to safety related Division 3 HPCS equipment and has a mission time of 24 hours. The frequency and magnitude of load oscillations were such that the DG could not have provided power to required safety related loads for 24 hours. To be clear, the EDG did run for more than an hour after breaker closure, but only 45 minutes after reaching full load at which point it was no longer capable of

Regardless of the time the 1 hour clock started, the resident inspectors believe that this failure should be considered as an “EDG failure to run”. Plant data revealed that at 3:22 AM, DG-3 began to exhibit degraded performance but still provided an average (based on 1 minute average) of >2547 KW which is sufficient to meet all post-accident loads. The diesel engine was allowed to continue to operate until about 3:42 AM when the control room operators logged that after running DG-3 fully loaded for **over an**

hour (emphasis added), the component exhibited load swings of 200-300 KW. The component was secured due to the degraded performance shortly after the operators logged the issue with DG-3. Since the component continued to operate after observing the degraded performance, it is not clear if the monitored function was immediately lost or if the component would have continued to operate for its required mission time. To date, the licensee has not performed an engineering evaluation of the degraded condition to determine at what point the monitored function was lost. The inspectors believe that a strong case can be made that a run failure should be assigned based on NEI 99-02, Revision 6, Page F-28, Lines 28-31

The NRC staff evaluated this issue based on the characteristics of the EDG failure (i.e., the functional response of the EDG and the failure mechanism), and applying reasonable decision-making using the guidance in effect at the time of the failure. The oscillations were caused by foreign material in the governor – a condition that had existed for several years and that did not impact prior breaker closure and sequencing operations. Figure 1 in this FAQ shows that the oscillations did not occur during the breaker closure or the load sequencing or gradual loading action. Rather, the oscillations occurred 66 minutes after breaker closure and 45 minutes after the full load (for purposes of the test run) was achieved, which is indicative of a challenge to the EDG’s ability to continue to run for its mission time. Even though the foreign material existed in the governor for several years, the EDG had started and load sequenced several times without failure. Therefore, this failure appears to have been exacerbated by the running (vice start or loading) of the EDG.

Because Figure 1 data is more reflective of an EDG failure-to-run for its mission time rather than a loading failure, the EDG failure at Columbia should have been reported as a failure-to-run.
