Risk Methods Insights Gained From Fire Incidents

Sandia National Laboratories

**U.S. Nuclear Regulatory Commission
Office of Nuclear Regulatory Research
Washington, DC 20555-0001**

Manuscript Completed: August 2001
Date Published: September 2001

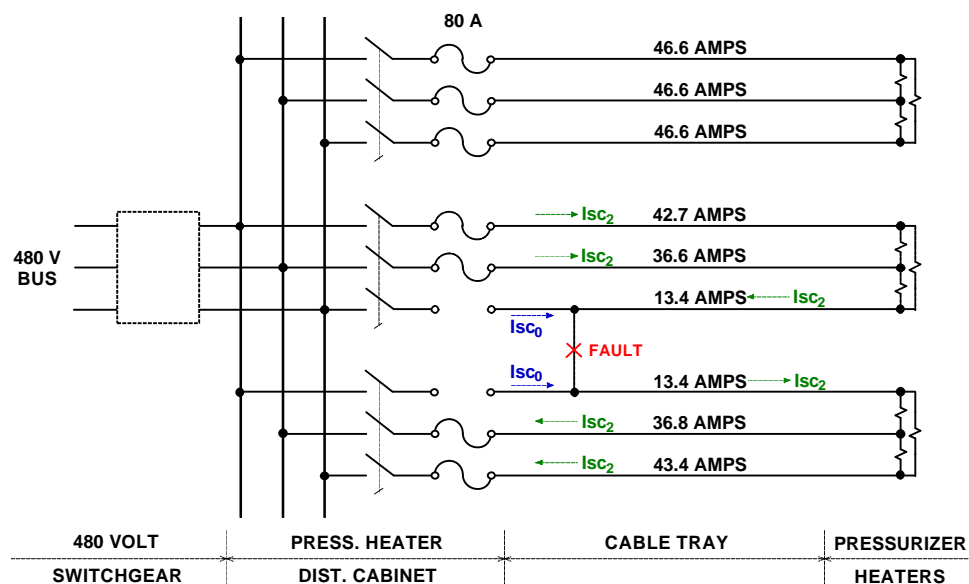
Figure A1-1: Schematic of Pressurizer Heater Circuits.

In terms of the fire cause, there are many similarities between the two incidents. The investigation concluded that the most probable cause of both fires was thermally and mechanically stressed cables, coupled with the use of individual fuses to provide for clearing of faults on each phase of the three-phase 340-volt circuits. It also appears that the cables were undersized for their design current loads under their actual installations conditions.

The initial fault is thought to have been a cable-to-cable, phase-to-phase hot short involving two separate power feeds from the same three-phase power bus. The fusing configuration allowed back-feeding of fault current through the un-faulted phases of each power feed which led to an even more severe over-current condition for the conductors. Figure A1-1 provides a schematic of the power circuit for the pressurized heaters. In that figure, I_{SC0} depicts the initial short circuit after cable failure and I_{SC2} is the subsequent short circuit current back-fed through the heaters. Note that the portion of I_{SC2} passing through the intact fuses is below the continuous rating of each fuse.

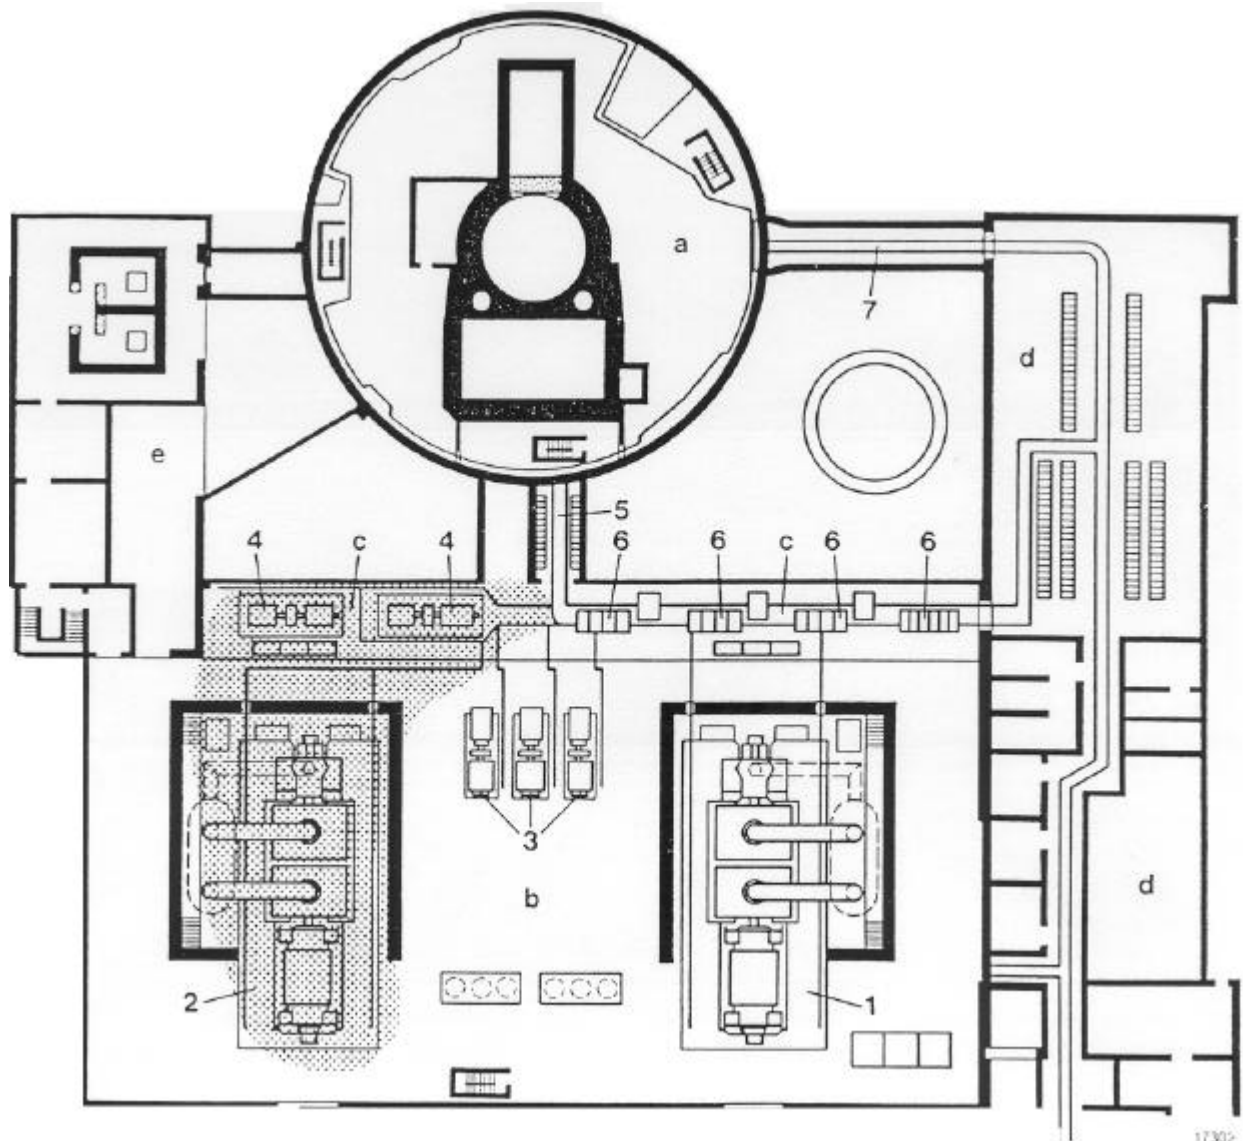
Figure A2-1 Location of Fire at Mühleberg (from Reference [2-1])

Figure A2-1 is a simplified layout drawing of the plant that shows the area where fire occurred. Note that the single lines extending between various items depict cable routes. Item 2 in that figure is the turbine-generator B, item 4 is the two motor generator sets, items 5 and 6 are the non-safety switchgear and item 7 is the cable "bridge" (as noted in Reference [A2-1]) between the reactor and turbine buildings.

Extensive damage was inflicted on the turbine building itself. It is estimated that 75% of the roof

covering, 60% of the windows and 50% of the paintwork were severely damaged. Some of the purlins of the building were deformed, concrete surfaces near the turbine B, a number of gratings and wall insulation slabs were damaged. Aside from cables and electrical equipment, little direct damage was sustained by major mechanical equipment. Some peripheral items, insulation and piping were found to be damaged. However, the cables and electrical equipment sustained extensive damage. Turbine instrumentation, control panels, lighting equipment and 3000 kg of PVC cables were found to be severely damaged.

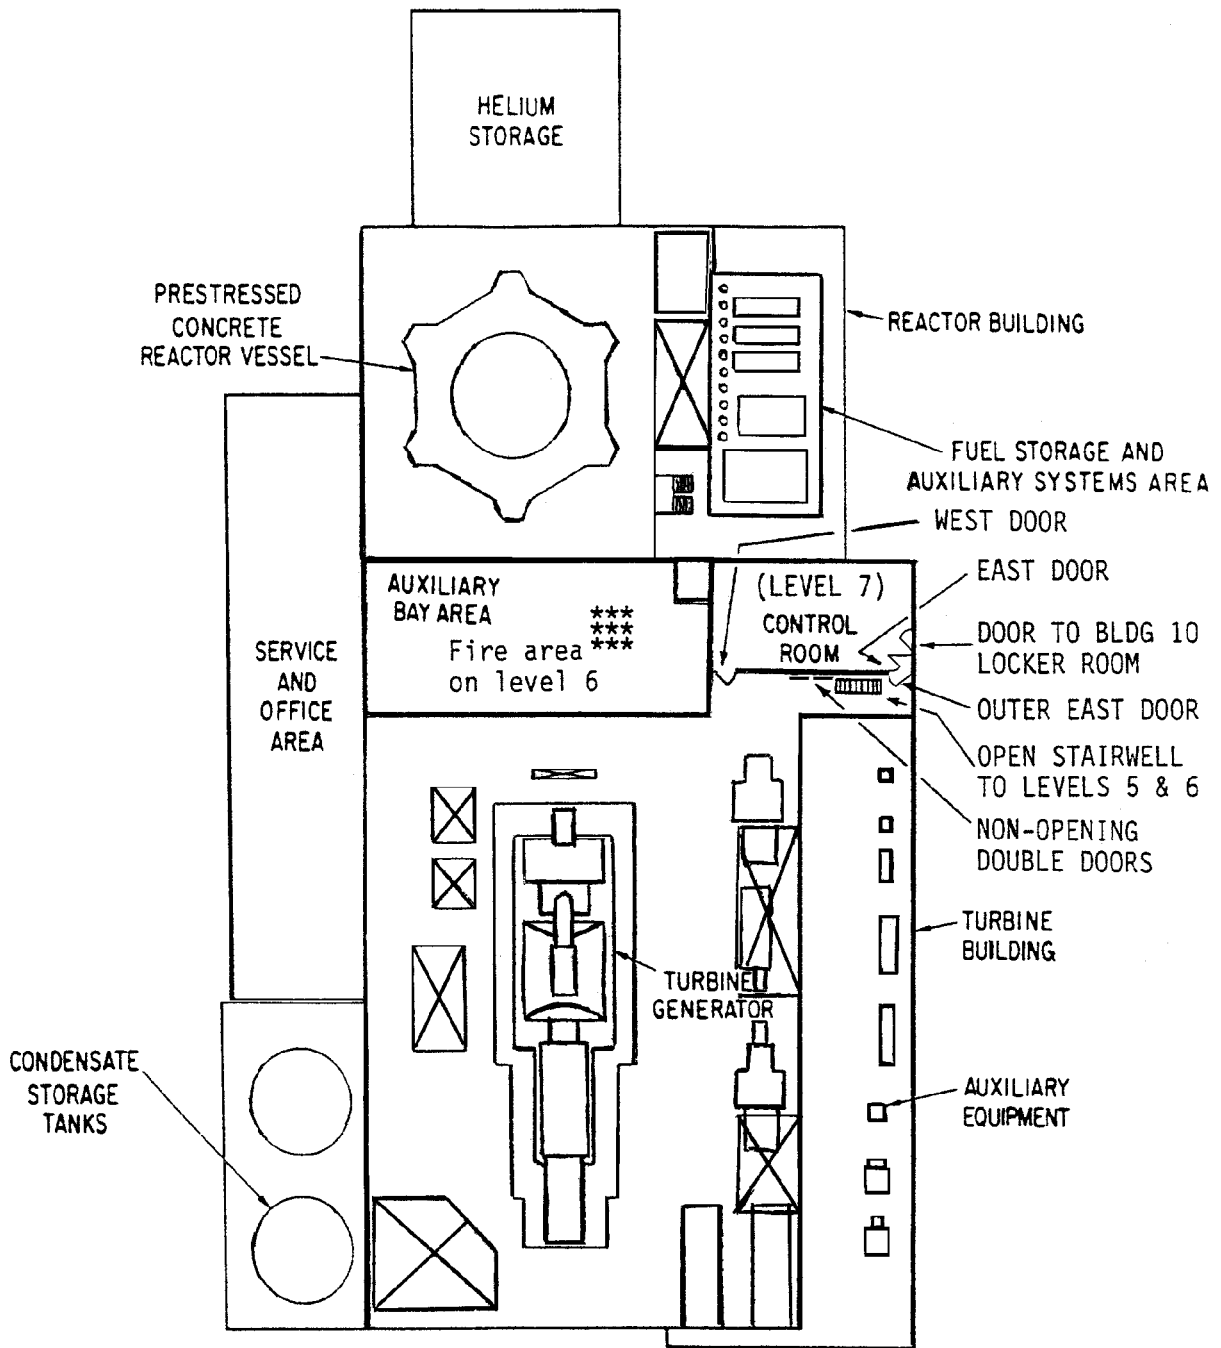
Figure A14-1: Plan view of the reactor building and turbine building including fire area on Level 6 and control room on level 7 (from Reference A14-1).

On October 2nd, 1987 the plant was coming out of a long outage and was in the midst of its initial power ascension. As part of this process, the operators closed a hydraulic valve in the turbine building, when they noticed a drop in hydraulic oil pressure. An inquiry into the causes of this drop discovered that a filter bowl (canister) had failed and high pressure oil (about 3,000 psig) was spraying (close to 15 feet distance) onto hot exposed steel. The petroleum based hydraulic oil ignited starting the fire. The temperature of hot surfaces were above the auto-ignition point of the oil. The equipment operator who discovered the fire initially succeeded in extinguishing the fire using a portable dry-chemical extinguisher. However, since he did not close the valve feeding the failed filter, the oil continued to spray and re-flashed (re-ignited). By this time the size of the fire was relatively large (estimated as 8' x 3').

The damage caused by this fire was limited to the immediate area of the fire at the north end of the turbine building. Several cables were damaged that had some effect on the control room. Valves, instruments and structural elements were affected by the fire. However, there was minor impact on plant shutdown and reactor cooling capability.
