Fabrication Flaw Density and Distribution In Repairs to Reactor Pressure Vessel and Piping Welds

United States Nuclear Regulatory Commission

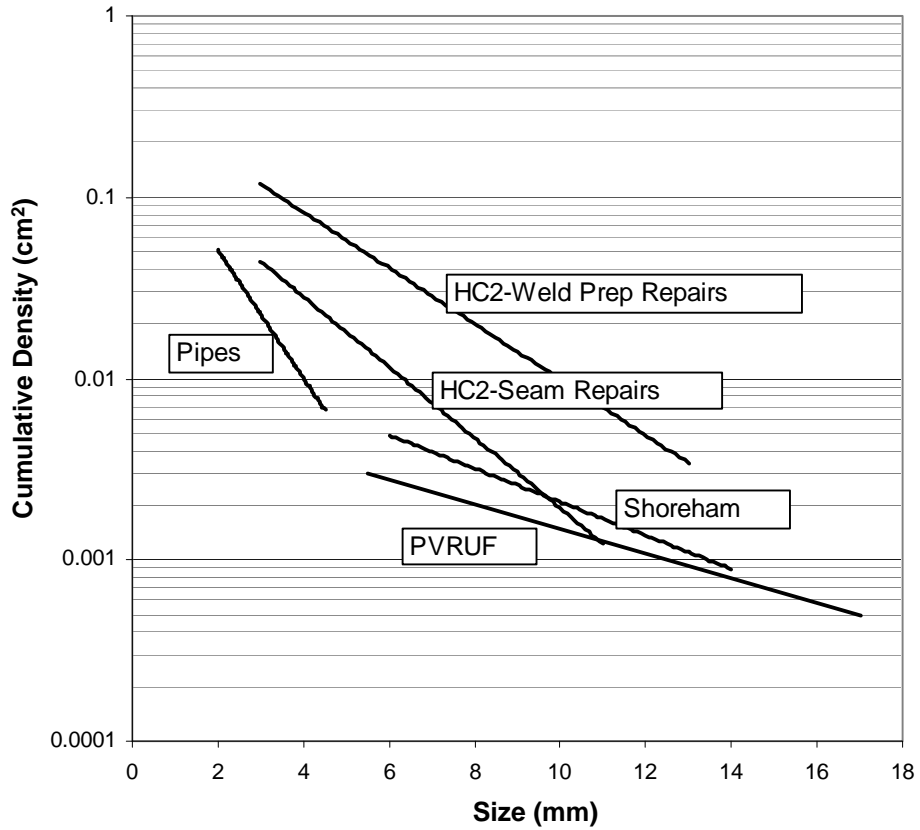
Figure E.1 Comparison of Flaw Density and Through-Wall Size Distributions for Repair Flaws in Three Reactor Pressure Vessels and in a Dissimilar Metal Piping Weld. HC2 stands for the Hope Creek Unit 2 vessel. No weld repairs were found in the weld segments from the River Bend Unit 2 vessel.

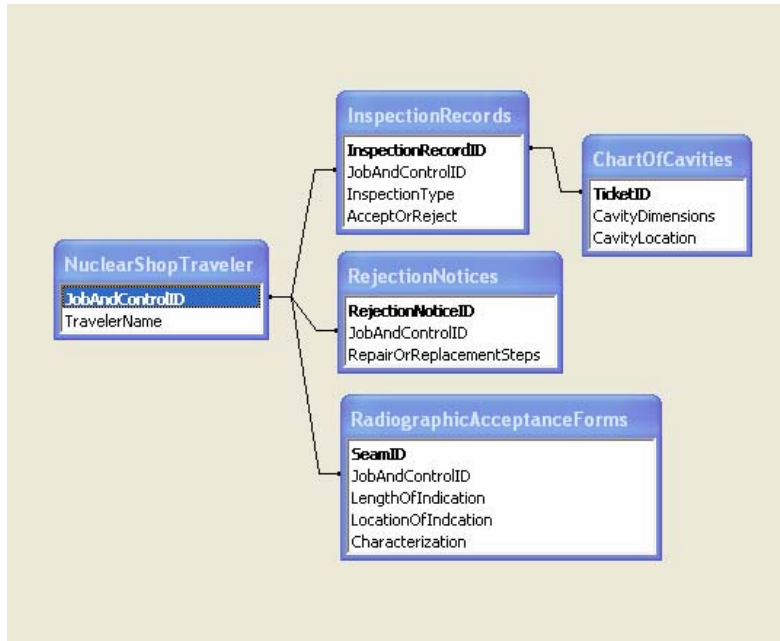
Figure 2.1 Repair Record Types, Fields, and Relationships from Construction Records of PVRUF Reactor Pressure Vessel

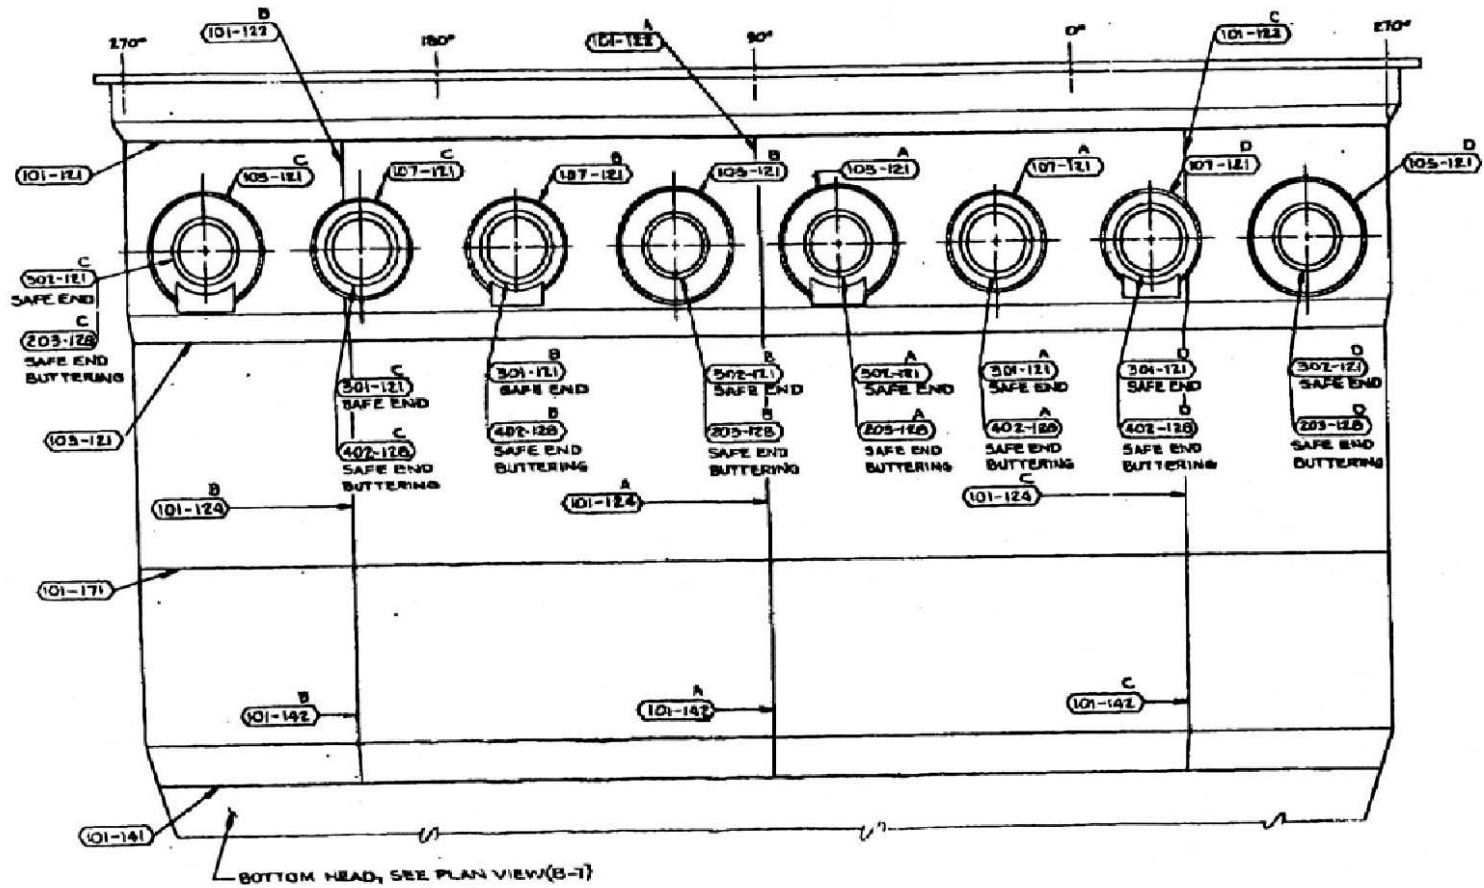
Figure 2.2 Roll-Out Diagram for Seam Welds in PVRUF Reactor Pressure Vessel Showing Weld Identification Numbers

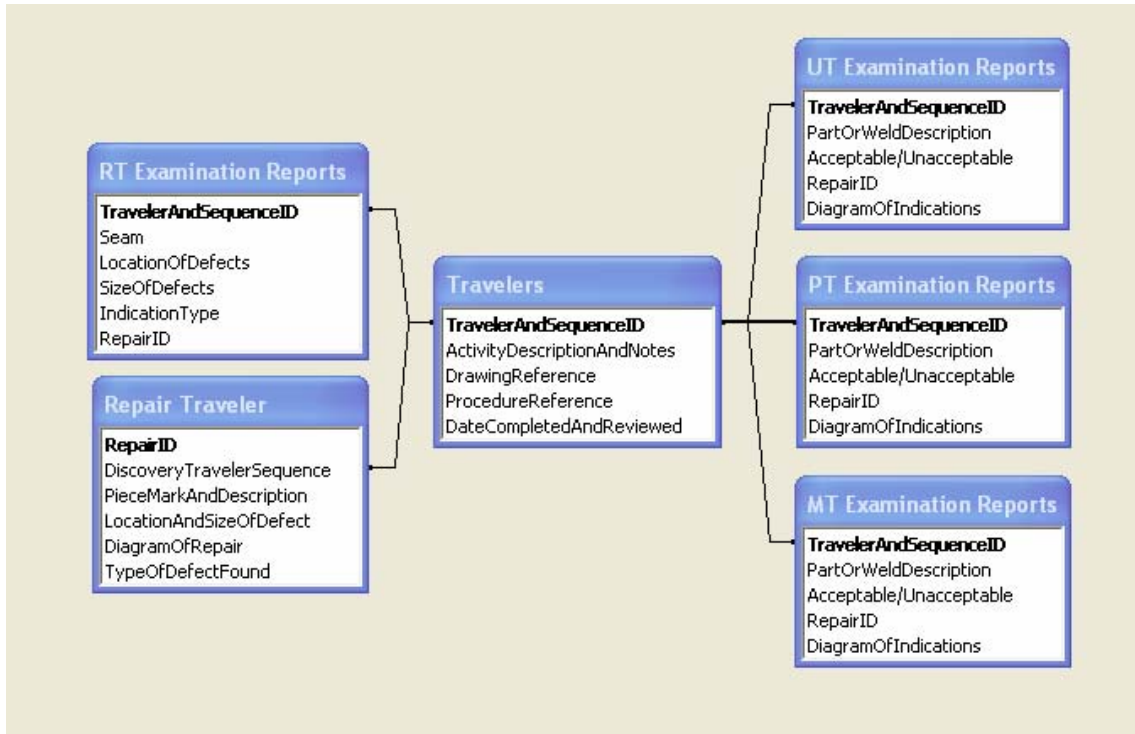
Figure 2.3 Hope Creek Unit 2 and River Bend Unit 2 Reactor Pressure Vessel Repair Records and Their Relationships

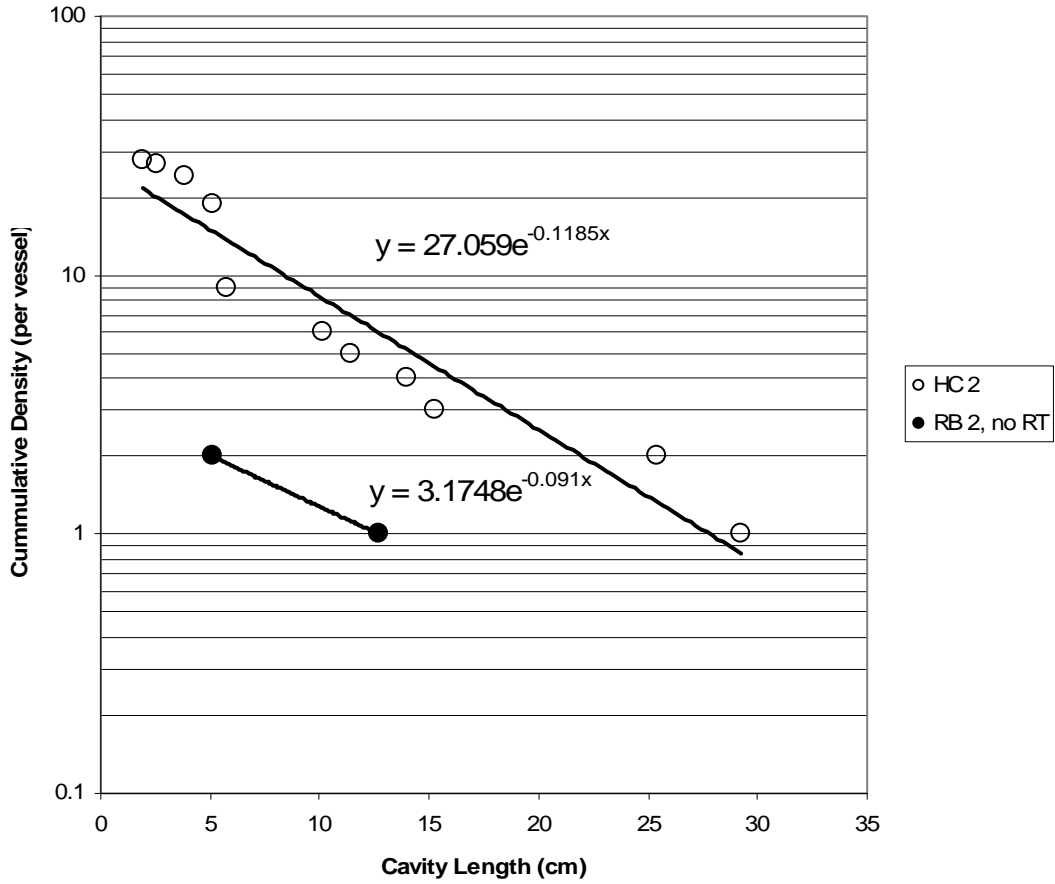
Figure 2.4 Comparison of Cavity Length of Cladding Repairs in the Hope Creek Unit 2 and River Bend Unit 2 RPVs

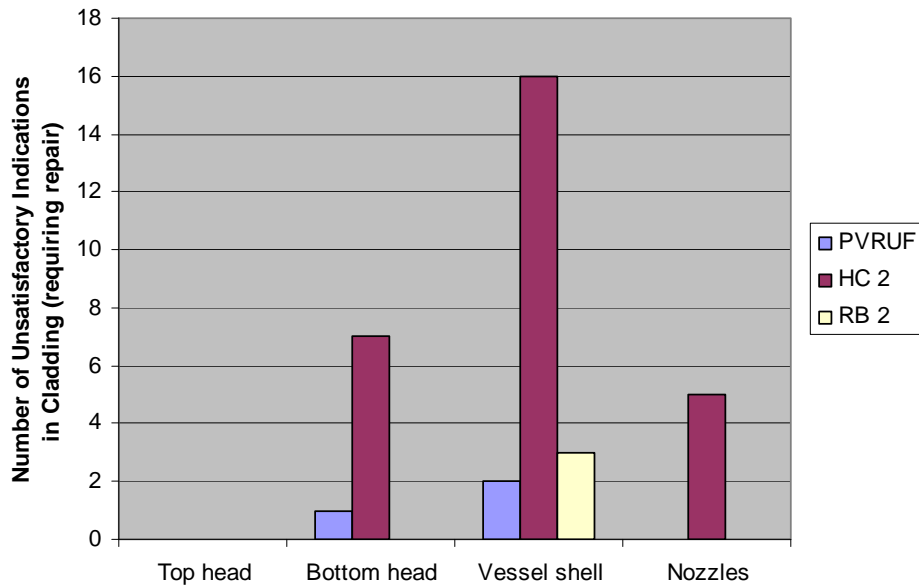
Figure 2.5 Comparison of Estimated Repair Frequency in the Cladding of Three RPVs

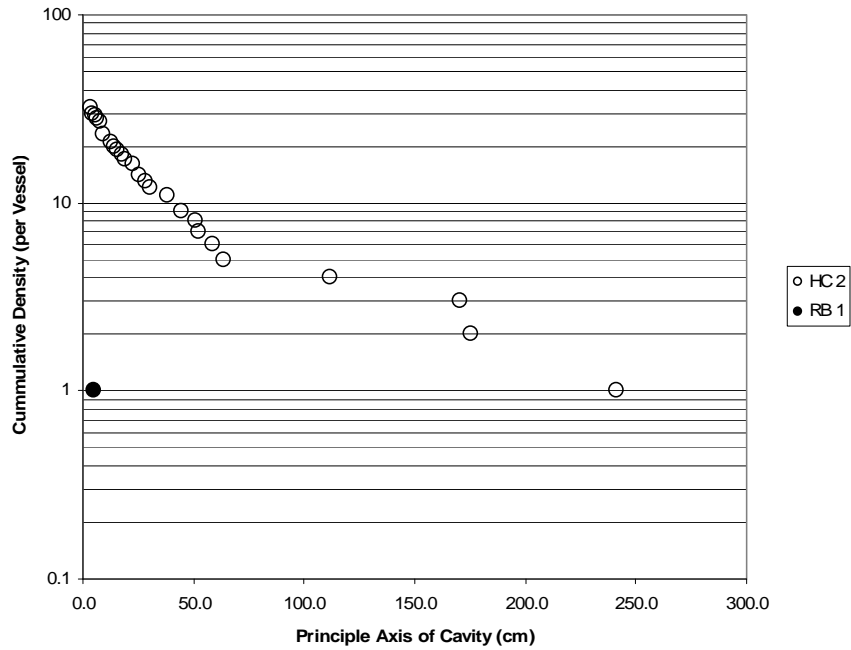
Figure 2.6 Comparison of Cavity Length in the Base Metal of Hope Creek Unit 2 and River Bend Unit 2 RPVs. Dimensions as described in the text.

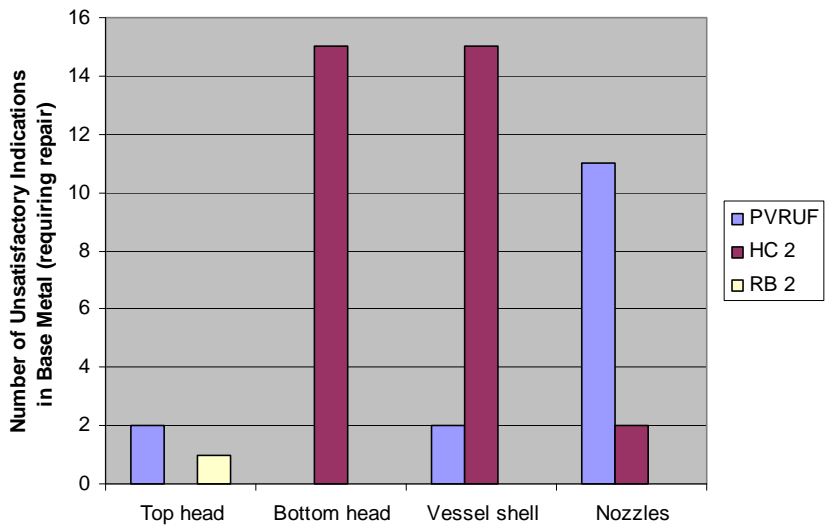
Figure 2.7 Comparison of Estimated Repair Frequency in the Base Metal of Three RPVs

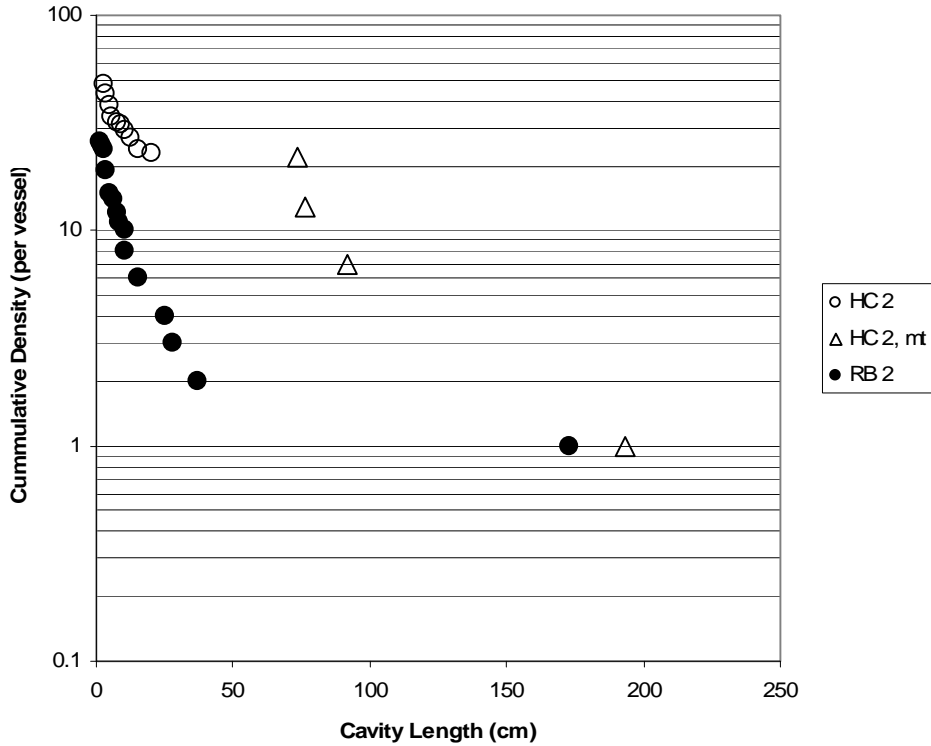
Figure 2.8 Comparison of Cavity Length for Repair of Material Handling Defects in the Hope Creek Unit 2 (HC) and River Bend Unit 2 (RB) RPVs. The data series shown as “HC, mt” uses the length of individual magnetic particle testing areas instead of individual cavity dimensions as described in the text.

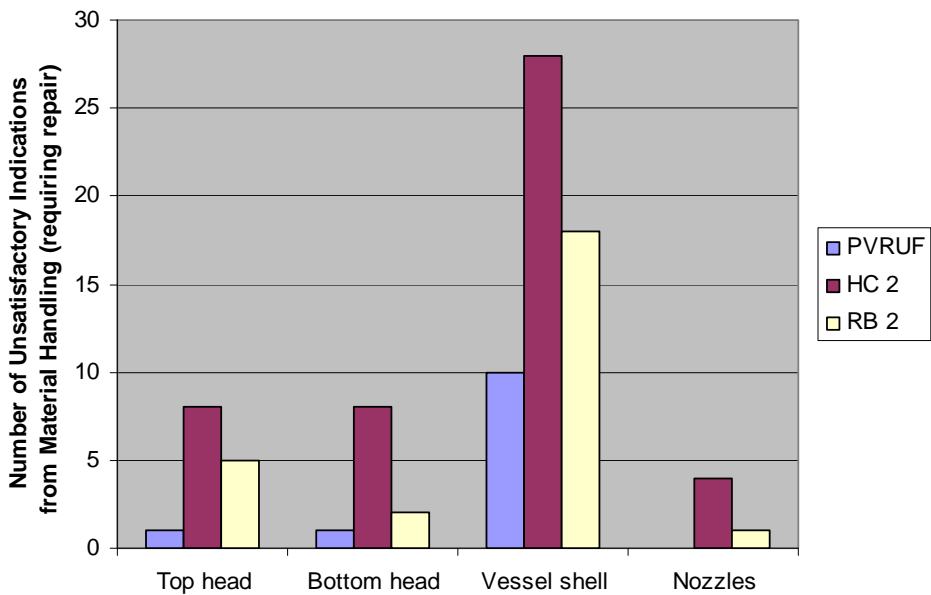
Figure 2.9 Comparison of Estimated Repair Frequency for Material Handling Defects in Three Reactor Pressure Vessels

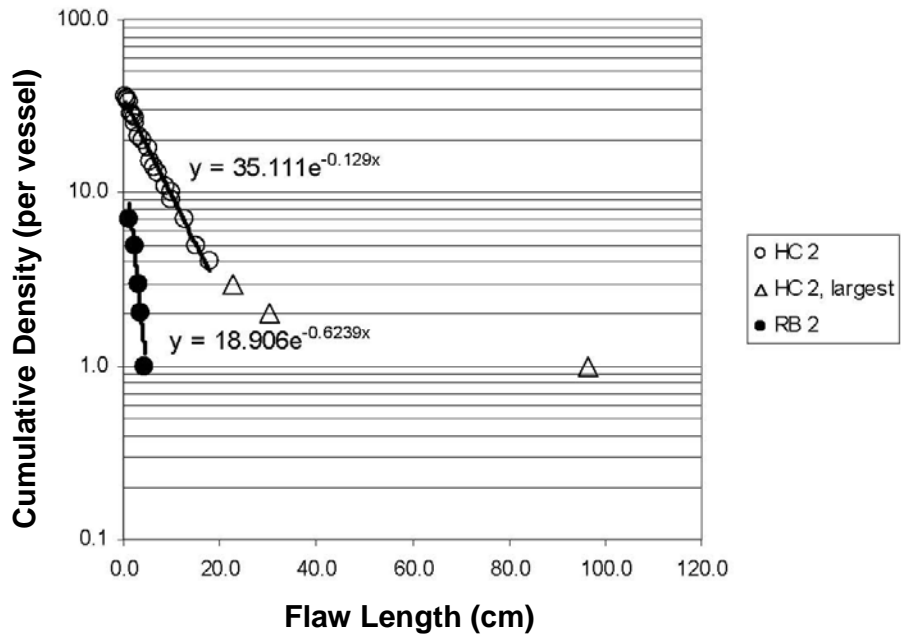
Figure 2.10 Comparison of Defect Length in the Seam Welds of the Hope Creek Unit 2 and River Bend Unit 2 RPVs

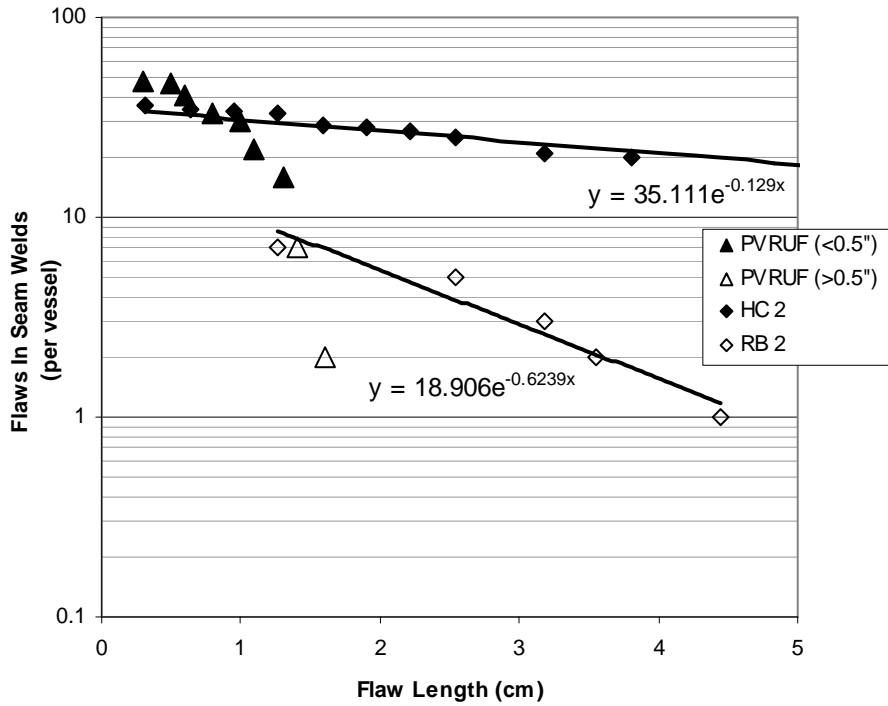
Figure 2.11 Comparison of Flaw Length in the Seam Welds of Three RPVs

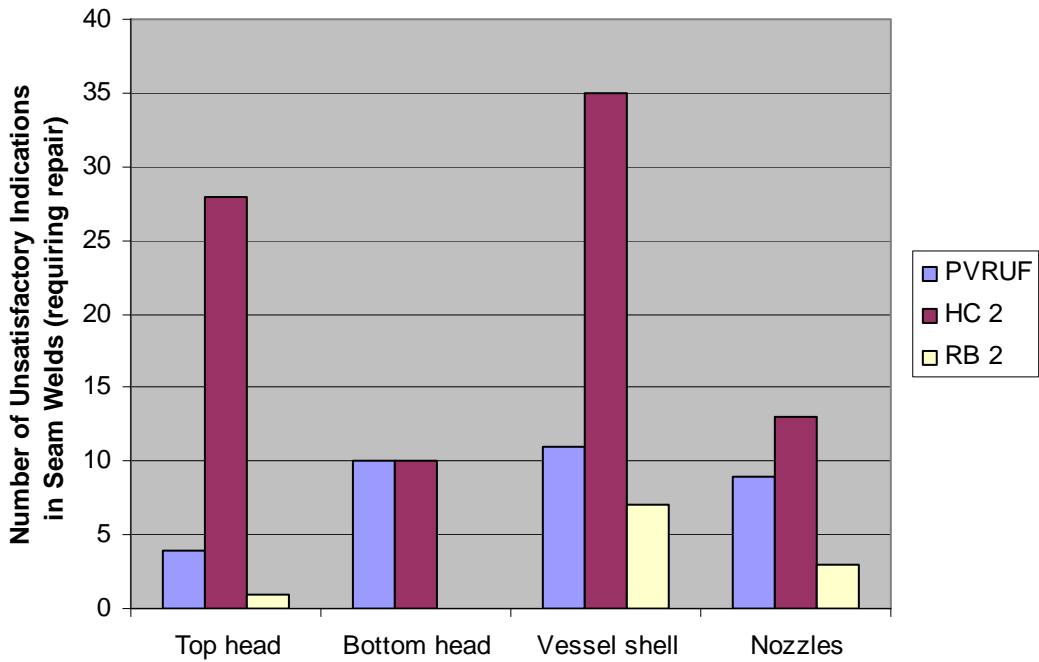
Figure 2.12 Comparison of Estimated Repair Frequency for the Seam Welds in Three RPVs

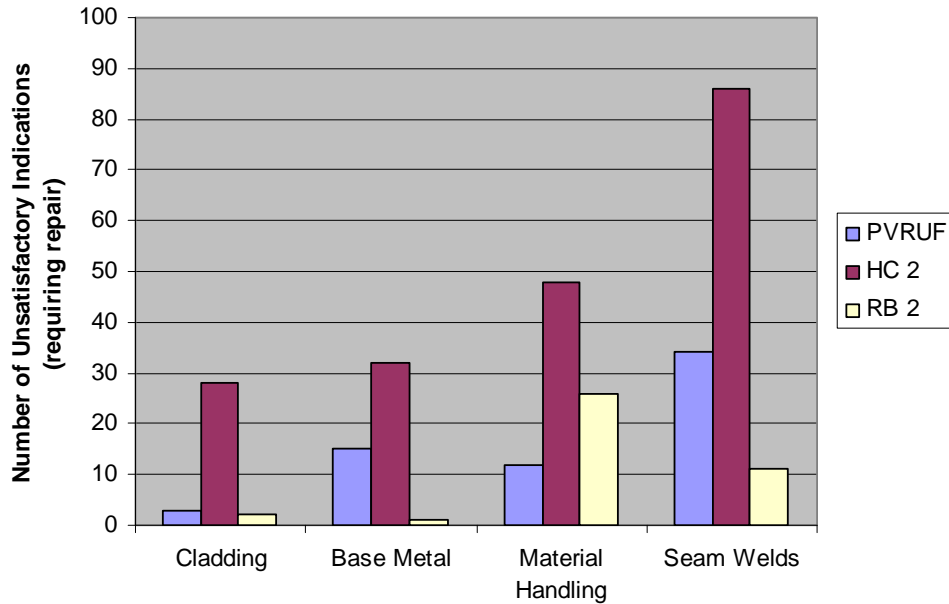
Figure 2.13 Summary of Repair Frequency for Three Reactor Pressure Vessels

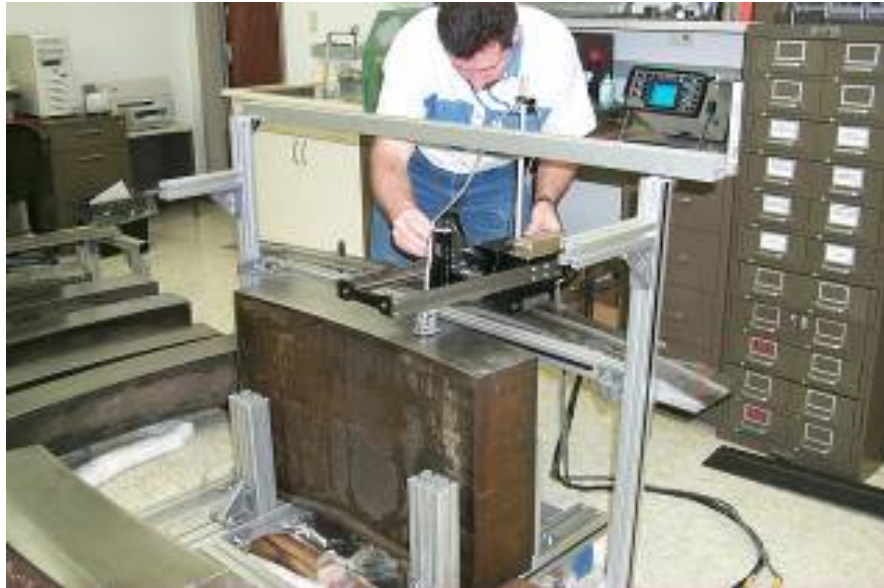
Figure 3.1 Hope Creek Unit 2 Base Metal Specimen in the NDE Laboratory for Ultrasonic Inspection Using Cut and Machined Surface

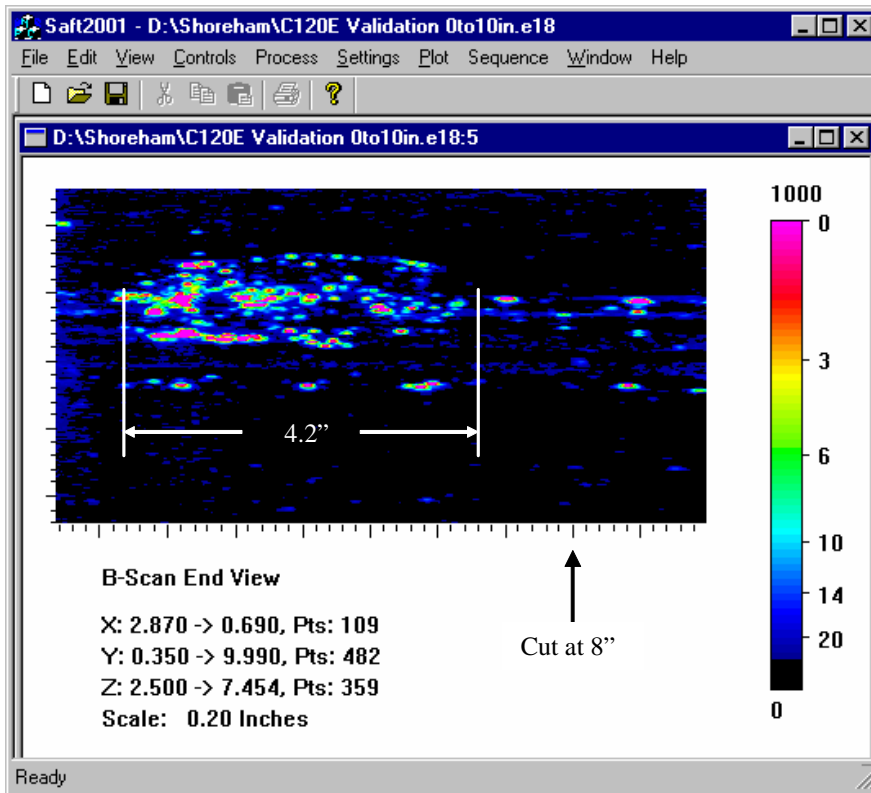
Figure 3.2 Location of an Undocumented Repair in Shoreham Specimen C120E. The units in this figure are shown in inches because the SAFT-UT system is programmed to do so. To convert to centimeters, multiply by 2.54.

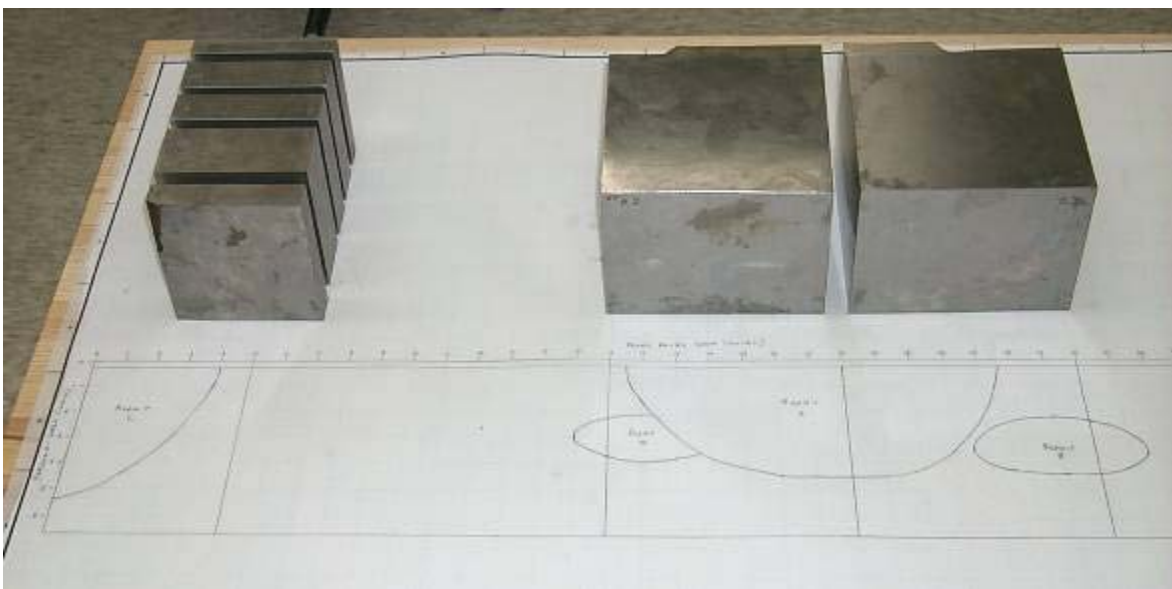
Figure 3.3 Sectioning of Repair Metal from Hope Creek Unit 2

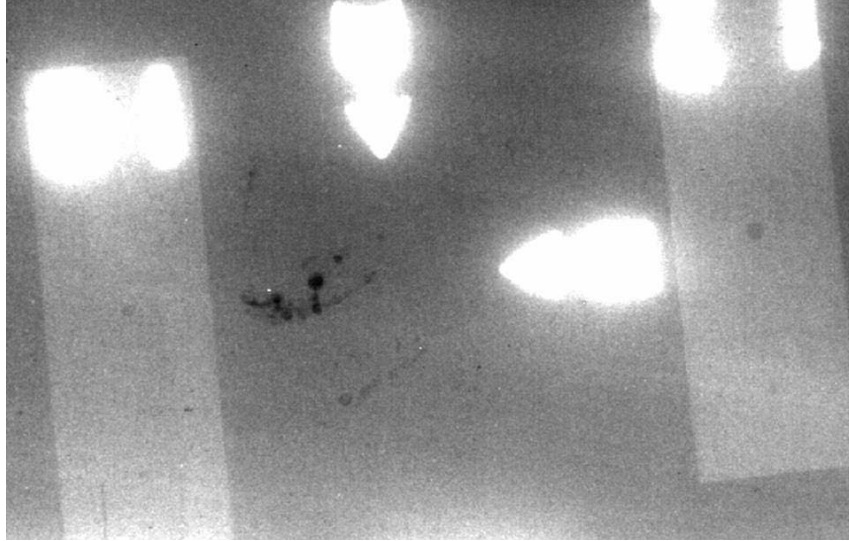
Figure 3.4 Image of Repair Flaw Using Film Radiography

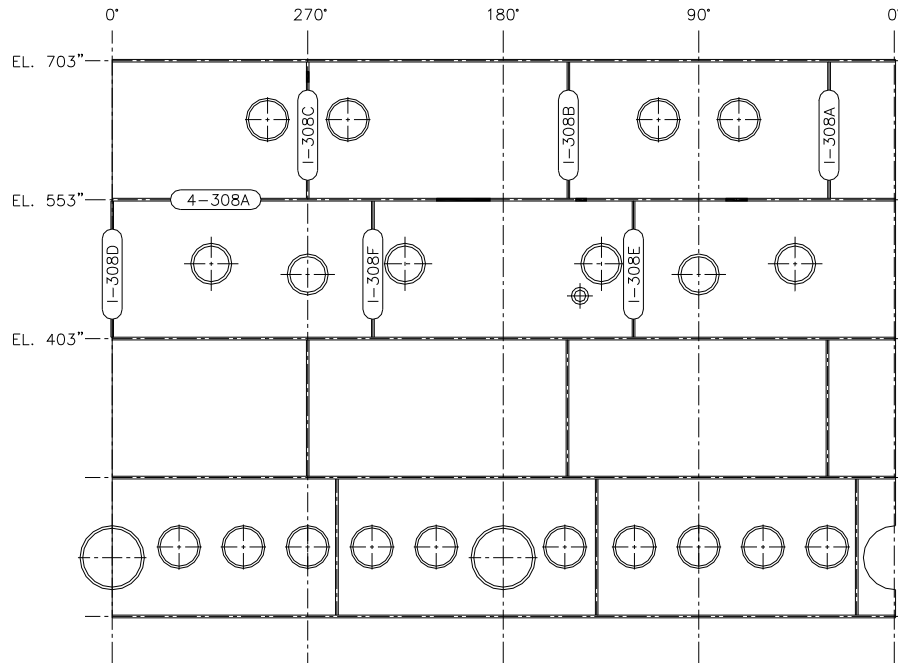
Figure 3.5 Schematic Representation of Seam Welds in Four Shell Courses of the Shoreham Vessel with the Identification Numbers of the Welds in Material Studied

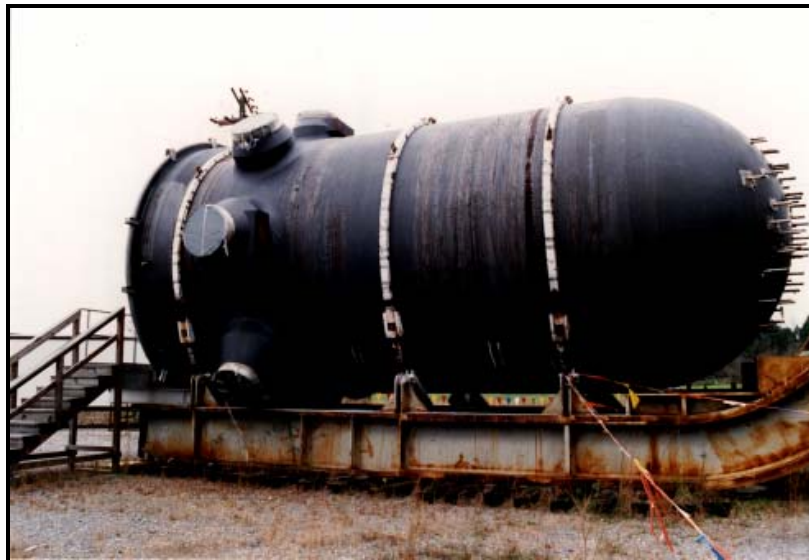
Figure 3.7 PVRUF Reactor Pressure Vessel at Oak Ridge National Laboratory

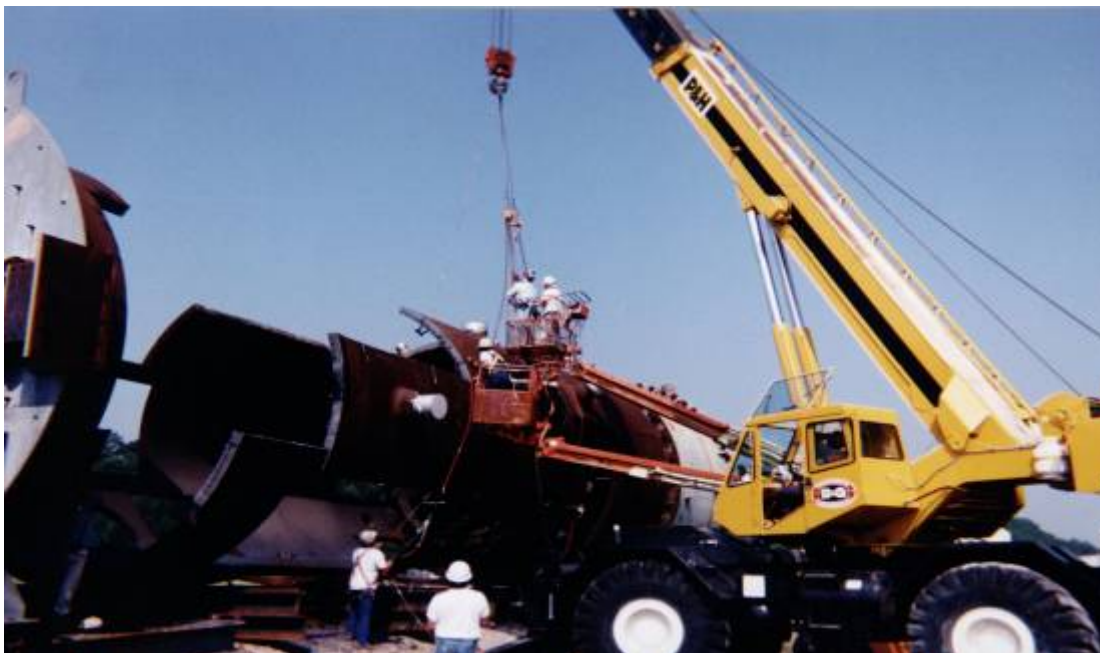
Figure 3.9 River Bend Unit 2 RPV During Disassembly

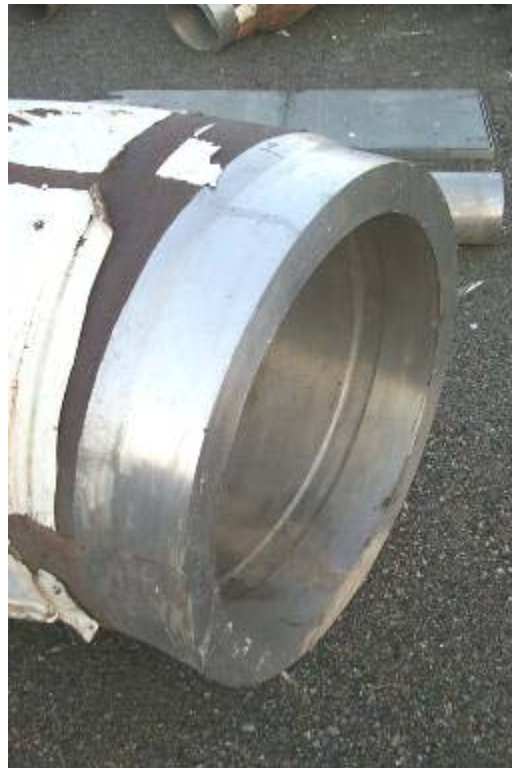
Figure 3.10 Dissimilar Metal Weld Specimen at PNNL – Safe End to 91-cm-Diameter Carbon Steel Elbow Weld

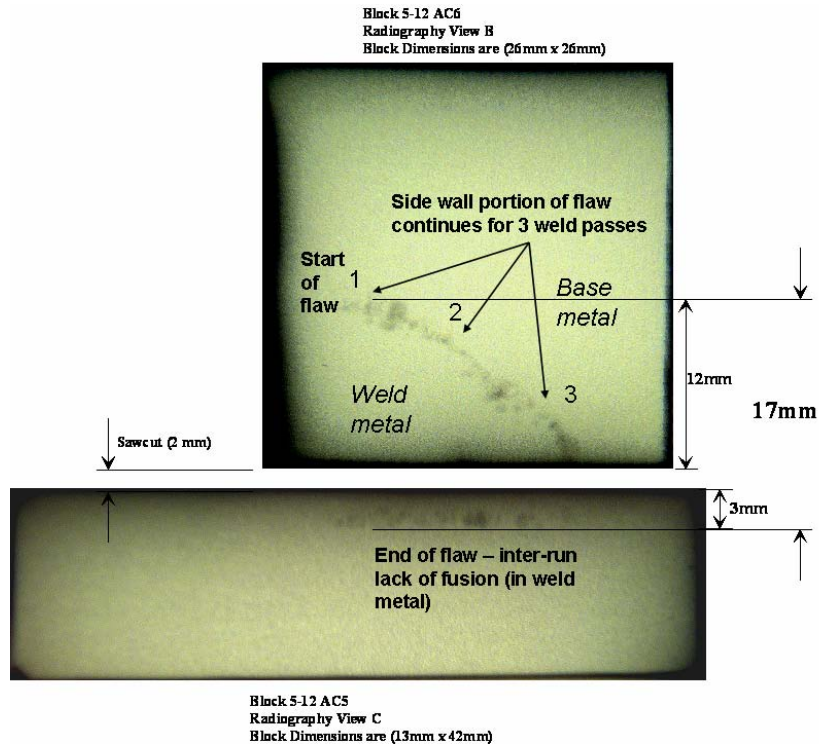
Figure 4.1 Radiographic Images of PVRUF 17-mm Flaw in OD Seam Weld Repair. The location of this repair flaw and the repair cavity surrounded by the original weld can be seen in Figure 4.5.

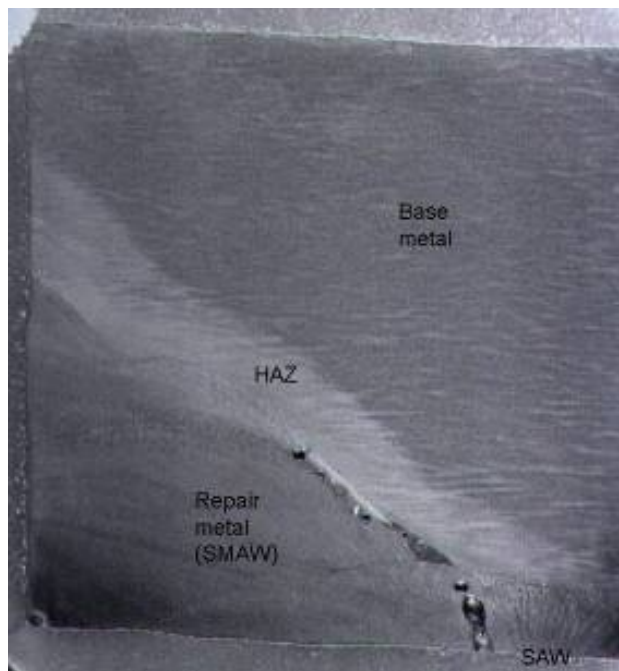
Figure 4.2 Micrograph of Portion of PVRUF 17-mm Flaw Showing Location and Composition

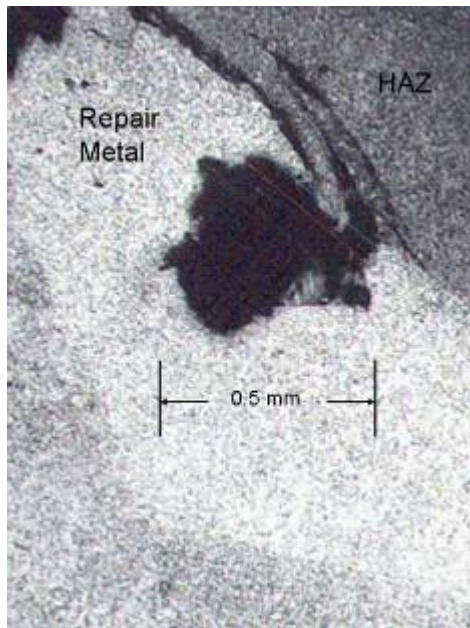
Figure 4.4 Micrograph Showing Magnified View of Crack-Like Portion of PVRUF 17-mm Flaw

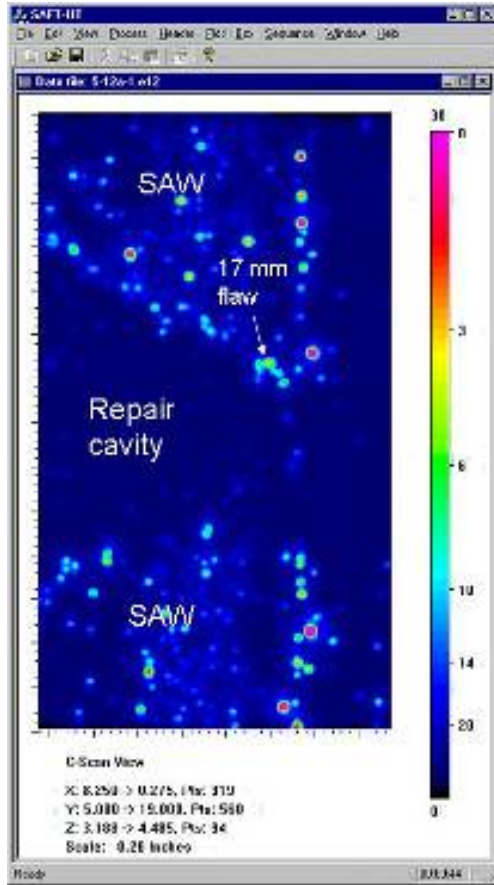
Figure 4.5 Weld-Normal UT C-Scan Image of Weld Fusion Zone Showing Profile of Weld Repair Cavity and Location of PVRUF 17-mm Flaw. To convert to centimeters, multiply by 2.54.

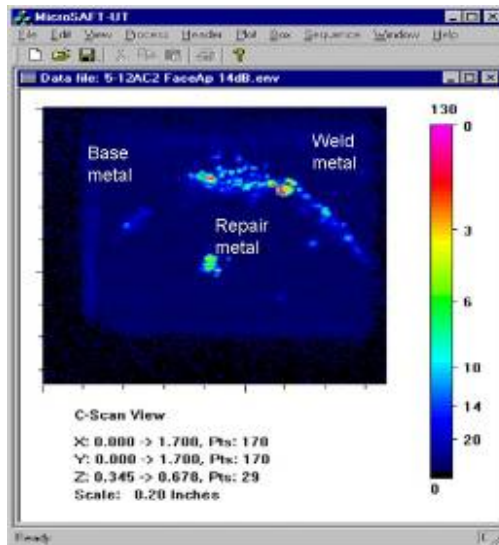
Figure 4.6 Focused Ultrasound (10 MHz) Result Showing Top View of PVRUF 12-mm Repair Flaw. To convert to centimeters, multiply by 2.54.

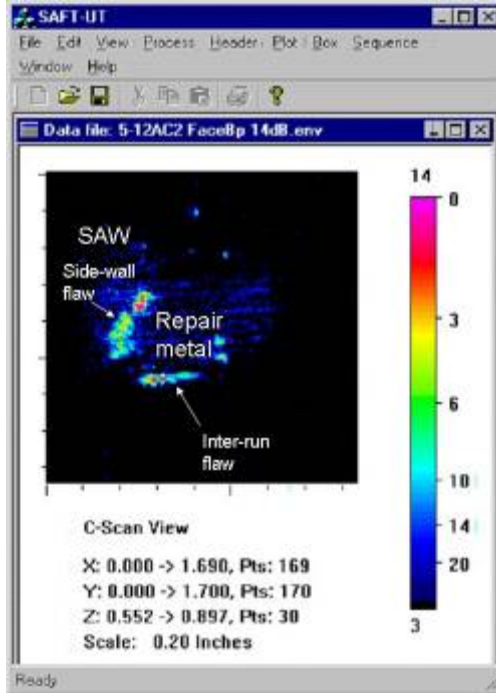
Figure 4.7 Focused Ultrasound (10 MHz) Result Showing Side View of PVRUF 12-mm Flaw. To convert to centimeters, multiply by 2.54.

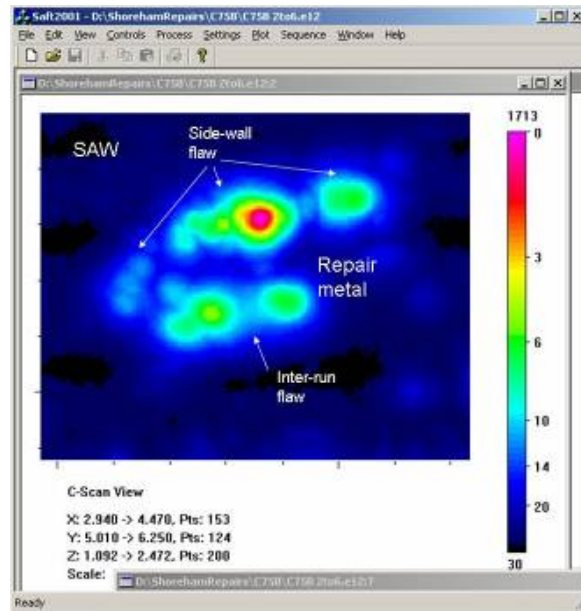
Figure 4.9 High-Resolution Image of Shoreham 14-mm Repair Flaw. To convert to centimeters, multiply by 2.54.

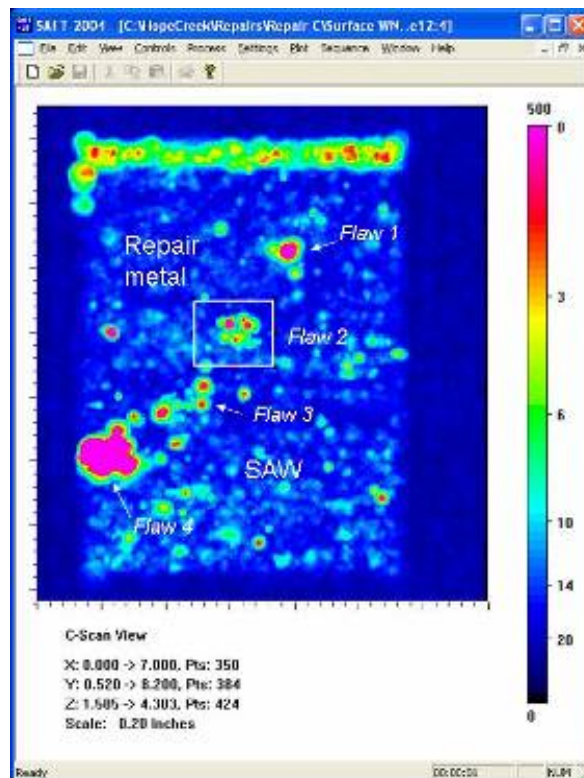
Figure 4.10 Weld-Normal UT C-Scan Image of Flaw in Fusion Zone and on End of Repair Cavity C in Hope Creek Unit 2 Reactor Pressure Vessel. To convert to centimeters, multiply by 2.54.

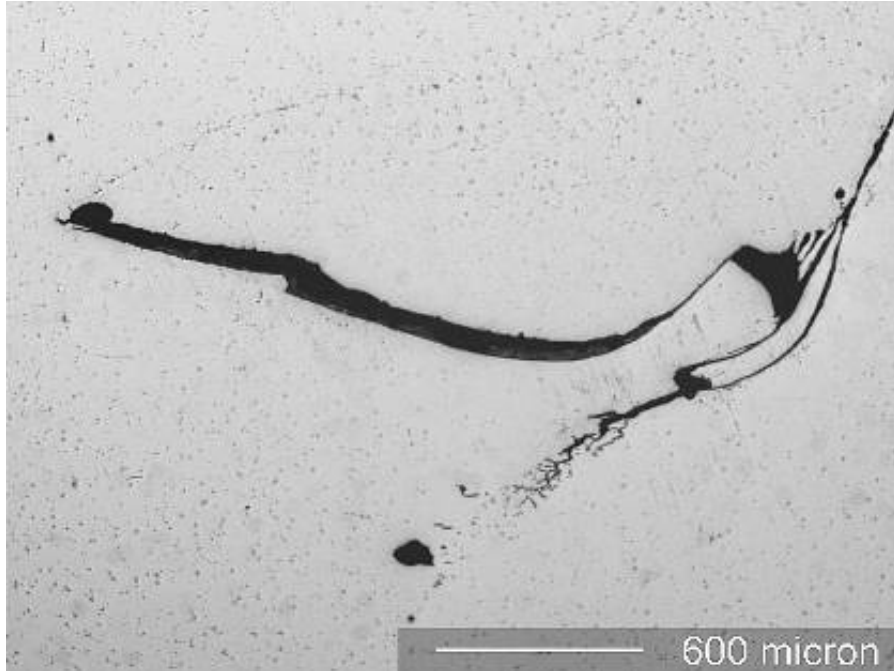
Figure 4.11 Micrograph, as Machined, of Portion of Crack in Hope Creek Unit 2 RPV Specimen C2CC

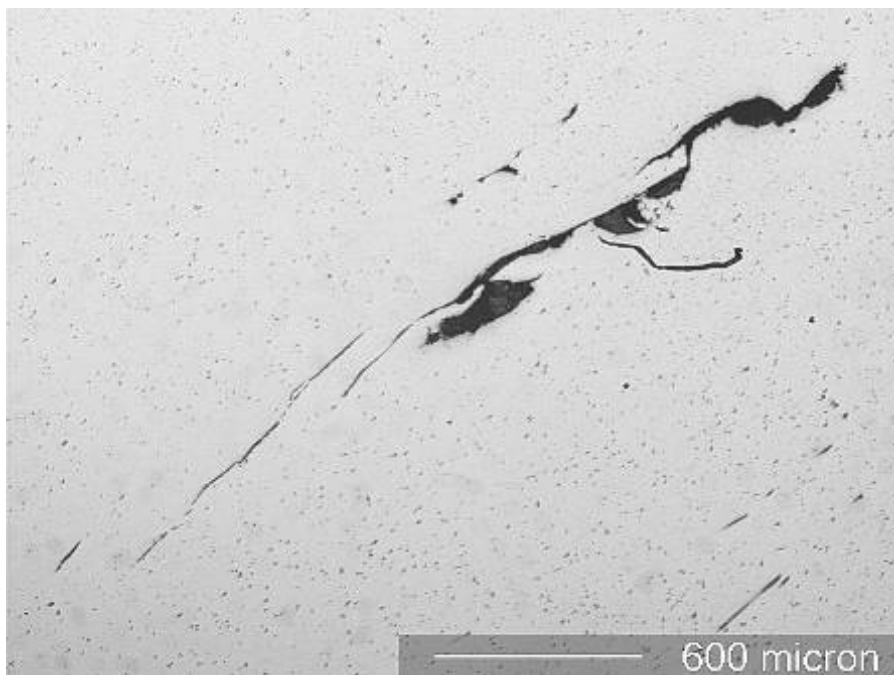
Figure 4.12 Micrograph, as Machined, of Portion of Crack in Hope Creek Unit 2 RPV Specimen C2CC

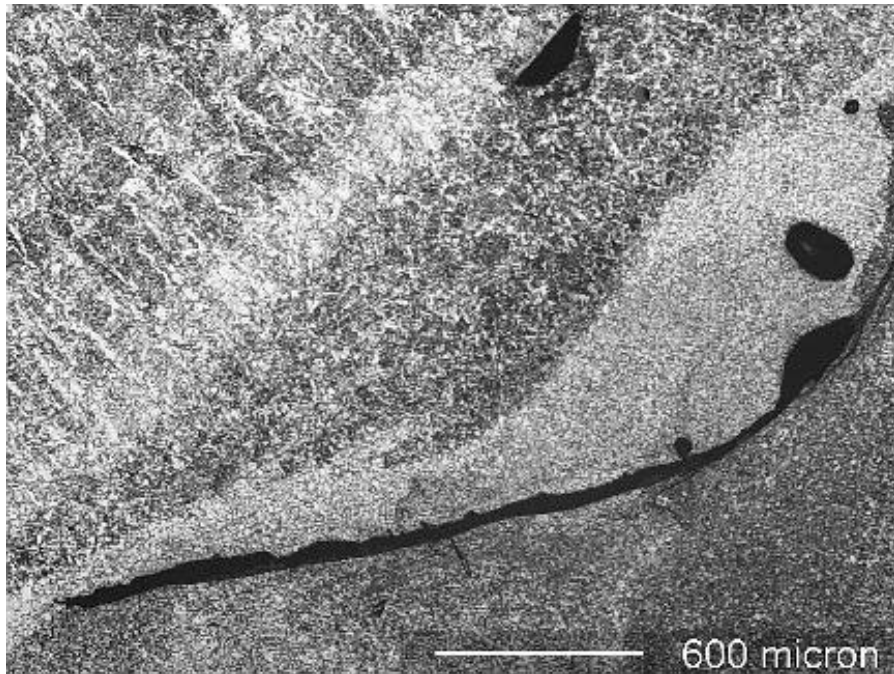
Figure 4.13 Micrograph, as Polished and Etched, of Portion of Crack in Hope Creek Unit 2 RPV Specimen C2CC

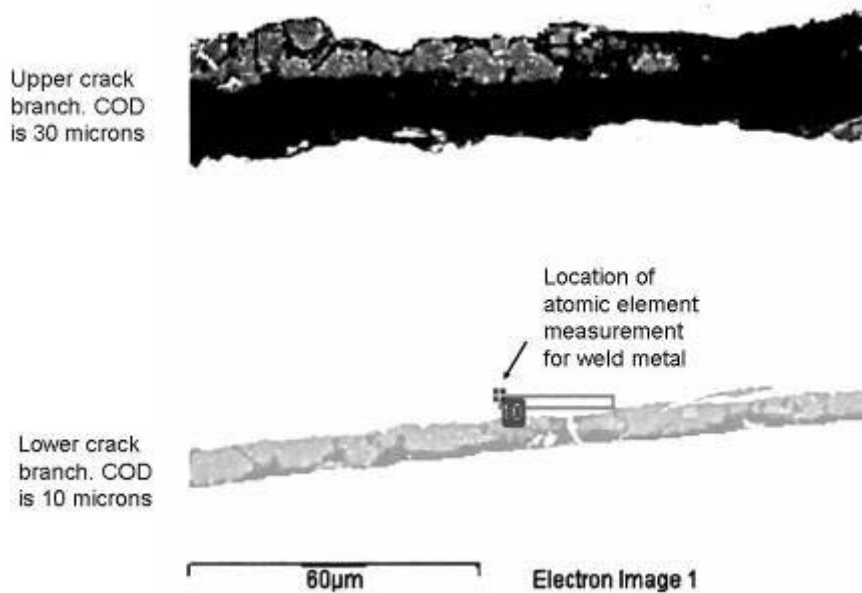
Figure 4.14 Electron Image of Portion of Two Cracks in Hope Creek Unit 2 RPV Specimen C2CC

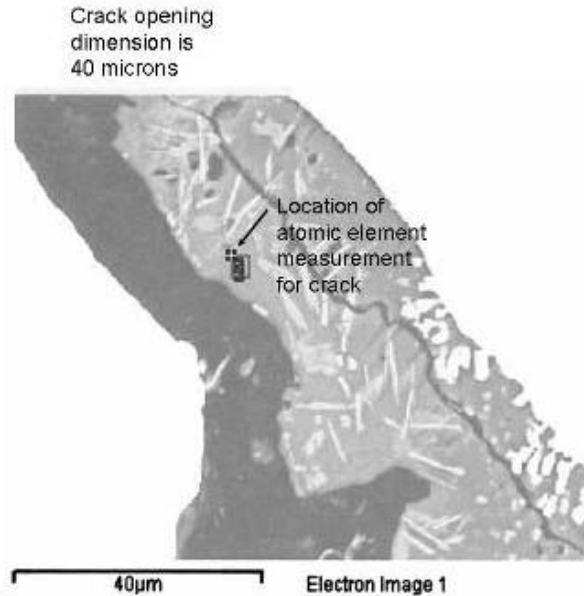
Figure 4.17 Electron Image of Portion of Crack in Hope Creek Unit 2 RPV Specimen C2CC

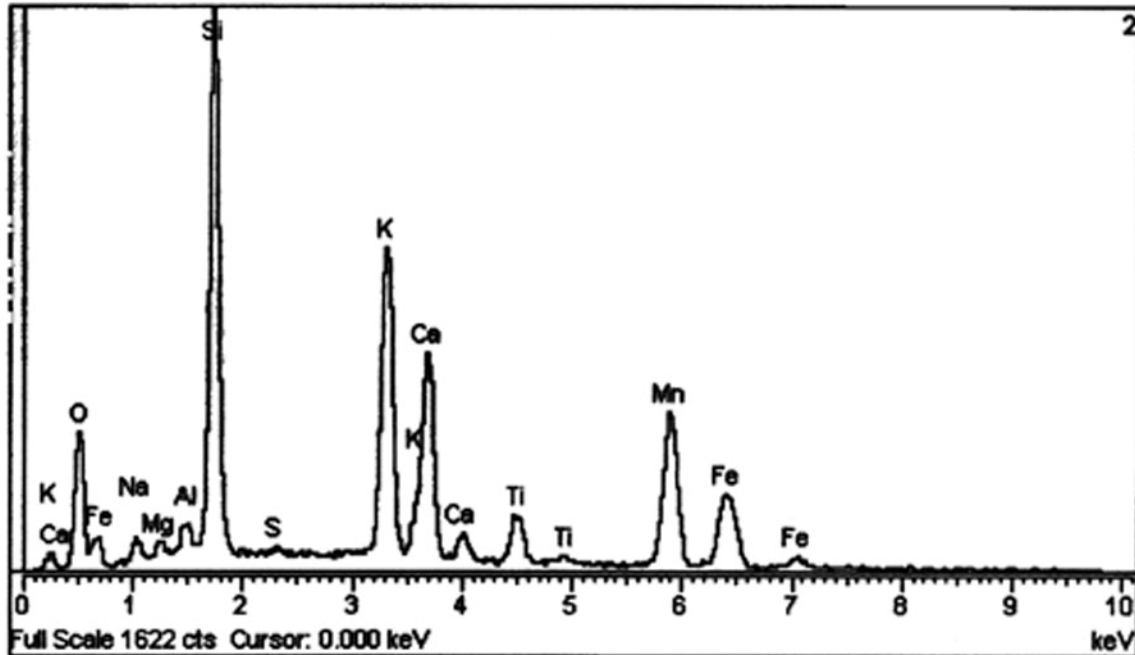
Figure 4.19 X-Ray Spectrum from Elemental Analysis of Contamination in Crack in Hope Creek Unit 2 RPV Specimen C2CC

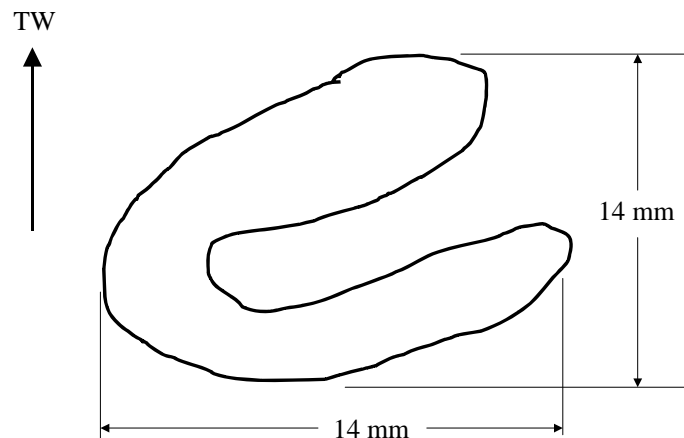
Figure 4.20 Shoreham 14-mm Repair Flaw with More Conservative Treatment A of Flaw Dimensions

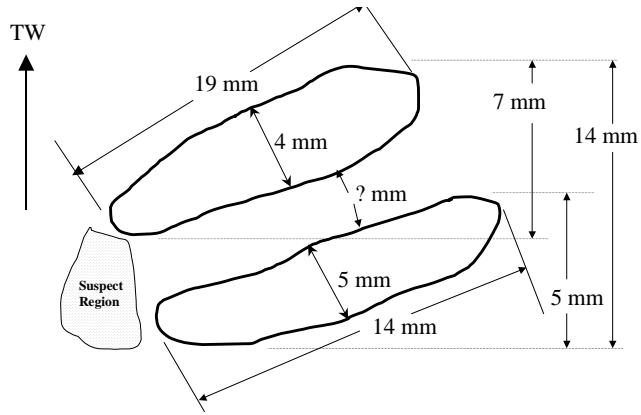
Figure 4.21 Shoreham 14-mm Repair Flaw with Less Conservative Treatment B of Flaw Dimensions

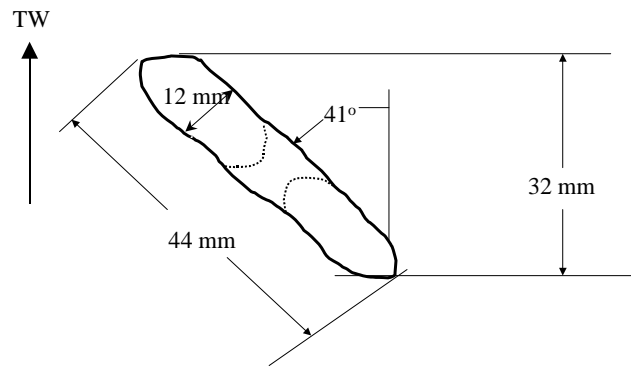
Figure 4.22 Shoreham 32-mm Repair Flaw with More Conservative Treatment A of Flaw Dimensions

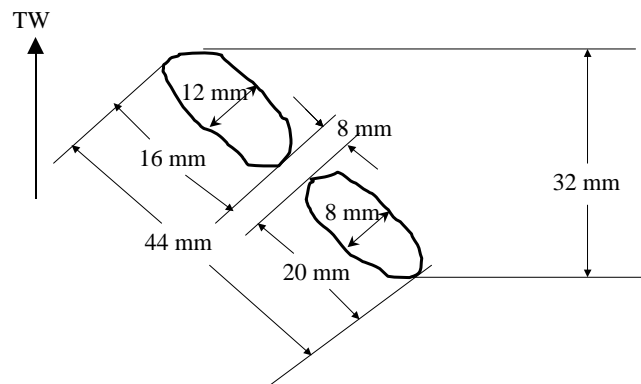
Figure 4.23 Shoreham 32-mm Repair Flaw with Less Conservative Treatment B of Flaw Dimensions
