Fabrication Flaw Density and Distribution In Repairs to Reactor Pressure Vessel and Piping Welds

United States Nuclear Regulatory Commission

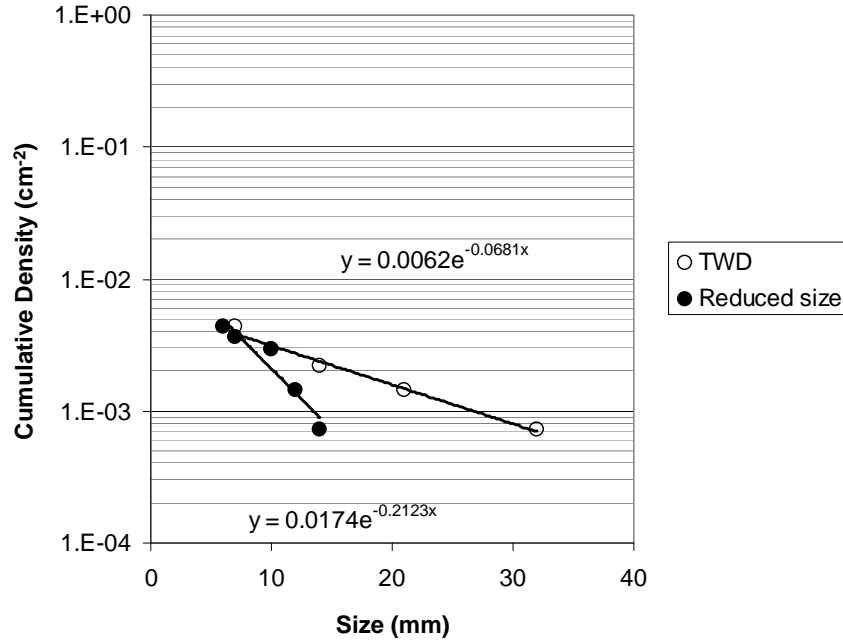
Figure 5.1 Through-Wall Dimension and Reduced Size Distribution Based on Fracture Mechanics for Flaws in Repairs in Seam Welds of Shoreham Reactor Pressure Vessel

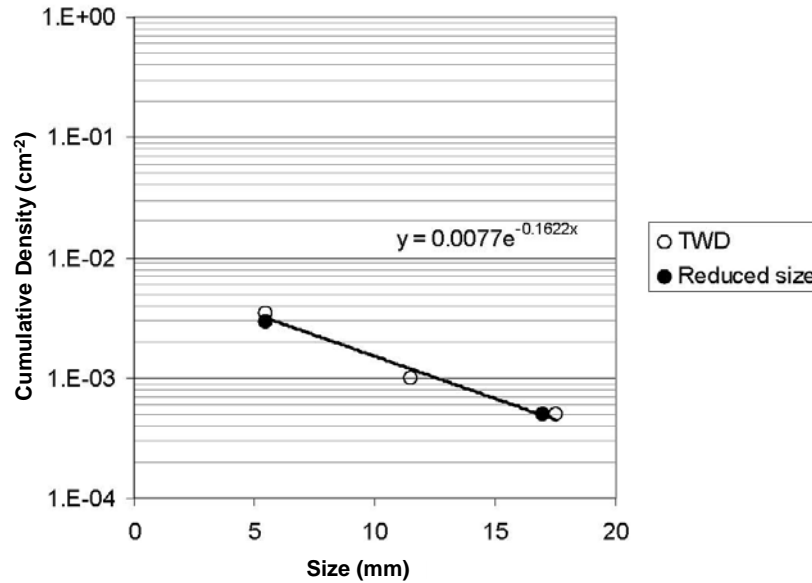
Figure 5.2 Through-Wall Dimension and Reduced Size Distribution Based on Fracture Mechanics Considerations for Flaws in Repairs in Seam Welds of PVRUF Reactor Pressure Vessel

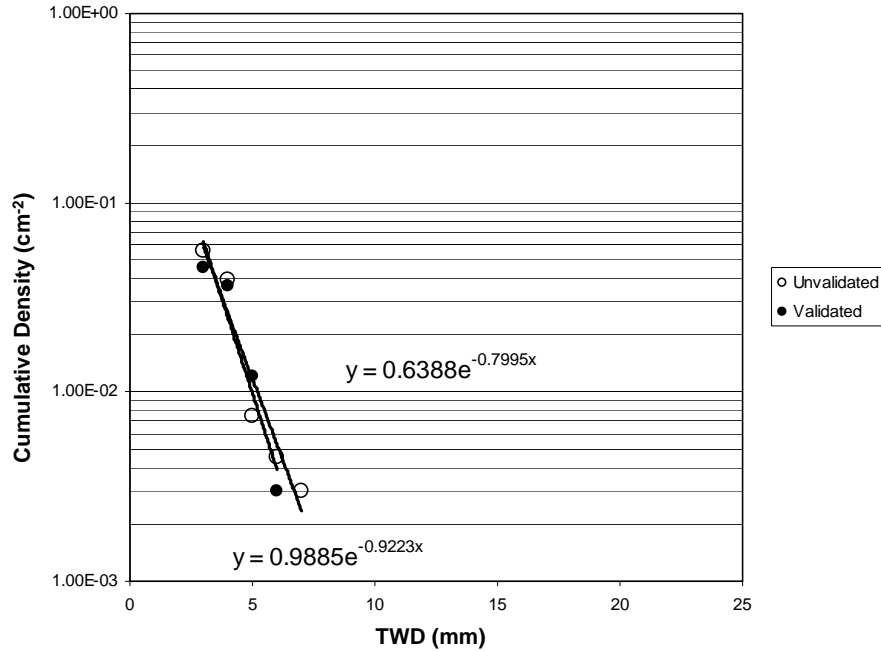
Figure 5.3 Validated and Unvalidated Through-Wall Size Distribution for Flaws in Seam Weld Repair A for Seam BE in Hope Creek Unit 2 Reactor Pressure Vessel

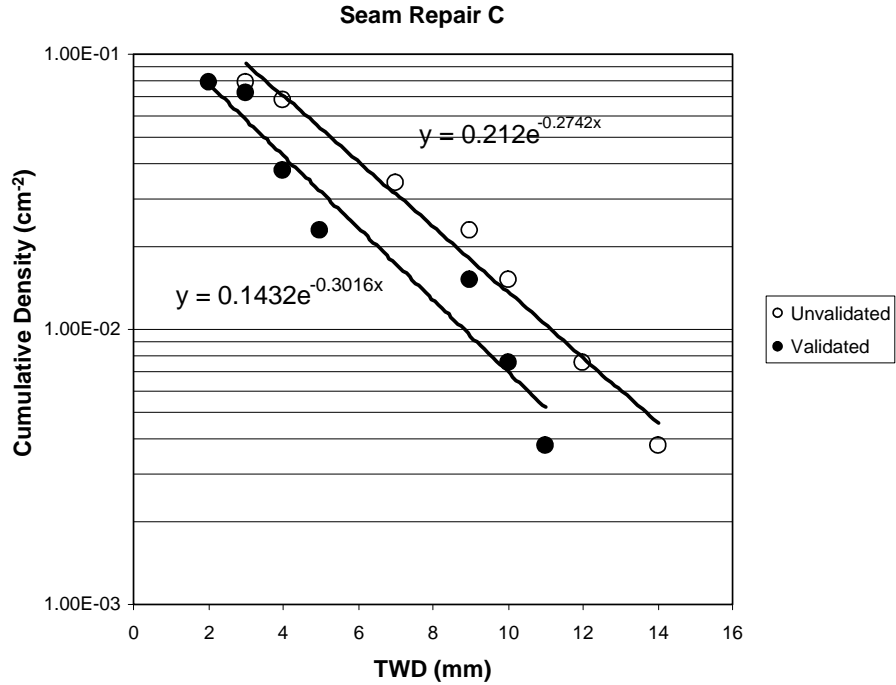
Figure 5.4 Validated and Unvalidated Through-Wall Size Distribution for Flaws in Seam Weld Repair C for Seam BE in Hope Creek Unit 2 Reactor Pressure Vessel

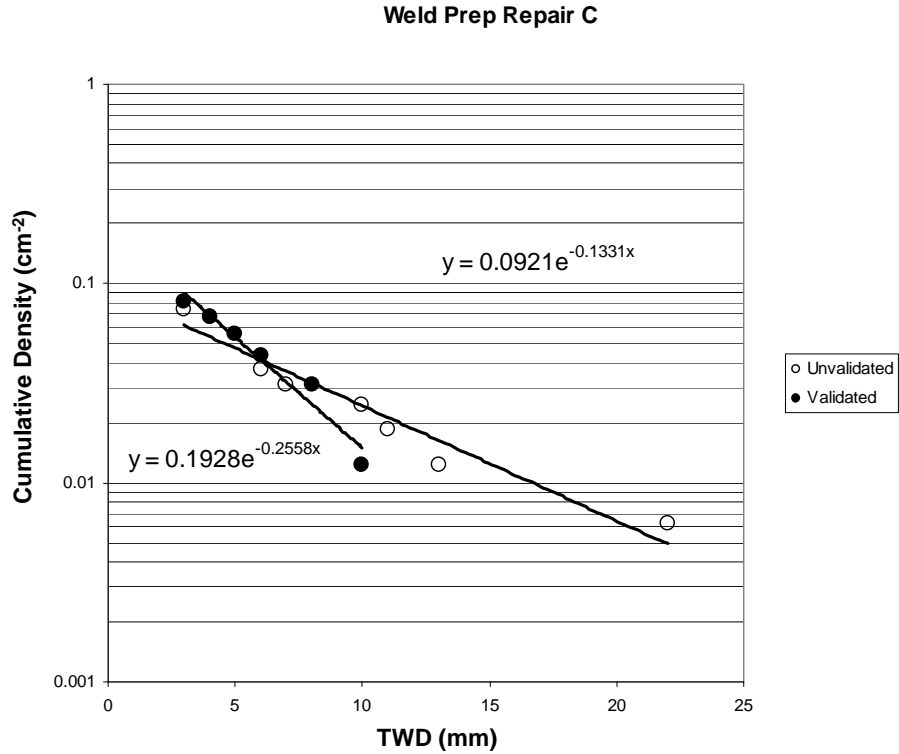
Figure 5.5 Validated and Unvalidated Through-Wall Size Distribution for Flaws in Weld Preparation Surface Repair C on Base Metal Piece 22-2 for Seam BE in Hope Creek Unit 2 Reactor Pressure Vessel

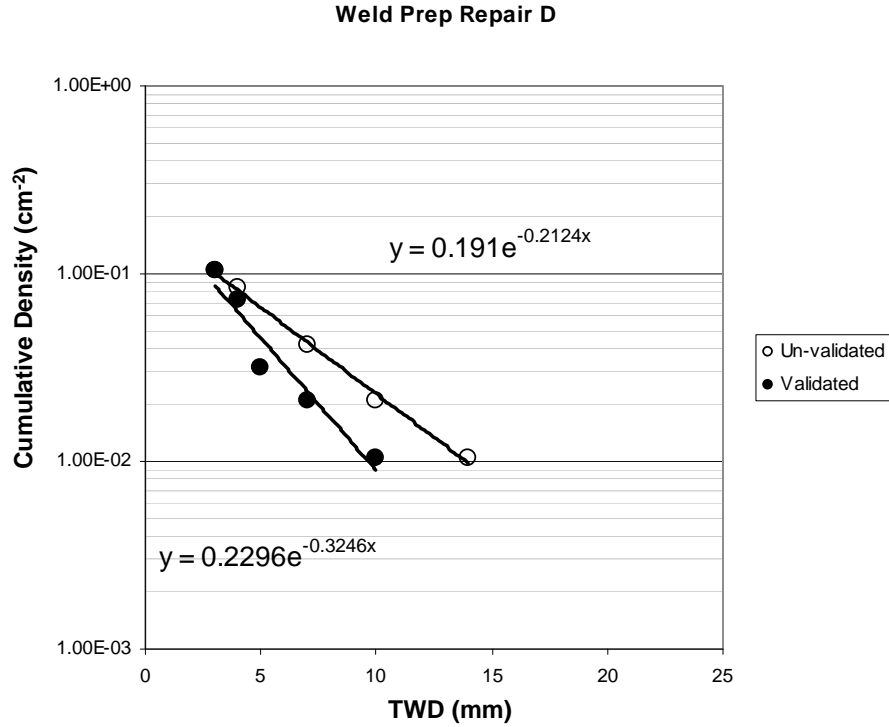
Figure 5.6 Validated and Unvalidated Through-Wall Size Distribution for Flaws in Weld Preparation Surface Repair D on Base Metal Piece 22-2 for Seam BE in Hope Creek Unit 2 Reactor Pressure Vessel

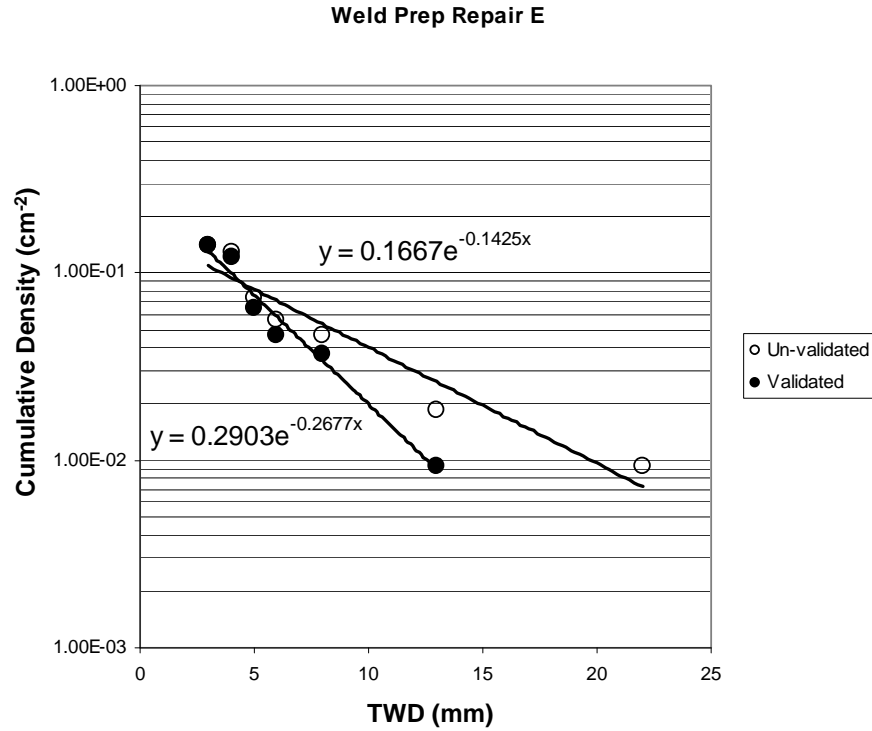
Figure 5.7 Validated and Unvalidated Through-Wall Size Distribution for Flaws in Weld Preparation Surface Repair E on Base Metal Piece 22-2 for Seam BE in Hope Creek Unit 2 Reactor Pressure Vessel

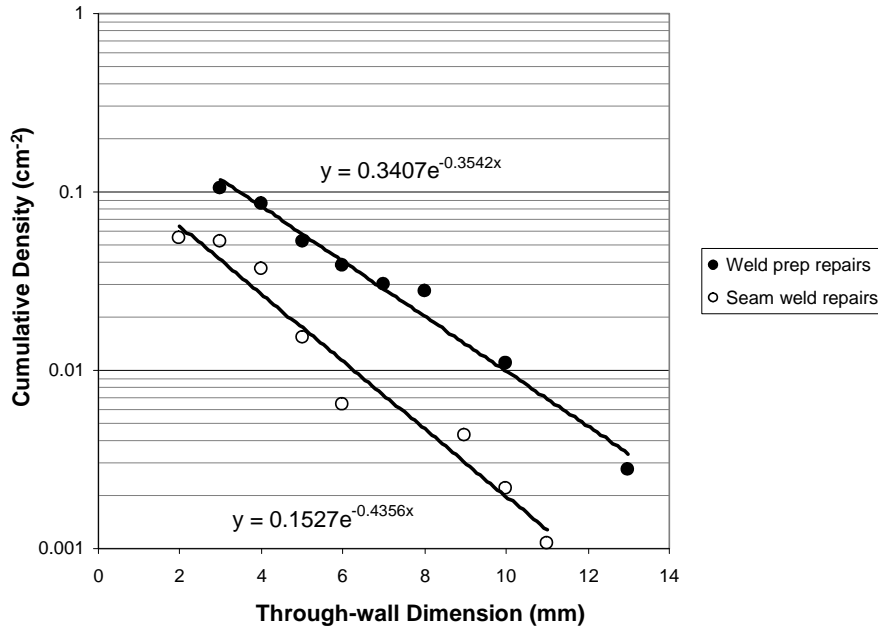
Figure 5.8 Validated Cumulative Through-Wall Size Distribution for Seam Weld Repairs and Weld Preparation Surface Repairs in the Hope Creek Unit 2 Reactor Pressure Vessel

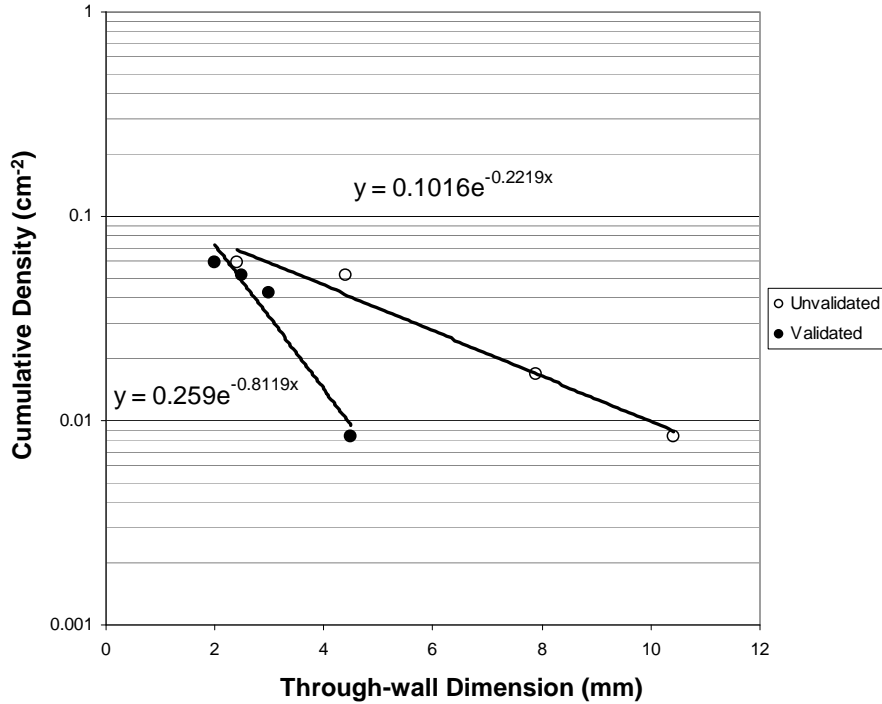
Figure 5.9 Validated and Unvalidated Cumulative Through-Wall Size Distribution for Flaws in Repairs in Dissimilar Metal Welds of Piping

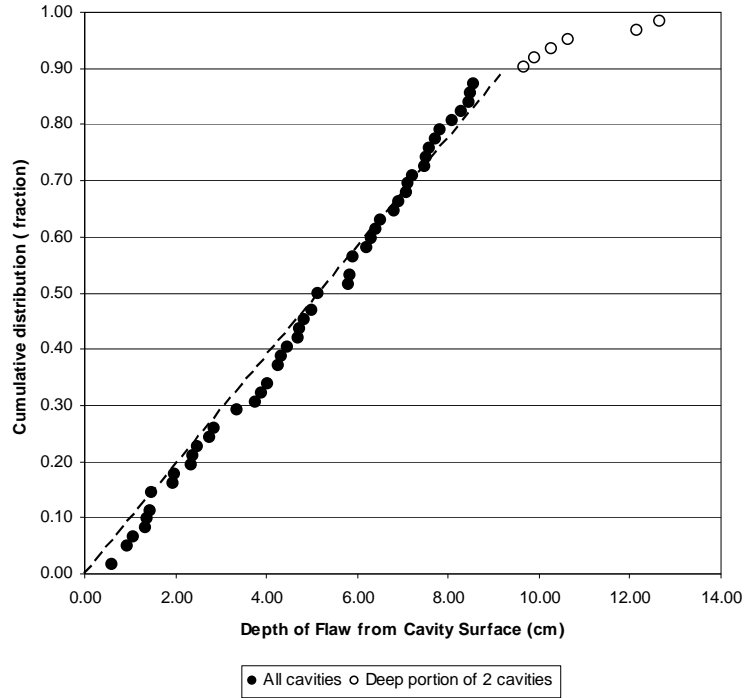
Figure 5.10 Distribution of Repair Flaws Through the Cavity Depth in Centimeters from the Cavity Surface

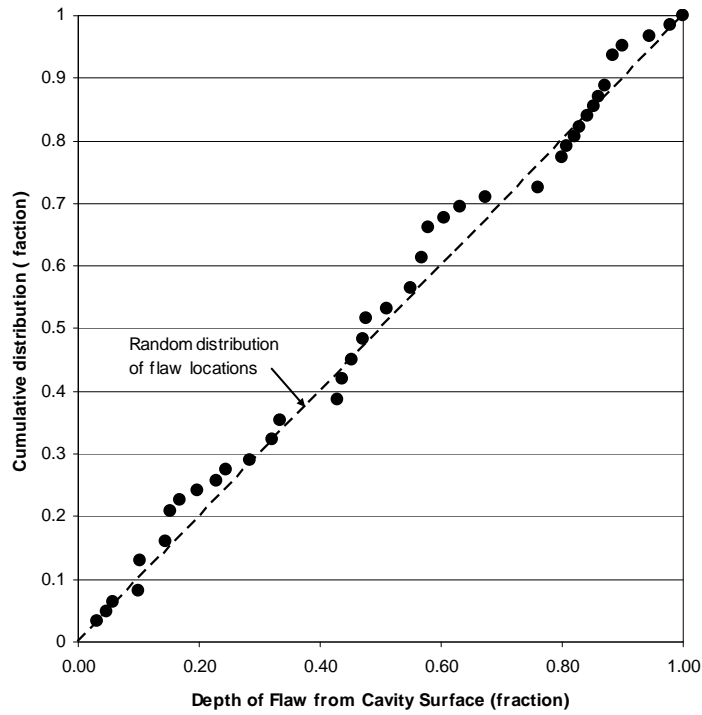
Figure 5.11 Distribution of Repair Flaws Through the Cavity as a Fraction of the Cavity Depth

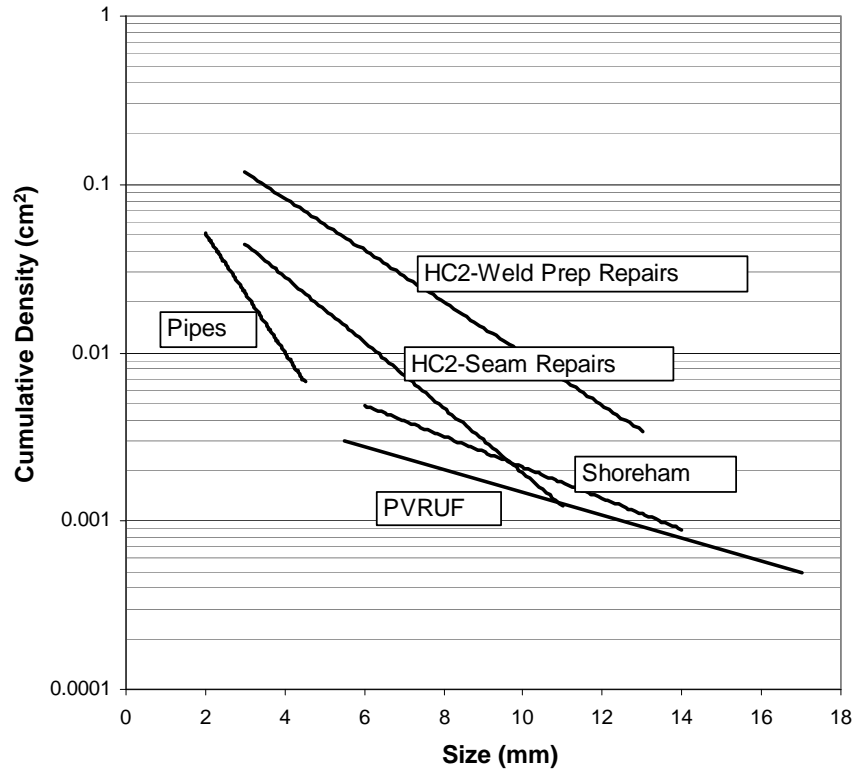
Figure 6.1 Comparison of Flaw Density and Through-Wall Size Distributions for Repair Flaws in Three Reactor Pressure Vessels and in Dissimilar Metal Welds of Piping

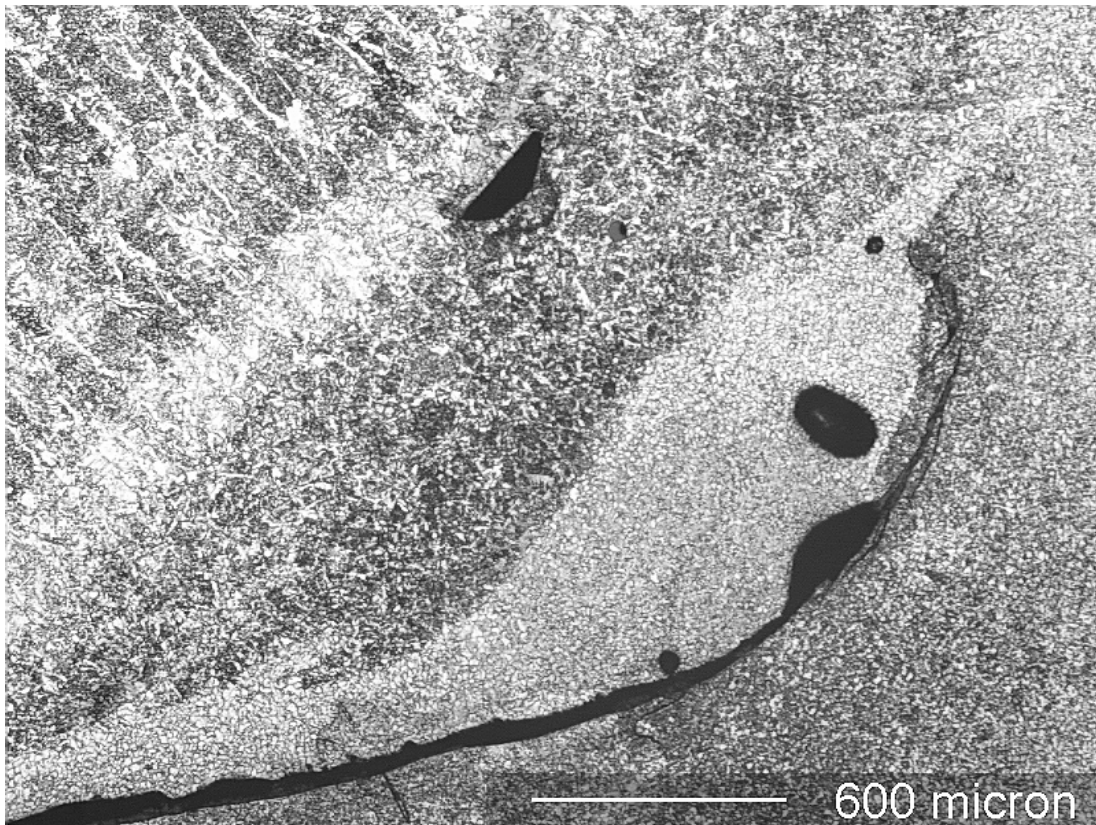
Figure A.1 Flaw C2CC on the End of Seam Repair C, as Polished and Etched. Flaw has properties of lack of fusion with weld solidification cracks.

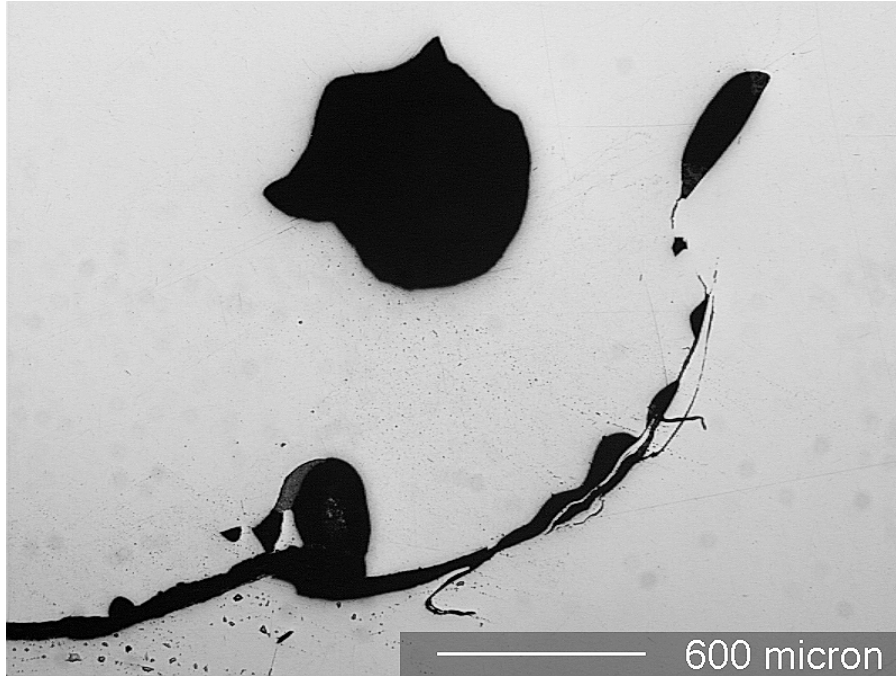
Figure A.2 Flaw C2CC on the End of Seam Repair C, as Machined

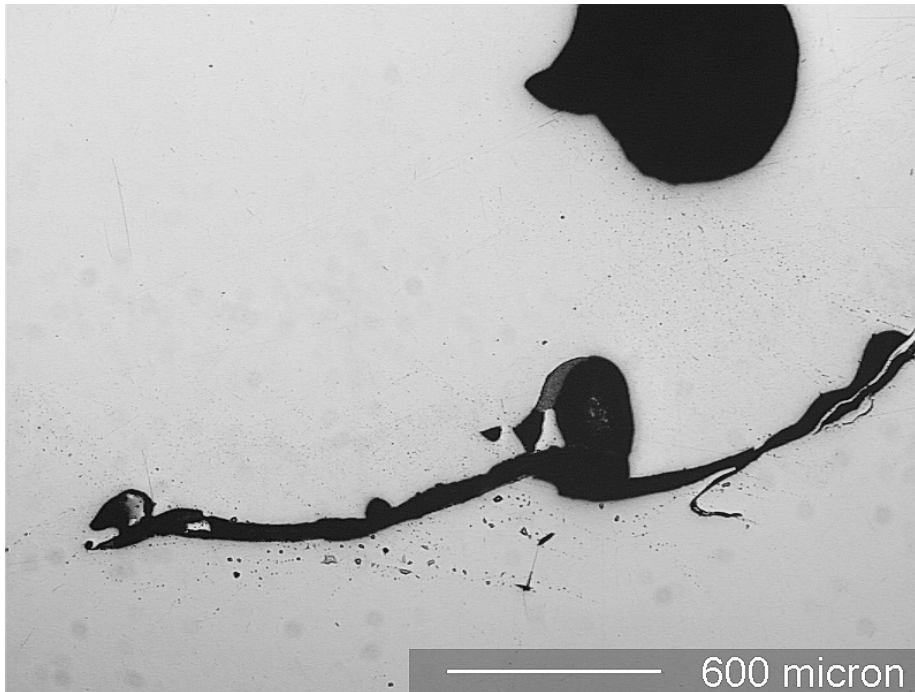
Figure A.3 Flaw C2CC on the End of Seam Repair C, as Machined

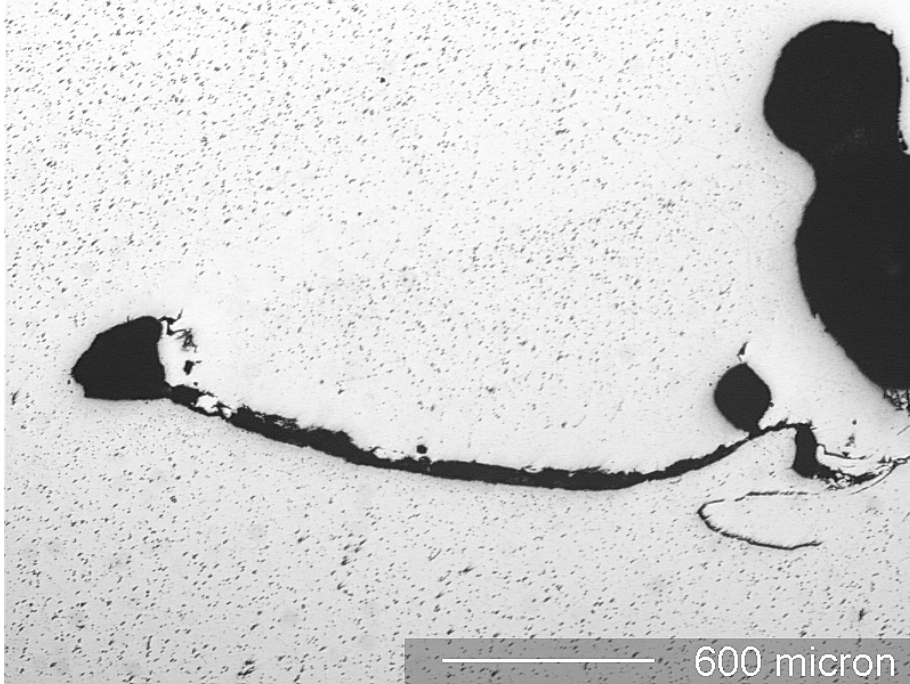
Figure A.4 Flaw C2CC on the End of Seam Repair C, as Machined

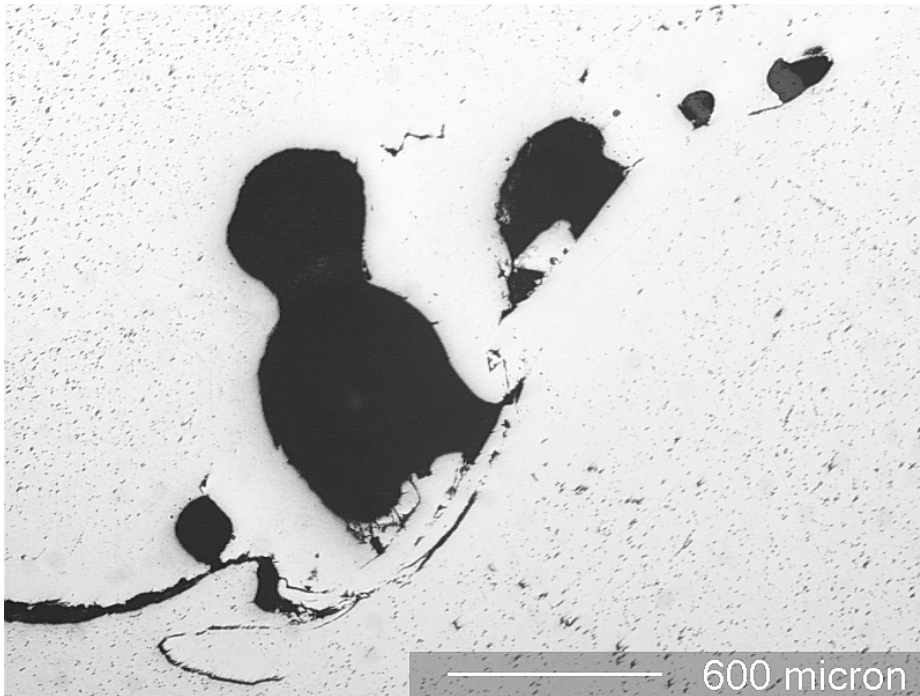
Figure A.5 Flaw C2CC on the End of Seam Repair C, as Machined

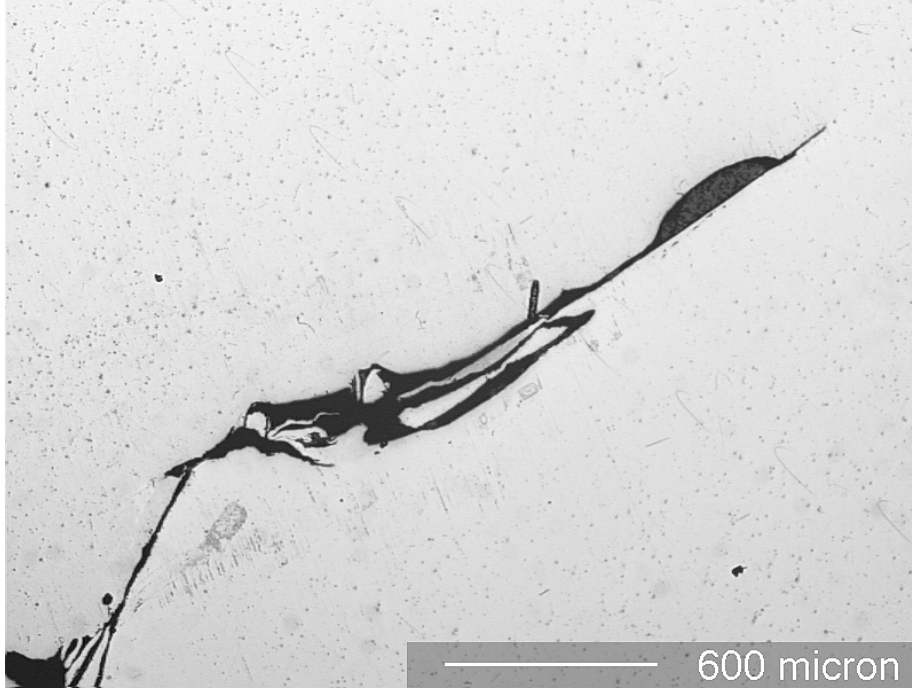
Figure A.6 Flaw C2CC on the End of Seam Repair C, as Machined

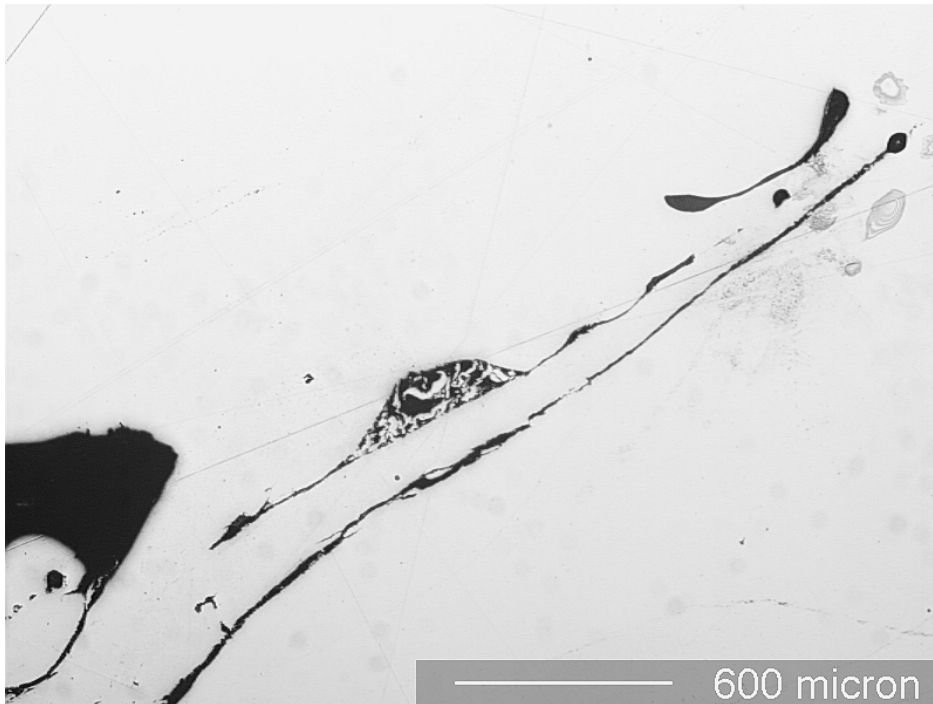
Figure A.7 Flaw C2CC on the End of Seam Repair C, as Machined

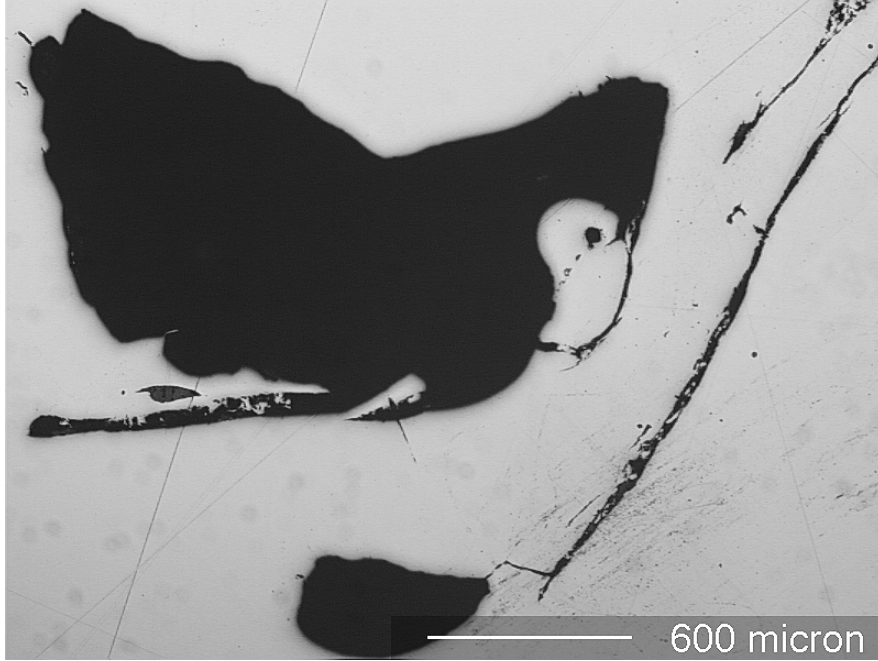
Figure A.8 Flaw C2CC on the End of Seam Repair C, as Machined

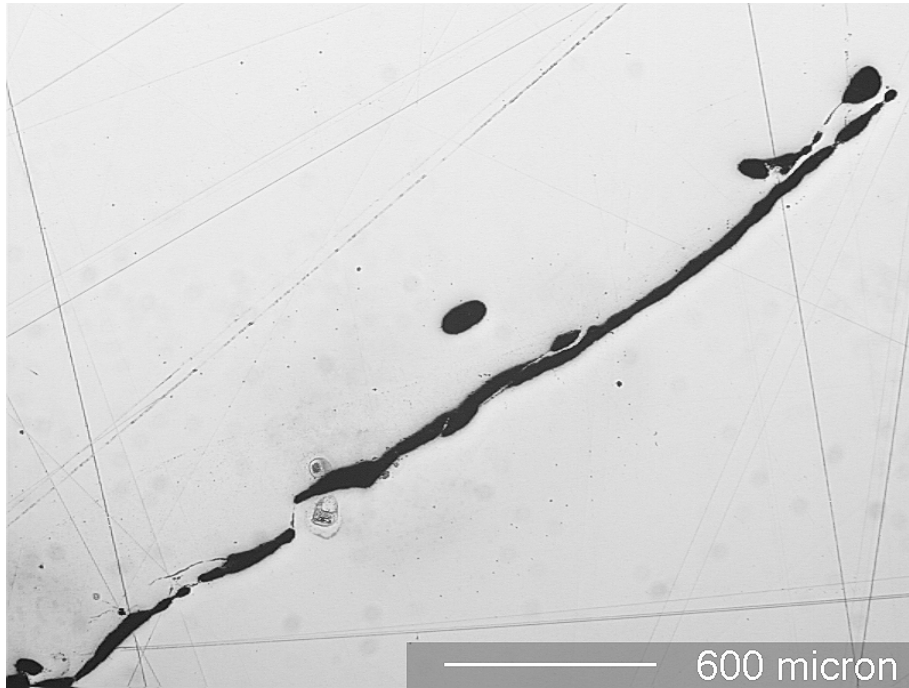
Figure A.9 Flaw C2CC on the End of Seam Repair C, as Machined

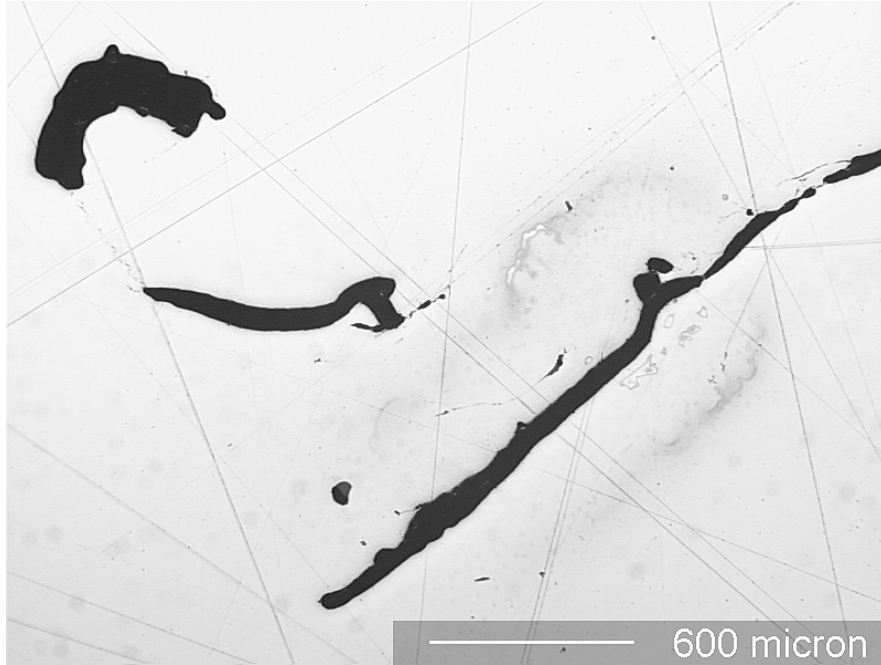
Figure A.10 Flaw C2CC on the End of Seam Repair C, as Machined

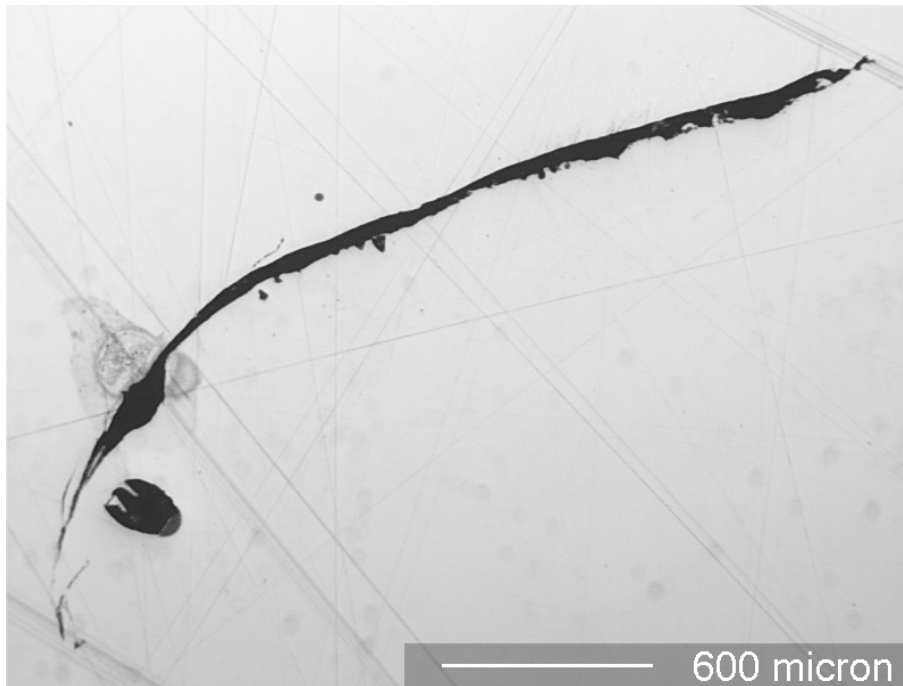
Figure A.11 Flaw C2CC on the End of Seam Repair C, as Machined

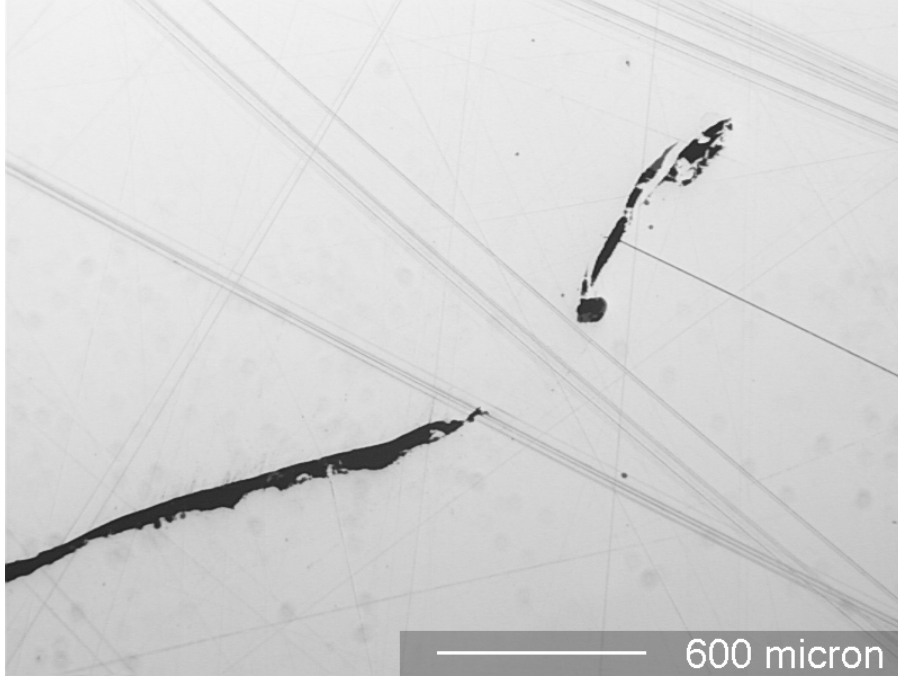
Figure A.12 Flaw C2CC on the End of Seam Repair C, as Machined

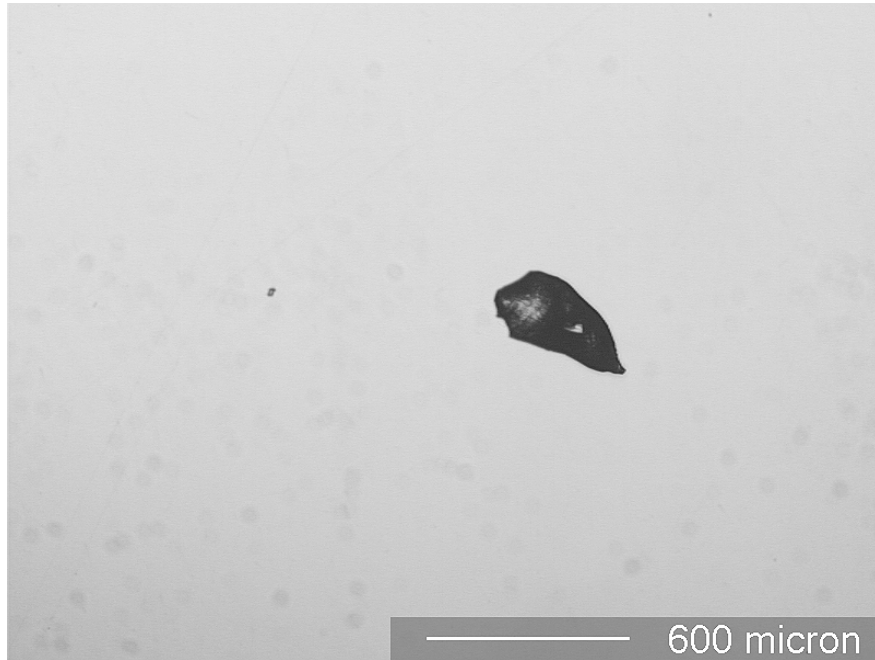
Figure A.13 Flaw C2CC on the End of Seam Repair C, as Machined

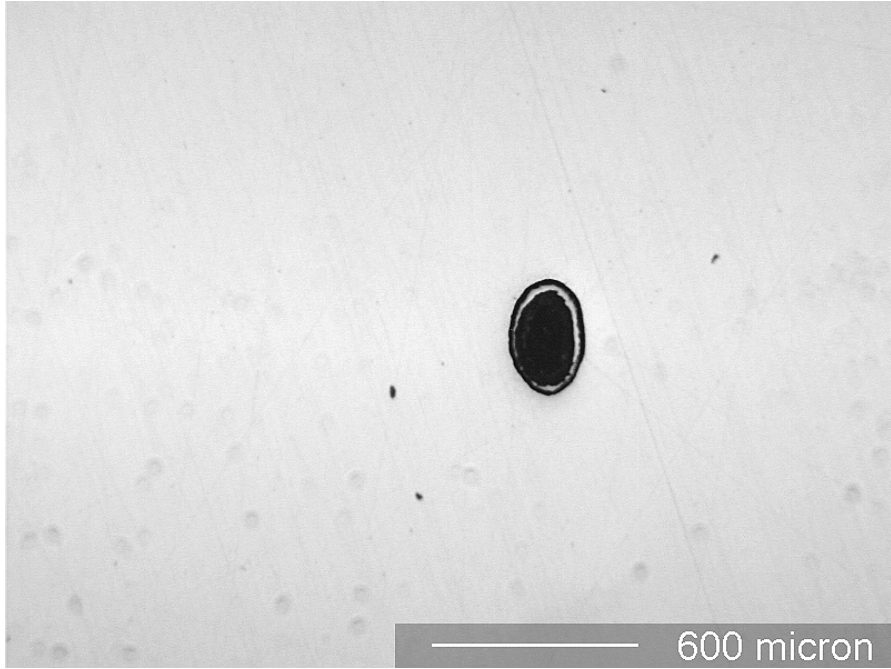
Figure A.14 Flaw C2CC on the End of Seam Repair C, as Machined

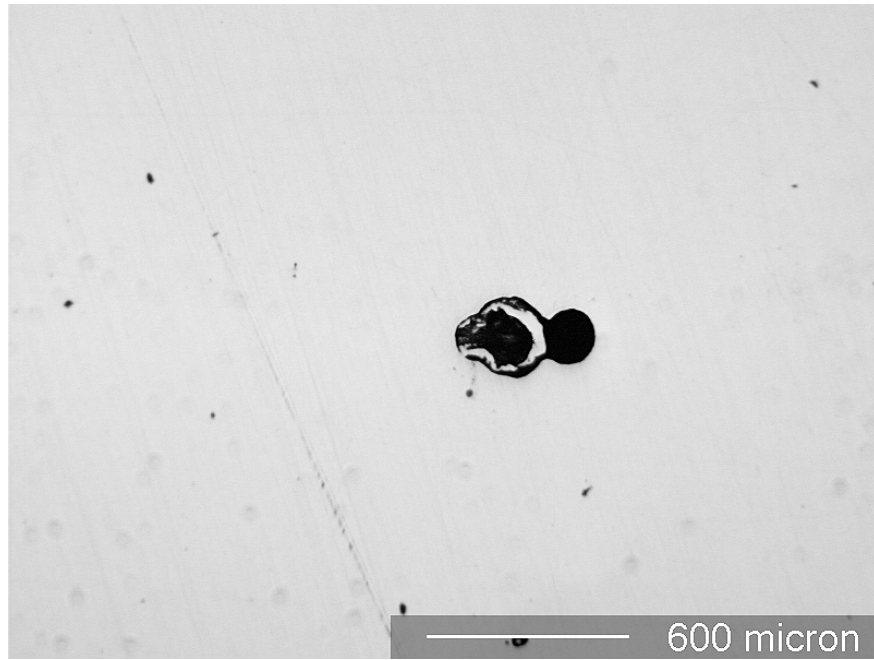
Figure A.15 Flaw C2CC on the End of Seam Repair C, as Machined

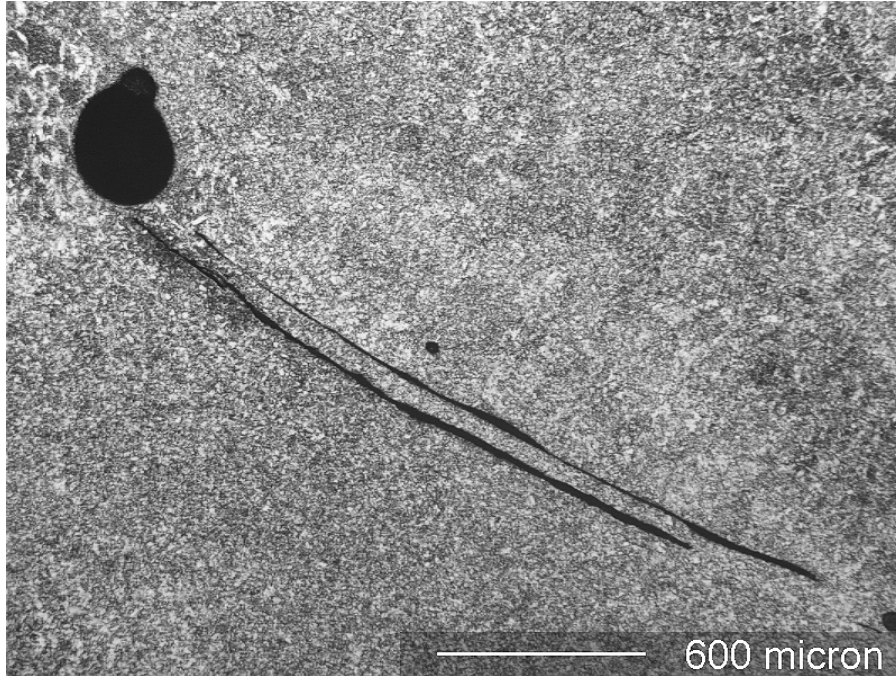
Figure A.16 Flaw C2CC on the End of Seam Repair C, as Polished and Etched

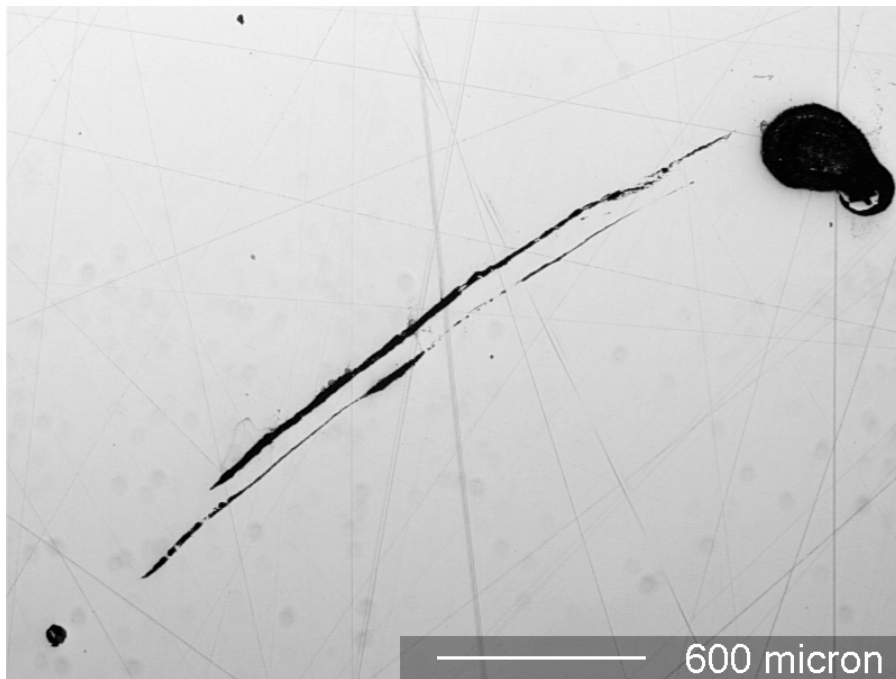
Figure A.17 Flaw C2CC on the End of Seam Repair C, as Machined

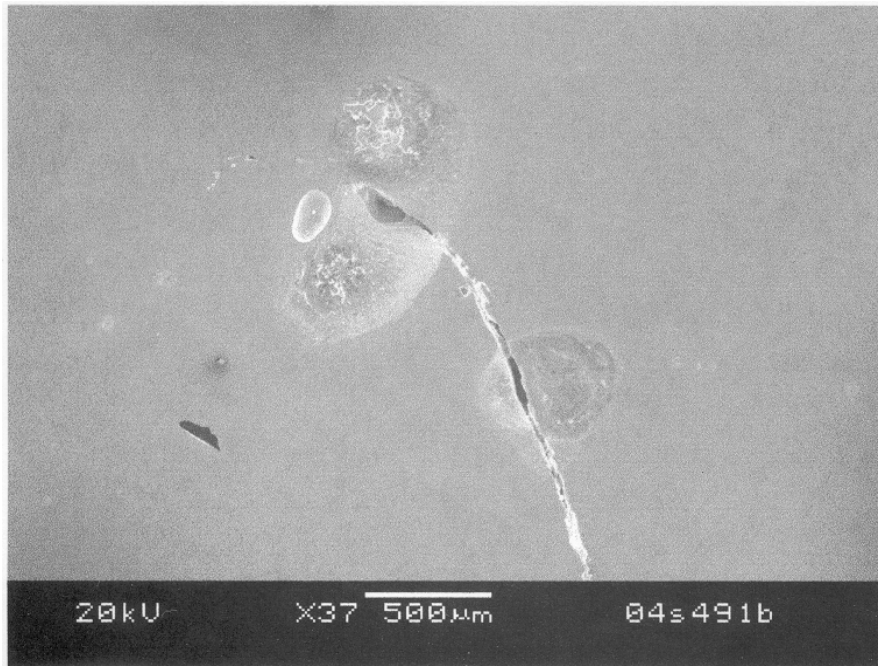
Figure B.1 Flaw C2CC on the End of Seam Repair C

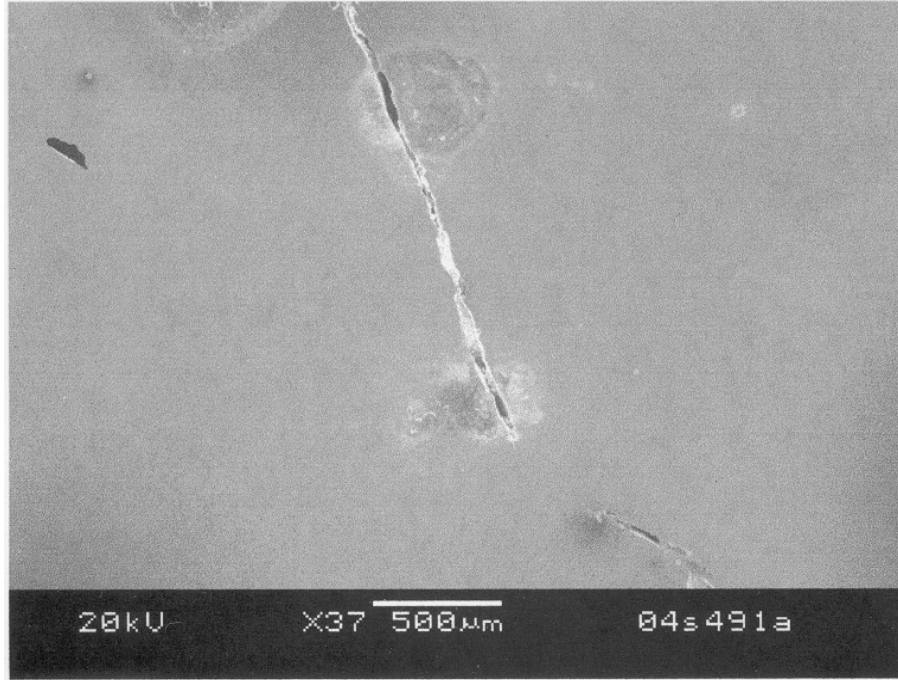
Figure B.2 Flaw C2CC on the End of Seam Repair C

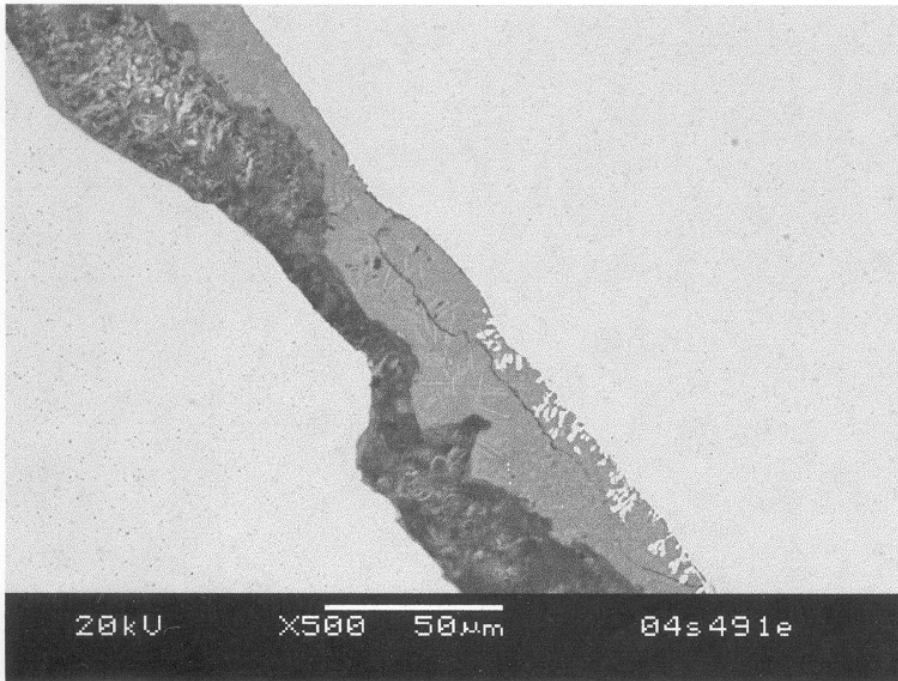
Figure B.3 Flaw C2CC on the End of Seam Repair C

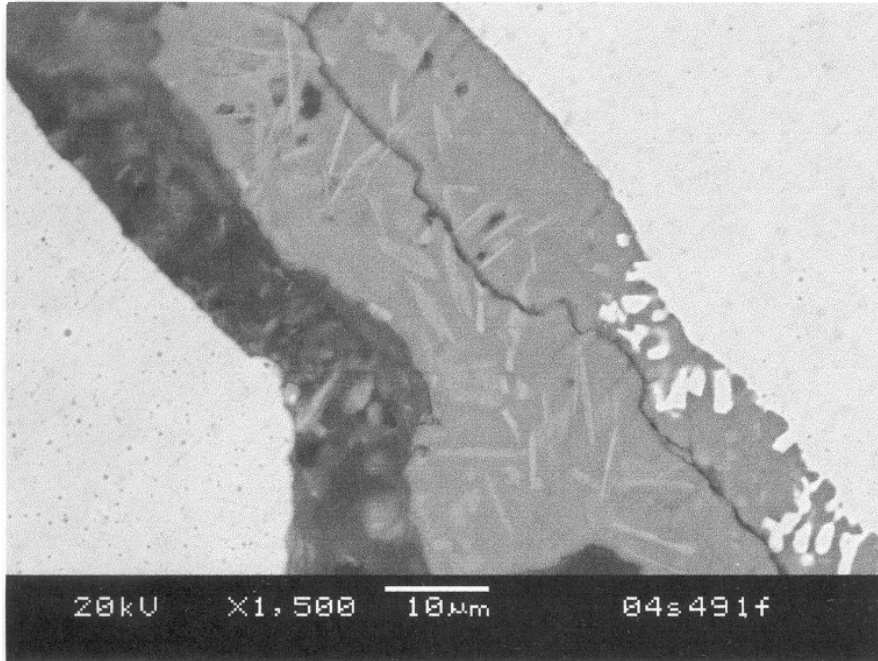
Figure B.4 Flaw C2CC on the End of Seam Repair C

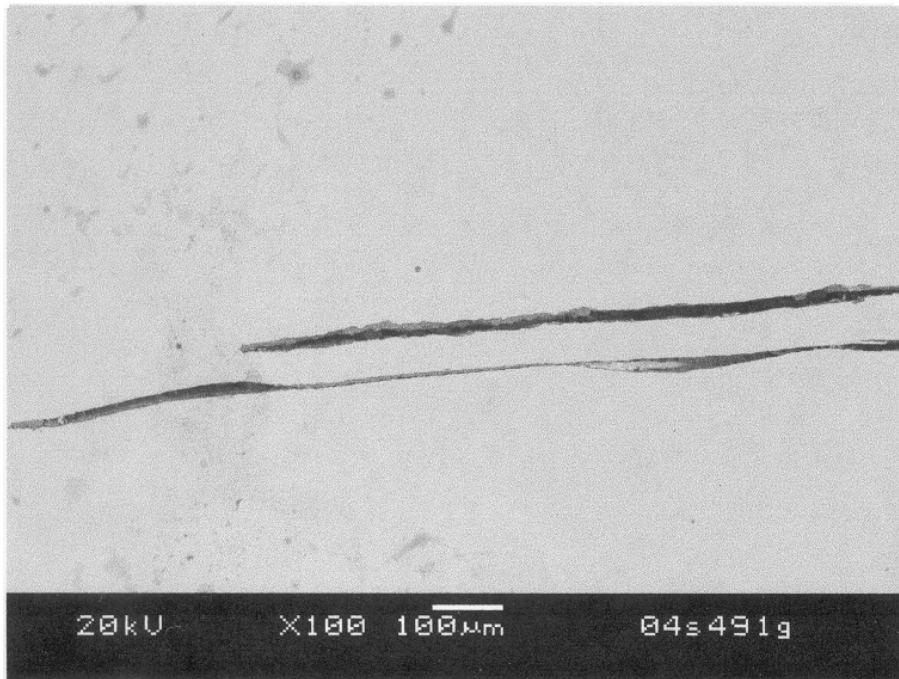
Figure B.5 Flaw C2CC on the End of Seam Repair C

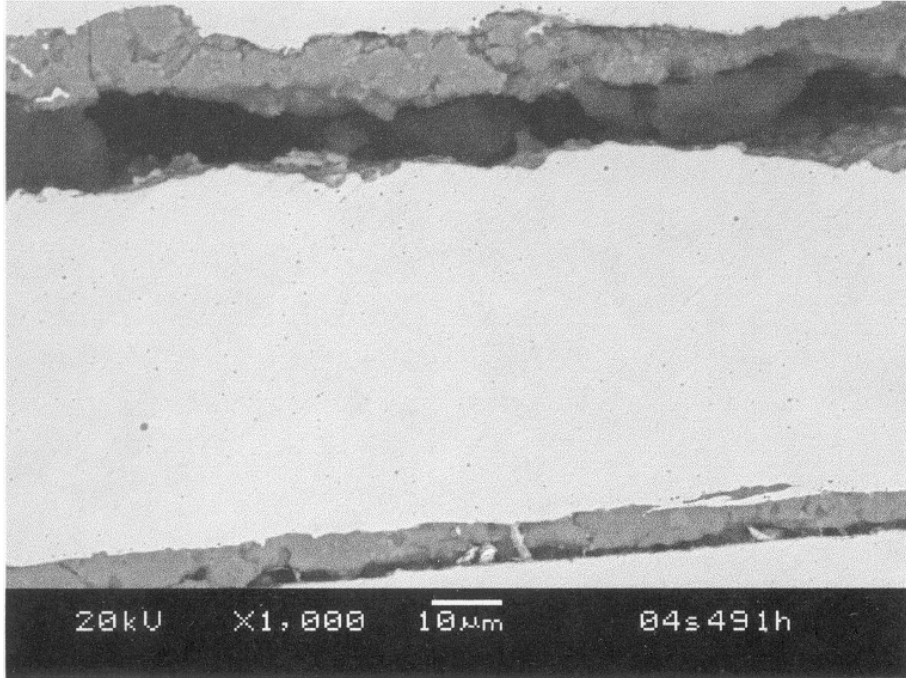
Figure B.6 Flaw C2CC on the End of Seam Repair C

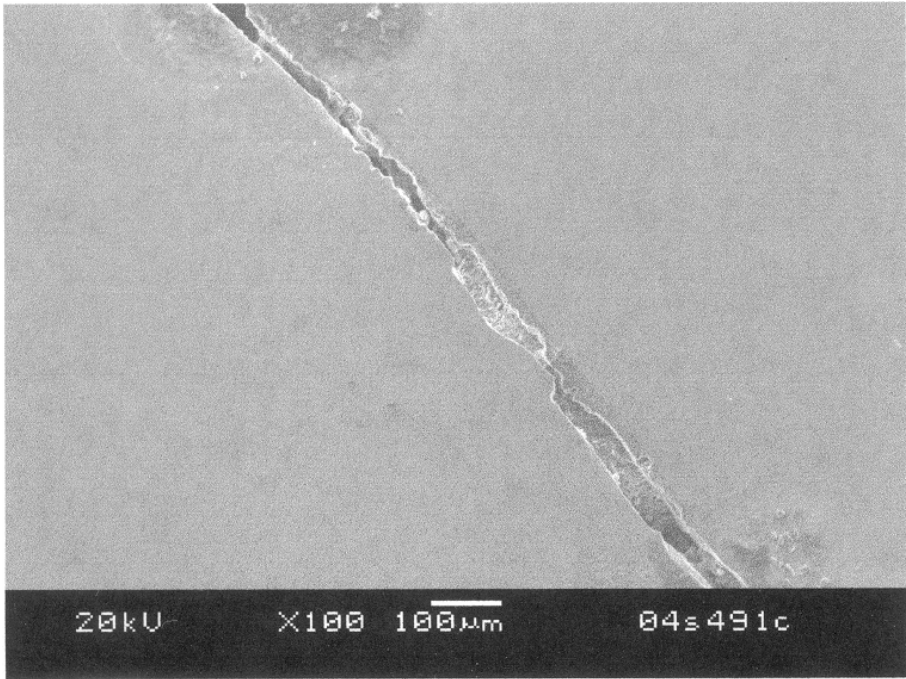
Figure B.7 Flaw C2CC on the End of Seam Repair C
