Fabrication Flaw Density and Distribution In Repairs to Reactor Pressure Vessel and Piping Welds

United States Nuclear Regulatory Commission

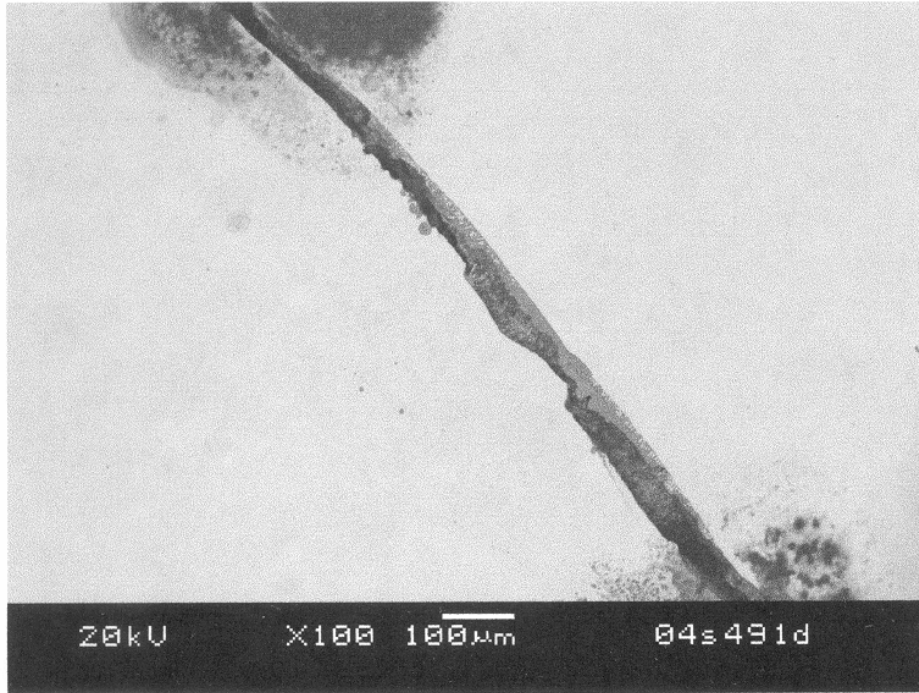
Figure B.8 Flaw C2CC on the End of Seam Repair C

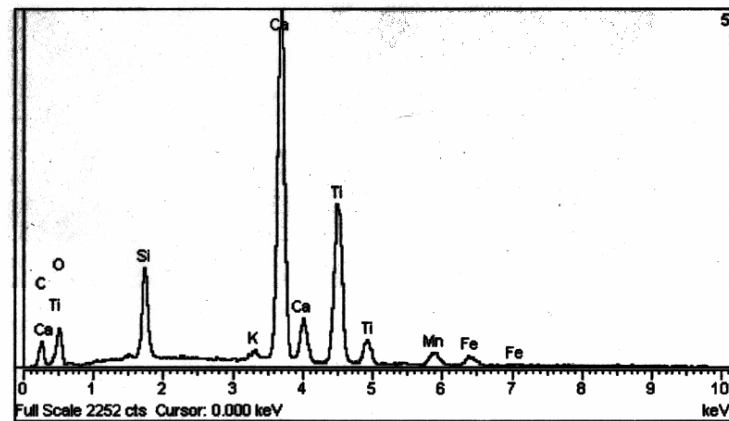
40µm Electron Image 1

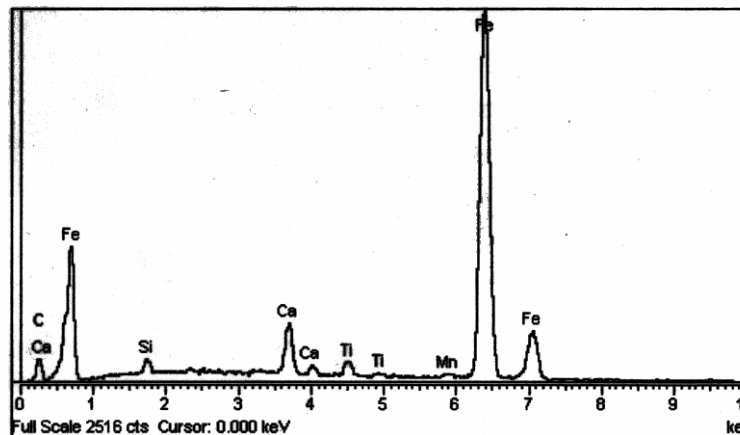
40µm Electron Image 1
