AIR QUEST® ENVIRONMENTAL, INC.

April 5, 2010

Re: Results of Drywall Investigation for the Single-Family Residence Addressed at 2834 St. Barts Square, Vero Beach, FL 32967

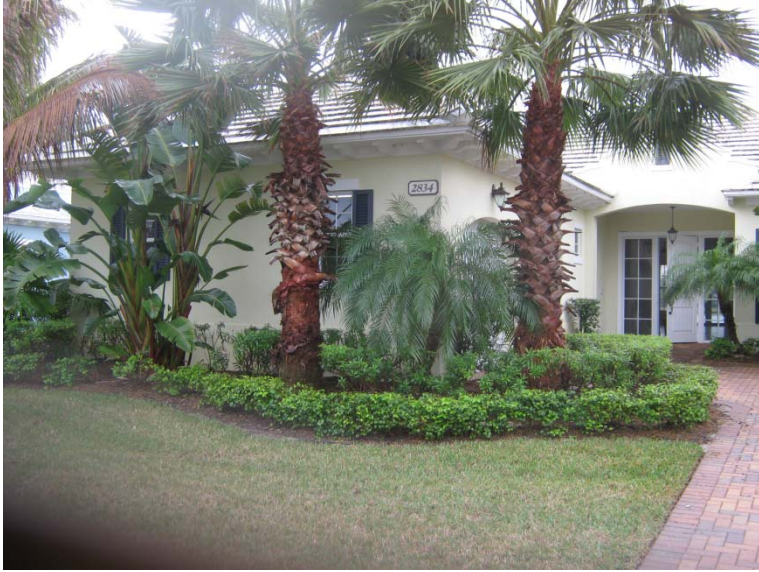
Exterior of the residence.

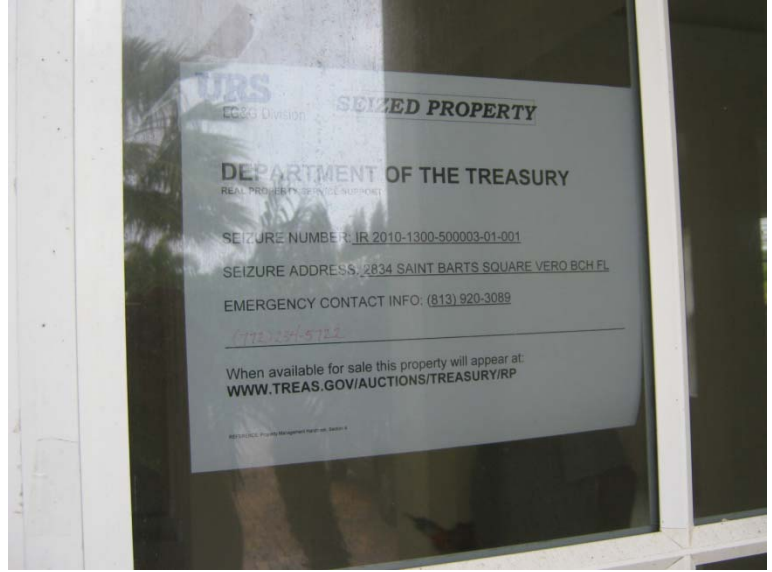
URS notification on the window.

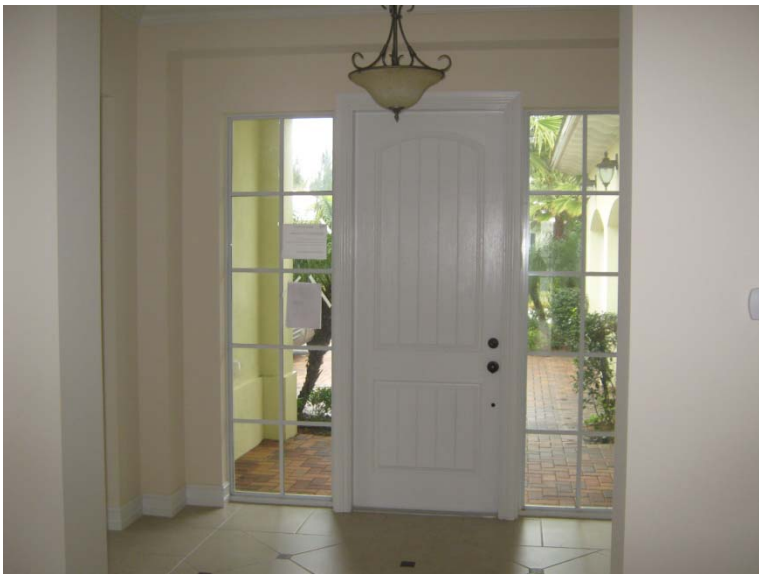
The foyer of the residence.

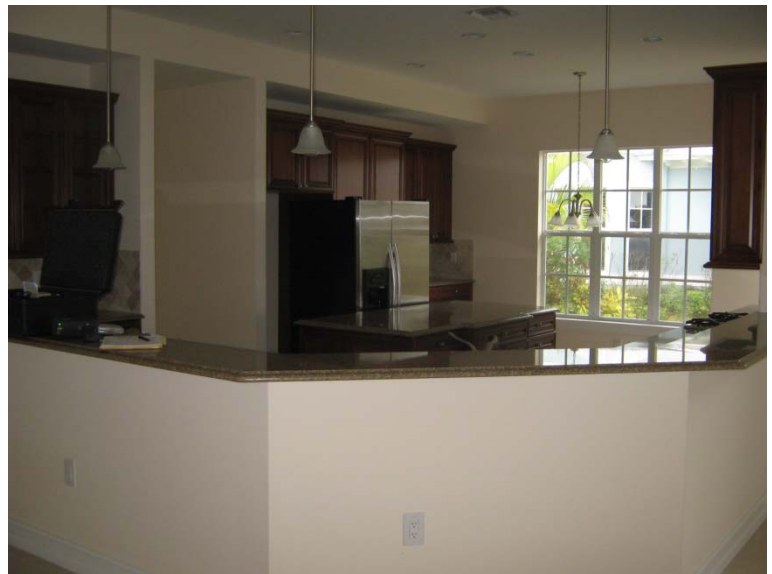
The kitchen.

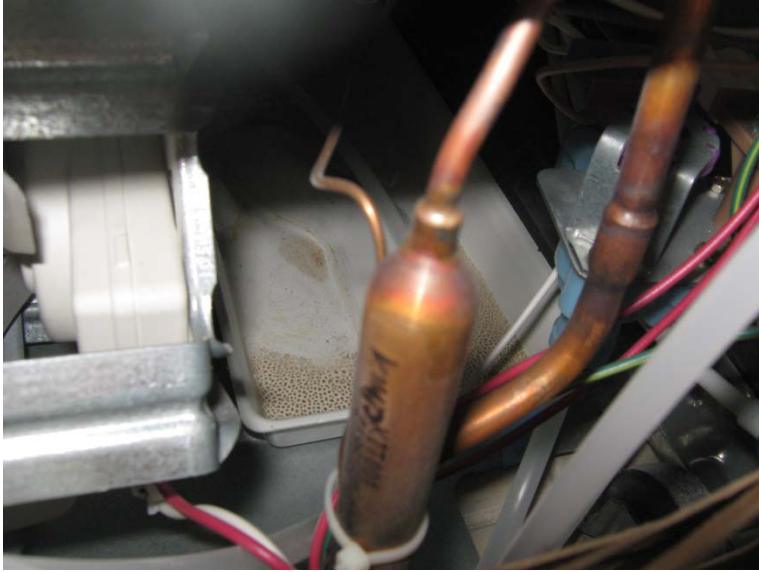
The refrigerator coils.

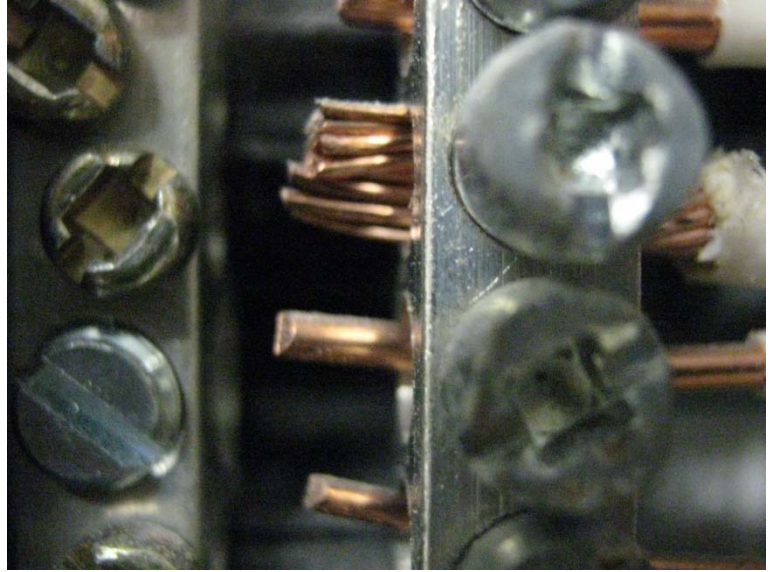
Example of stripped electrical wires in the main panel.

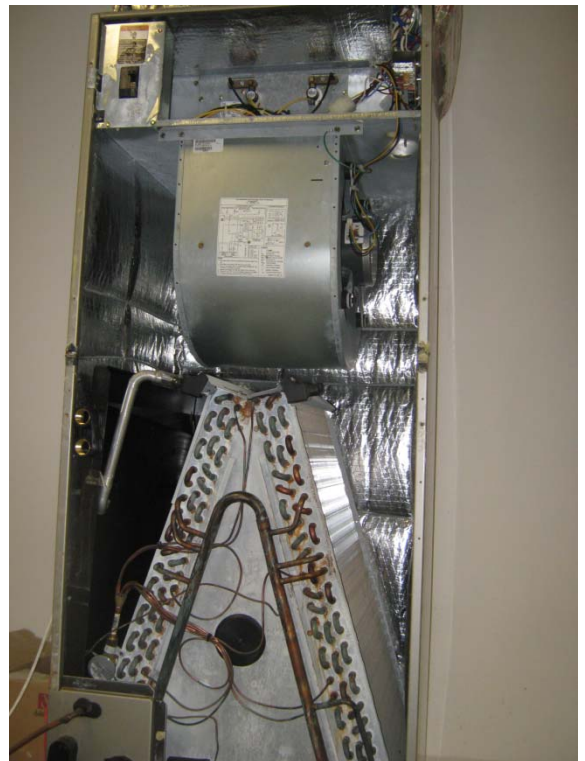
The air-handler unit within the garage.

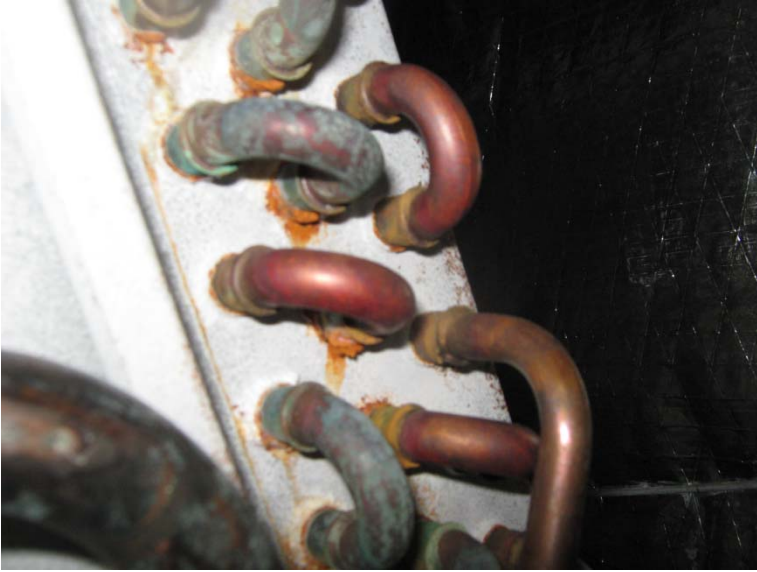
Close-up of AHU coils.

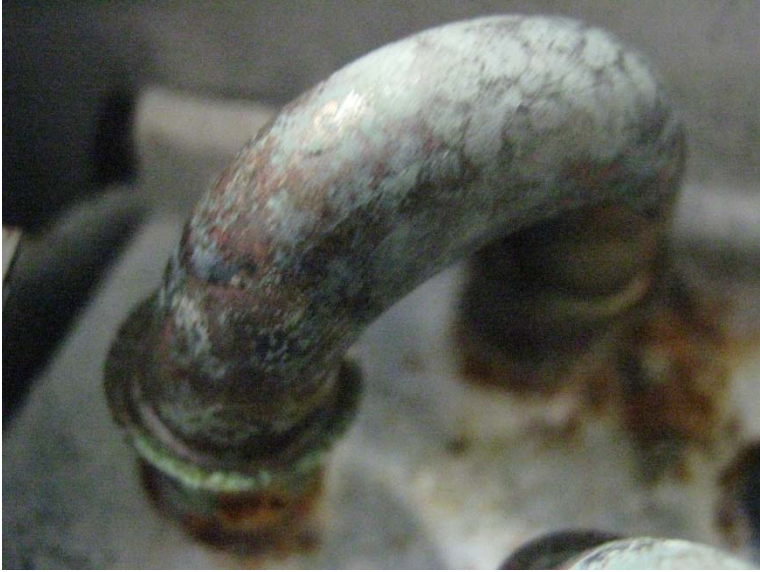
Close-up of AHU coils.

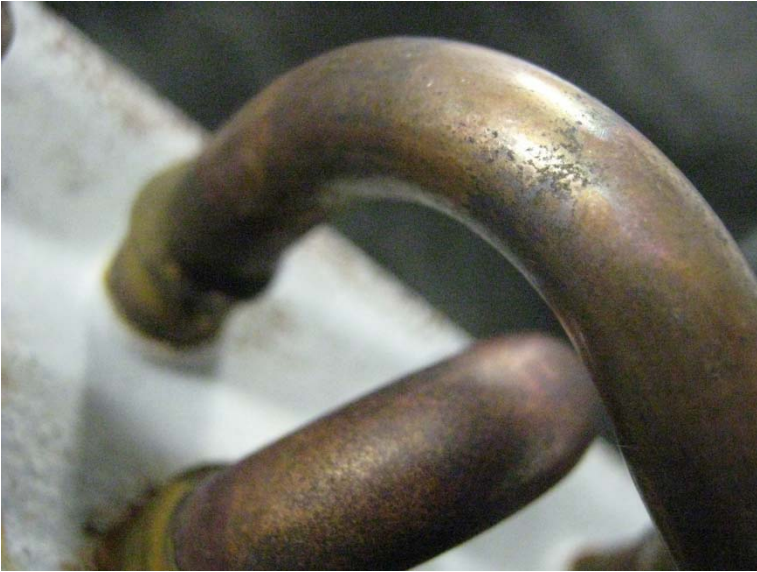
Close-up of AHU coils.

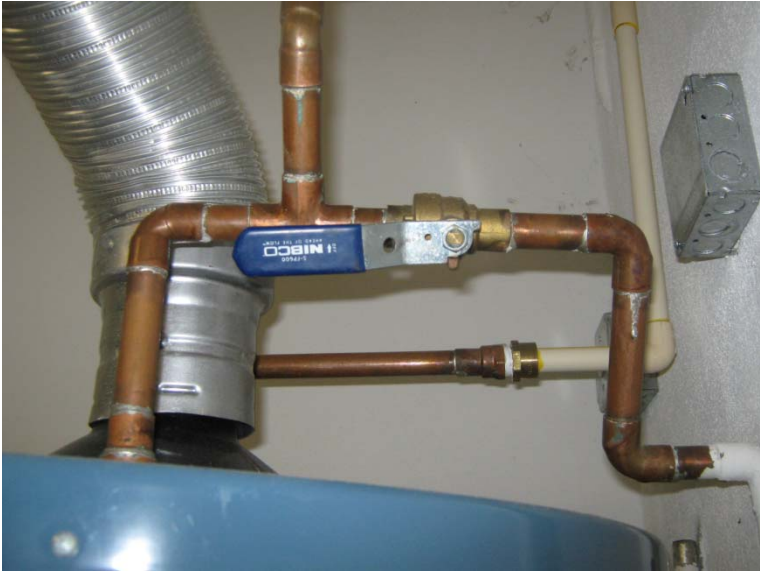
An example of the copper plumbing.

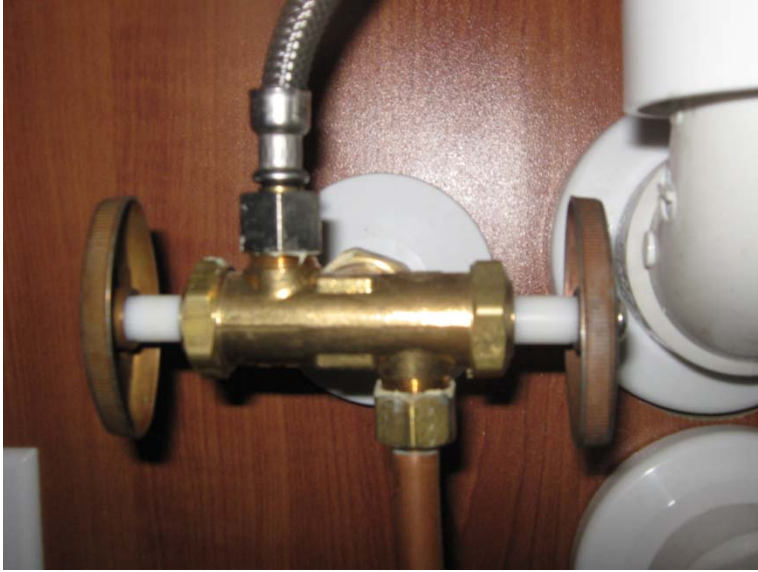
An example of the copper plumbing.

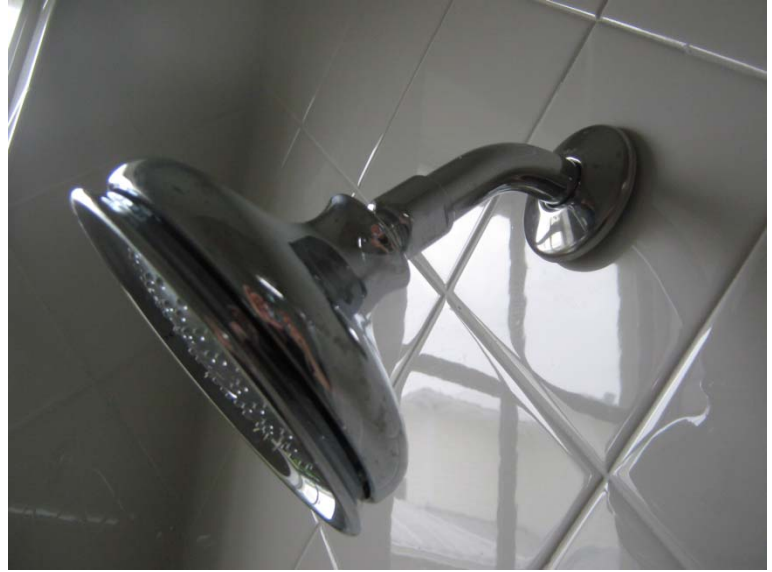
An example of the plumbing fixtures.

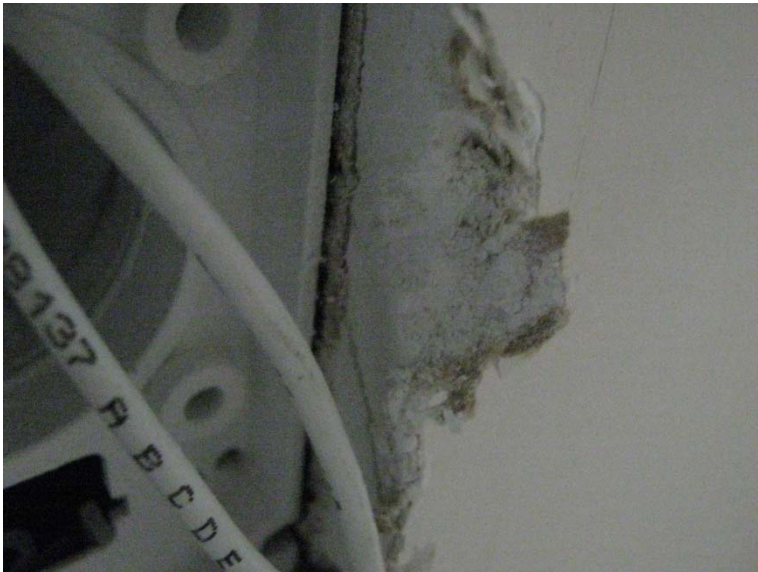
Example of a clean gypsum sample location.

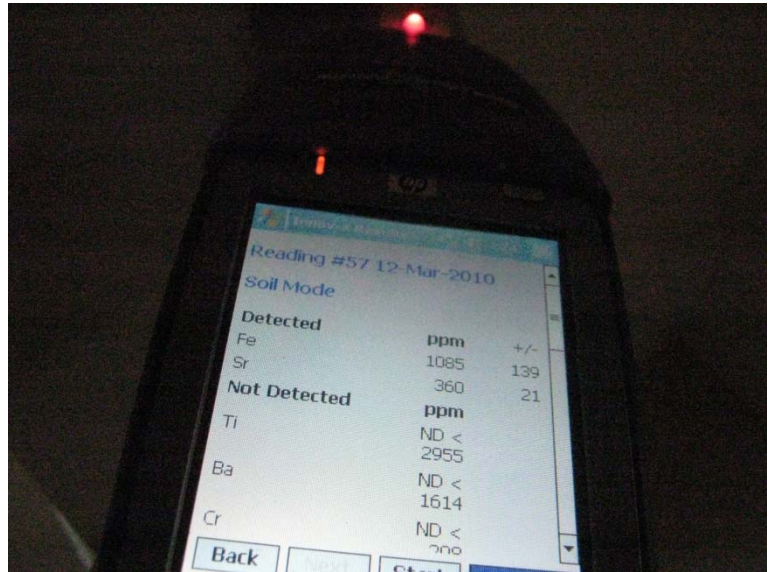
Example of a clean gypsum sample readings.

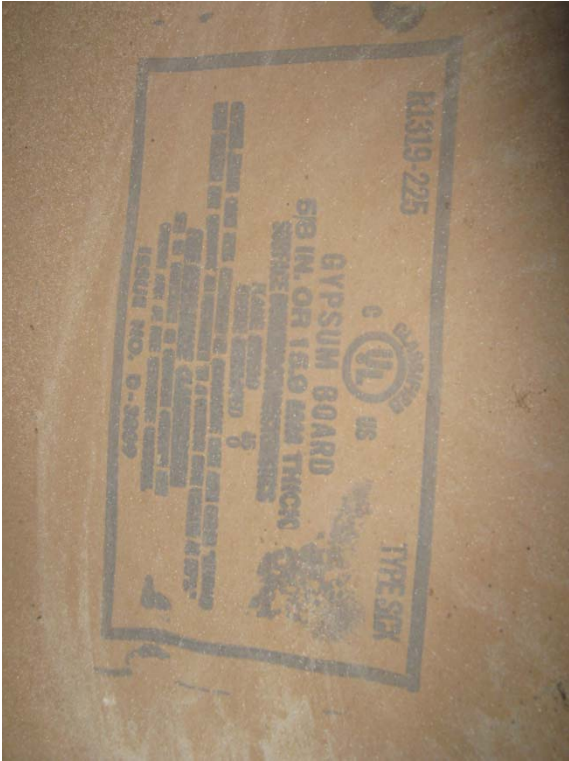
Wallboard label within the attic.

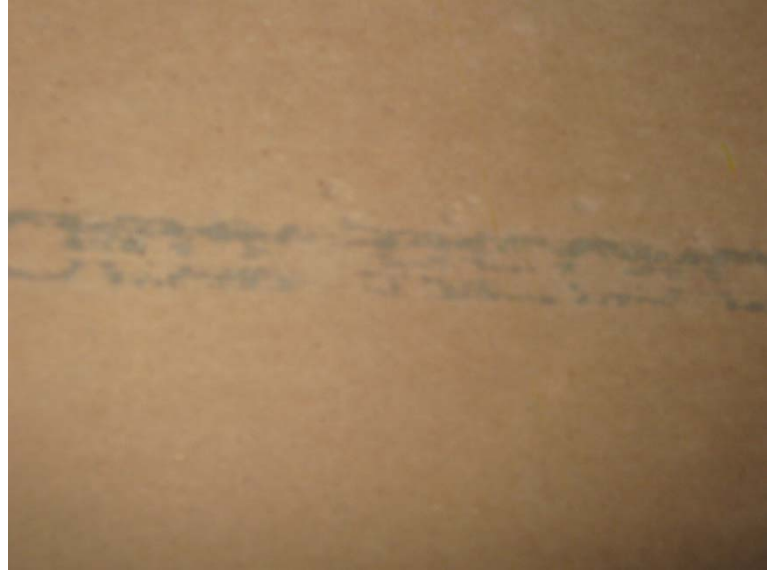
Wallboard label within the attic.

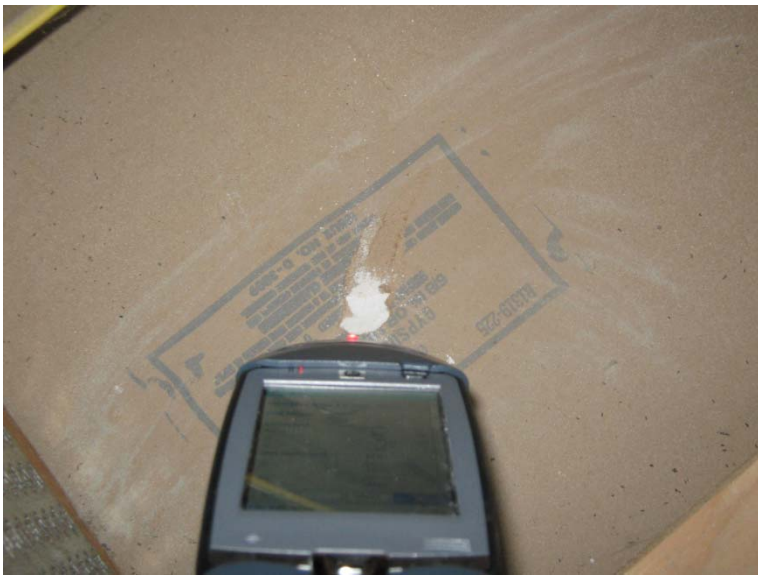
Example of sample location.

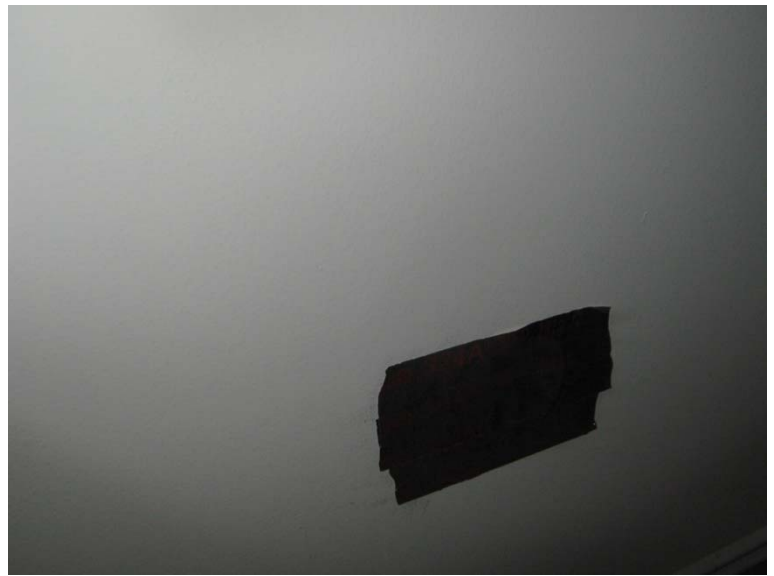
Core sample location behind the refrigerator.
