REPORT OF INVESTIGATION

**Underground Metal Mine
(Gold)**

**Fatal Explosives Accident
May 28, 2010**

**Discovery Day Mine
Gold Run Enterprises LLC
Forks of Salmon, Siskiyou County, CA
Mine ID No. 04-05222**

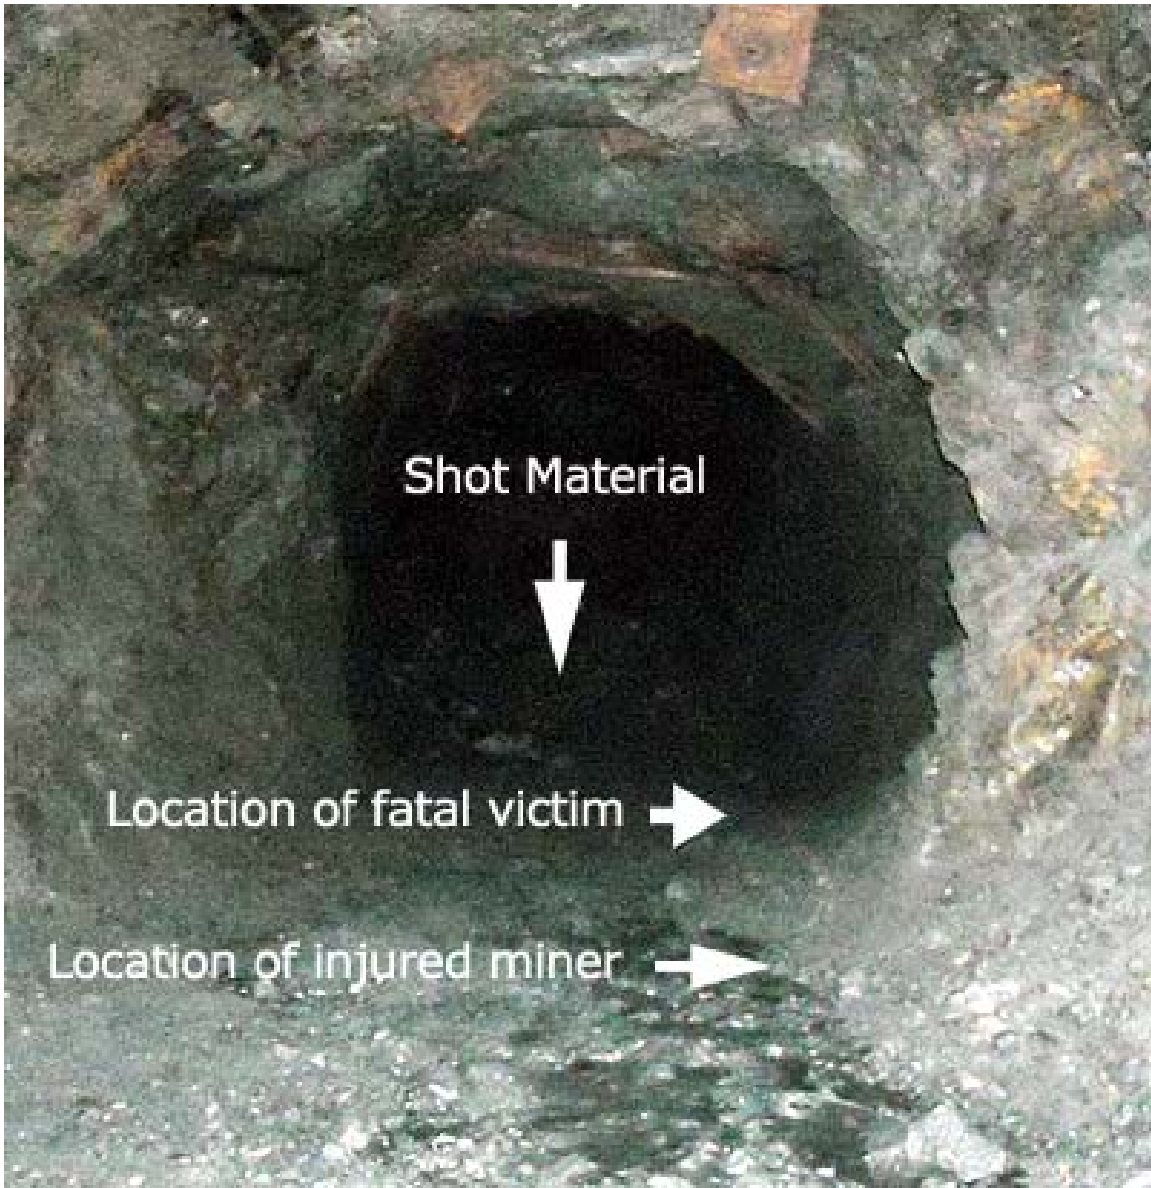
Shot Material

Location of fatal victim

Location of injured miner

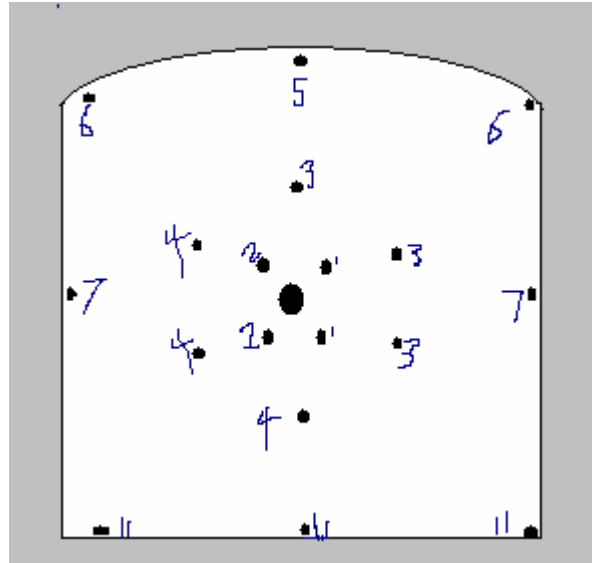
Diagram of blast round indicating detonator timing sequence

Two of the blastholes were reported to have been wet and muddy. The primer used in these two blastholes was the much smaller 10 gram DYNO Stinger instead of the recommended 1 ½ X 8 inch cartridge of Nitroglycerin Dynamite. The portions of “shock tube” observed remaining in the face at the time of inspection would have been consumed if these two blastholes detonated as planned.

Sketch indicating the pattern drilled for this blast round. This is a typical 'Burn-Cut' blast round. The center empty blast hole is about 5 ½ inches in diameter and closely surrounded by four opening blastholes (#1 [500 mS] & # 2 [800mS] time delays). The second row of six blastholes is shaped like a wagon wheel containing both # 3 [1100 mS] & #4 [1400 mS] time delays. The back is shot next with #5 [1700 mS] & #6 [2000 mS] time delays. Both walls are shot with #7 [2300 mS] time delays and finally, the bottom lifters are shot with # 11 [3900 mS] timing delays, completing the round. Total elapsed time from the first detonation to the final lifter is designed to be approximately 3 ½ seconds total. [mS = milli-seconds]

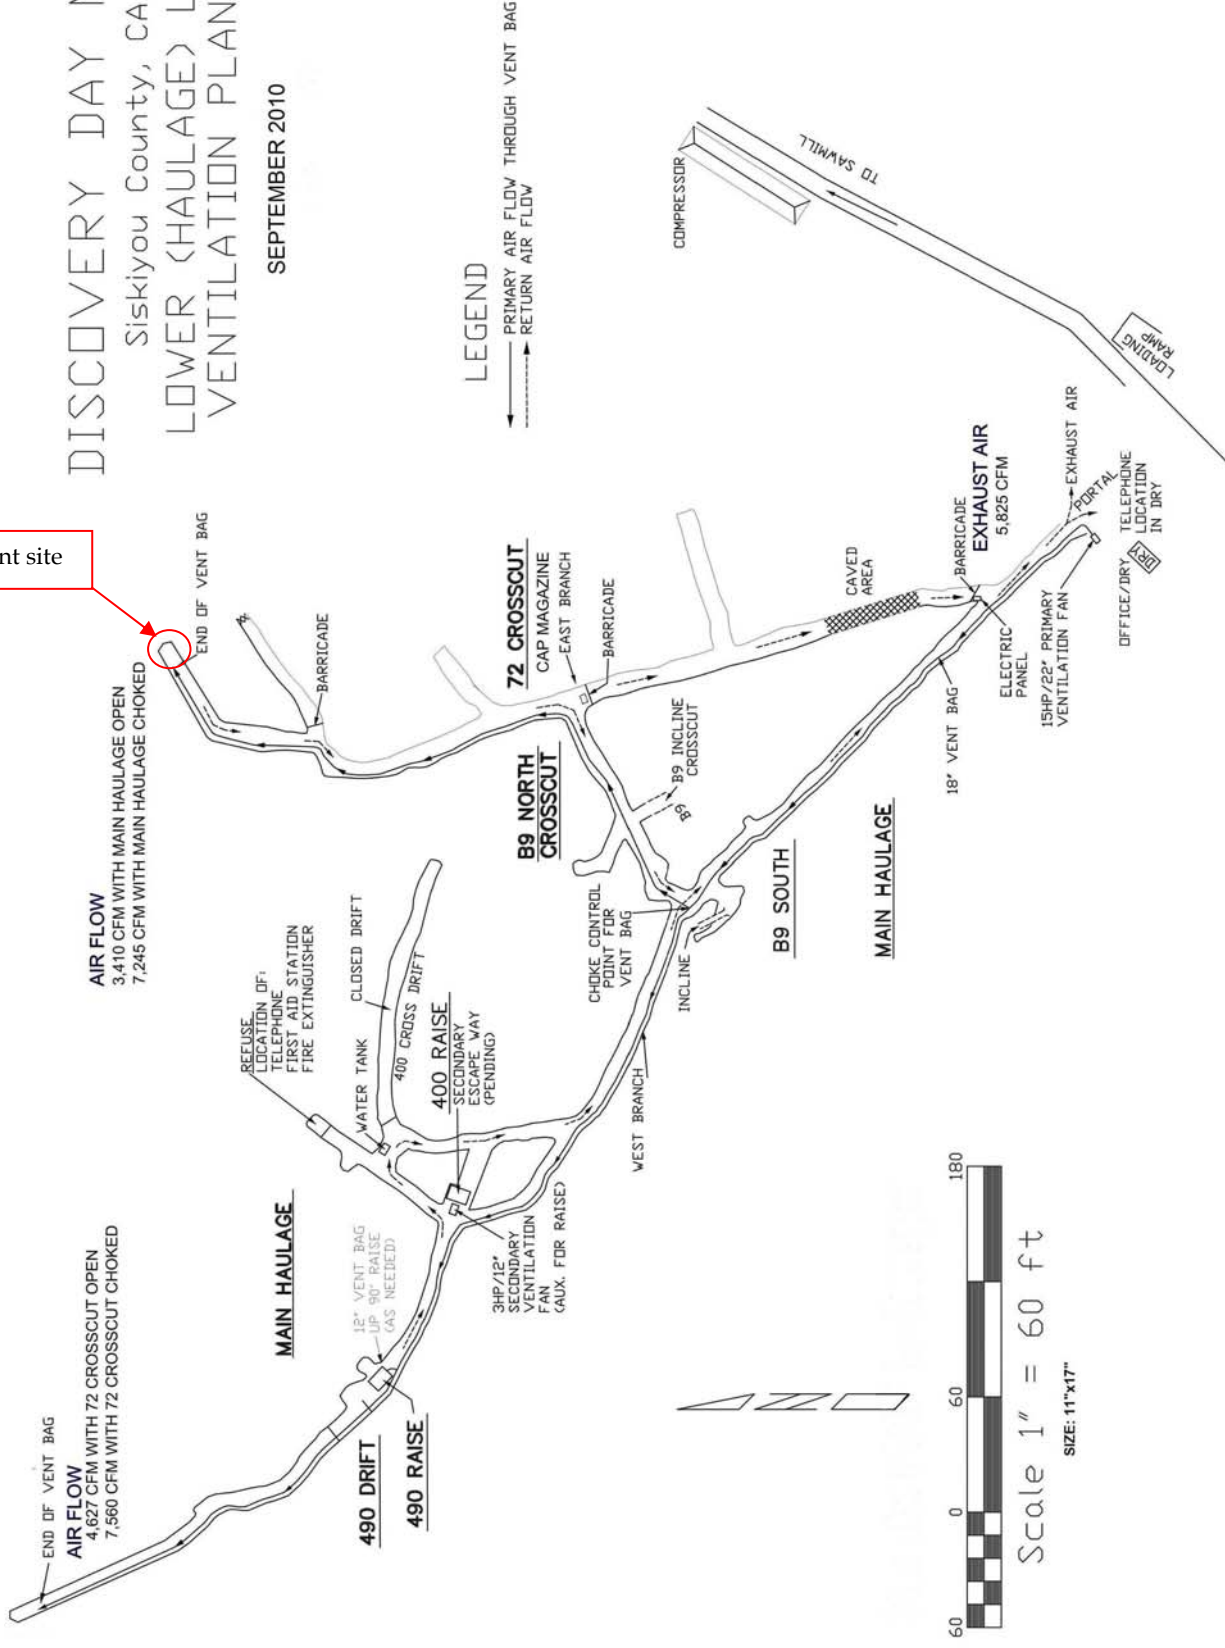
DISCOVERY DAY MINE
 Siskiyou County, CA
 LOWER (HAULAGE) LEVEL
 VENTILATION PLAN MAP
 SEPTEMBER 2010

Accident site
