**REPORT OF INVESTIGATION**

**Underground Metal Mine  
(Gold)**

**Fatal Falling Material Accident  
August 12, 2010**

**Meikle Mine  
Barrick Goldstrike Mines Inc.  
Carlin, Eureka County, Nevada  
Mine I.D. No. 26-02246**

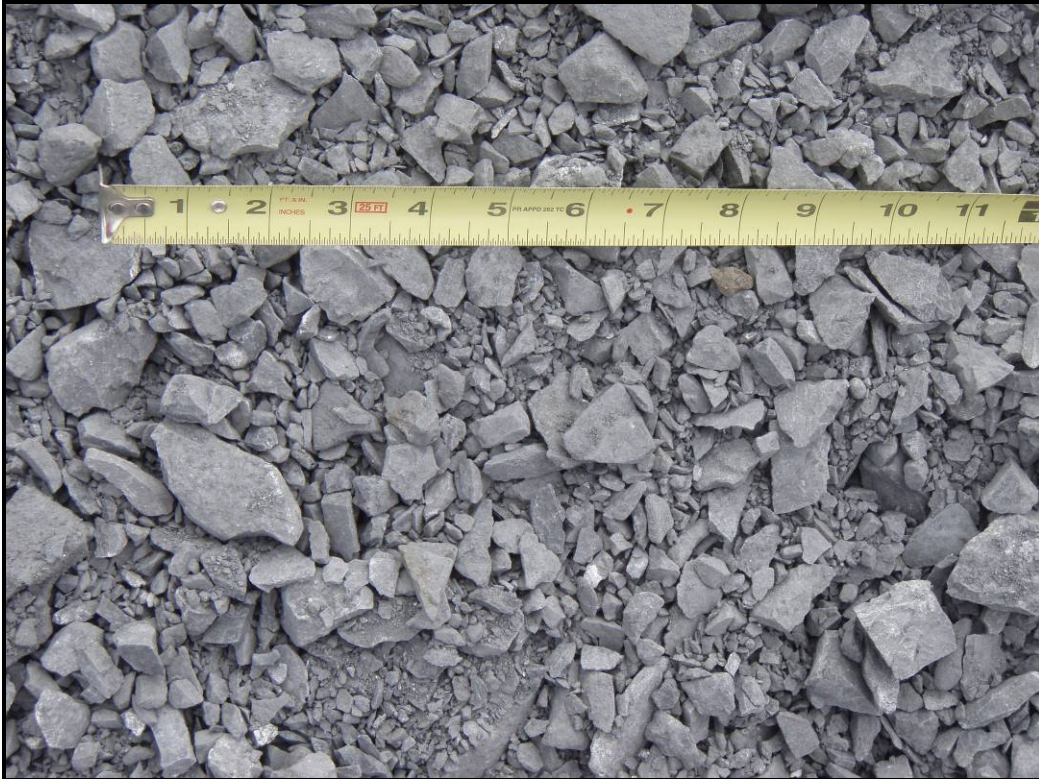
Photo 1 – Minus 3-inch aggregate and fines at surface stockpile near top of ventilation shaft.

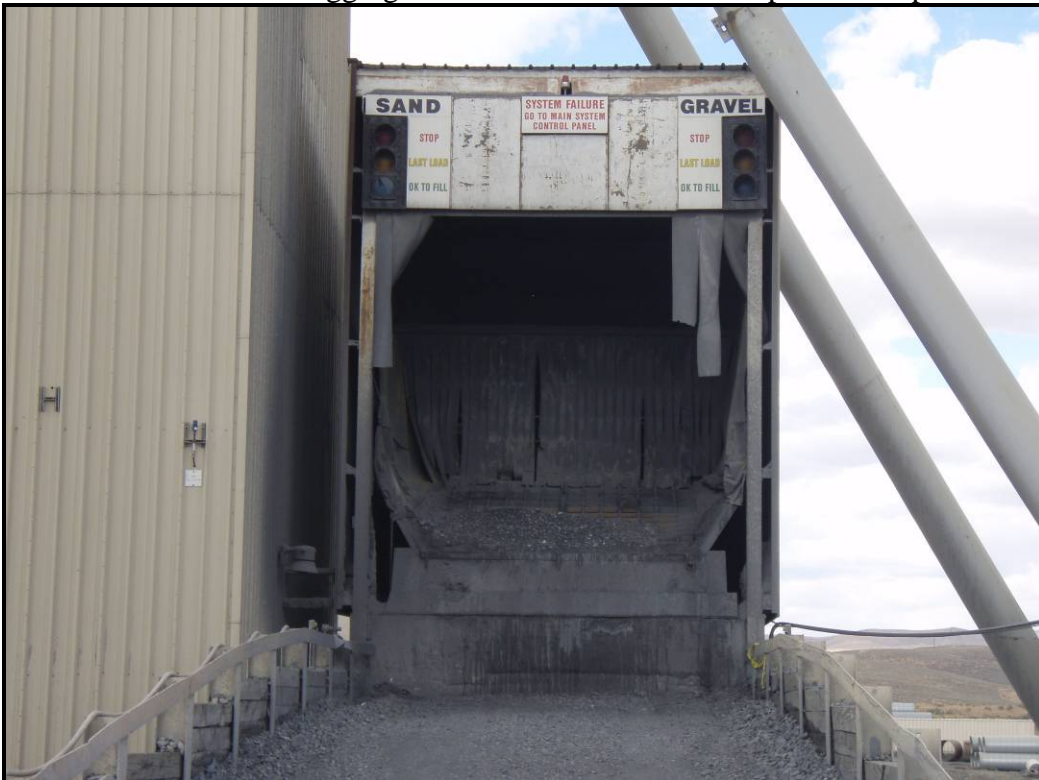
Photo 2 – Surface feed grizzly and hopper adjacent to top of ventilation shaft. Note stop and go operation lights above the hopper.

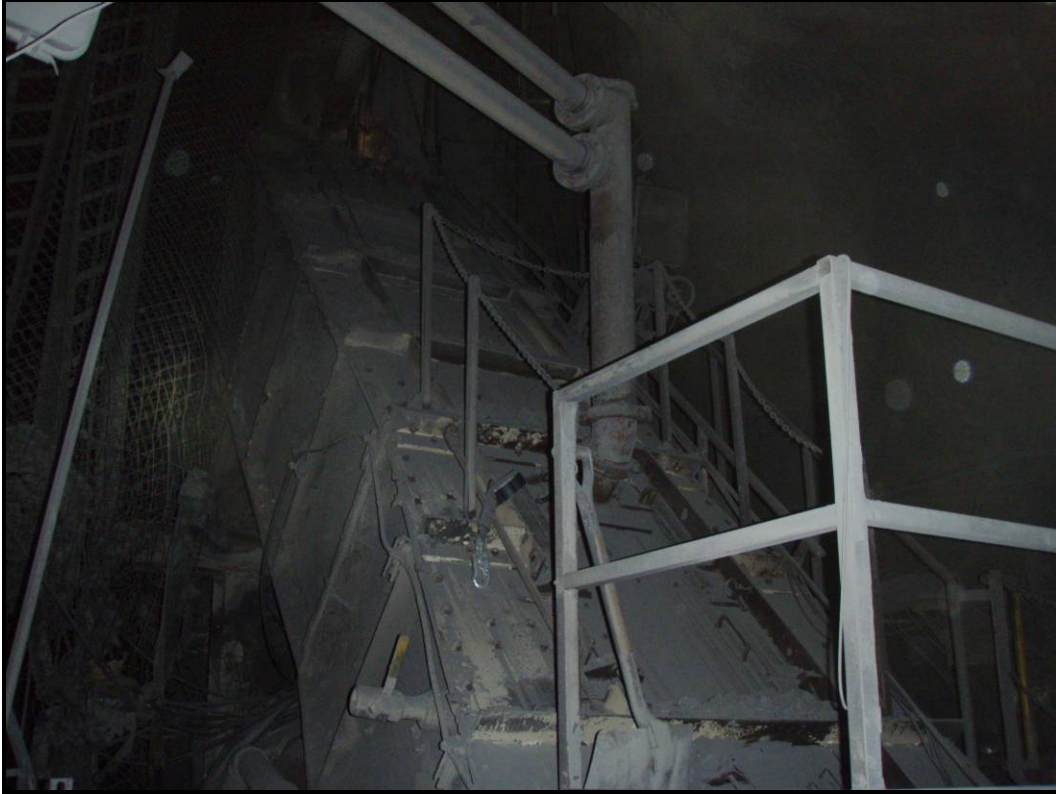
Photo 3 – Discharge chute leading from side of rock box at 860 level.

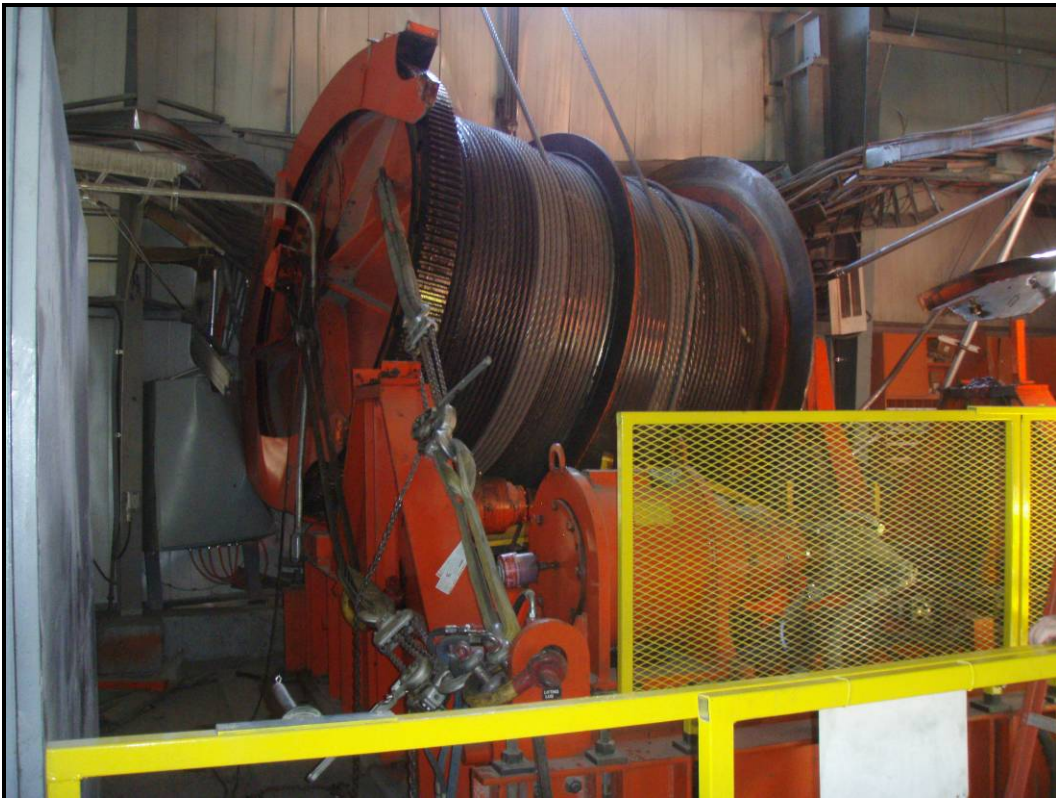
Failure of the aggregate piping system subjected the hoist to heavy loads when it was impacted by the falling pipes and aggregate. Loads on the top of the conveyance stressed the hoist ropes and caused the ropes to rip the drum out of its support pillow blocks. The two hoist ropes on the drum were 1 5/8-inch diameter. Each hoist pillow block was 4 5/8 inches wide and 2 1/8 inch thick anchored with four 1-inch diameter bolts, measuring 6 1/2 inches long. Specifically, the left side pillow block (as viewed looking from the hoist operator's booth) sheared through itself. The two bolts holding the block remnant were still intact and the other two anchor bolts stripped out and failed. On the right side, the pillow block was intact, but all four of the bolts failed, releasing the block. One nut was wedged in the mounting bracket. The bracket was slightly bent and one bolt was on the floor by the wall. Overall, the right side of the drum moved further toward the building wall closest to the shaft (photo 4). The hoist, ropes, structures and all supporting components did not have any role in the cause of the accident.

Photo 4 – Ventilation shaft hoist drum ripped from pillow block mounts.

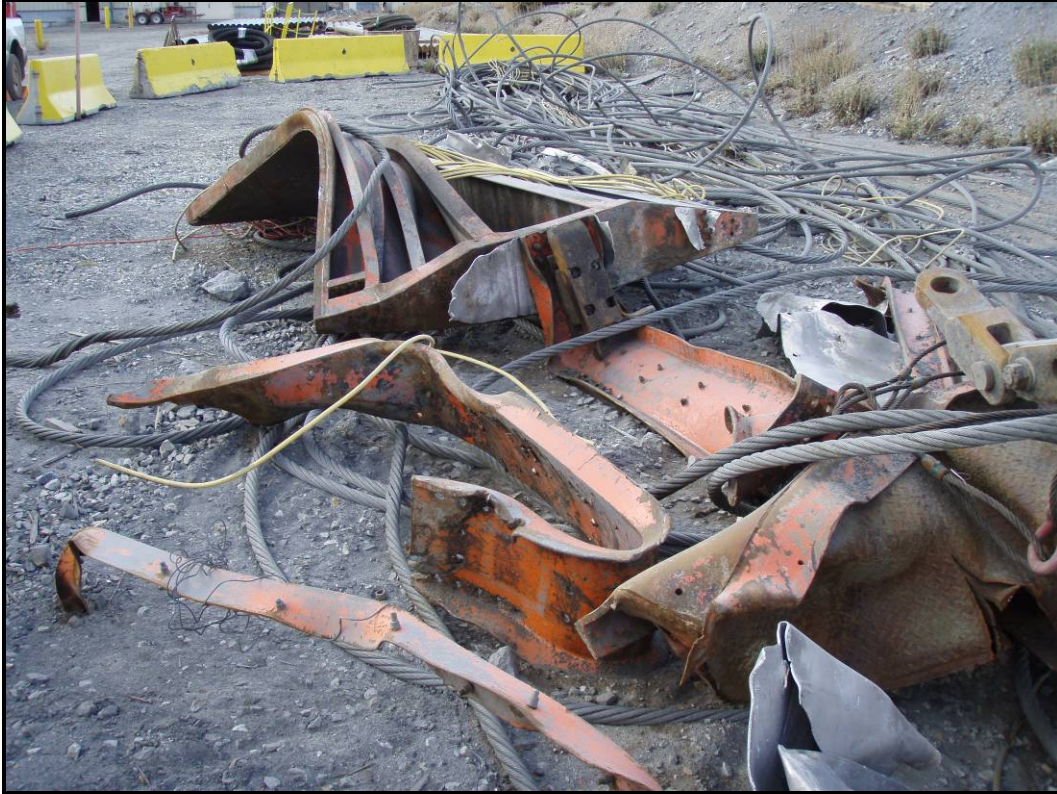
The cage was severely damaged as a result of the accident. The primary impact to the top of the cage appeared to be the side that would have been farthest from the pipes (photo 5). A severe bow was noted in the floor of the cage on the side opposite the pipes. The cage and attachments did not have any role in the cause of the accident.

Photo 5 – Damage to hoist platform and other hoist components.

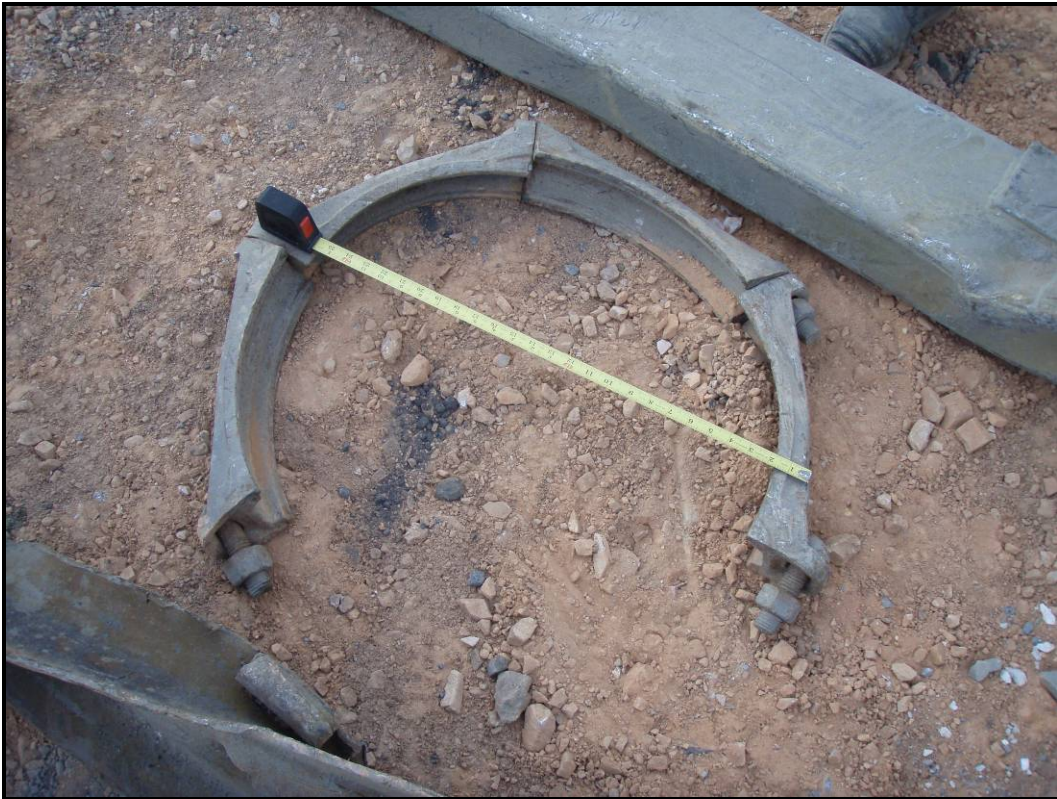
Photo 6 – Partial Victaulic Style 31 coupling for 24-inch-diameter aggregate pipe.

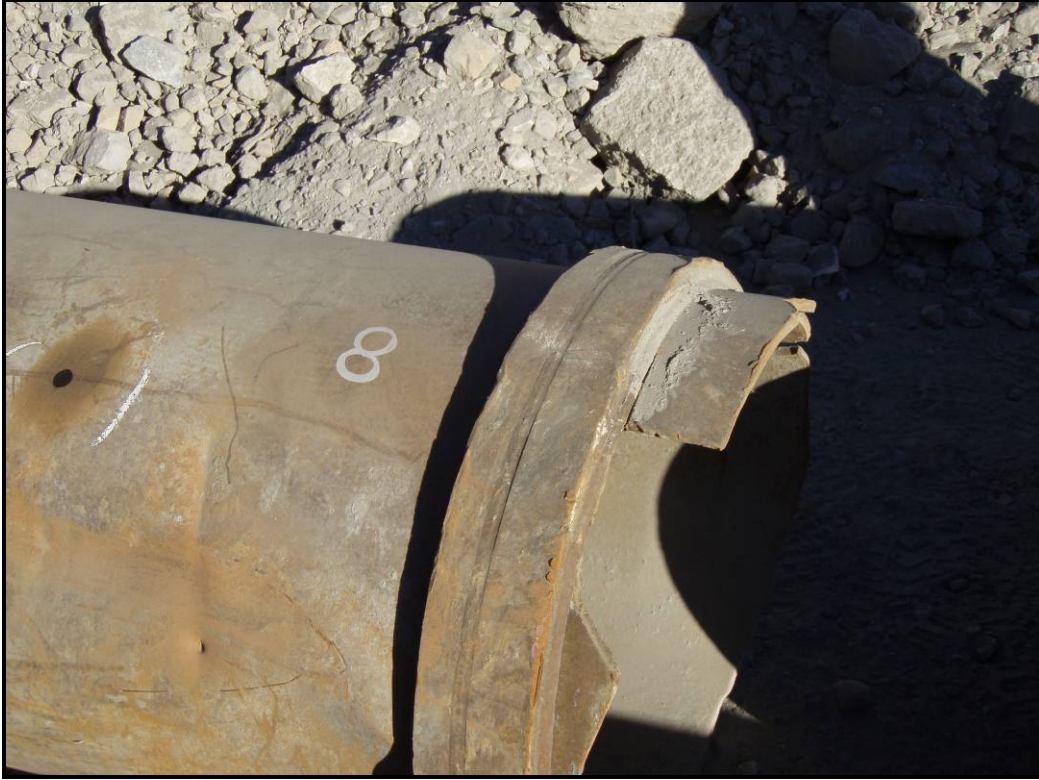
According to the manufacturer, butt welding is not recommended for hardened pipe. Joseph Martinez, welder, indicated that he never pre-heated or post-heated the welds when working on the pipes. Welding was conducted when a pipe section needed to be shortened to make it fit in the aggregate system. This was accomplished by removing the spool end flange weld with air-

arcing and sliding down the end flange (i.e. ring for the coupling attachment). The pipe was cut and the flange slipped to the burned end and re-welded in place. Martinez recalled he shortened a pipe section down to 16 feet and another time he shortened a pipe by ½ inch. However, investigators found at least two sets of pipe spools at the evidence yard that had been welded together, indicating that no Victaulic coupling was used (photo 7).

Photo 7 – Two pipe spools welded together in lieu of using a Victualic coupling.

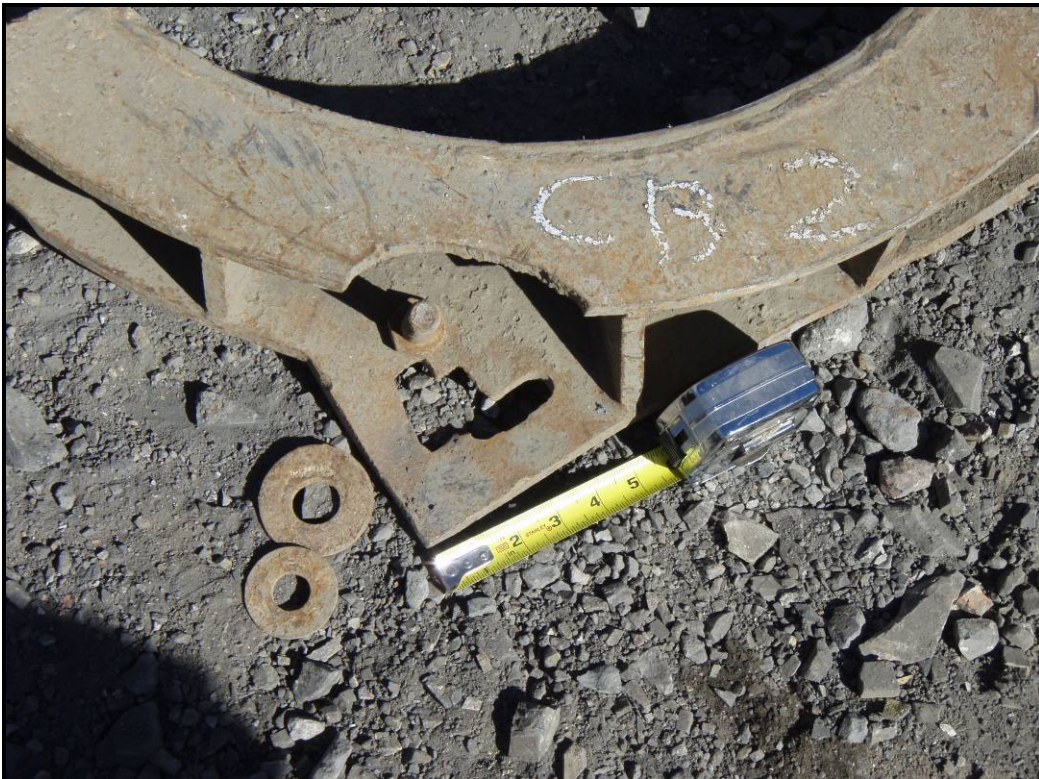
Photo 8 – Slotted hole for A325 bolt used to attach clamp bracket to bracket. Slot was burned out and was larger than the bolt head. This connection would have required a large washer.

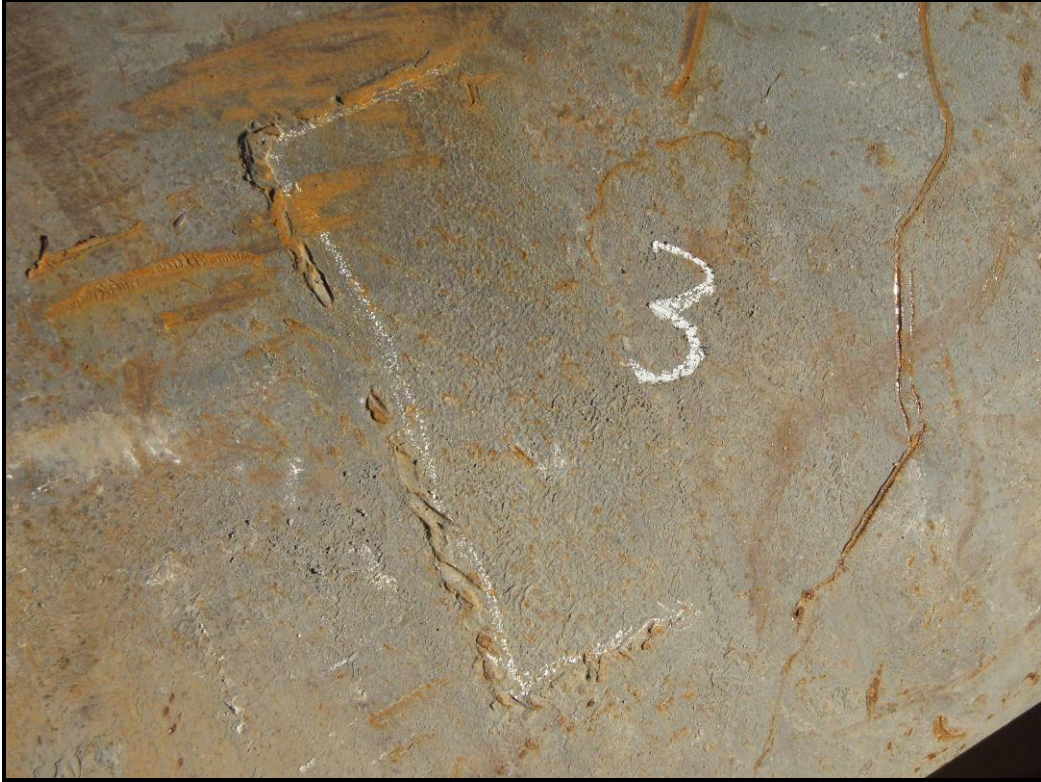
Photo 9 - Minimal bearing plate weld remnant traced in white chalk. Some of weld had been removed.

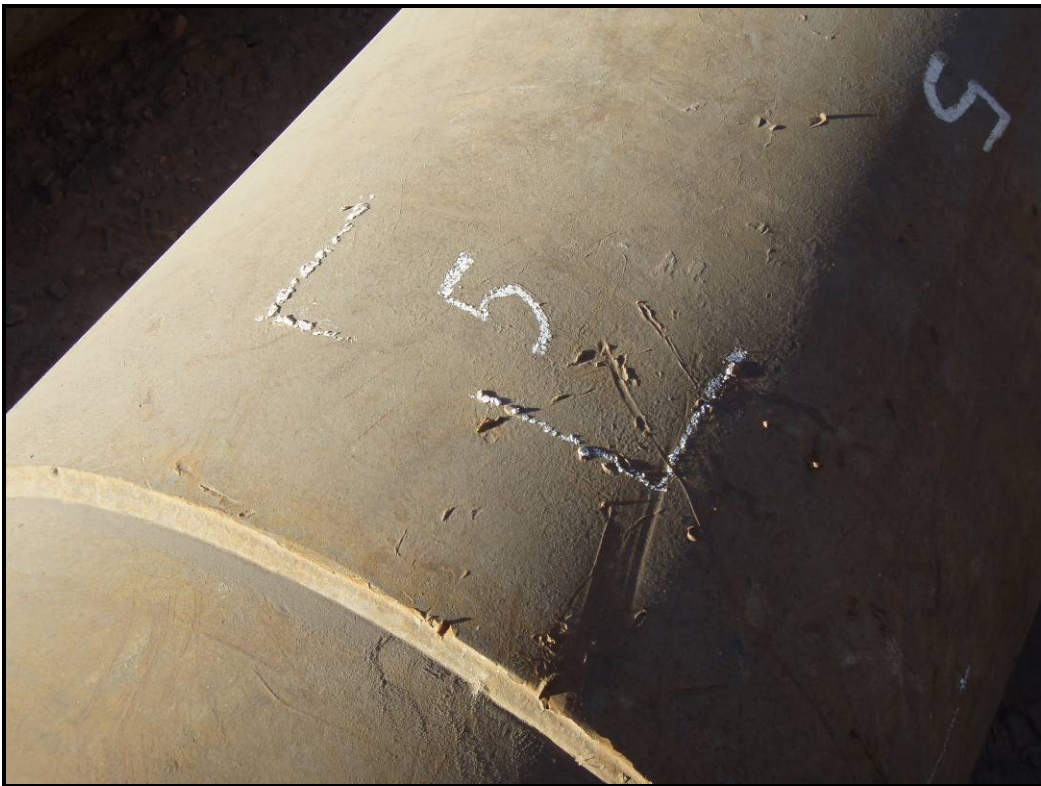
Photo 10 - Minimal bearing plate weld remnant traced in white chalk.

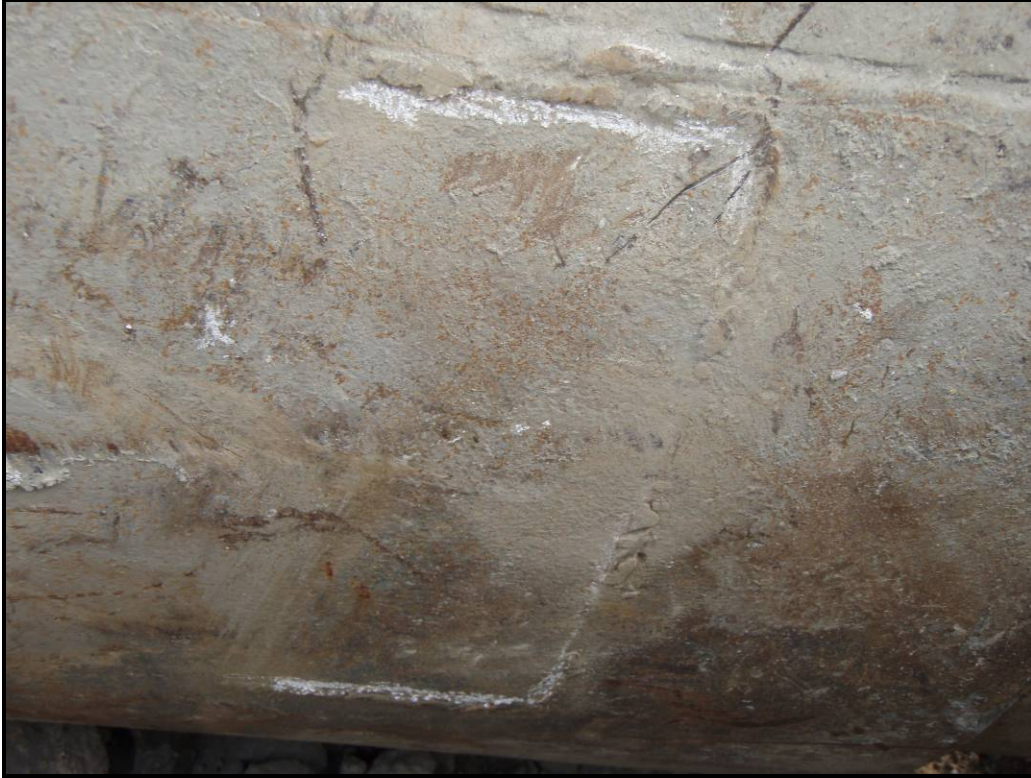
Photo 11 - Minimal bearing plate weld remnant traced in white chalk. Some of weld had been removed.

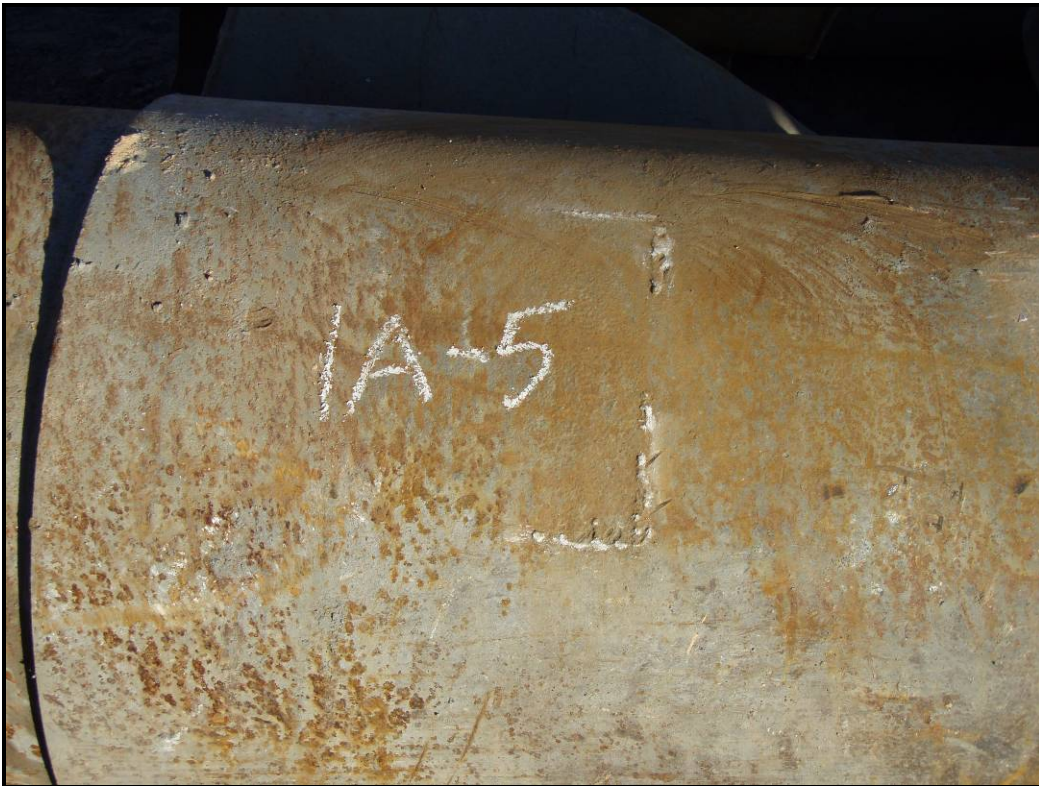
Photo 12 - Minimal bearing plate weld remnant traced in white chalk.

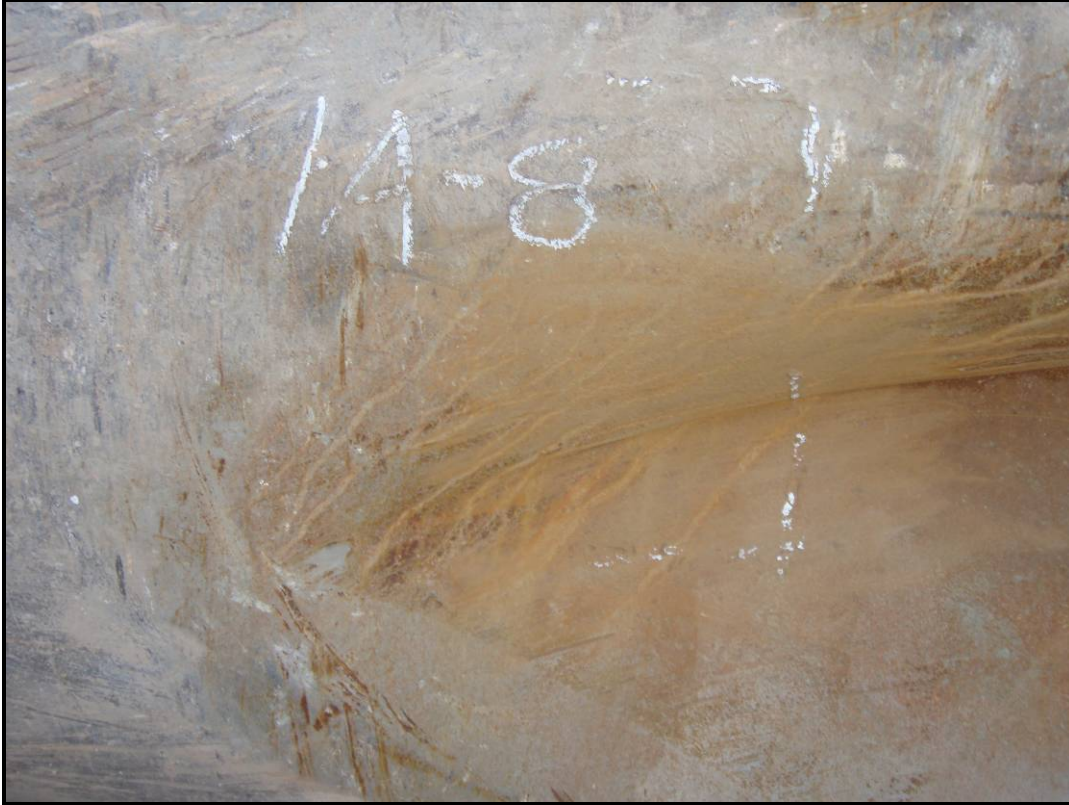
Photo 13 – Minimal bearing plate weld remnant traced in white chalk

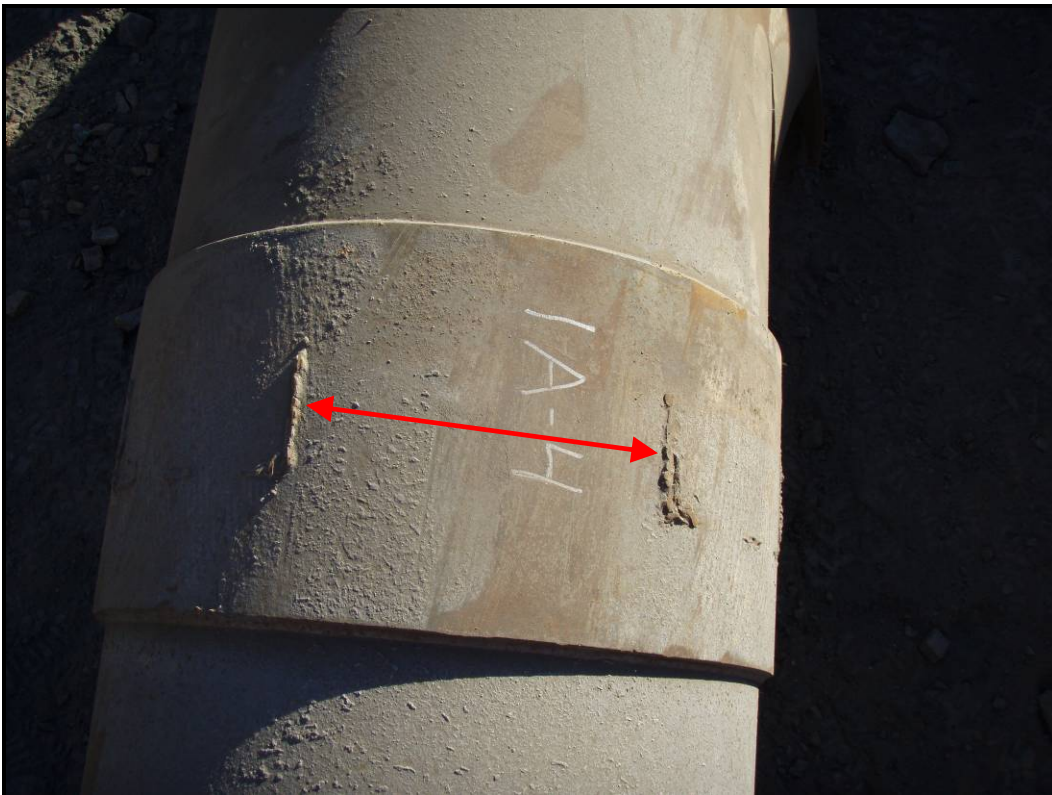
Photo 14 – Weld remnants show the two bearing plates were not installed 180 degrees apart.

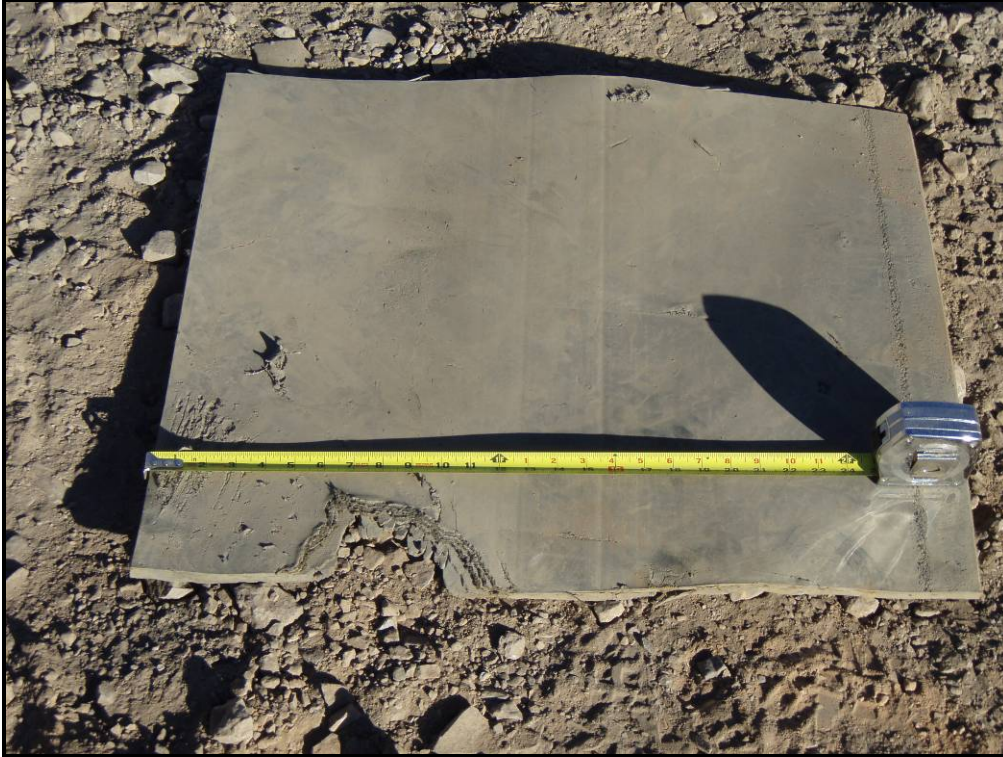
At the time of the failure, there was one section of worn through 24-inch pipe that was first identified on June 27, 2010. This section had been wrapped with conveyor belting. The belt patch, measuring 24 inches by 28 inches by 7/16 inches thick, was recovered in the debris at the bottom of the shaft (photo 15).

Photo 15 – A 24-inch by 28-inch conveyor belt piece used to patch the 24-inch-diameter aggregate pipe.

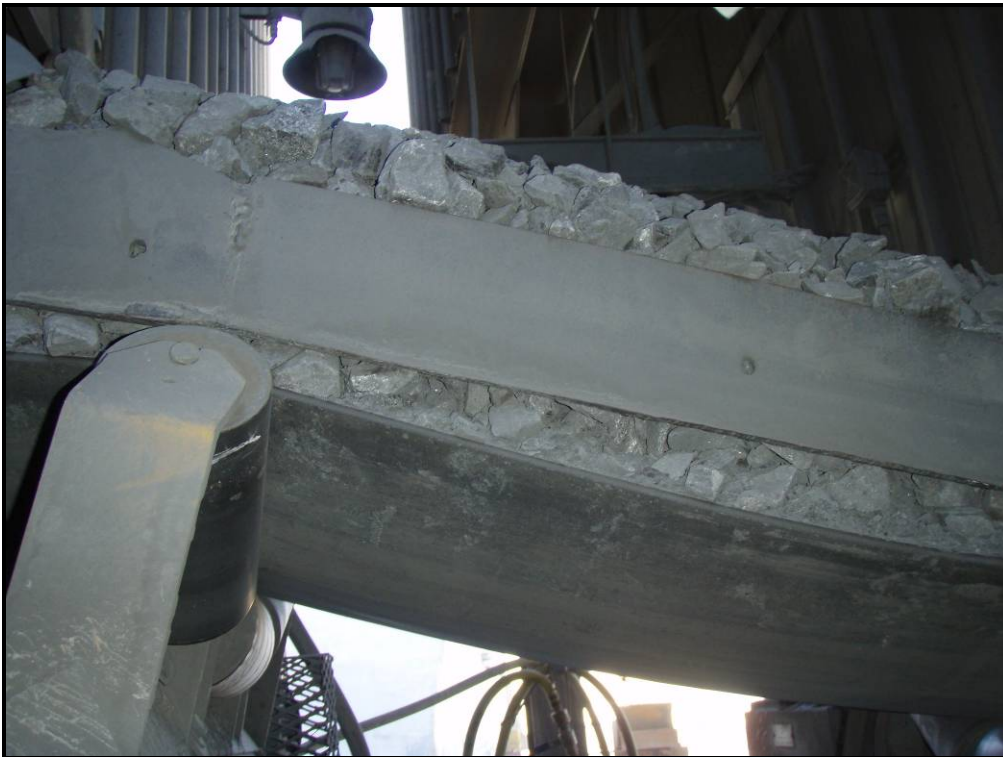
The feed bin at the surface was full. The 28-inch belt conveyor at the surface leading to the transfer box was full and overflowing (figure 6 and photo 16). The transfer box at the surface had three outlets. The center one for the 24-inch diameter pipe was open, while the two openings for the two 12-inch diameter pipes were closed. After the 24-inch pipe had fallen away, most of the material drained out of the transfer box except the materials above the two blocked off side pipes. Locks were found on the control panel at the surface for the two 12-inch diameter pipes. The lock-out date was June 22, 2010. The rock box (dead bed) at the

Photo 16 – The 28-inch-wide surface feed conveyor belt overflowing with aggregate.

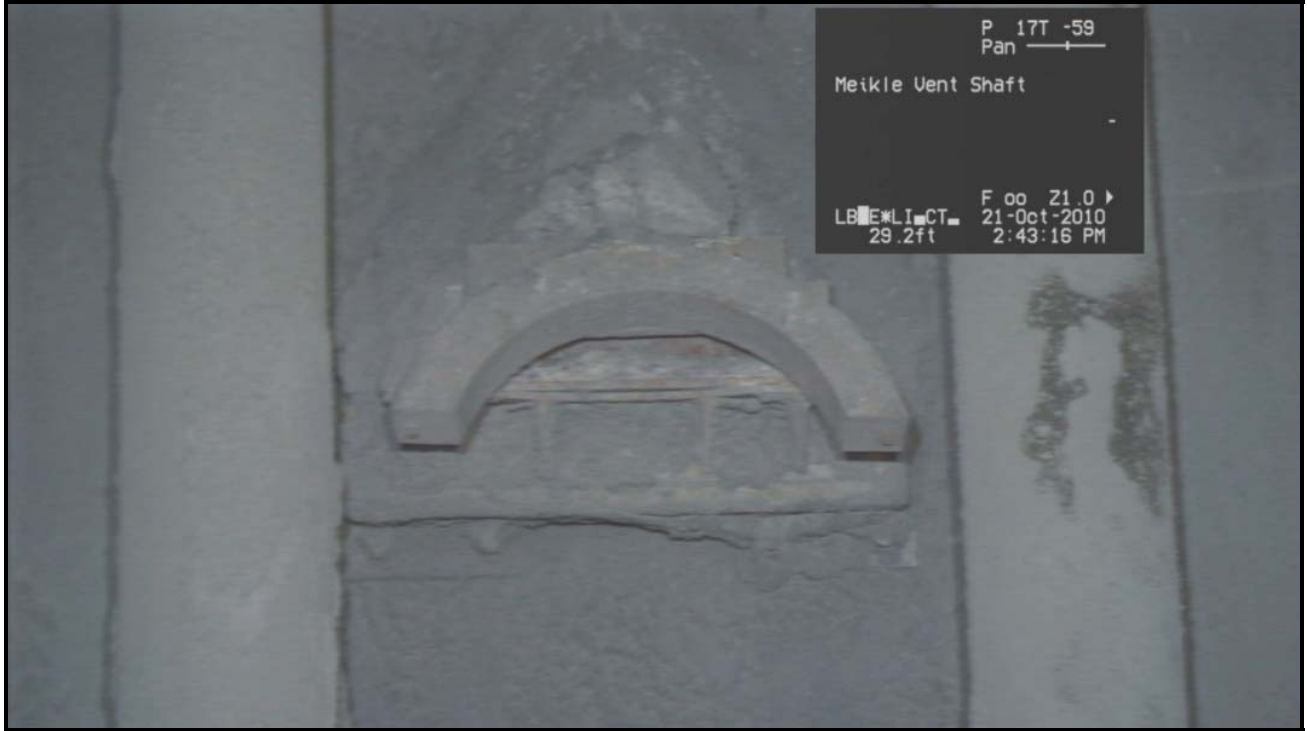
Photo 17 – Video Time 3:31 - Clamp bracket tilted downward and both clamp bolts sheared at a new bracket location.

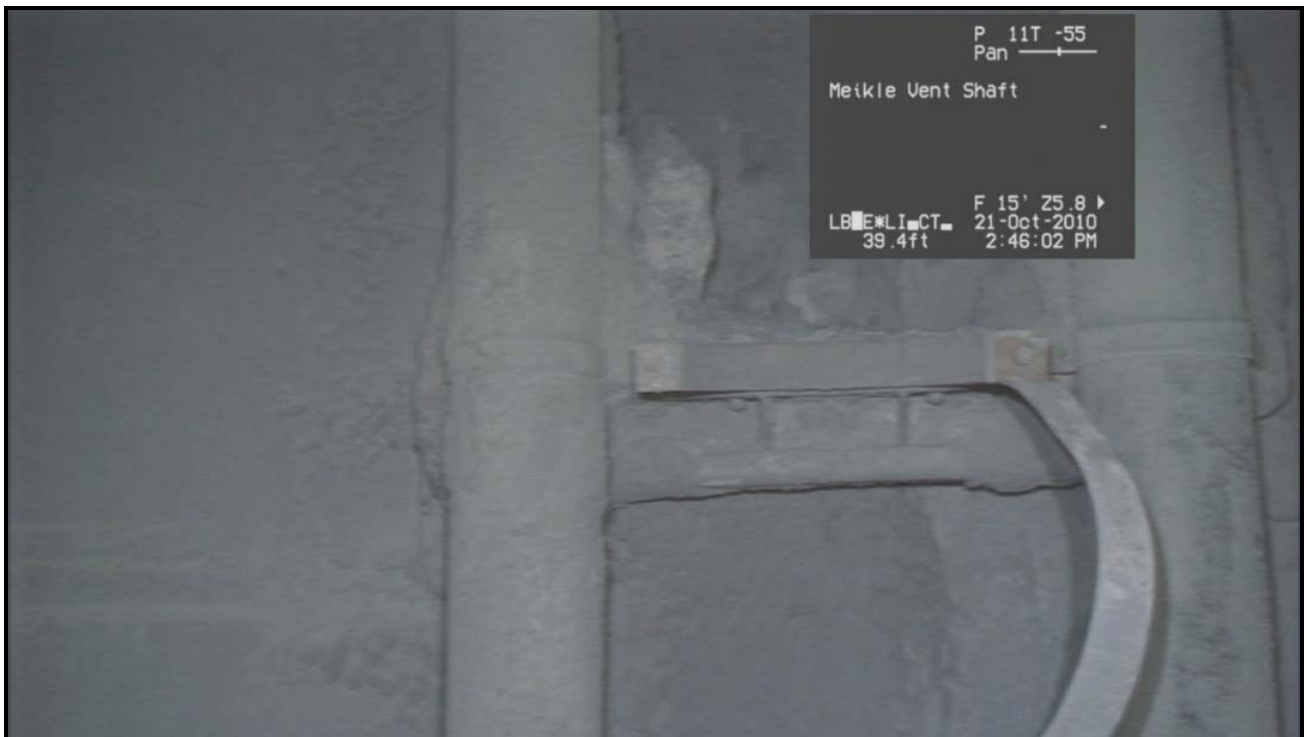
Photo 18 – Video Time 6:17 - Original bracket with one clamp bolt sheared.

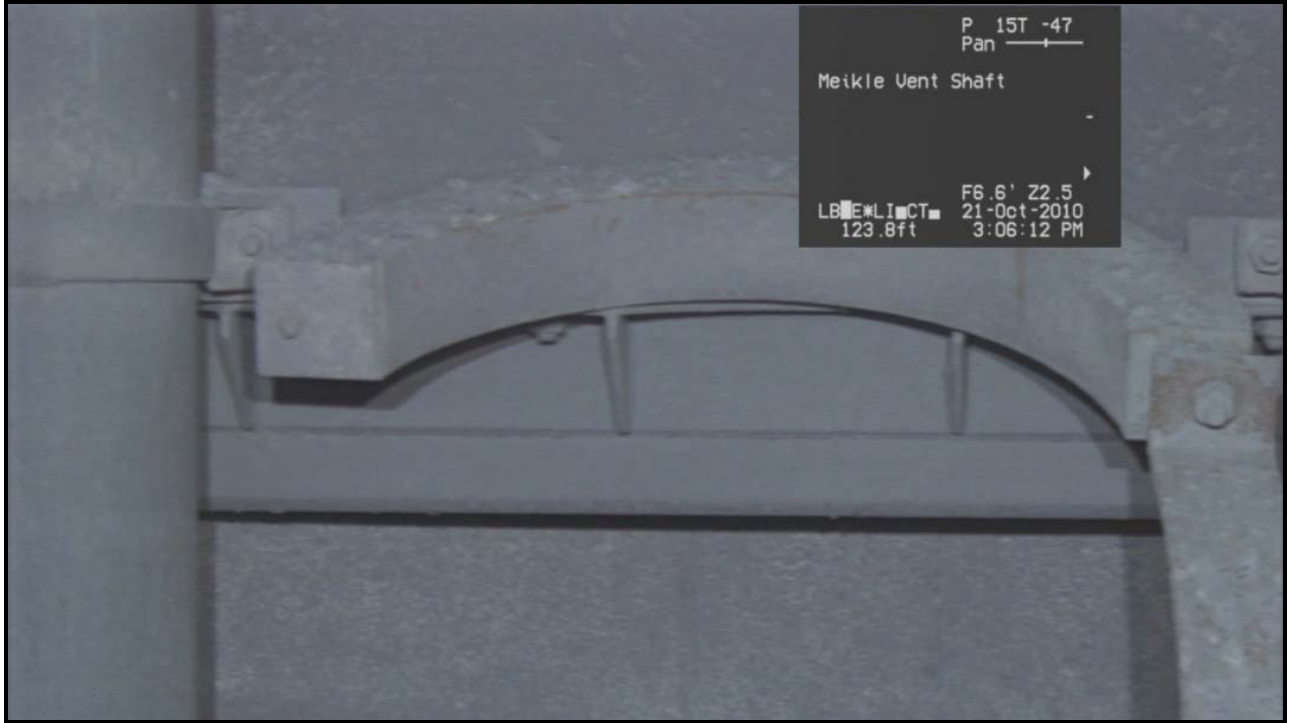
Photo 19 - Video Time 26:26 - Original bracket with one clamp bolt sheared.

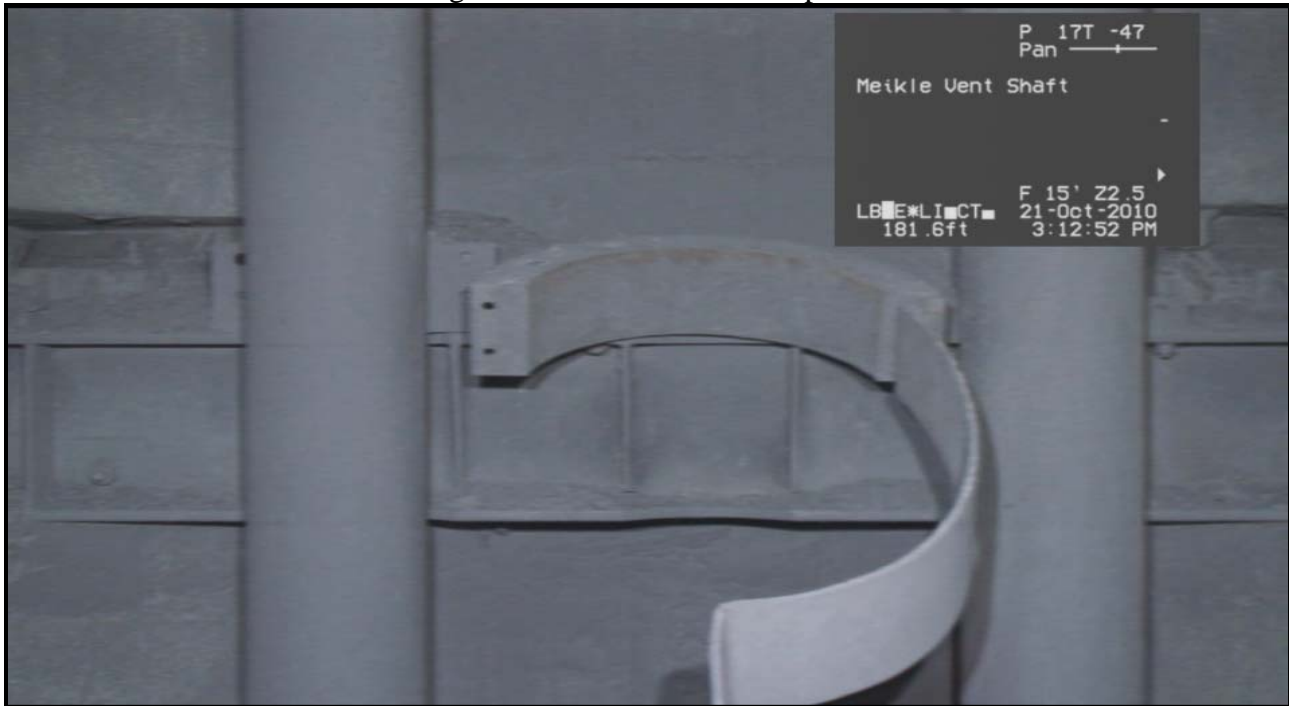
P Photo 20 – Video Time 33:07 – Both bearing clamp bolts on the left side failed at a location 272 feet from the collar.

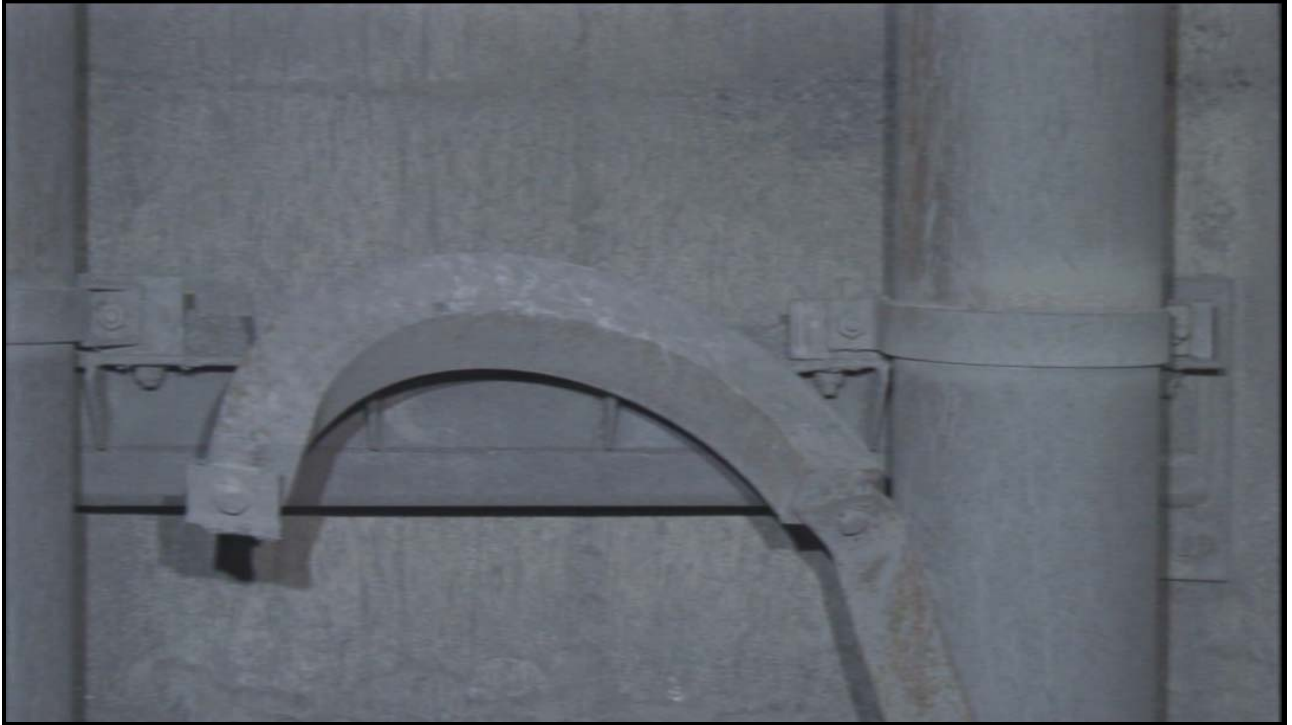
Photo 21 – Video Time 1:05:33 - Sheared clamp at an original bracket location. The clamp bracket was also tilted down.

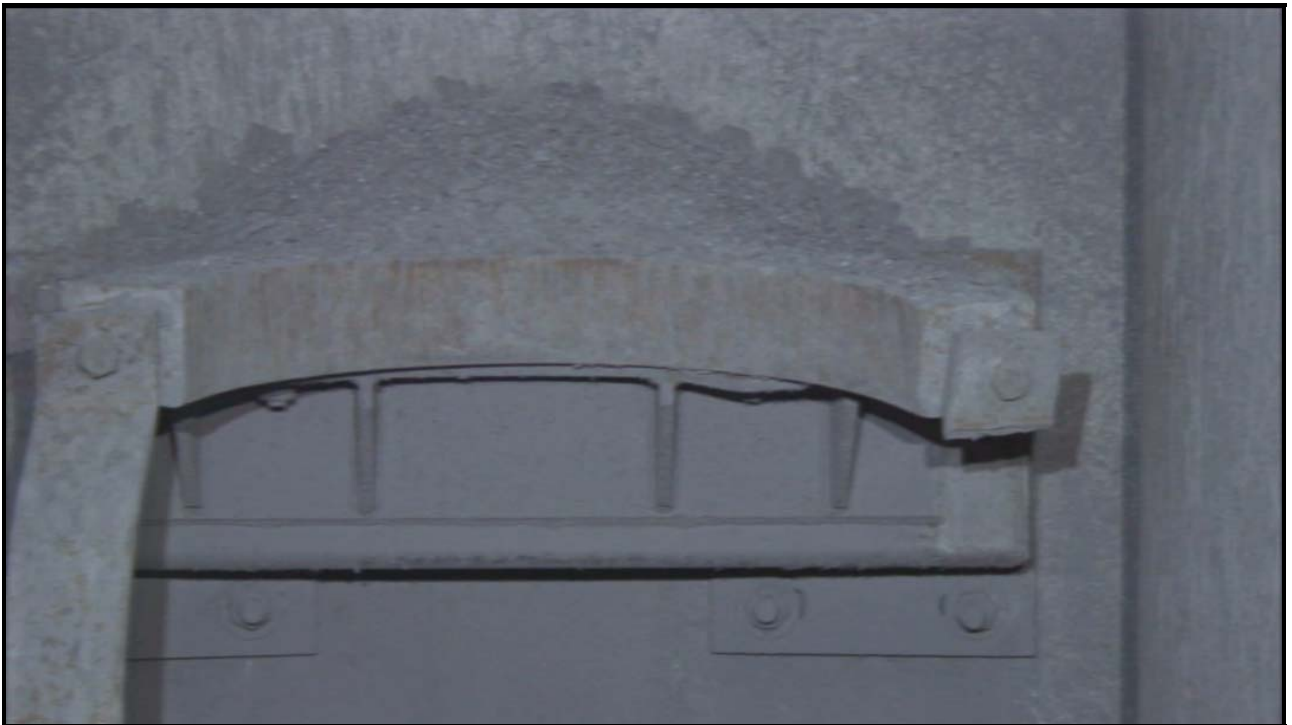
Photo 22 – Video Time 1:09:56 - Clamp sheared at a new bracket location.

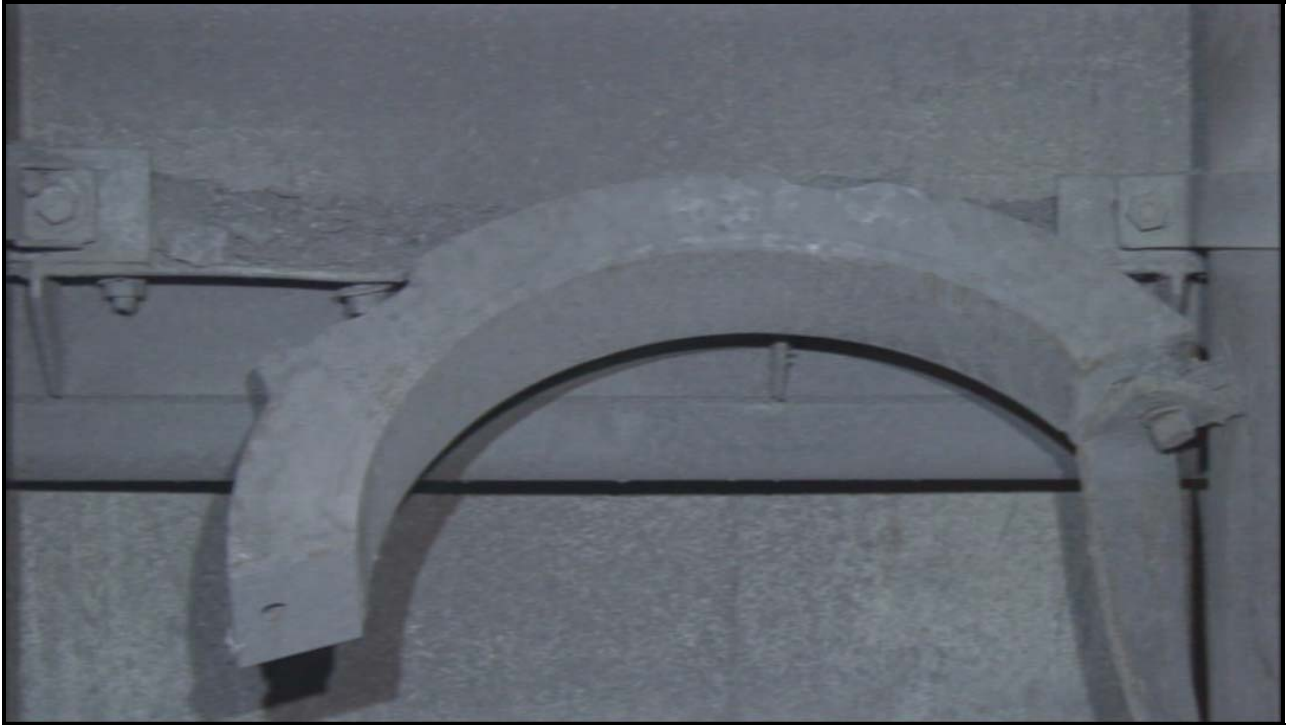
Photo 23 – Video Time 1:15:02 - Original bracket with one clamp bolt failed and a clamp bracket tilted down.

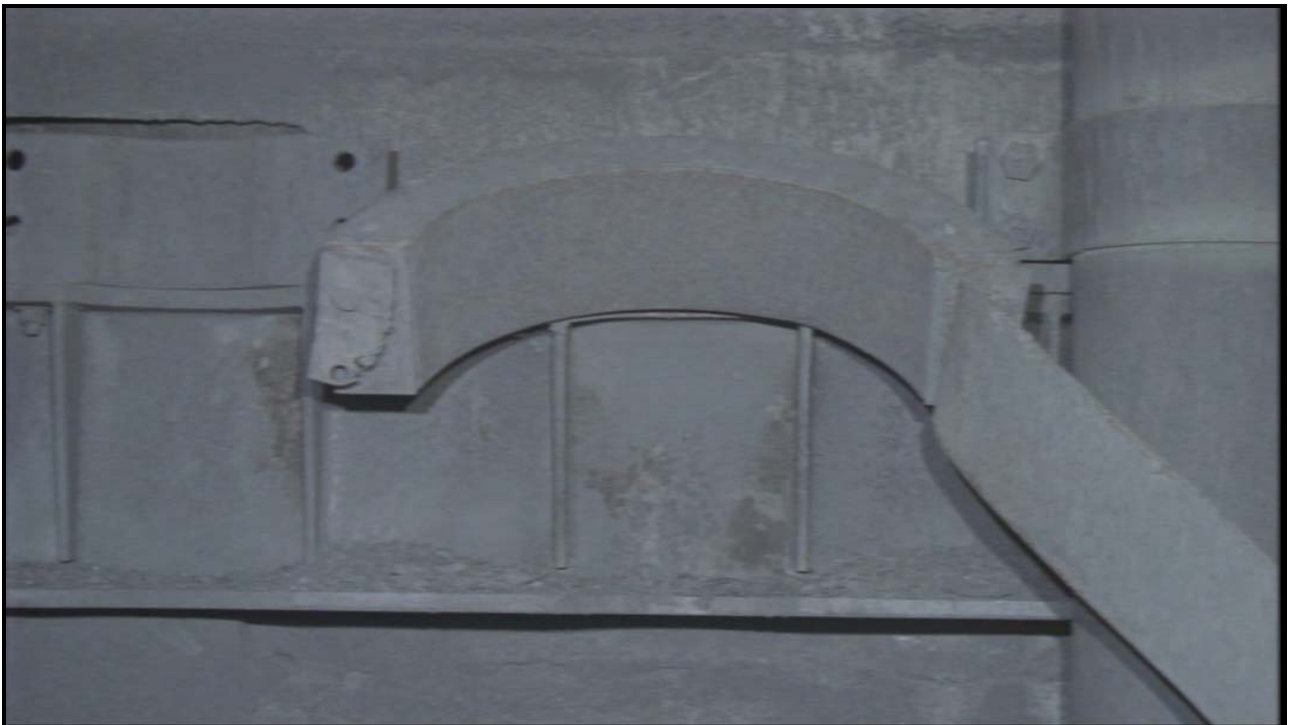
Photo 24 – Video Time 1:23:20 – Bearing clamp sheared at a location 472 feet from the collar.

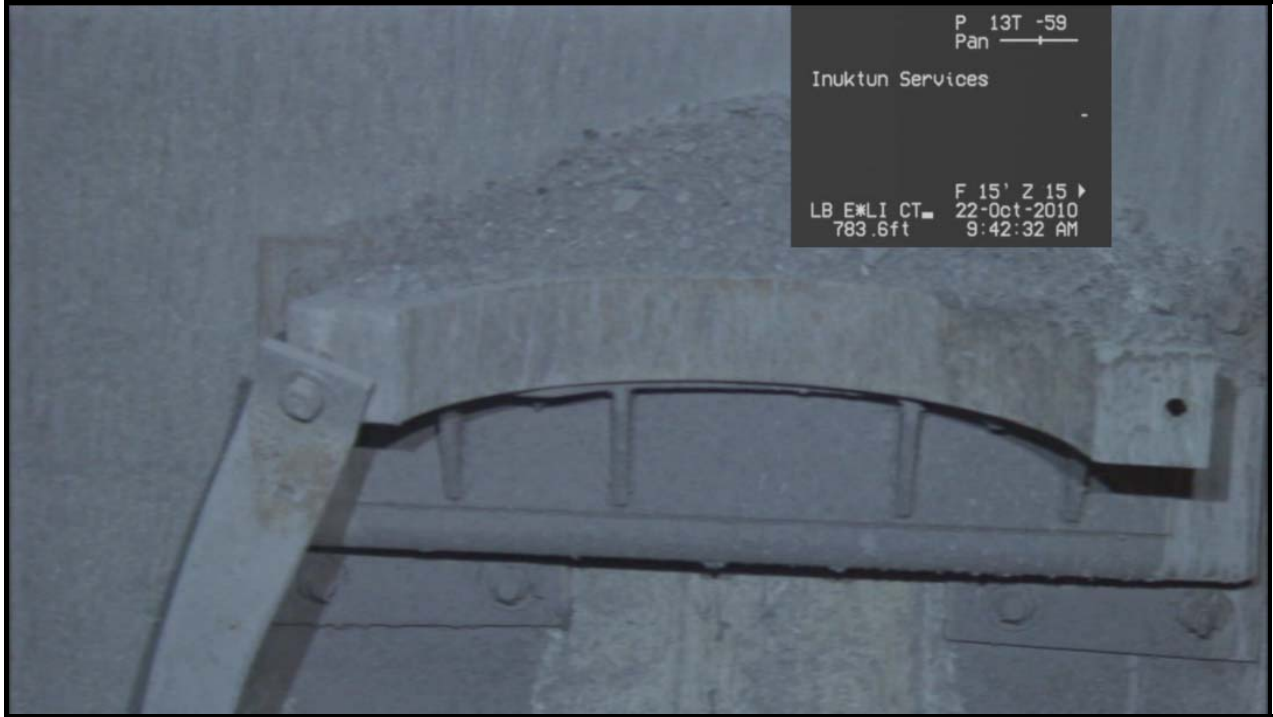
Photo 25 – Video Time 1:57:03 - Single clamp bolt sheared at a new bracket location.
