**REPORT OF INVESTIGATION**

**Underground Metal Mine  
(Gold)**

**Fatal Falling Material Accident  
August 12, 2010**

**Meikle Mine  
Barrick Goldstrike Mines Inc.  
Carlin, Eureka County, Nevada  
Mine I.D. No. 26-02246**

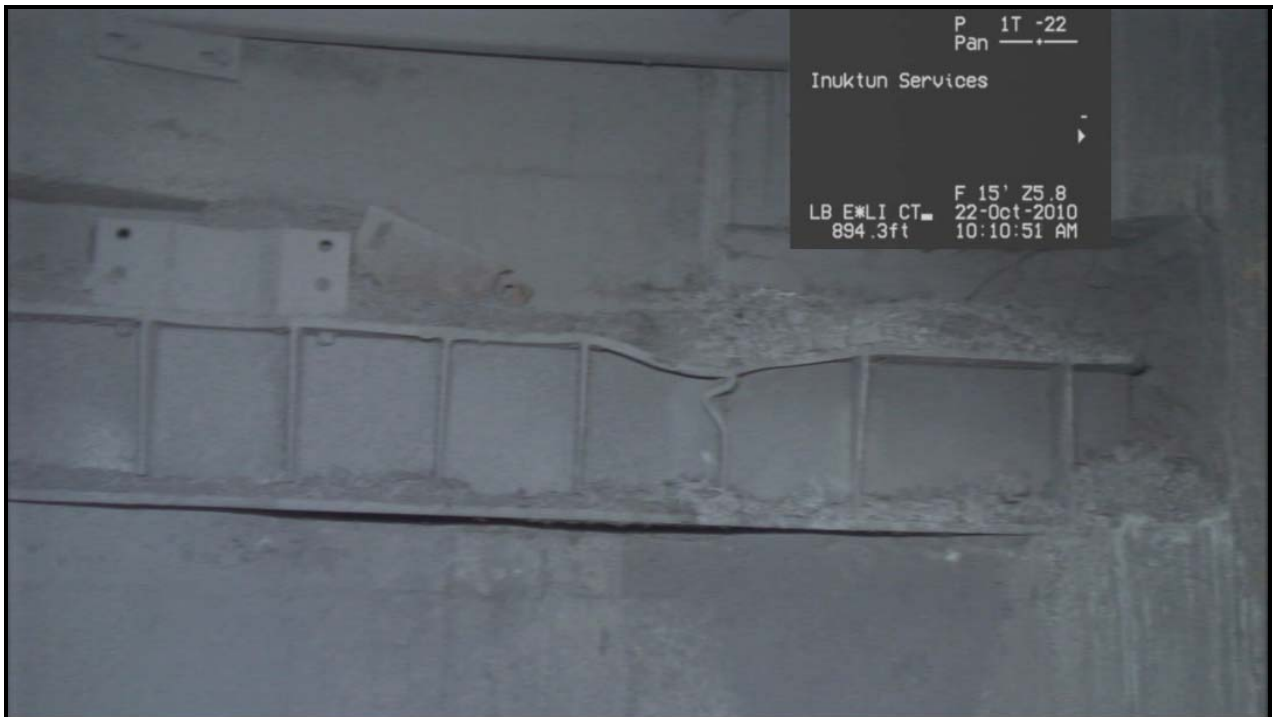
Photo 26 – Video Time 2:25:22 - Lowest bearing bracket with buckled stiffener where a 12-inch diameter pipe was previously attached. The bracket was at shaft elevation 807.

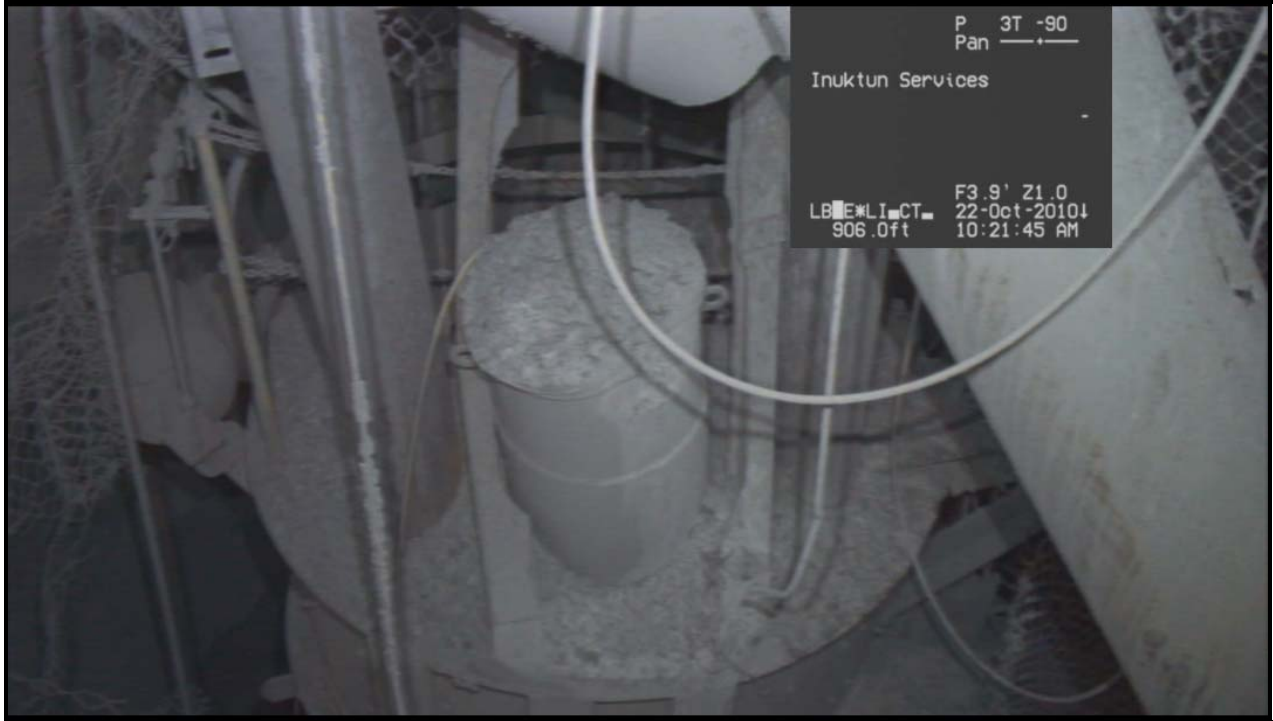
Photo 27 – Video Time 2:36:14 – 860 level rock box (silo) with lowest spool of 24-inch-diameter pipe sticking out of the top. The pipe was filled with aggregate and had dropped into the box.

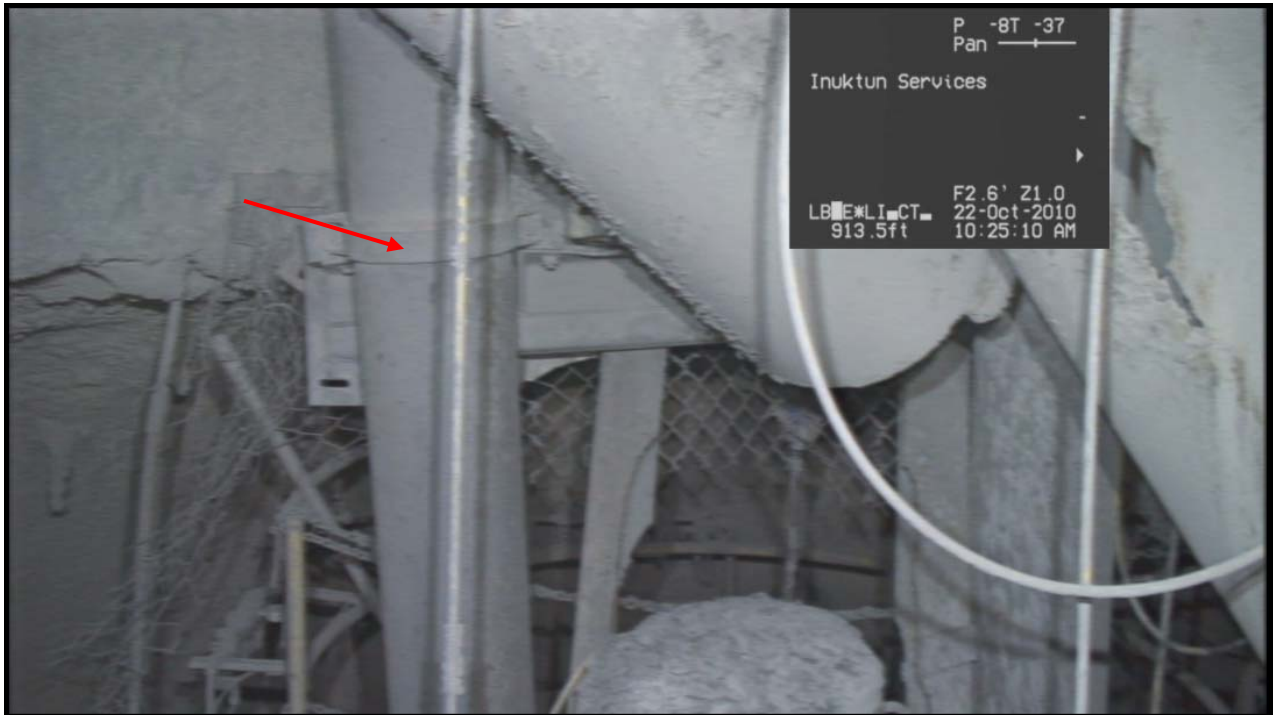
Photo 28 – Video Time 2:39:40 – Just above the 860 rock box, the lowest original bracket slid down the 12-inch diameter pipe, but the clamp (arrow) was still attached to the pipe. Also shown across the upper corner of the photo are wedged sections of 24-inch-diameter pipe.

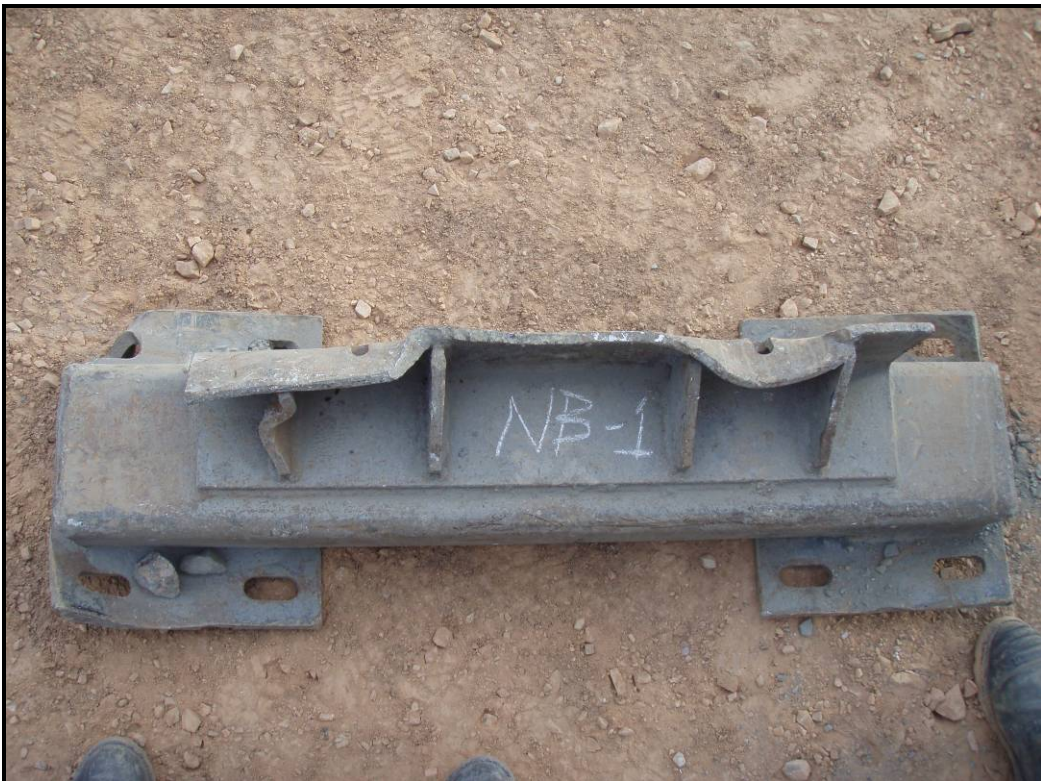
Photo 30 – New bracket (NB-1) at evidence yard. Stiffened angle bent down and stiffener buckled.

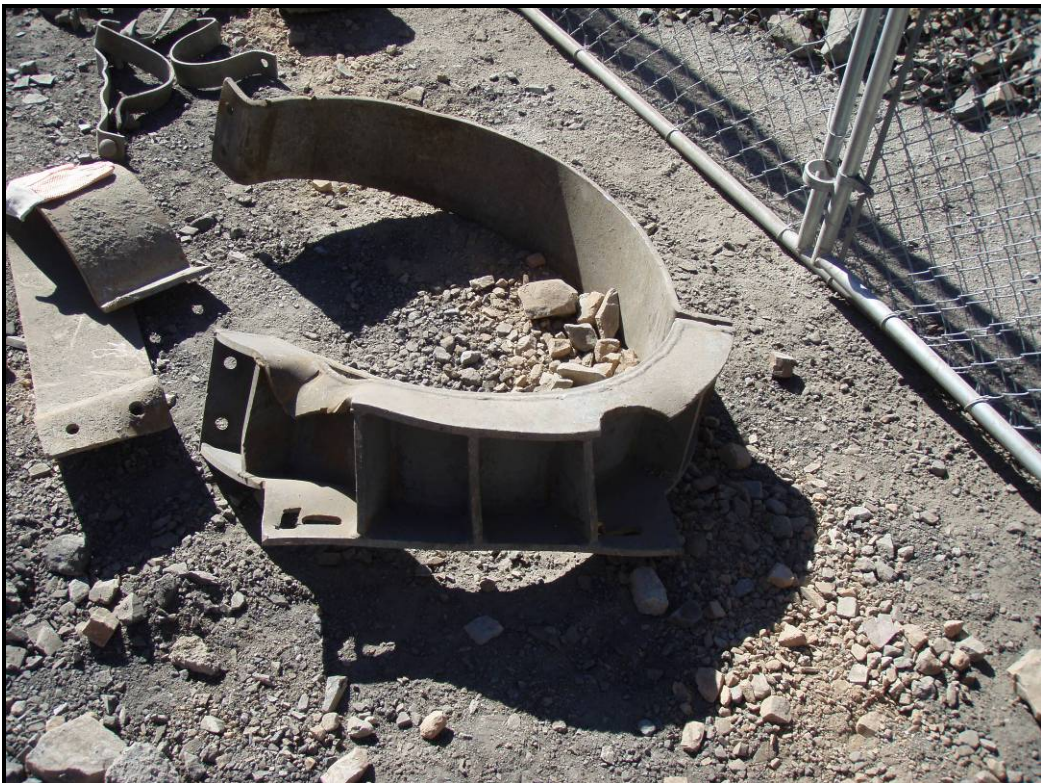
Photo 34 – Bearing clamp bracket and clamp at evidence yard. Additional slot burned in clamp bracket to accommodate misalignment.
