**Federal Aviation  
Administration**

## ADVISORY CIRCULAR

# AVIATION MAINTENANCE ALERTS

**ALERT  
NUMBER  
405**

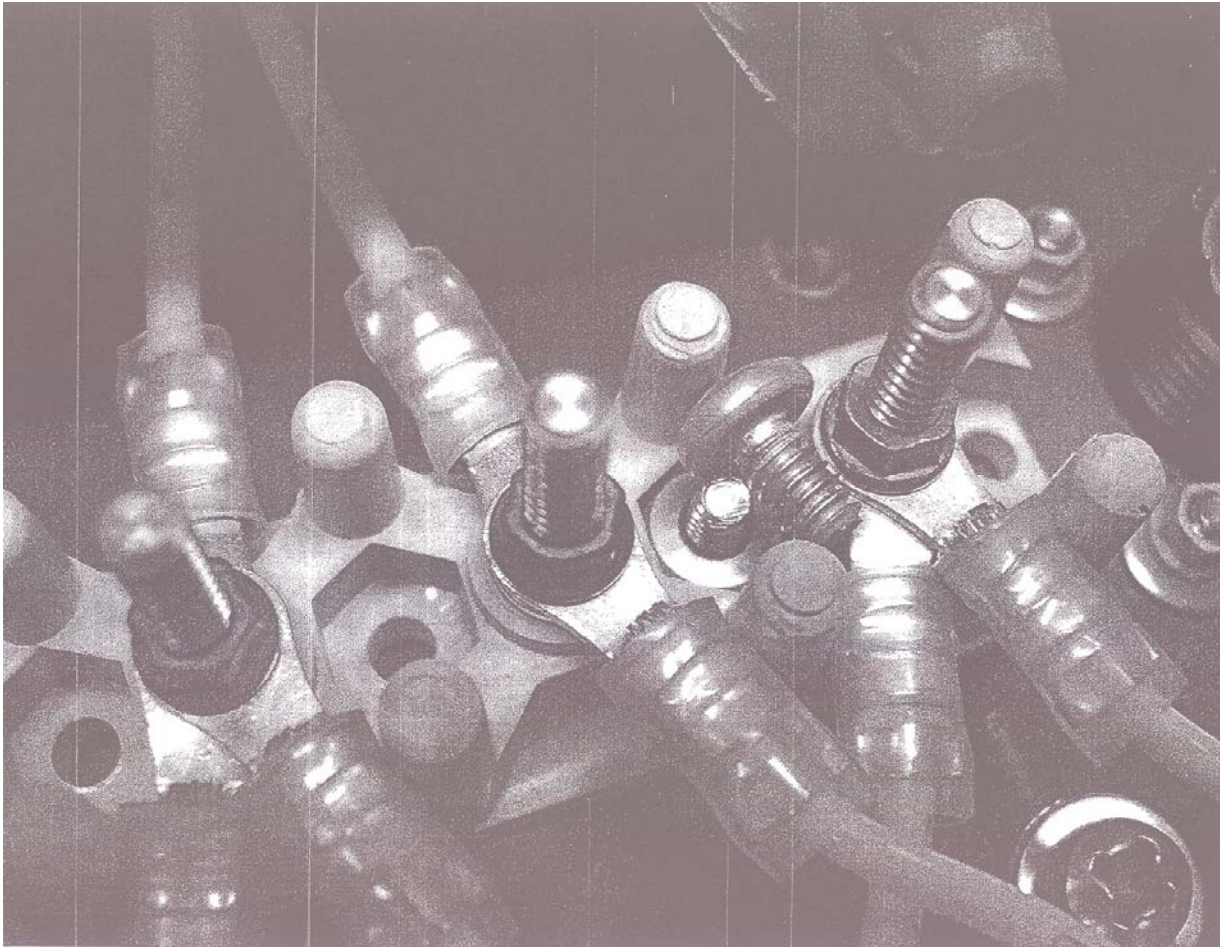
**Boeing: 737; Shorted "Logo" Light; ATA 3340**

An unidentified corporate submission states, "Inspection findings (*for this defect*) are: (1) a transformer mounting screw (Fig. 1-220) dislodged and floating loose in the unit—causing short-to-ground, (2) the socket (Fig. 1-65) is worn, and (3) the reflector (Fig. 1-73A) finish is worn. Refer to Koito CMM IPC 33-45-04 for the called out items." (*Koito Logo Light P/N: 8100037602.*)

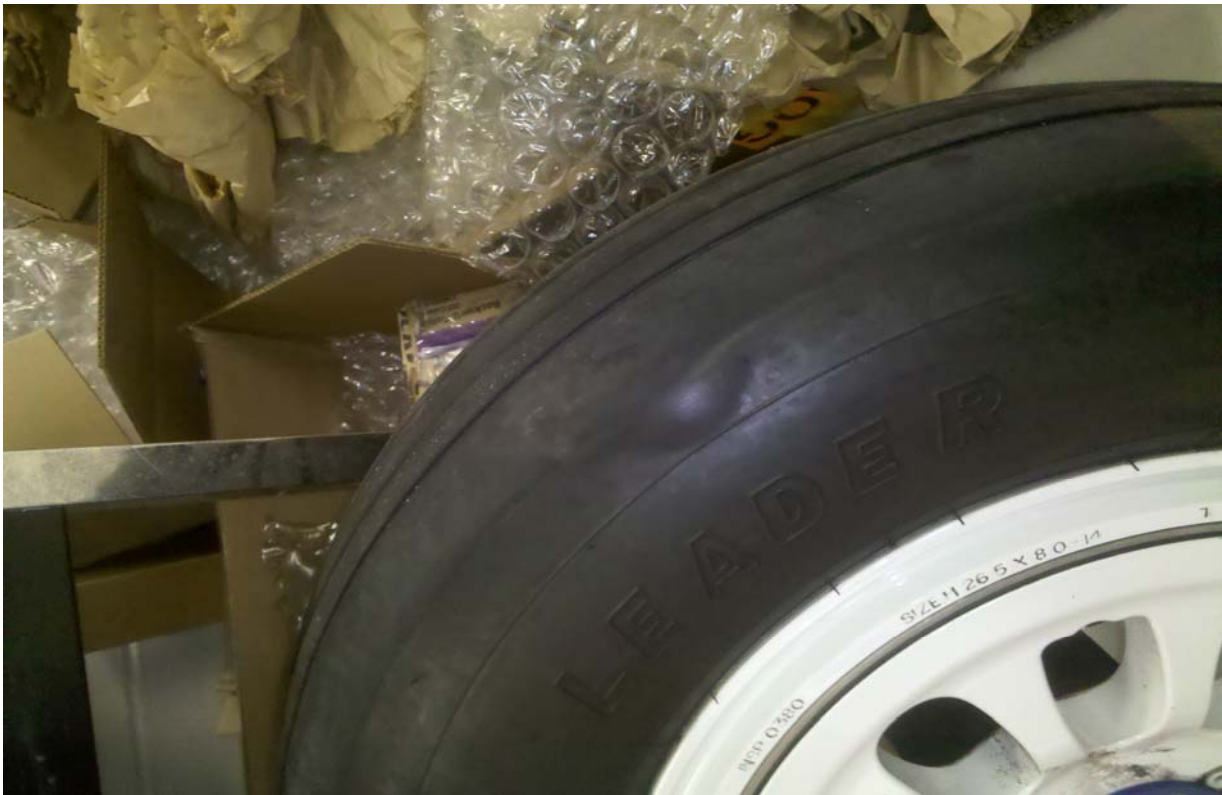
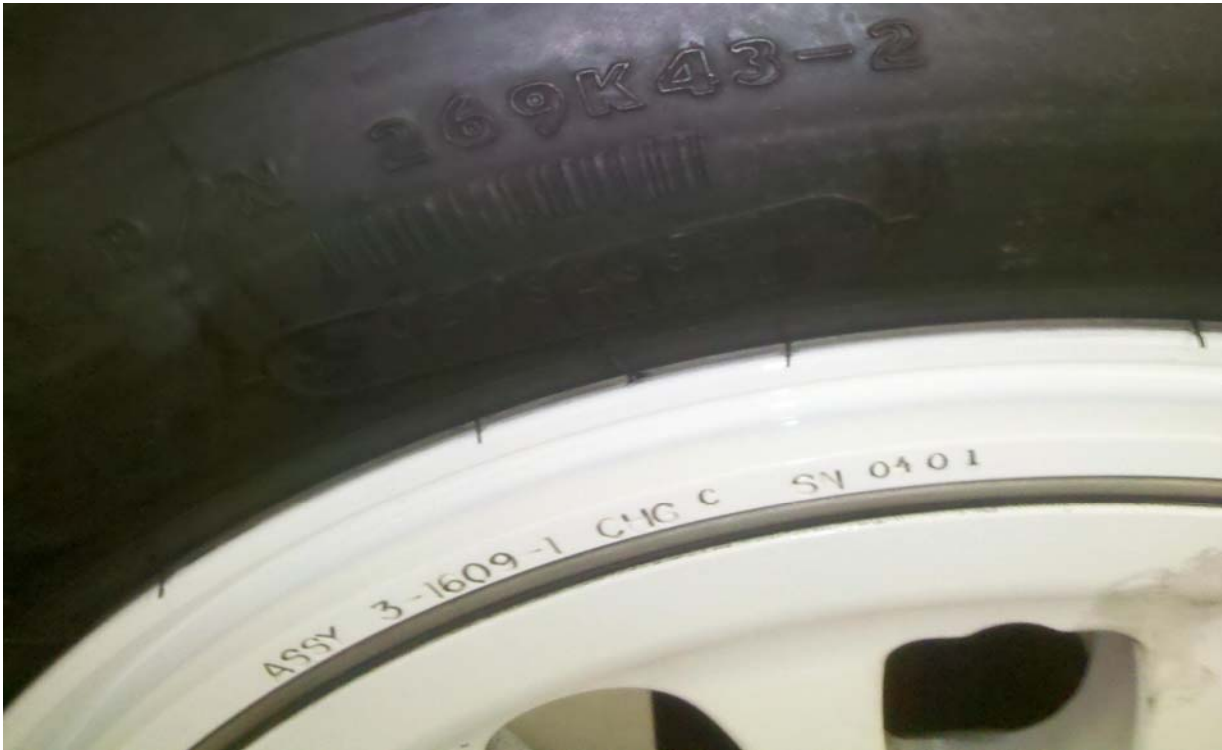
**Bombardier: BD100-1A10; Defective Tire; ATA 3244**

A commercial operator's technician says, "A bulge on the number two main tire (P/N 269K43-2) outer sidewall is consistent with bulges found on previous tires (P/N 269K43-1). This tire is being sent to Goodyear for evaluation."

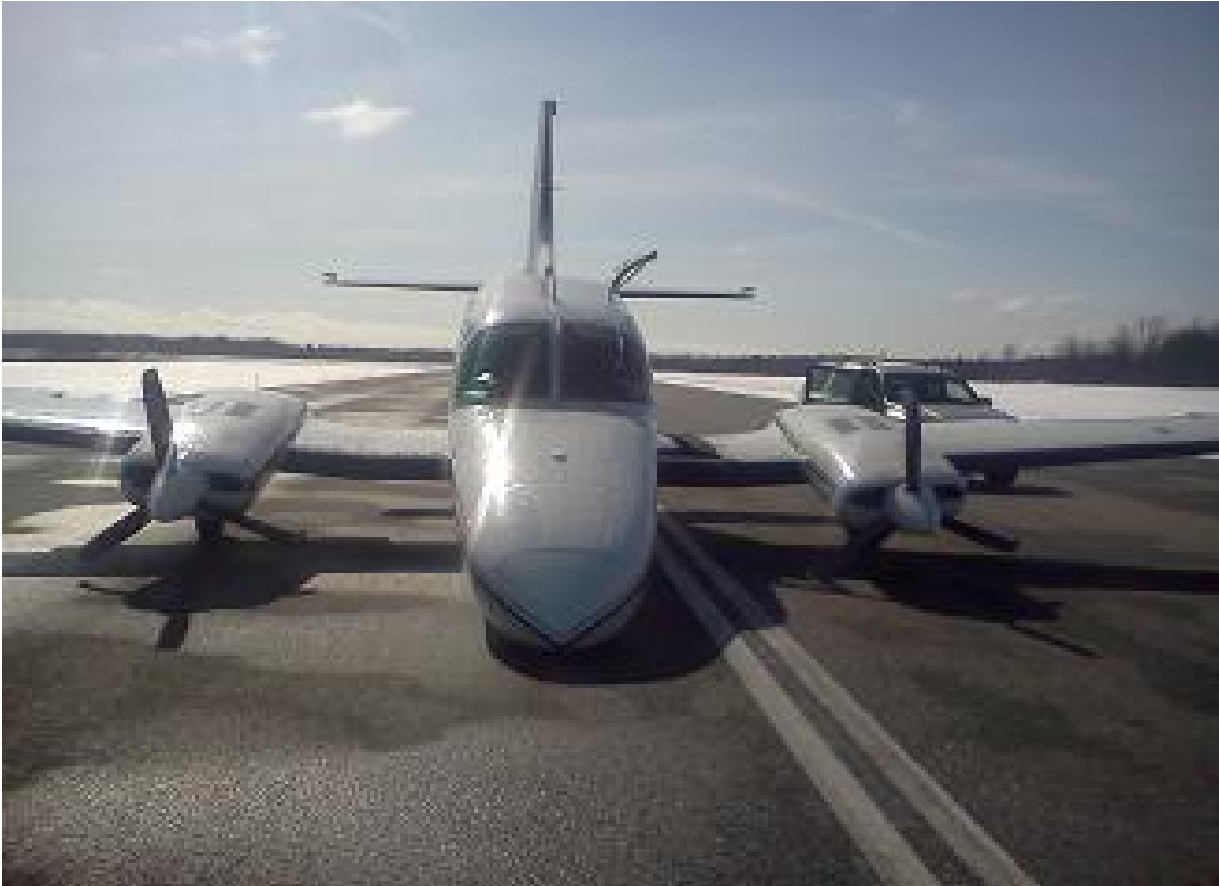
**Cessna: 402C; Failed Nose Gear Microswitch; ATA 3260**

"The nose gear collapsed on landing," says this electrical technician. "The nose gear actuator was removed and tested in a controlled environment. When the actuator was cold soaked, the microswitch (*P/N 1CH16*) failed to activate properly, giving a false indication the gear was down and locked. Due to gear failure, both aircraft propellers struck the ground and caused sudden stoppage to the engines. The aircraft also suffered structural damage to the nose section."

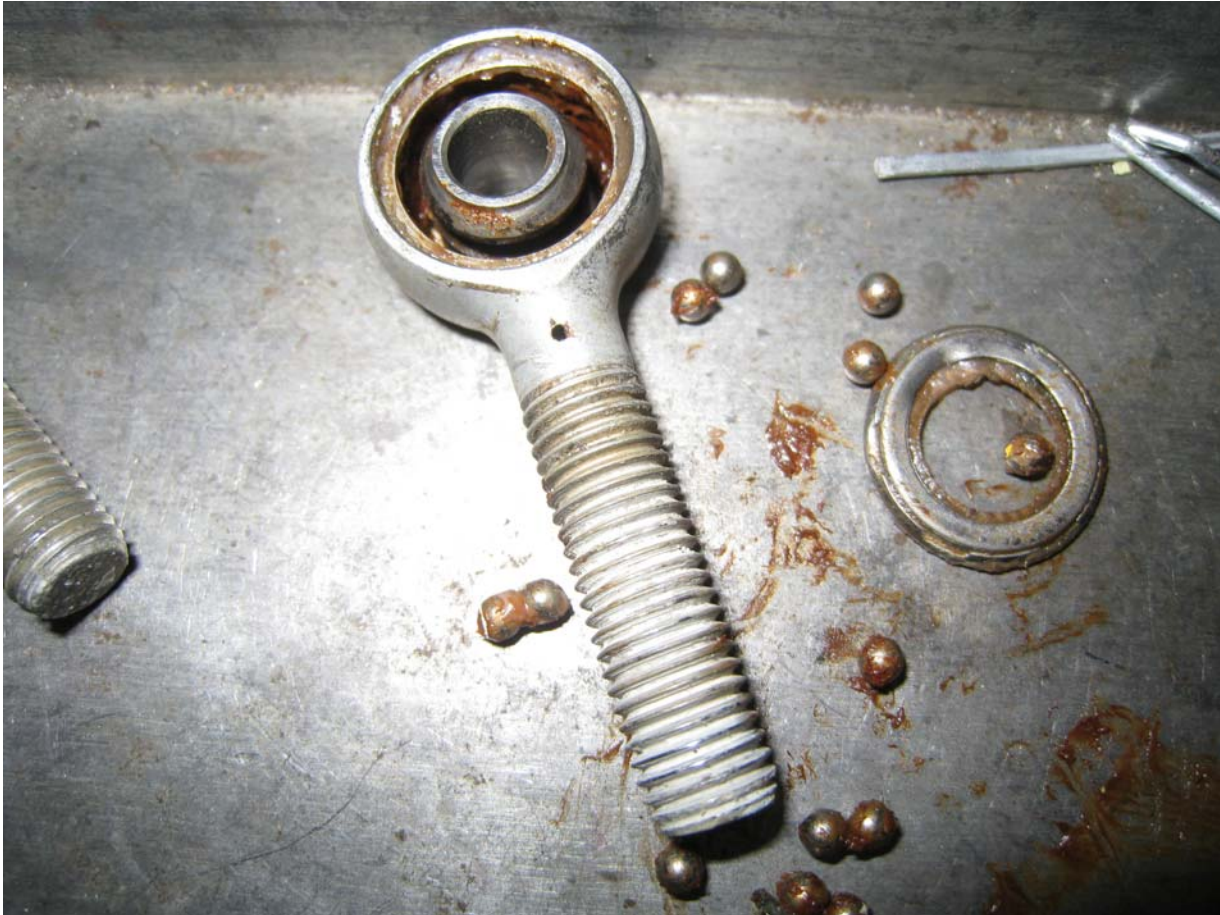
**Hawker: 800XP; Failed Elevator Trim Rod-ends; ATA 2731**

A submitter writes, "When conducting a maintenance preflight inspection, the technician noticed rust stains coming from the aft rod-ends (*P/N CN635MESP56*) of the elevator trim tab rod on both left and right elevator trim tabs. Further inspection revealed the grease seals on one end of both the left and right trim tab rod-ends had come off, and the ball bearings were mostly missing. Fortunately, the other rod-end on each of the trim tabs was still intact. However, rust stains were also noticed coming through these grease seals. In the process of replacing the rod-ends, it was noticed that TKS deicing fluid had penetrated into the hollow inner portion of the trim tab control rod, (*but*) no evidence of corrosion existed.

"Recommendation: Conduct a close-up visual inspection of the elevator trim tab rod-ends for rust staining and grease seal separation on an annual basis. Any time rust staining is observed coming out of the rod-ends, replace them. At each 48 month inspection, remove the rod-ends and visually inspect the control rods for corrosion."

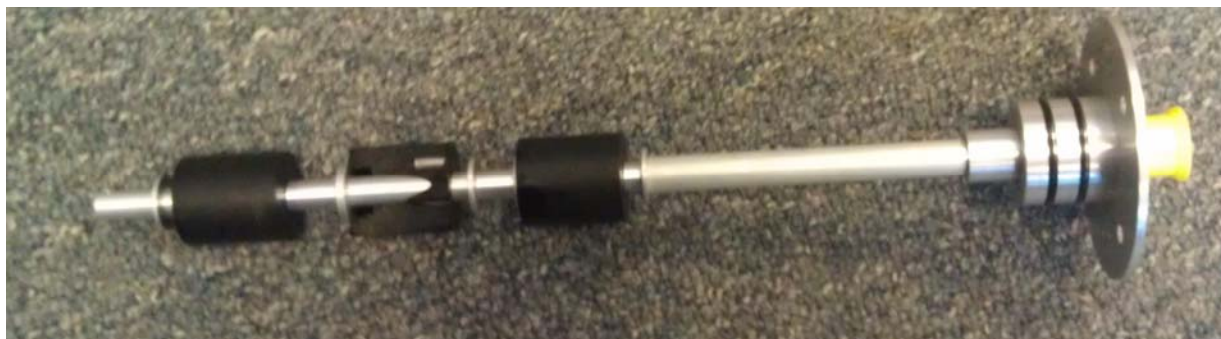
**Lear: 45; Broken Hydraulic Float Switch; ATA 2930**

"Maintenance was (*experiencing*) erratic indications when servicing hydraulic fluid," states this Air Carrier SDR report. "When serviced correctly per the maintenance manual, hydraulic 'low fluid' or 'over filled' messages from EICAS (*Engine Indicating Crew Alerting System*) would appear shortly thereafter. There was no evidence of fluid loss, and the mechanics were properly trained and equipped for the servicing task. The hydraulic float switch was removed for troubleshooting—it was found to have one float broken. The float switch assembly (*P/N 3L14F17*) was replaced with a new unit, and the hydraulic system checked in consultation with Learjet Field Support to ensure the possibility of system contamination was adequately addressed."

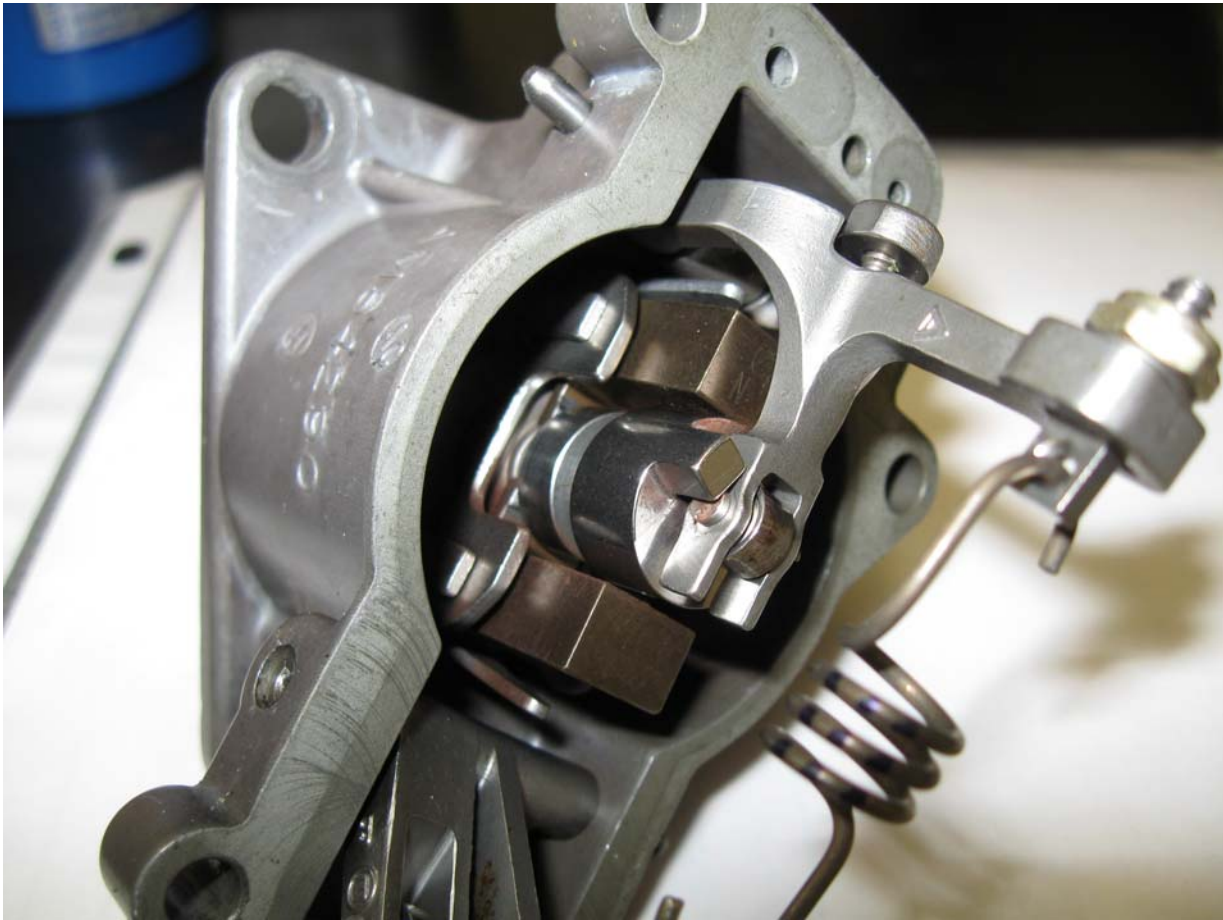
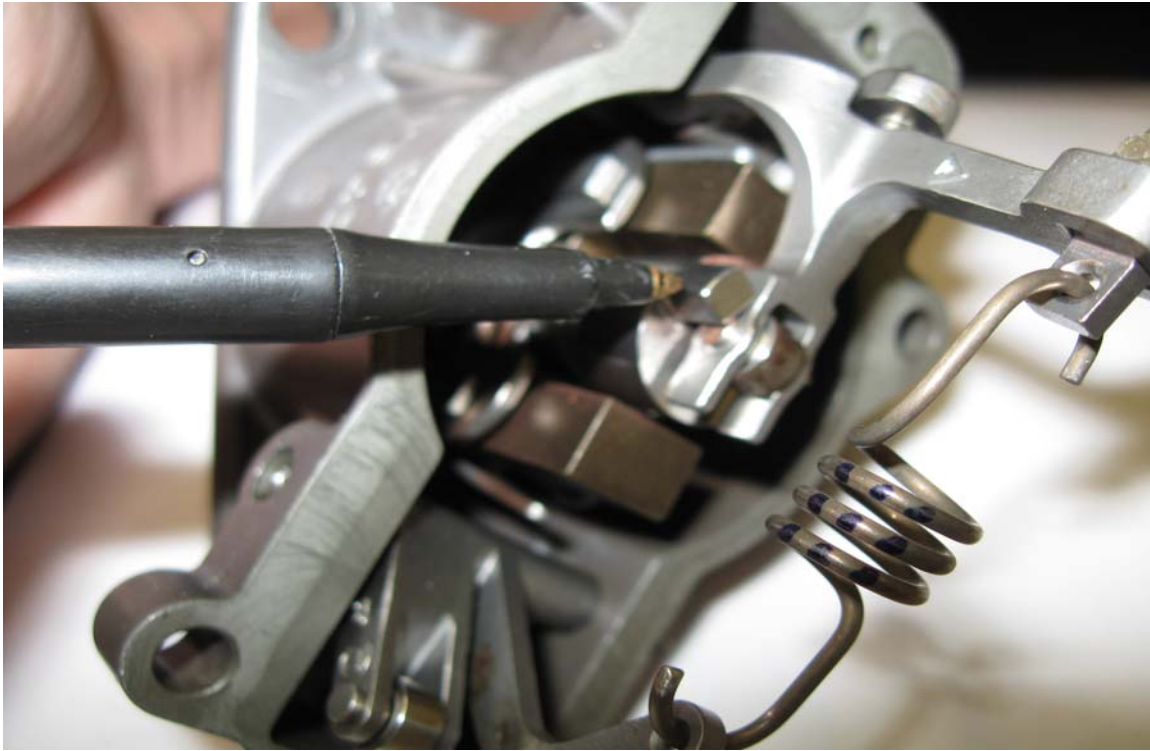
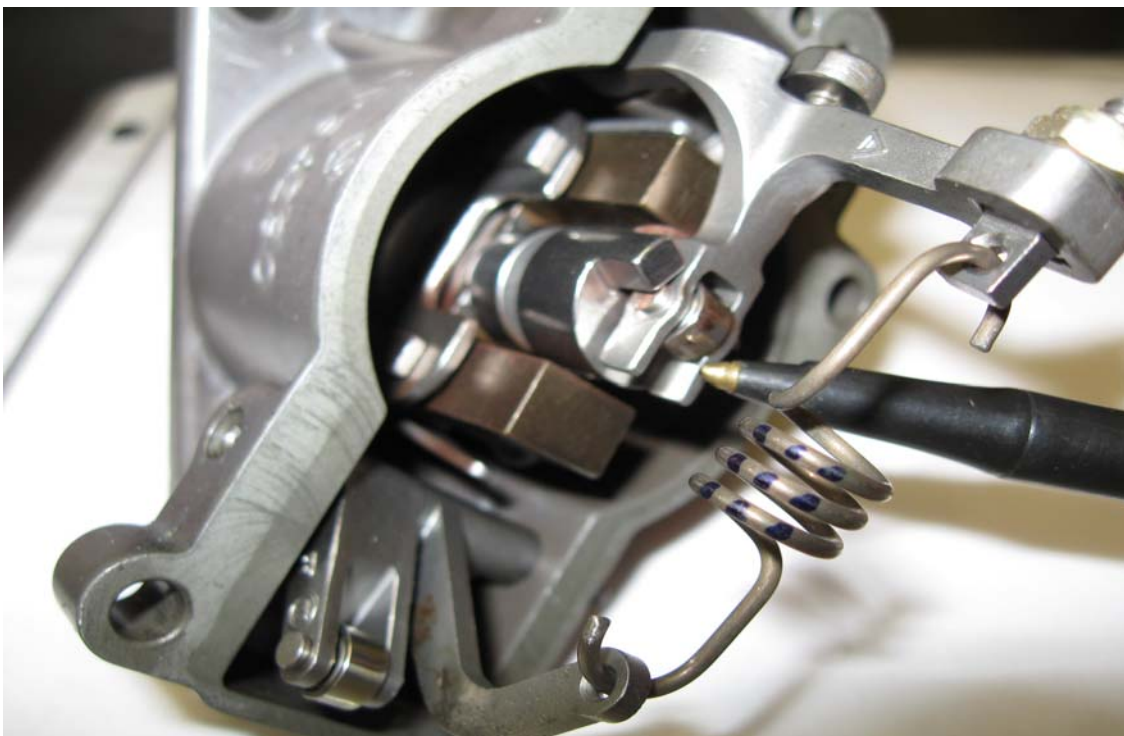
**Bell: 206L1; Improper Governor Assembly; ATA 7323**

"The governor allows the engine (*Allison 250C28*) to overspeed," says a mechanic. It failed the shop test. (*I*) disassembled the unit and found it improperly assembled. The spool bushing anti-rotation tang was engaged in the lever slot." (*There are 16 SDRS database entries for the Honeywell Governor P/N: 252469211, and 6 entries for the Bushing Assembly P/N: 2526146.*)

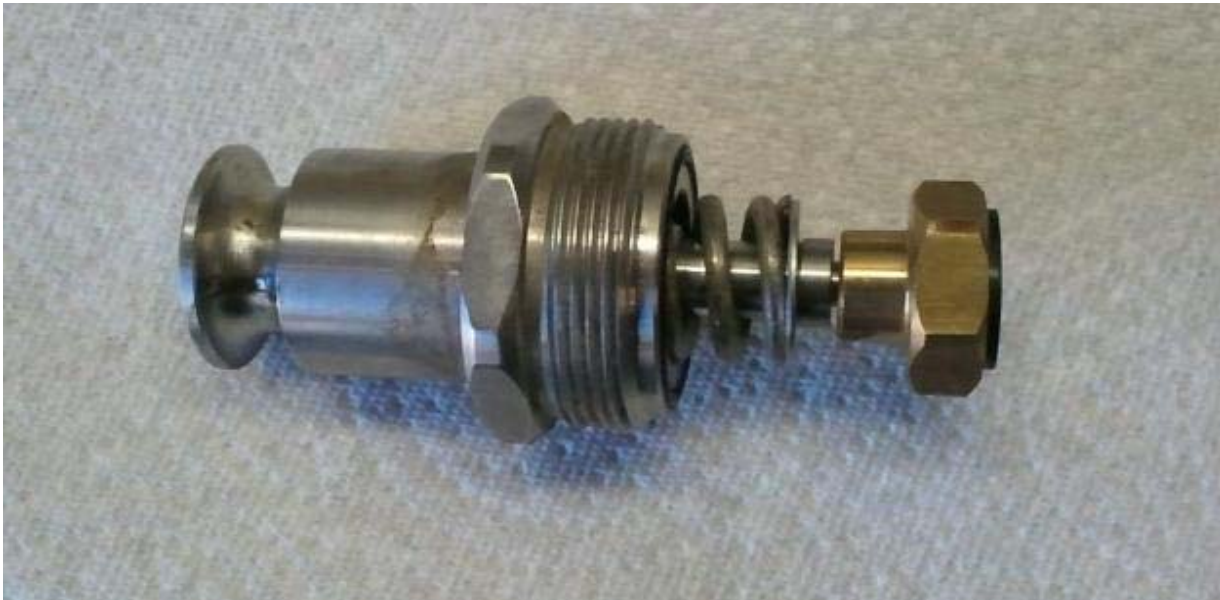
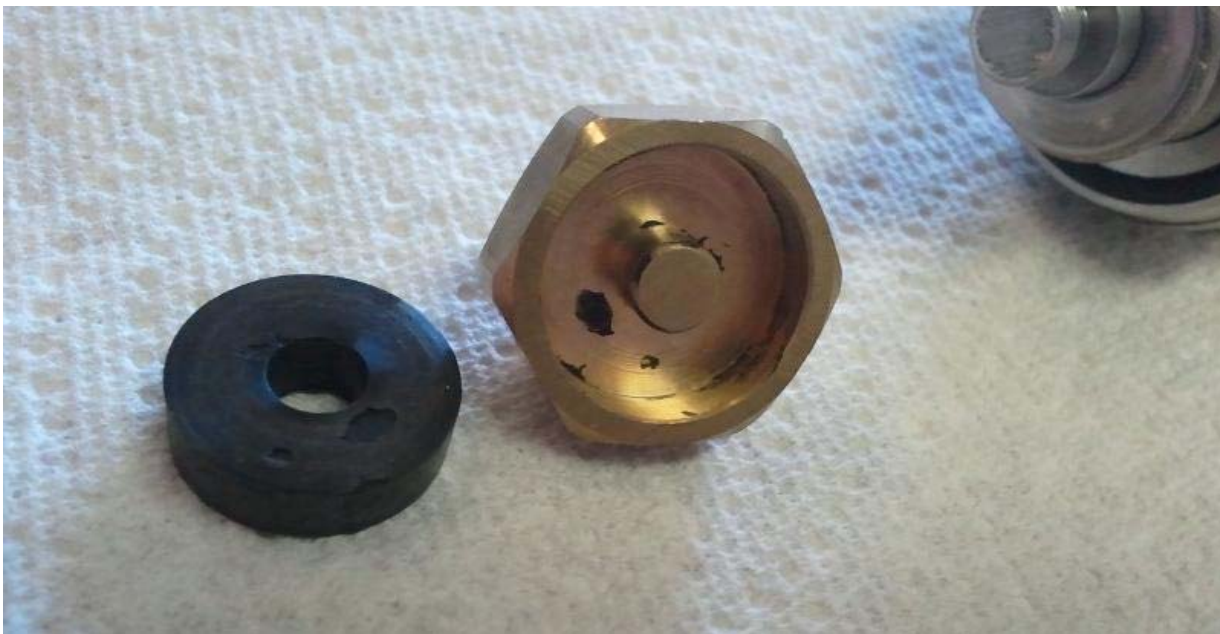
### Cameron: A315; Failed Blast Valve; ATA 5102

A repairman/pilot states, "The blast valve (main burner valve; P/N F8612) no longer functioned. Upon disassembling the blast valve from the burner, the shutter valve was visually inspected. The adhesive compound bonding the brass to the rubber ring was found to have failed, and the amount of adhesive bonding the two pieces also seems to be inadequately or unevenly applied. The rubber ring separating from the brass housing resulted in complete blockage of fuel (propane) to the burner coils—ultimately resulting in failure of the blast valve."

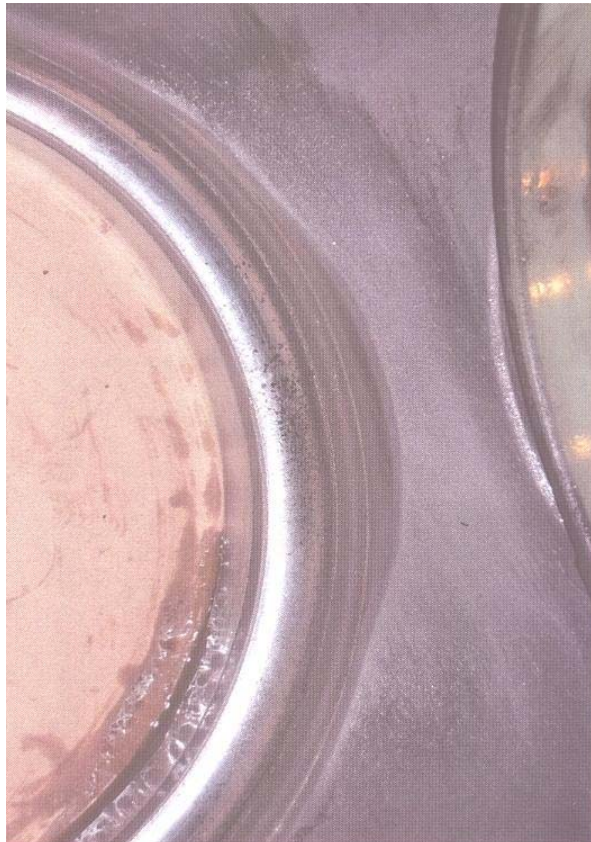
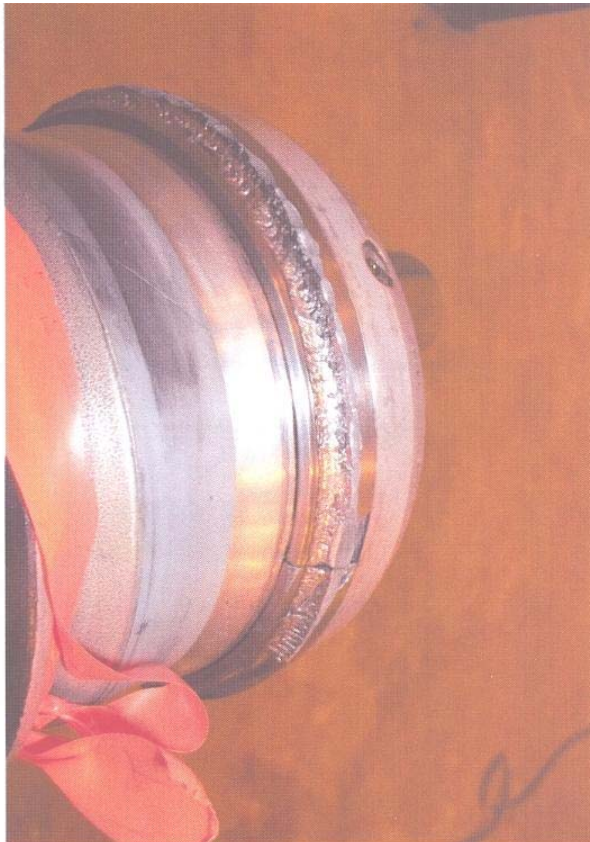
### **Hamilton Standard: 14SF7; Bearing Failure; ATA 6111**

The submitter states, "During inspection/maintenance of the propeller, the L/H number three blade (P/N SFA13M1R0A+D) was found to have bearing failure."
