43-16A

# AVIATION MAINTENANCE ALERTS

**ALERT  
NUMBER  
406**

**MAY  
2012**

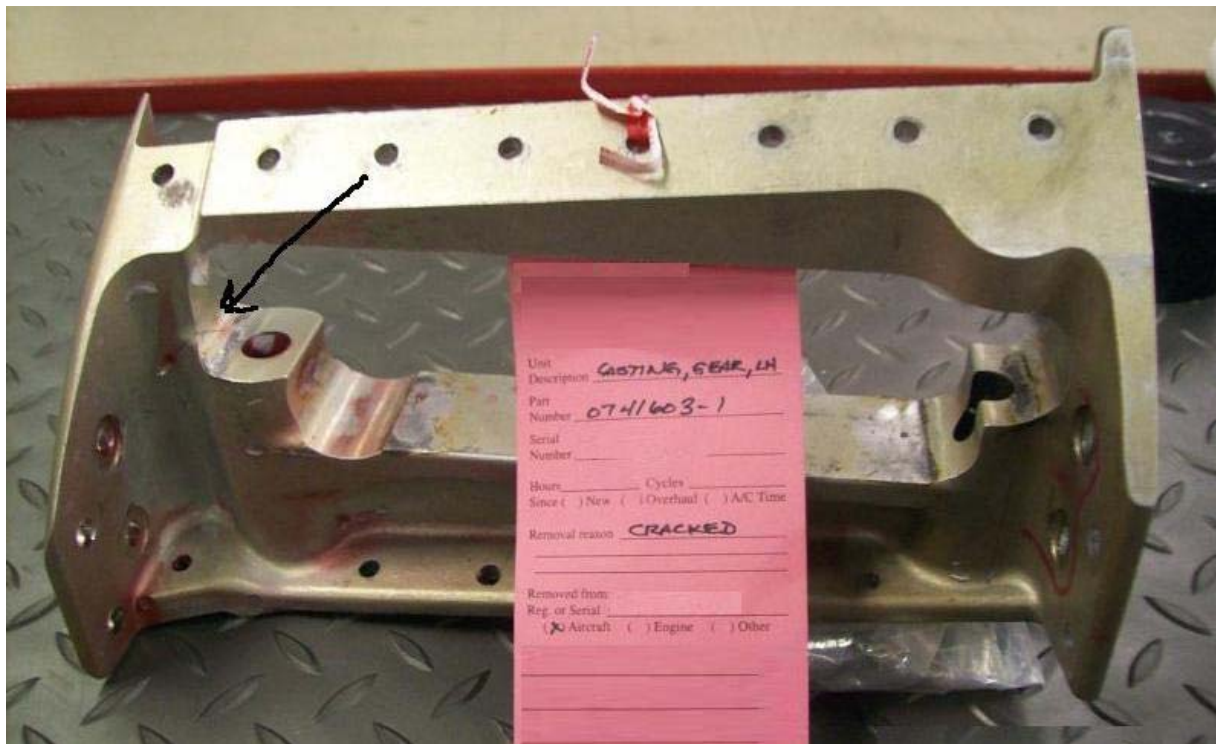
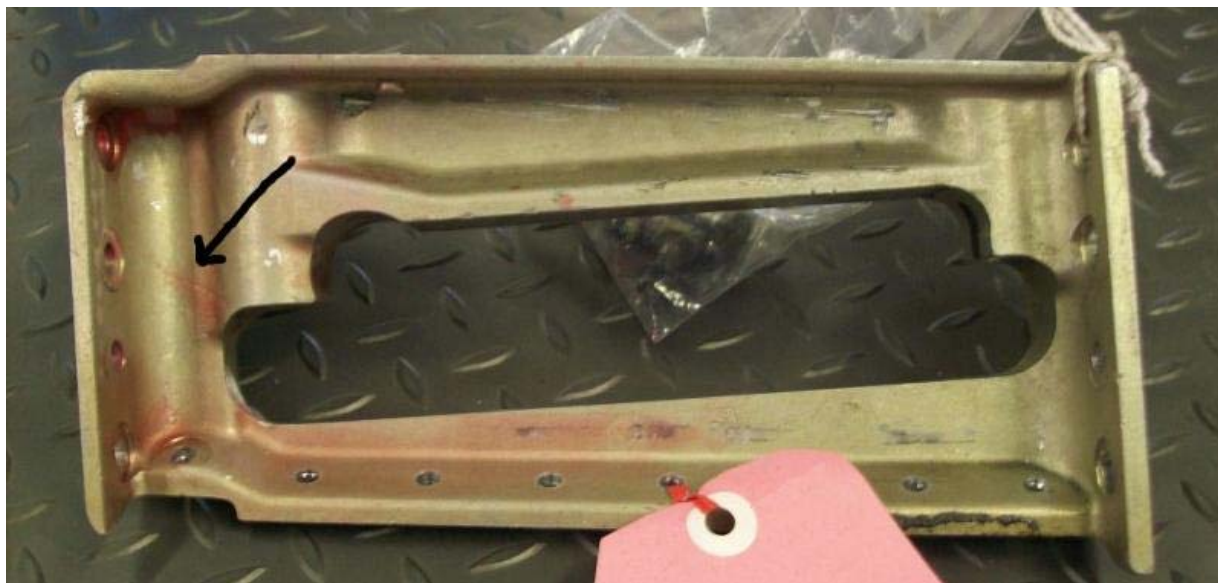
**Cessna: 182G; Cracked Main Landing Gear Attach Casting; ATA 5343**

A general aviation submission states, "A casting crack was found (*visually*) during the course of an Annual Inspection. The crack is located on the forward end of the support casting (*P/N 07416031*), (*starting*) 0.25 inches from the outboard mount holes and (*ends*) within 0.25 inches of the mount holes on the inboard side of the casting."

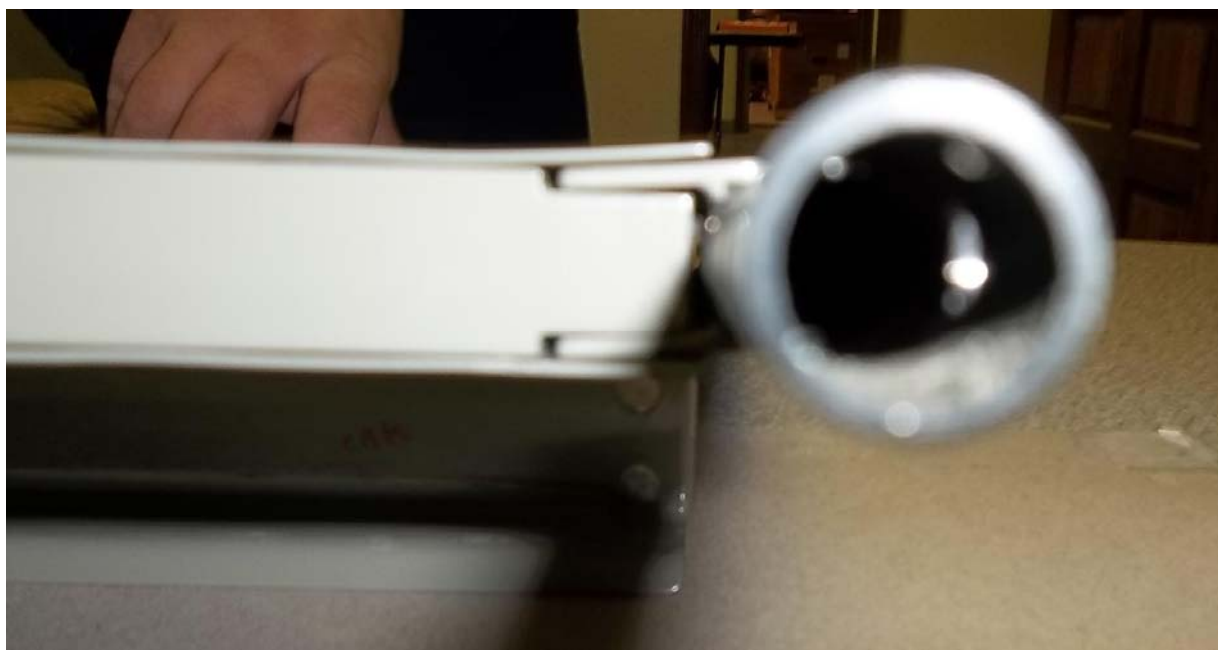
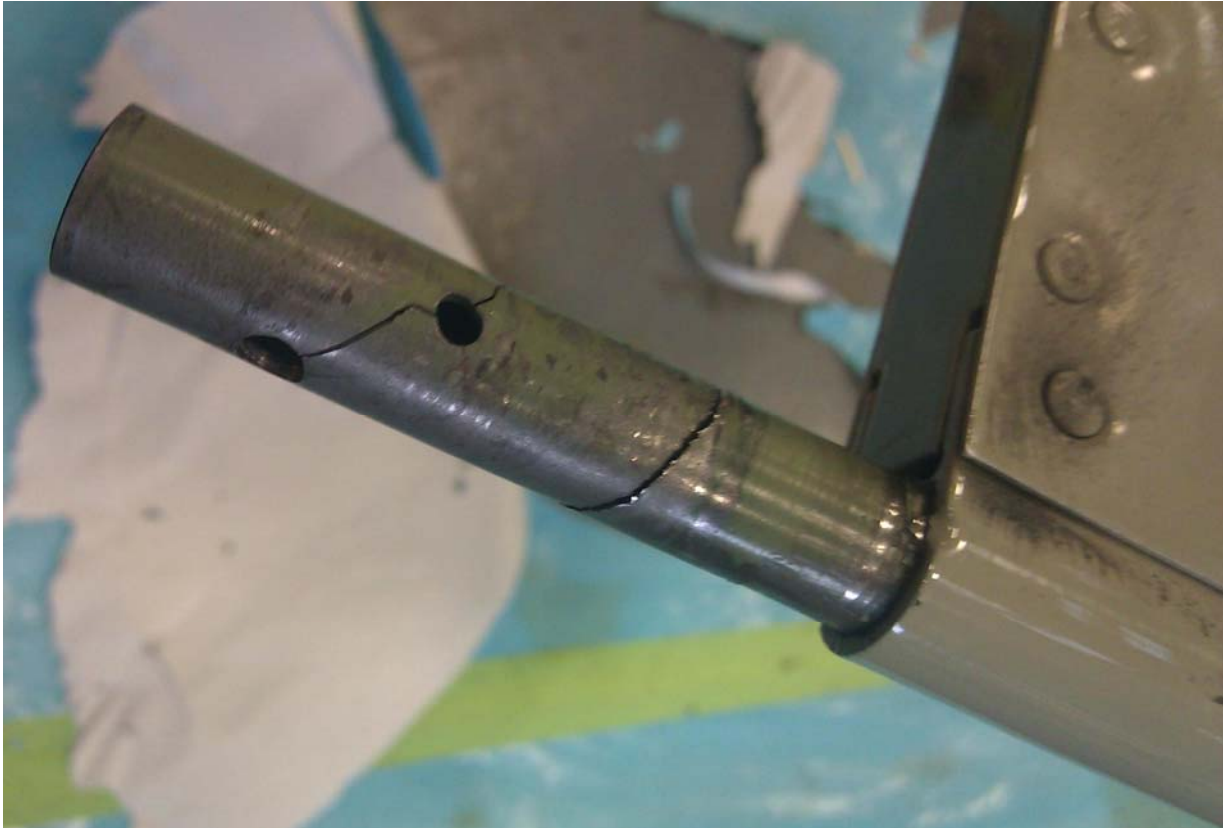
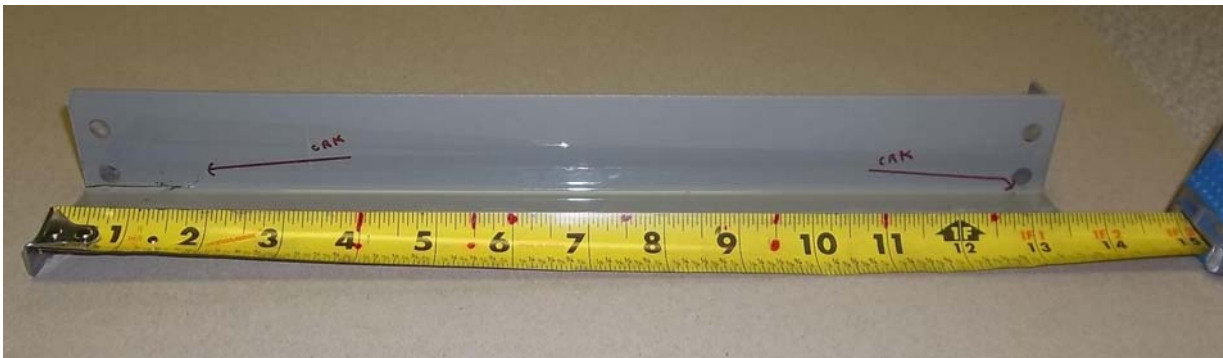
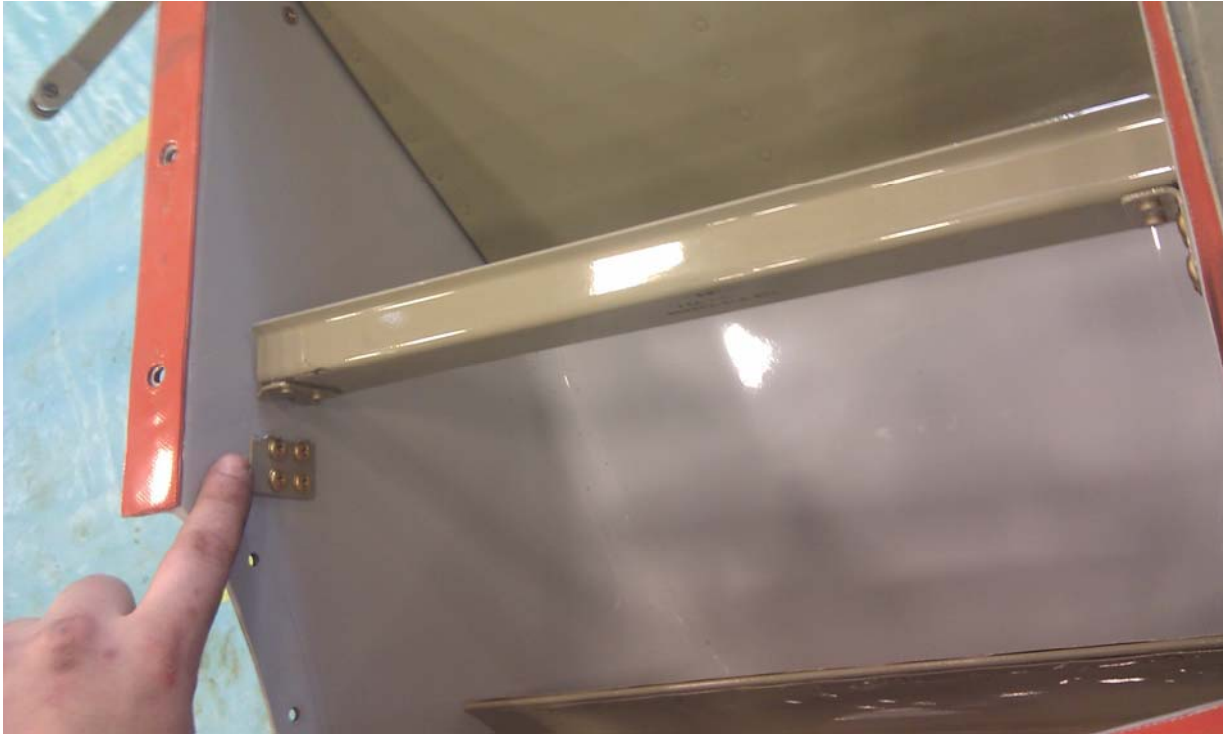
**Cessna: 208B; Cracked Inertial Vane Shaft; ATA 7160**

"Bypass door loose—will not close all the way," states this report from a Part 135 operator. "Upon investigation, (we) found the shaft cracked on the forward inertial vane assembly (P/N 200803511002). The mechanic also noticed the inlet splitter (P/N 200803511002) was cracked at *(its two ends, and one attach angle was broken)*." (Reader minder: *the italicized parenthetical expressions are my insertions—Ed.*)

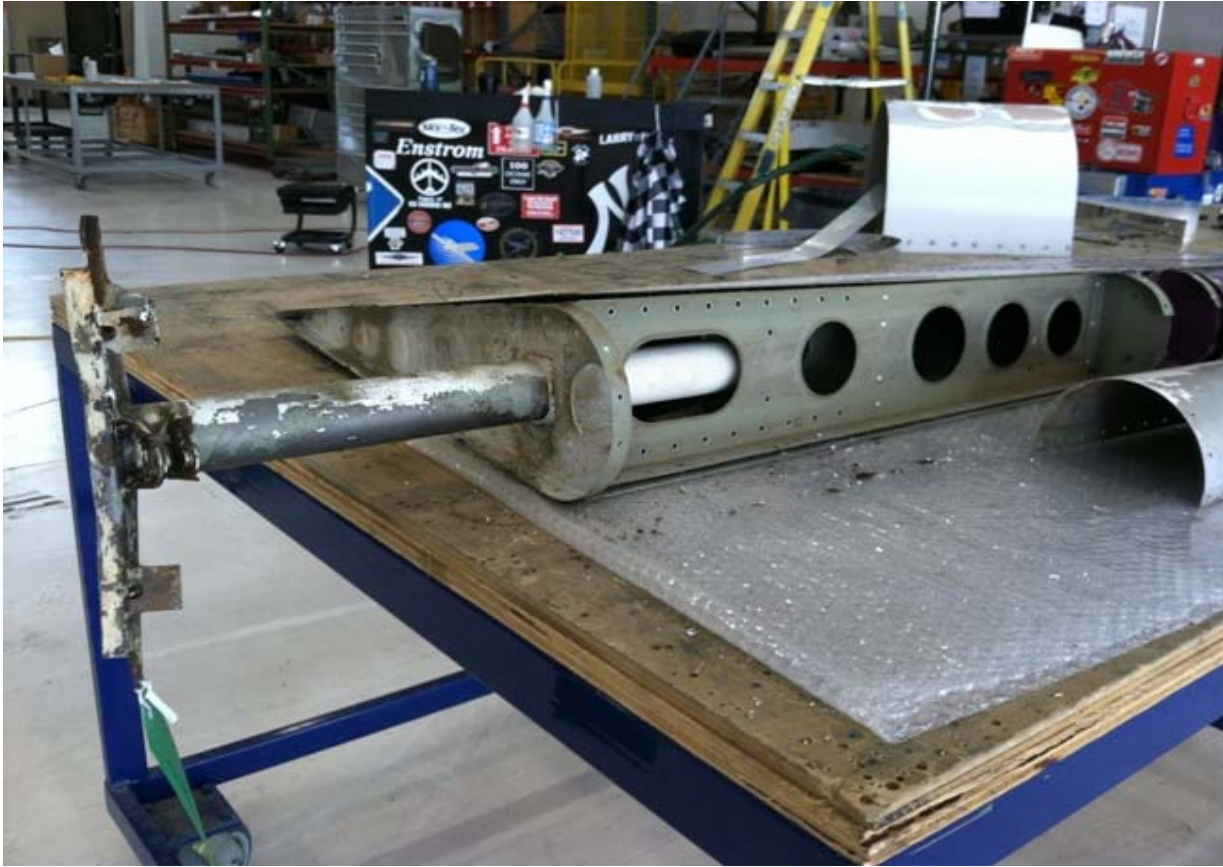
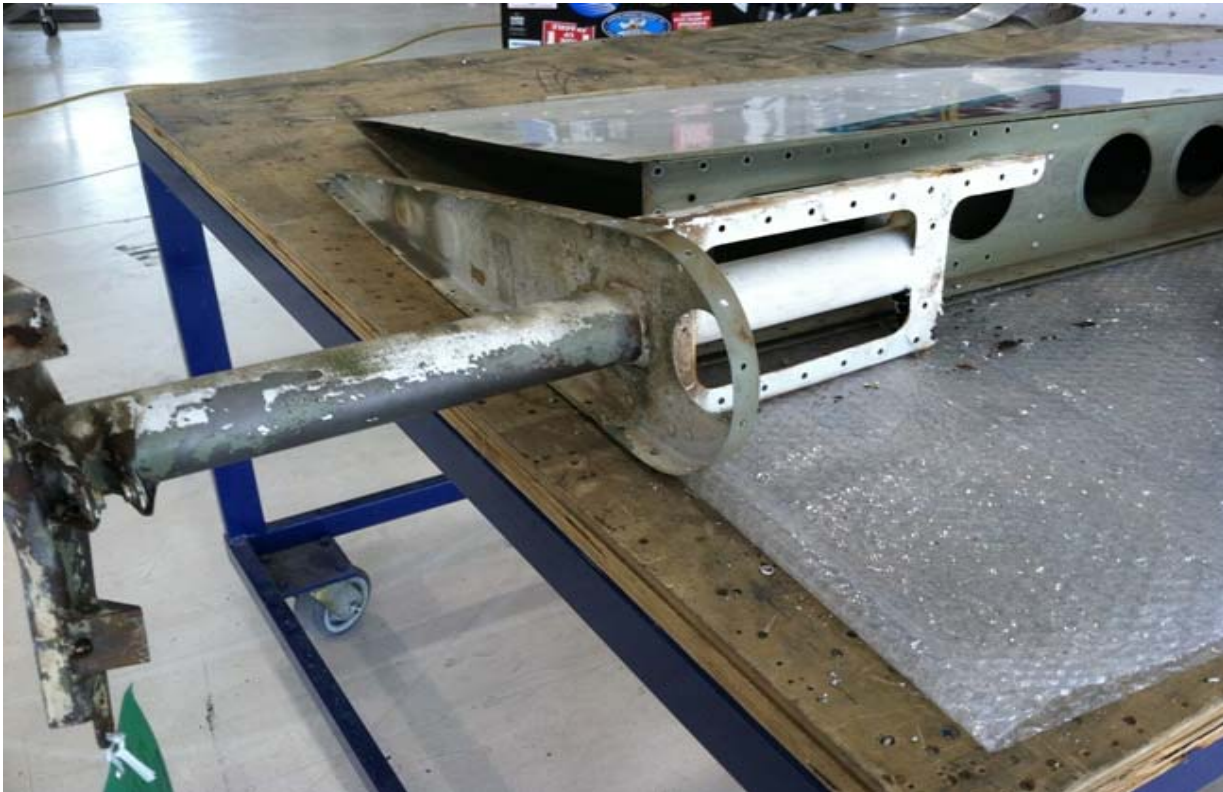
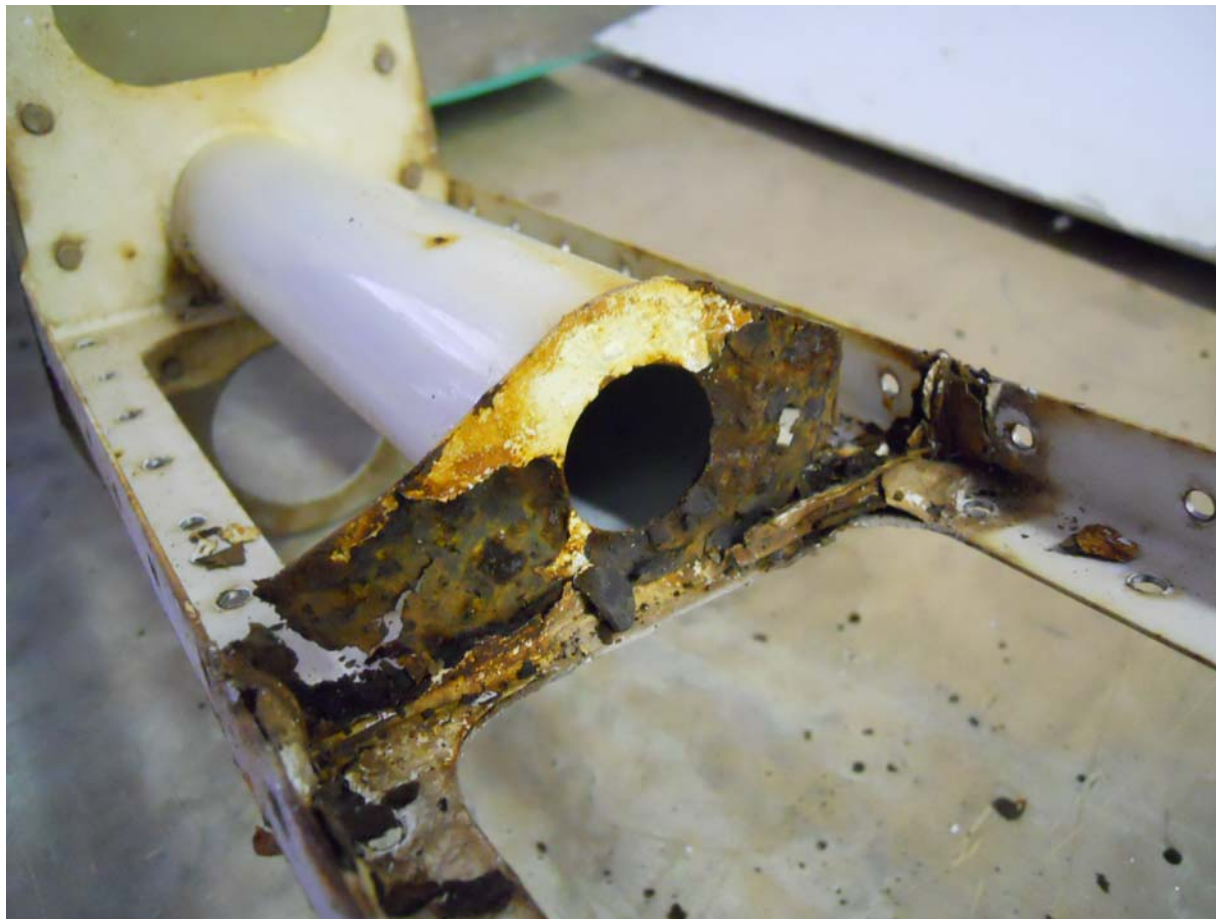
#### **Cessna: 208B; Rudder Torque Tube Corrosion; ATA 5540**

A repair station technician states, "This Hawaiian based aircraft arrived at our (*facility*) for maintenance. The rudder was removed from the aircraft, and its skin (*then removed*) to allow access to the rudder torque tube (P/N 263066-3). (*This torque tube...*) was scheduled to be replaced due to elongated holes in the bell crank. Severe corrosion was found on the upper part of the torque tube which is located under the skin—(*this area*) is not visible to any scheduled maintenance. The corrosion had reached the stage of 'blistered rust', and the 'L' angle on one side was easily separated with (*minor*) force (about 11 pounds; and wiggled twice)." "By design the rudder is not sealed on the top. The (*torque tube top attach*) bracket is located about a foot from the bottom—this cross member seems to pool water running down from inside the rudder (*even though*) there are drain holes in the design. Hawaii is listed as a 'moderate' corrosion environment.

"The operator had no way to inspect this location. A borescope would need to be used to (*even*) get an idea of the health of this part—(*but still*) it is better to remove and disassemble the (*rudder*). I would suggest a rudder inspection (*hole be designed and implemented*) so maintenance can easily inspect the torque tube for corrosion."

*(Okay—that IS UGLY! Ed.)*

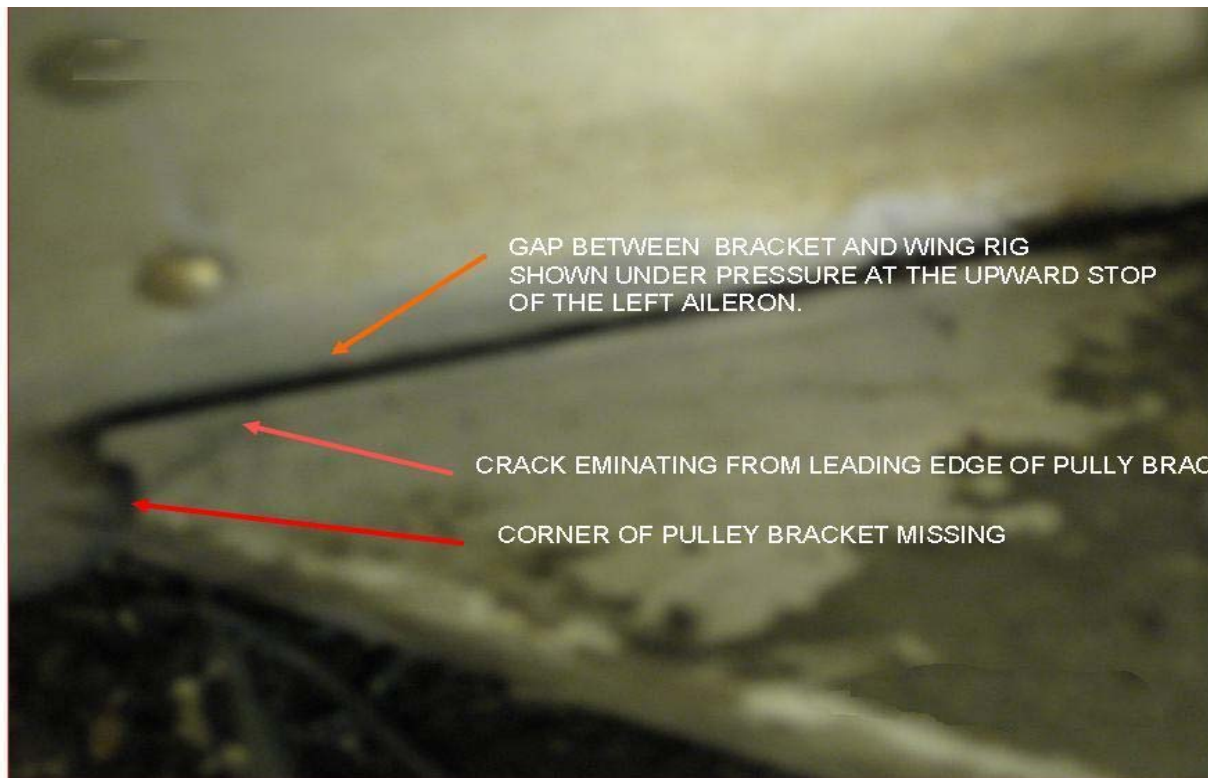
VIEW LOOKING INBD AT L/H WING LOWER AILERON PULLEY BRACKET ATTACHED TO THE L/H MAIN WING RIB. \* (NOTICE A PIECE OF THE BRACKET MISSING WITH GAP AT WING RIB). THE SEVERITY OF THE DEFECT WAS ACHIEVED BY ADDING UPWARD PRESSURE TO THE TRAVEL STOP WITH THE TRAILING EDGE OF AIRLERON.

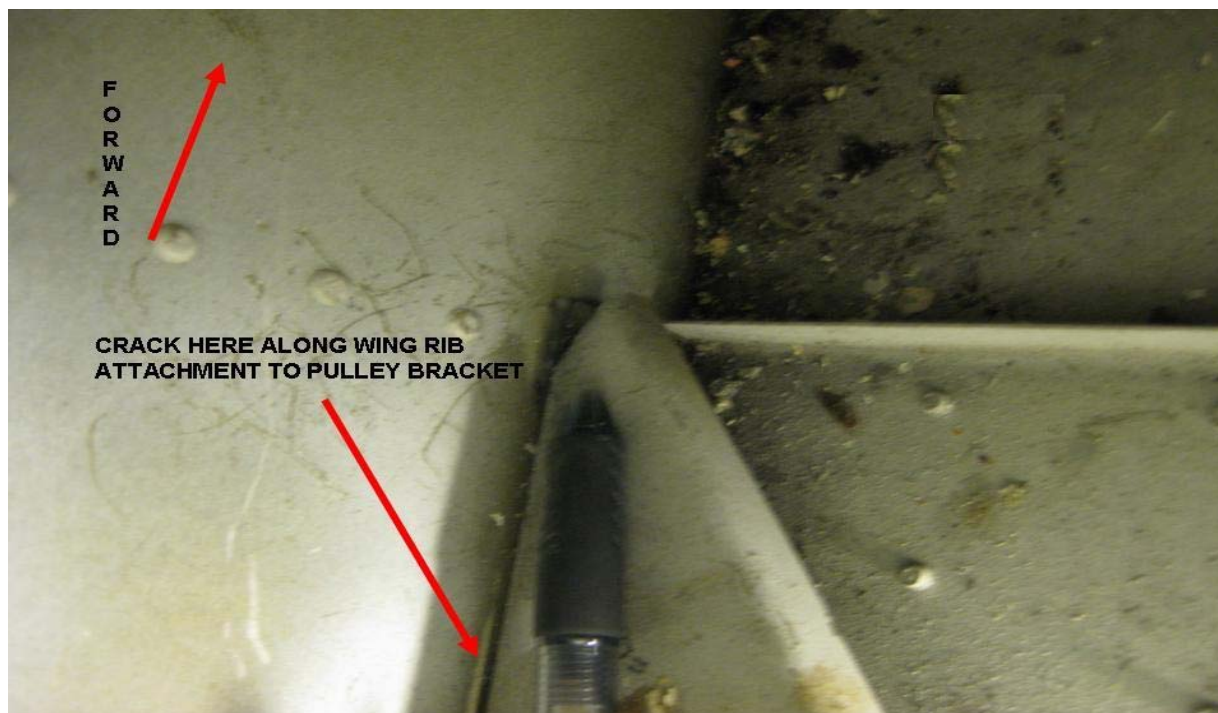
“VIEW LOOKING DOWN ON RIGHT HAND WING FORWARD CORNER OF LOWER PULLEY BRACKET”  
NOTE\*- THE CRACK WAS MORE EVIDENT WITH UPWARD PRESSURE ADDED TO THE TRAILING EDGE OF THE AIRLERON.

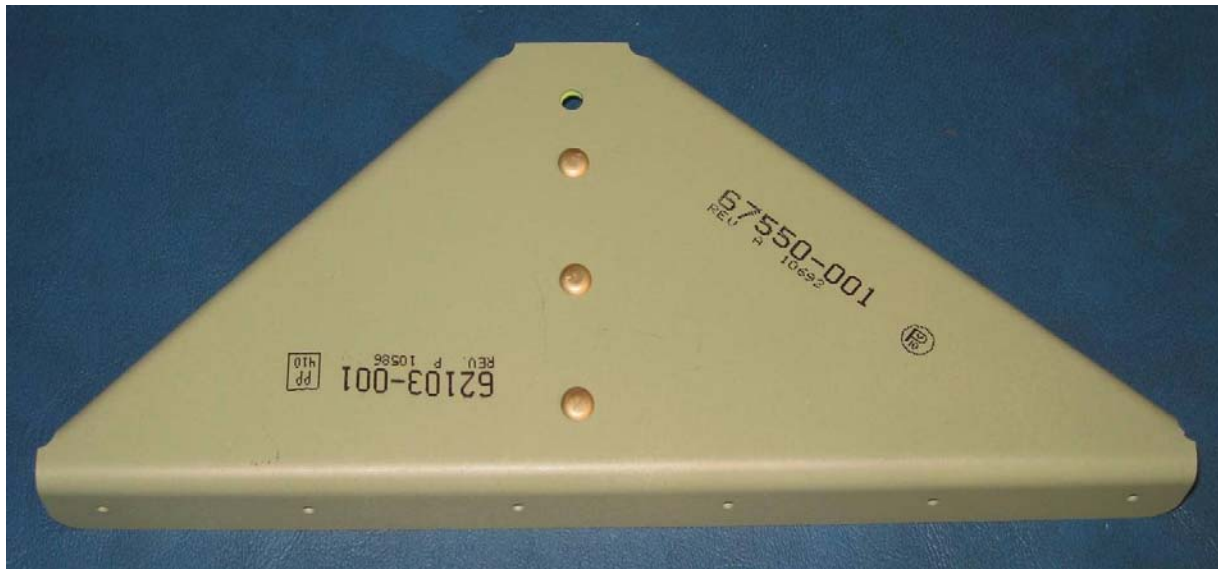
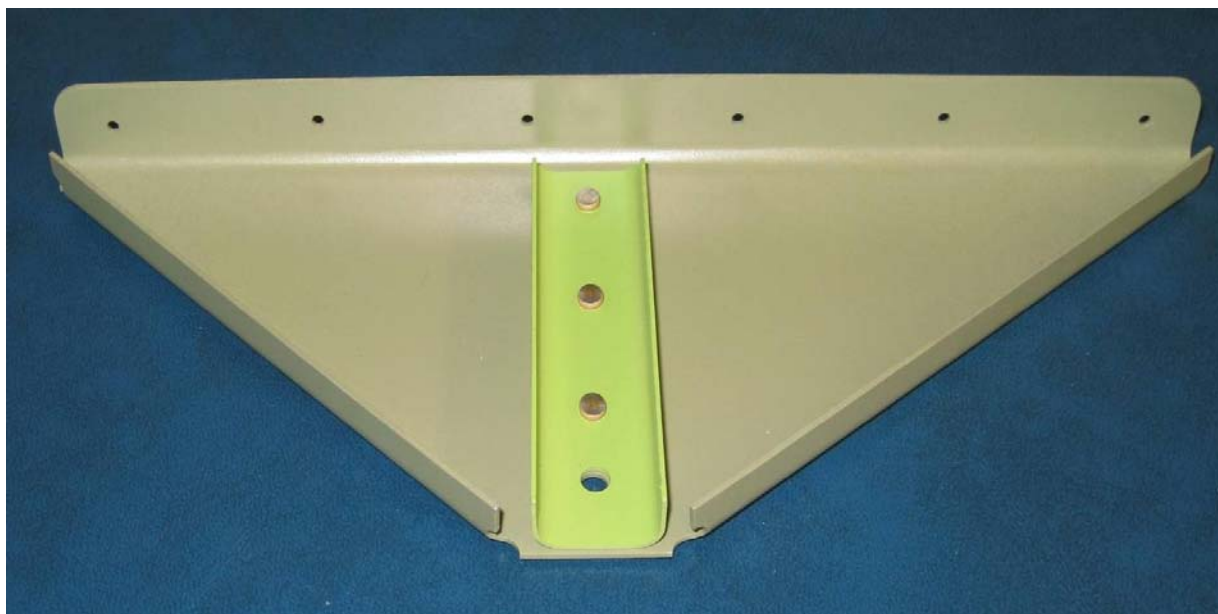
**Piper: PA28R200; Cracked Aileron Pulley Brackets; ATA 2710**

A General Aviation submission states, "During an Annual Inspection, both the L/H and R/H lower support aileron pulley brackets were *(found)* cracked in the forward inboard radius mount *(flange)* at each wing rib. A piece of one of these pulley brackets was detached." *(Pulley bracket P/N: 67550000.)*

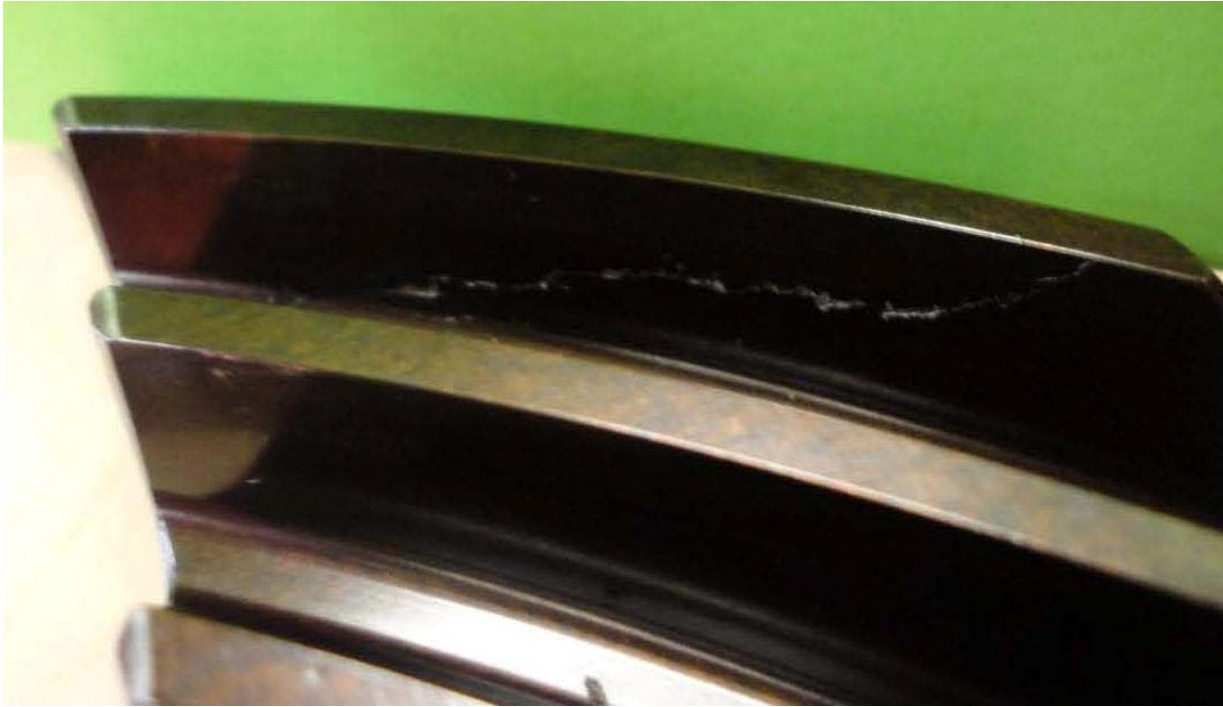
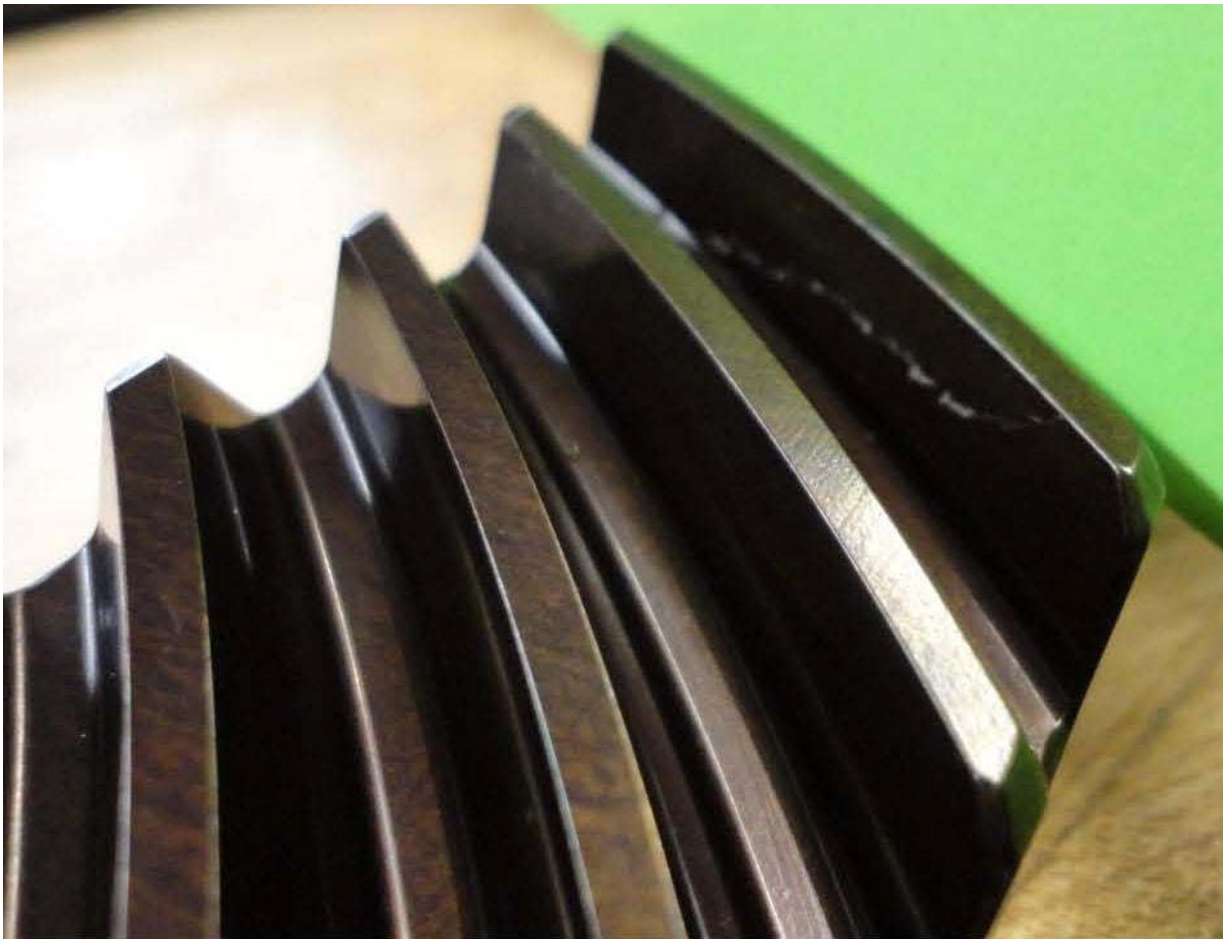
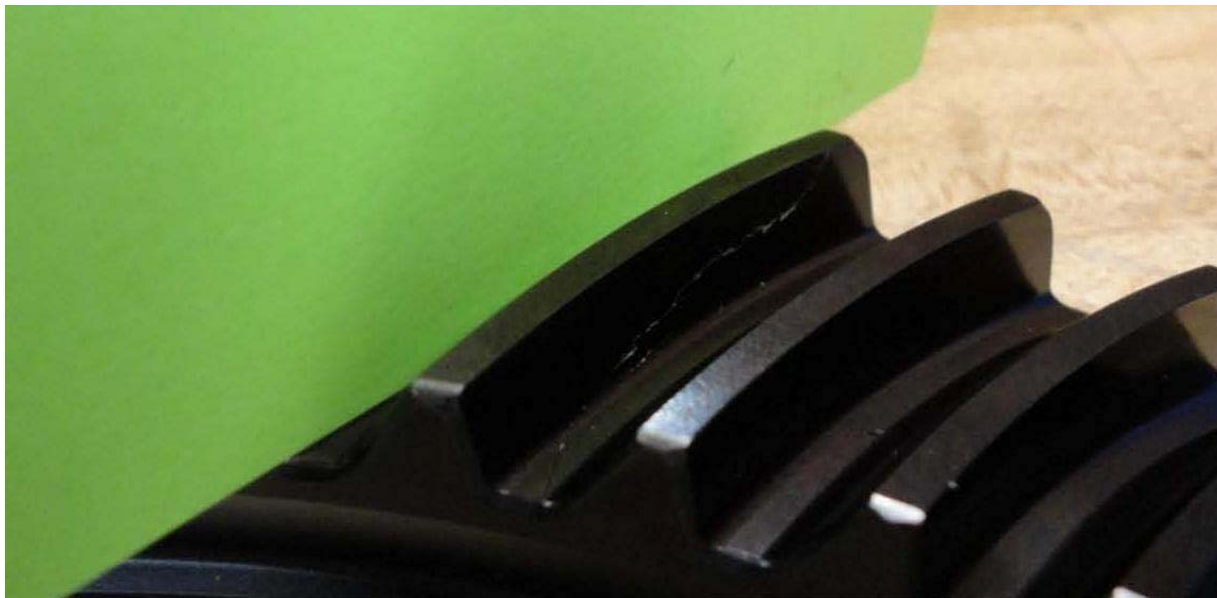
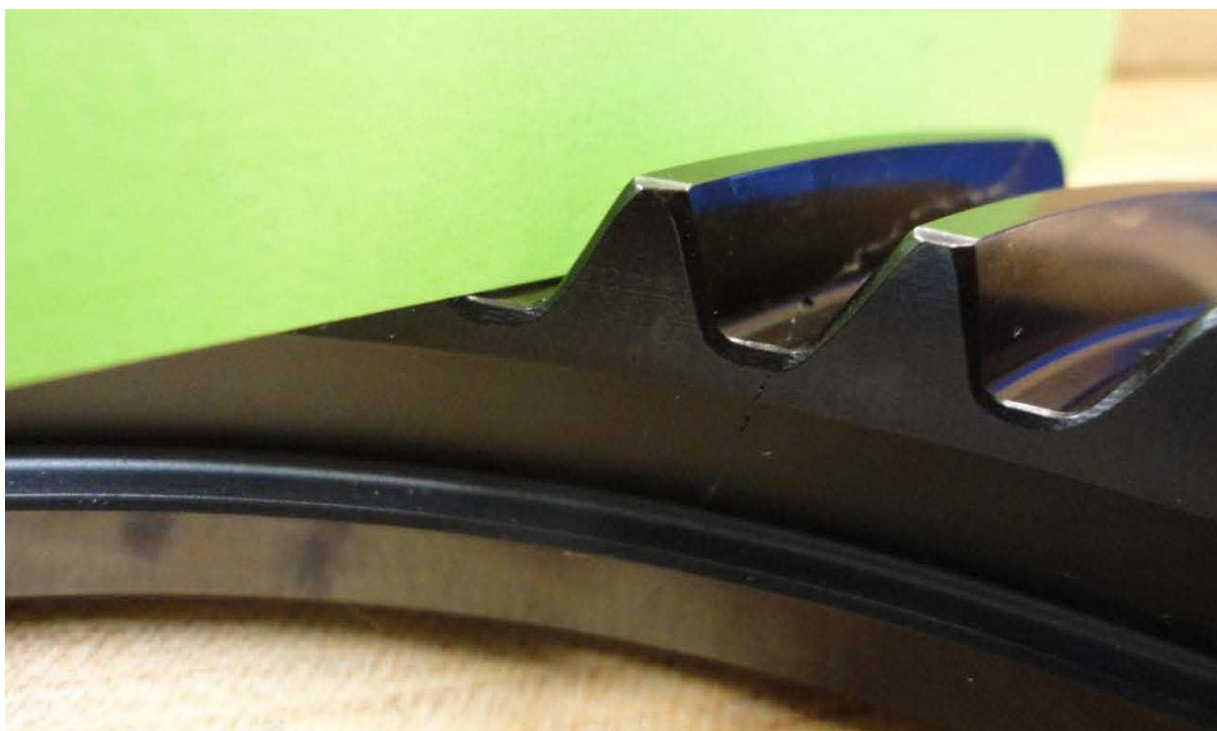
**Agusta: A119; Cracked Gleason Crown Gear; ATA 6320**

A quality control supervisor for this repair facility says, "During a 4800 hour overhaul inspection, the Gleason Crown gear was found to have a crack."

*(Gleason Crown gear P/N: 109040307103; Main Gear Box component P/N: 109040005103. A second such gear report is found in the SDRS database. Thanks for the photos—Ed.)*

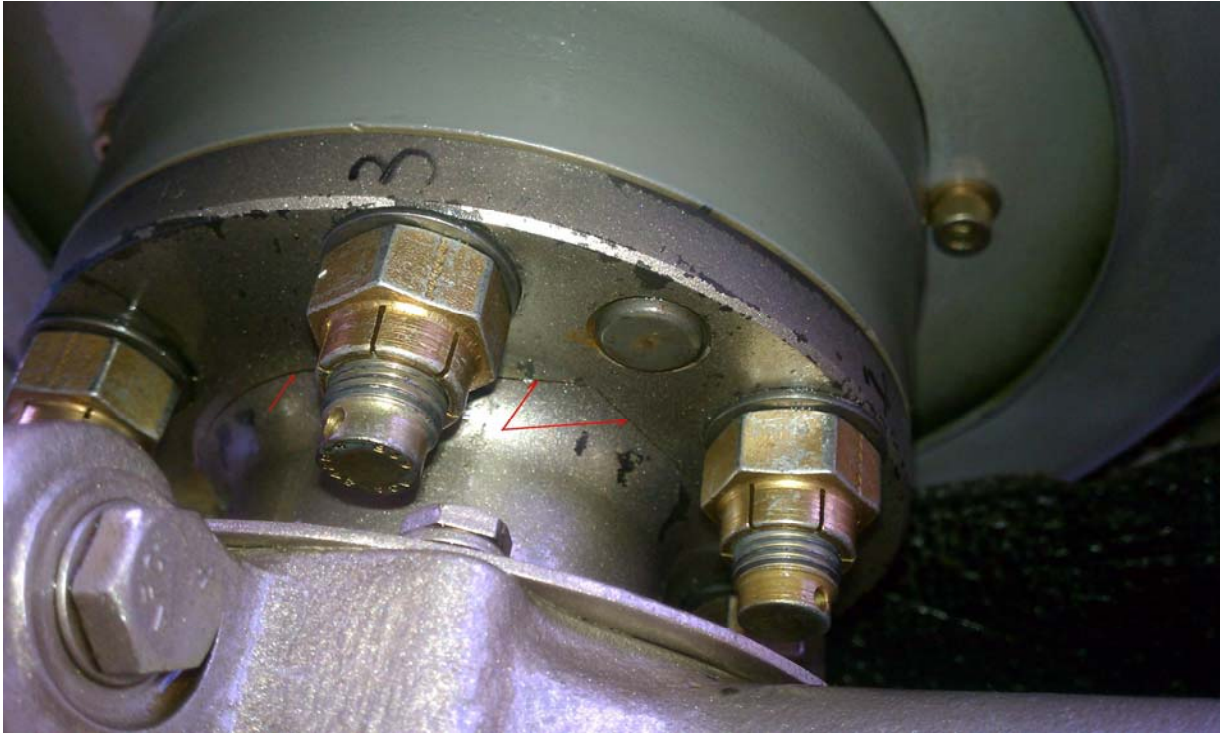
### Continental: IO520C; Cracked Crankshaft; ATA 8520

"The crankshaft cracked in the propeller flange at the radius," writes a technician. "The crack (*appeared*) in a 'V' shape. On one side the (*crack*) line was about four inches long, and the other about three inches." (*Crankshaft P/N: 649859.*)

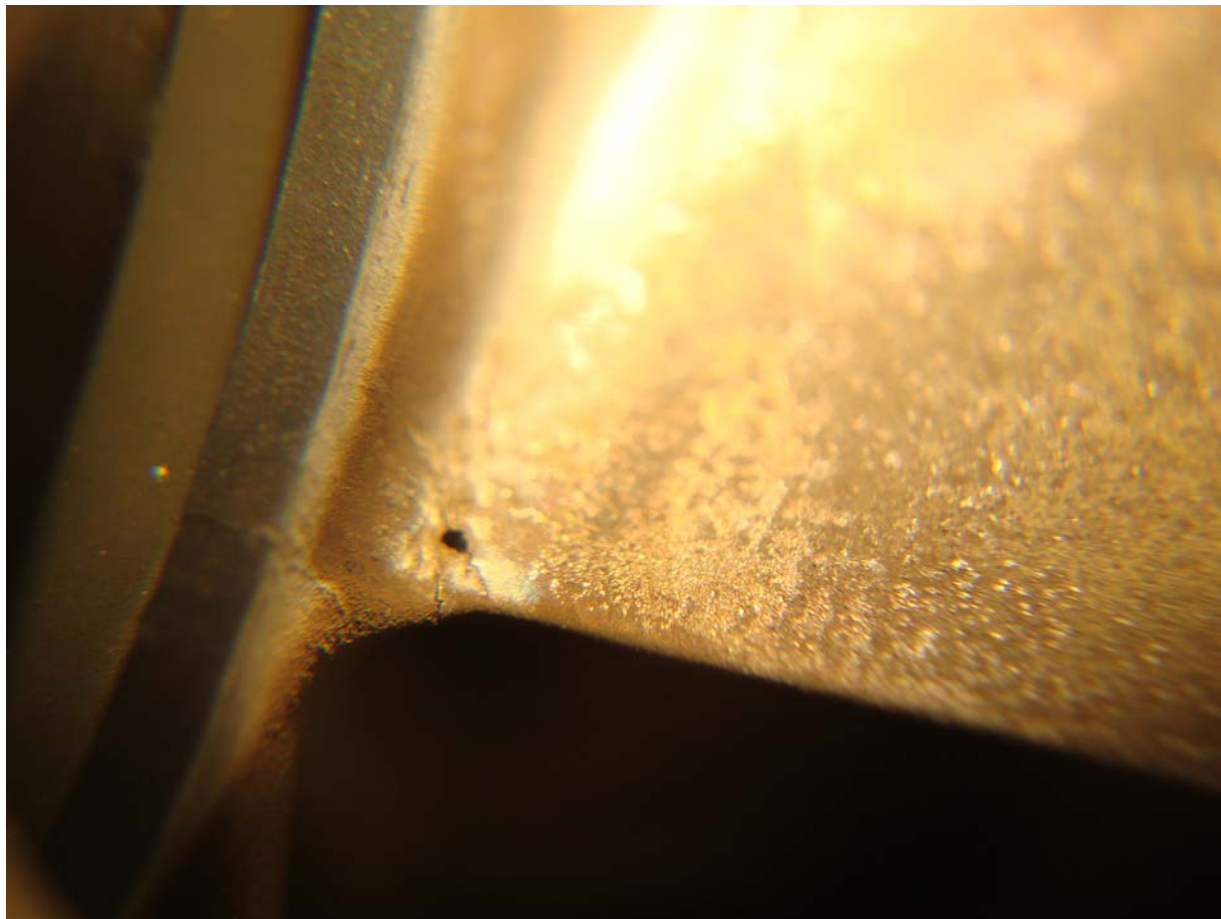
### Turbomeca: Arriel 2B1; Cracked Turbine Guide Vane; ATA 7250

An AS350B3 helicopter operator writes, "While disassembling the engine to perform modification TU166, (*I*) found the power turbine nozzle guide vane cracked (*P/N 0292517060*). The 'Module 3' (*P/N 70BM032020*) must be returned to the manufacturer for repair."

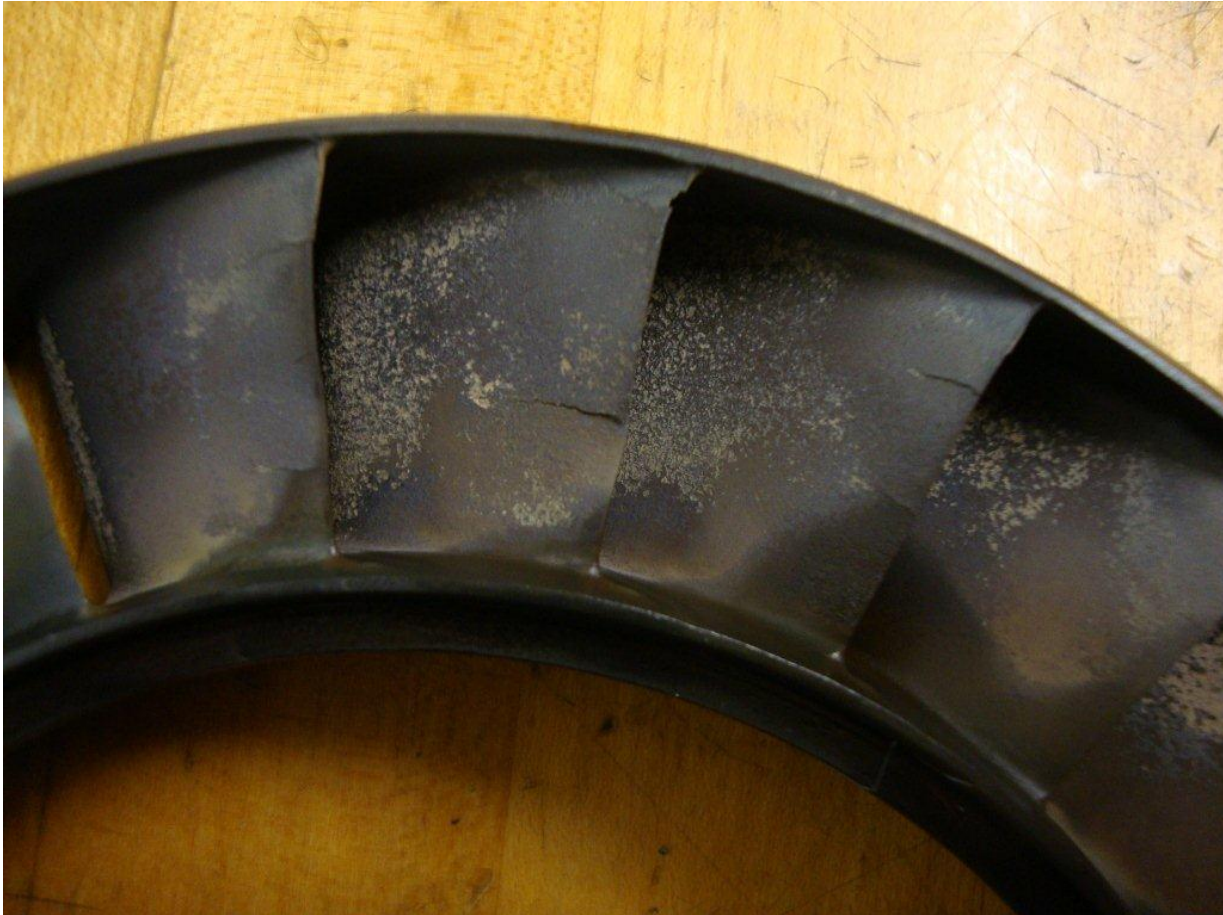
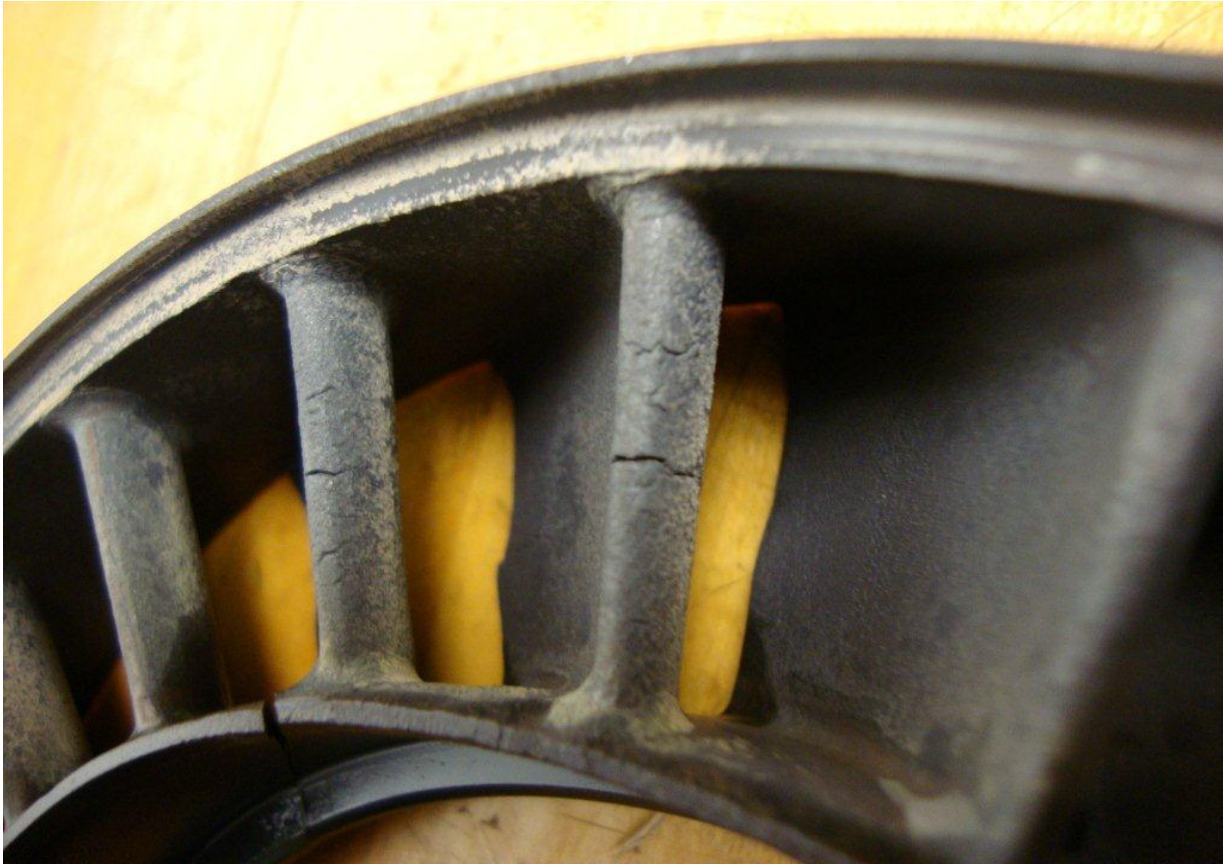
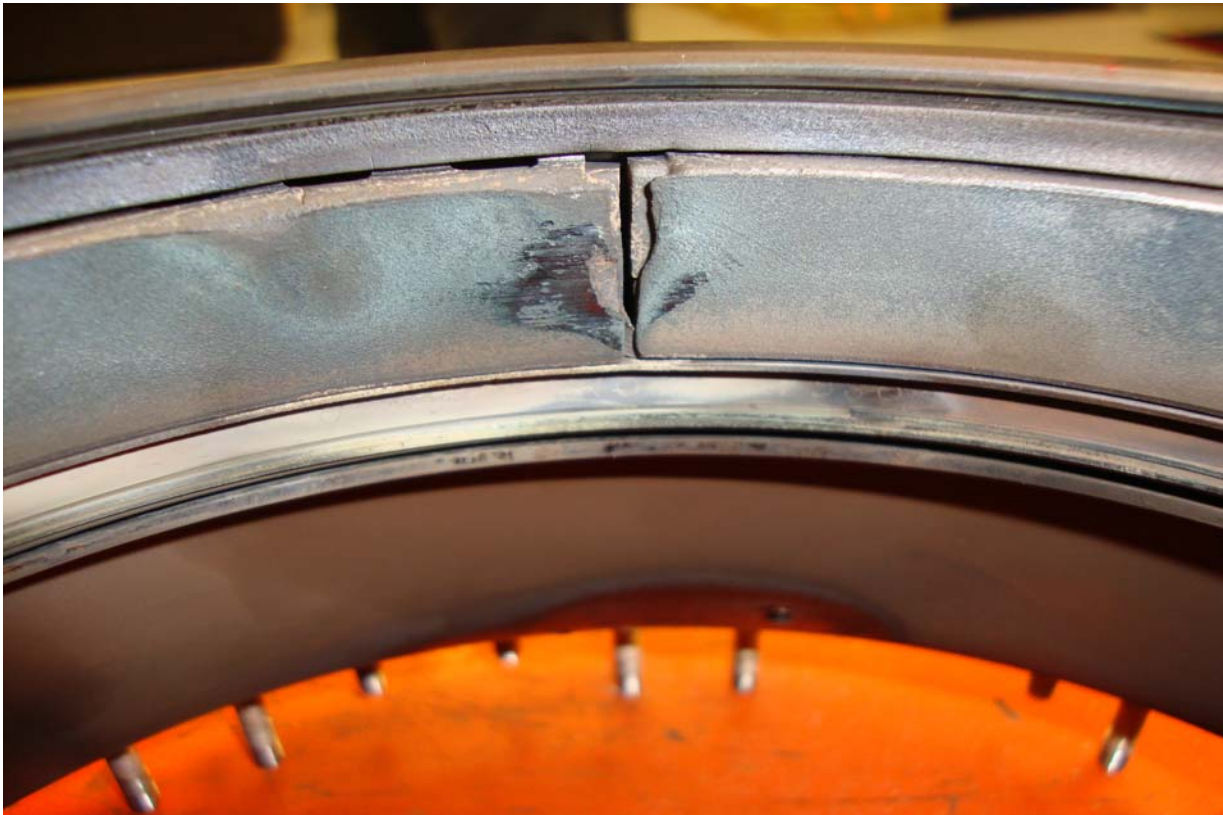
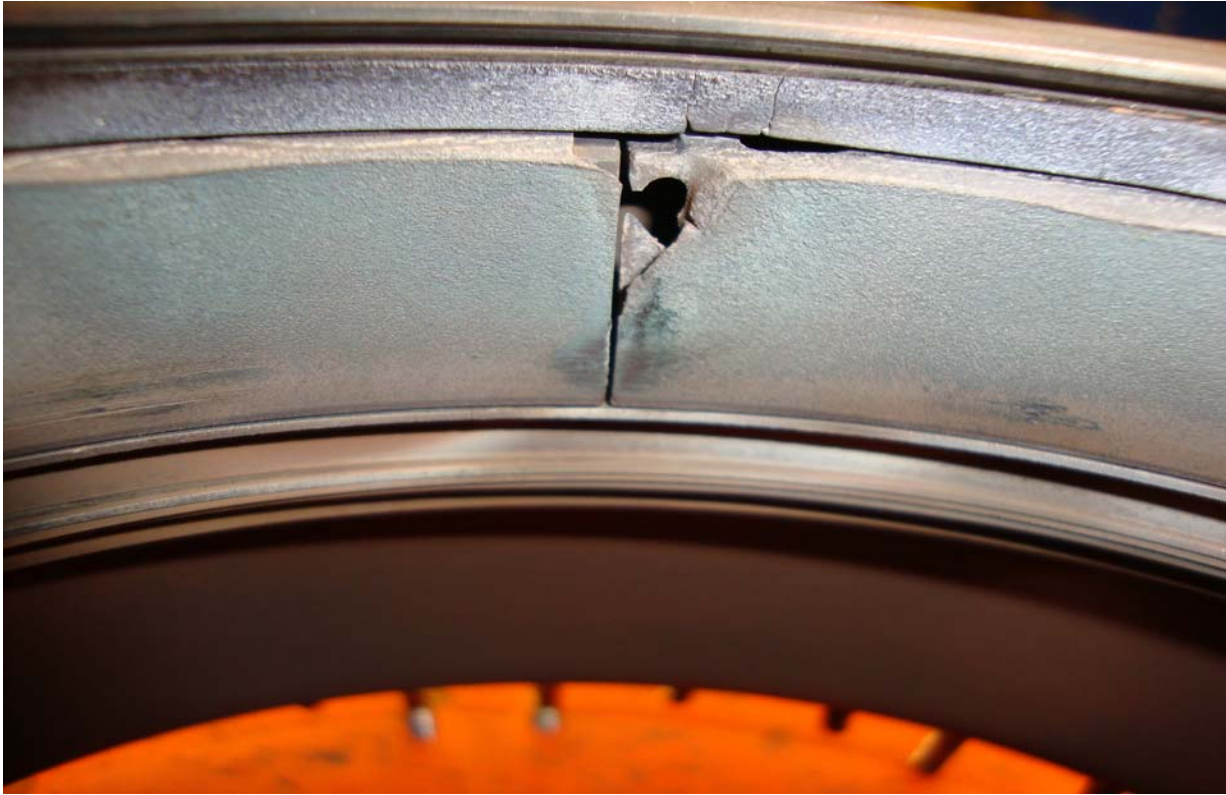
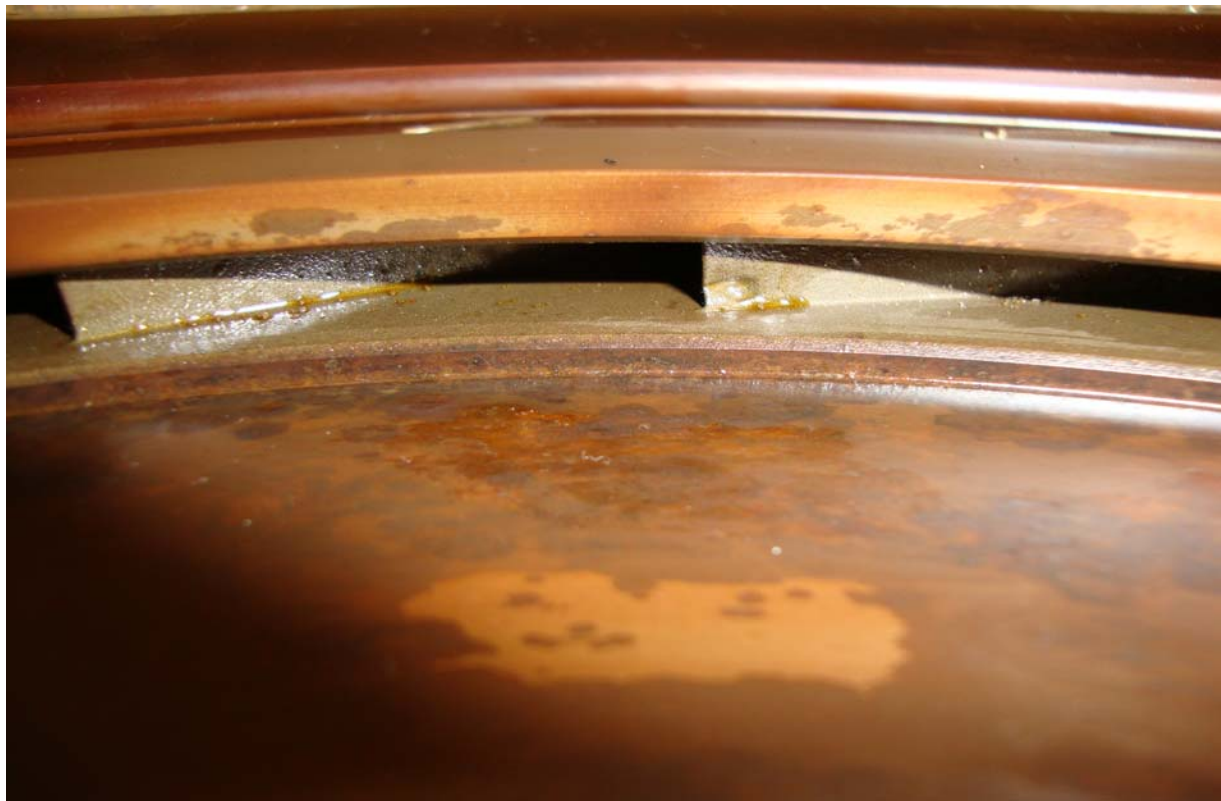
**Turbomeca: Arrius 2B2; Cracked Guide Vane(s); ATA 7250**

A technician for a corporate operation says, "While performing disassembly of this engine for a rear bearing oil pipe leak, (I) found damage to the following components, including: a PT nozzle guide vane cracked (HP segment, assembly P/N 0319217910); an HP nozzle guide vane cracked (P/N 0319218310); the flame tube cracked (P/N 031917850); Diffuser with FOD (P/N 0319210050; and the T-4 harness broken. All of these parts are being replaced." (Additional listed parts: Module 2 P/N: 70EM027070 with cracked guide vane P/N 1319411580.)
