43-16A

# AVIATION MAINTENANCE ALERTS

**ALERT  
NUMBER  
406**

**MAY  
2012**

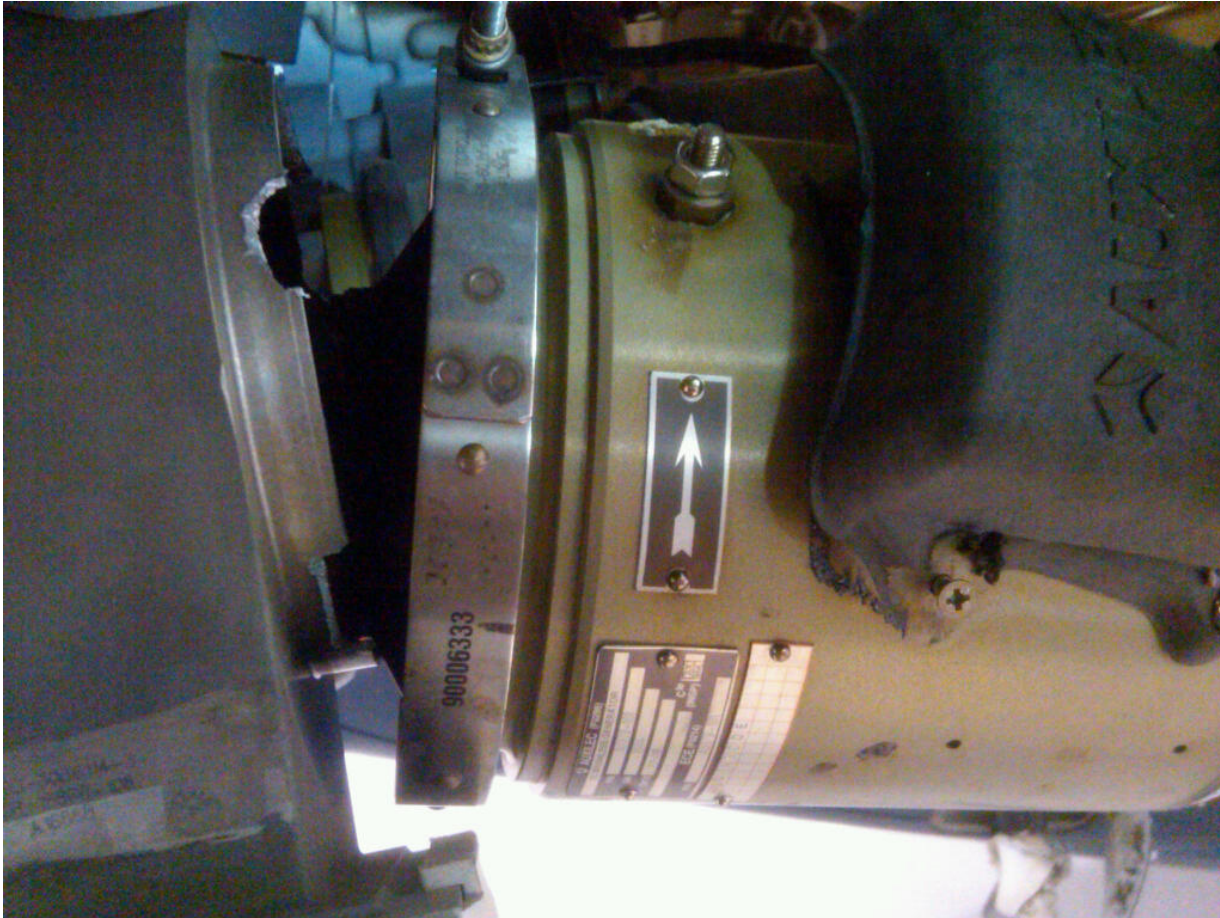
**Auxilec Generator: (P/N) A3579101; Failed Bearing; ATA 2434**

*(This report references a Bombardier BD1001-A10 aircraft with Honeywell AS90711A engines.)*

A technician for a corporate operation says, "The generator rear bearing (opposite drive shaft) failed on the right engine. *(Its)* mounting pad sheared and the generator split apart. The crew received a 'Generator Fail' CAS (*Crew Alerting System*) message." *There are six of these P/Ns in the SDRS database.*

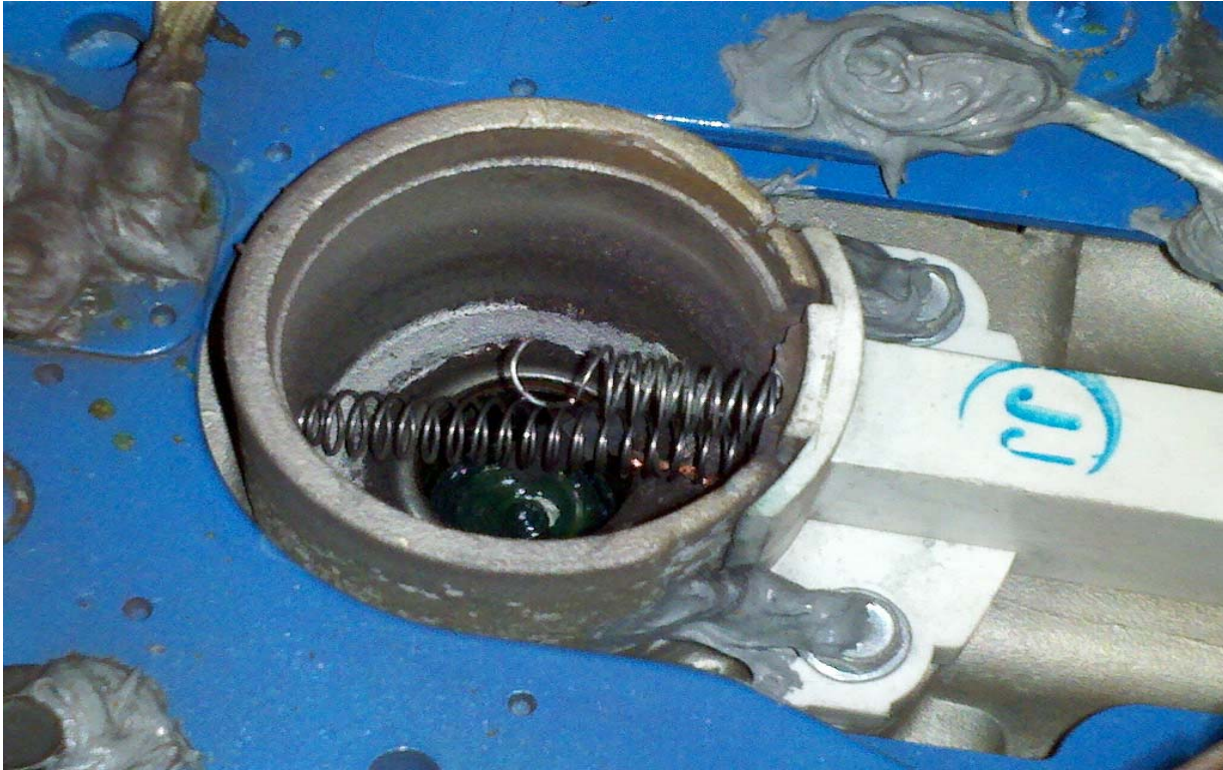
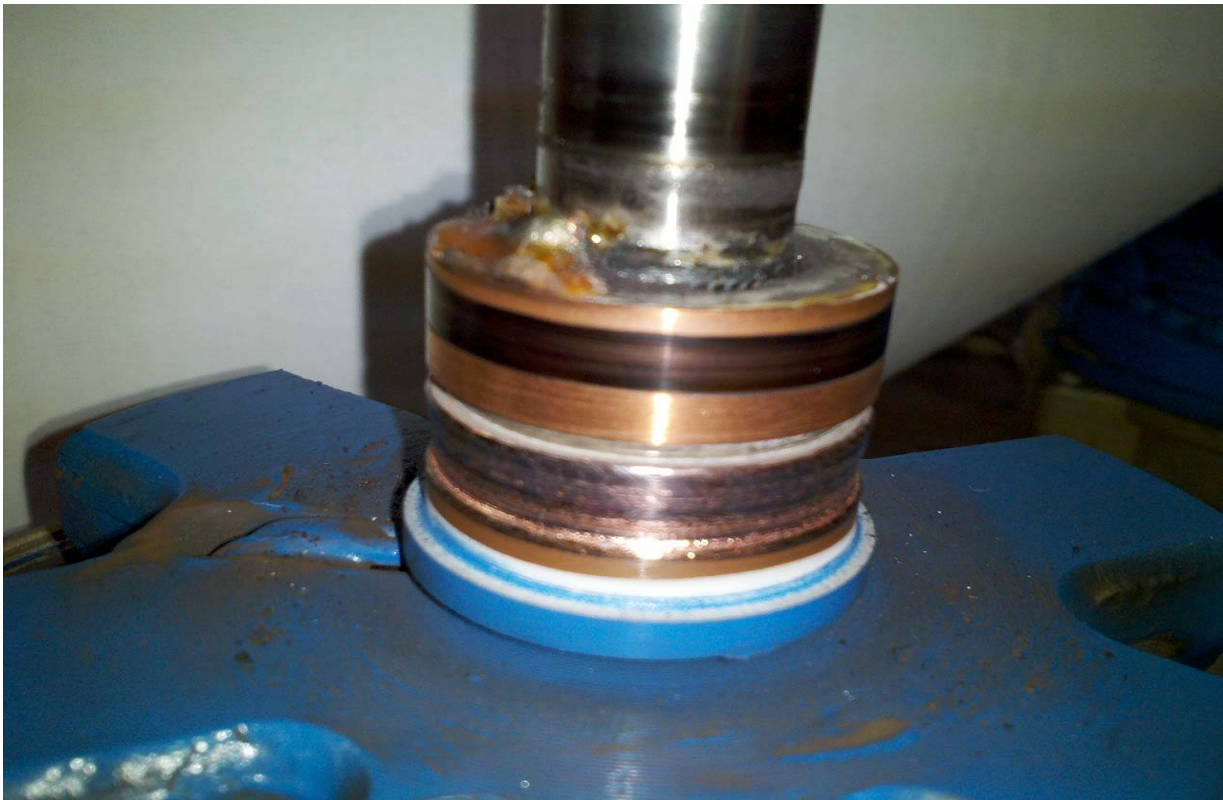
**Cessna Alternator: (P/N) 99105923; Brush Failure; ATA 2434**

"The alternator field circuit breaker tripped intermittently over the last 25 hours, (*causing*) various instances of radio noise," states this mechanic. "The alternator remained functional. (*I*) suspected possible brush failure, and elected to replace the alternator during an Annual Inspection.

"The alternator was disassembled—found the ground brush (*to be*) 0.375 inches long. The field brush was completely disintegrated, with the spring contacting the slip ring. This alternator is only available from the manufacturer. There are no known third party overhaul facilities. The aircraft manufacturer service documents provide no service or parts data. There are no aircraft manufacturer inspection protocols beyond external security checks. Brush and/or slip ring inspection can only be accomplished by disassembly of the case.

"I suggest a re-design to permit proper periodic inspection the brushes, make service and overhaul data available, and/or improve quality. Neither 'operation to failure' or 'periodic mandatory alternator replacement' is (*acceptable*)."
