**Federal Aviation
Administration**

ADVISORY CIRCULAR

AVIATION MAINTENANCE ALERTS

**ALERT
NUMBER
410**

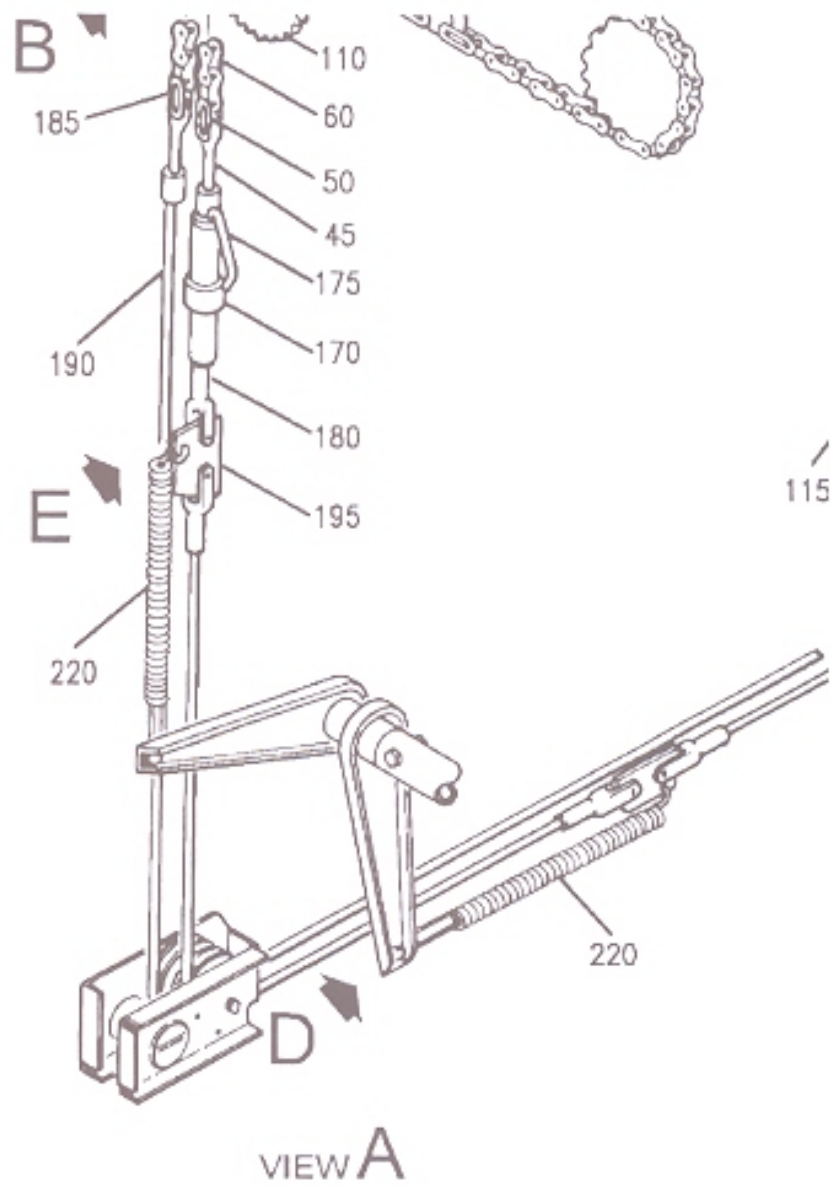
Beech: A36; Broken Aileron/Rudder Spring; ATA 2720

A technician working a corporate aircraft states, "During flight, the pilot noticed the aileron control was pulling to the right. The aircraft returned to base without incident. Upon inspection of the aileron control system, the upper aileron/rudder interconnect spring (P/N 35-5524664) was found broken at the end of the bell crank arm (P/N 002-524018-25). The probable cause for this failure is time in service."

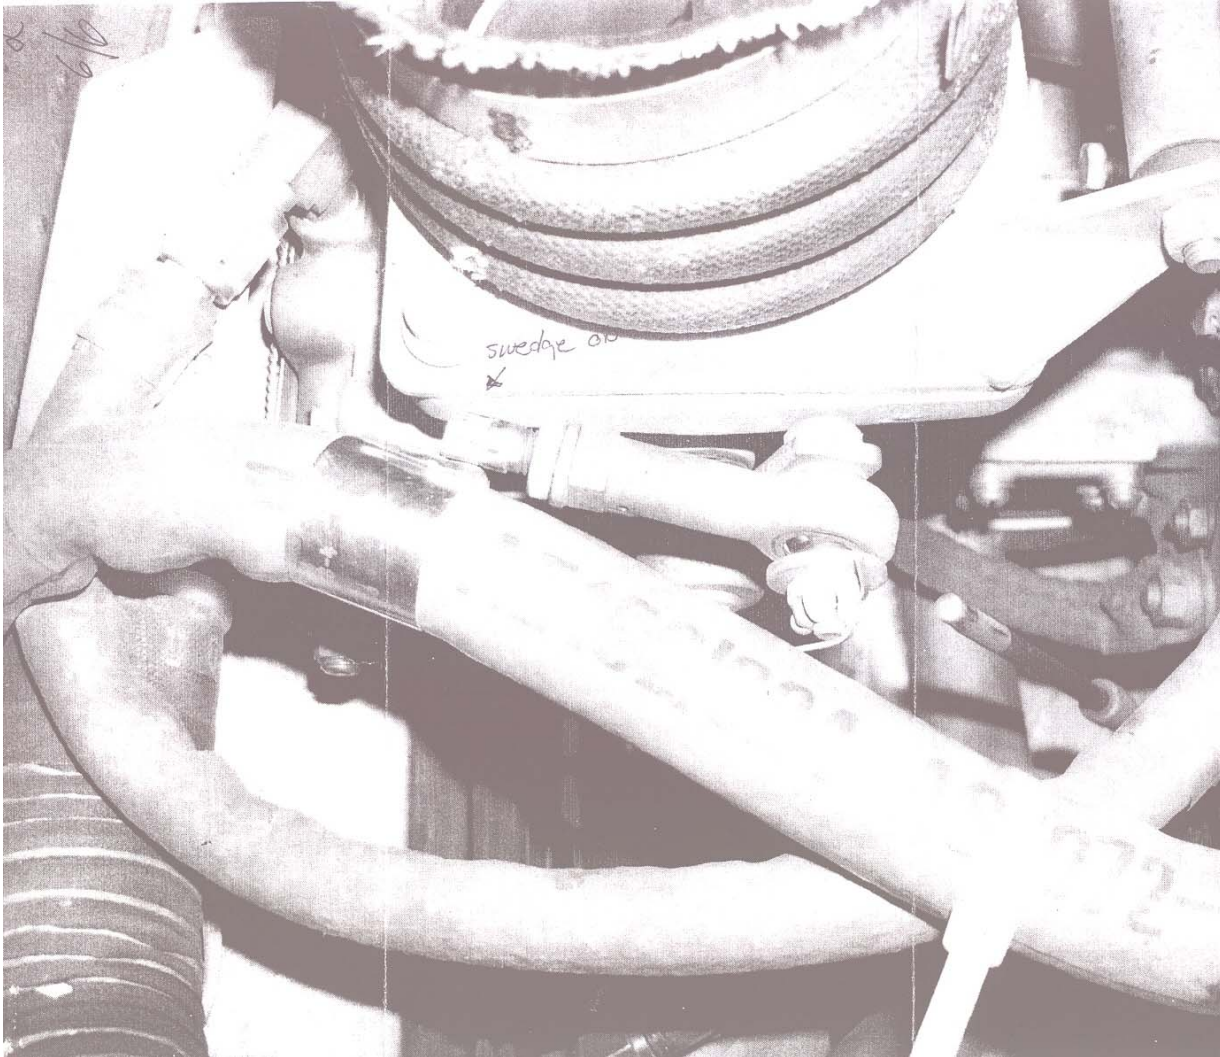
Beech: 58; Failed Throttle Control Rod; ATA 7603

"The throttle control (*rod*) end—threaded for a rod-end—came off the control (*rod*)," says this submitter. "It appears to have been swaged on to the end of the (*now separated*) control (*rod*)." (P/N: 1023890103. Are you saying this rod end was—or was not suppose to have been swaged in the first place? Ed.)

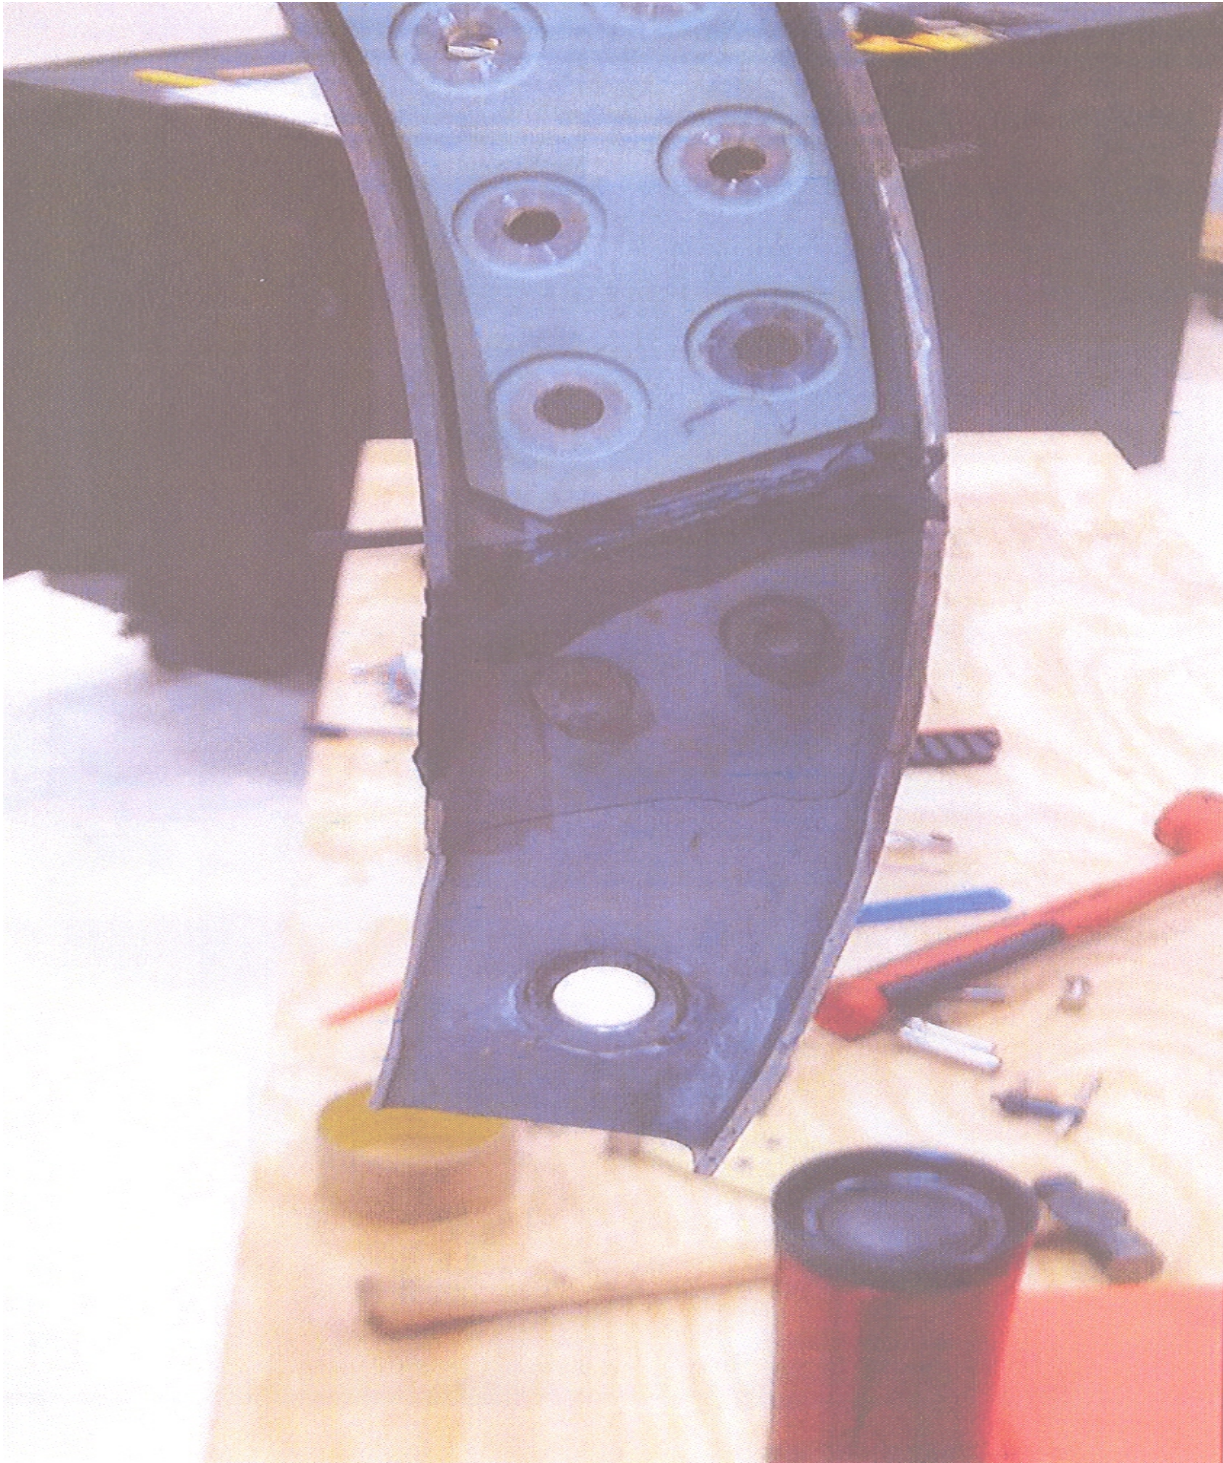
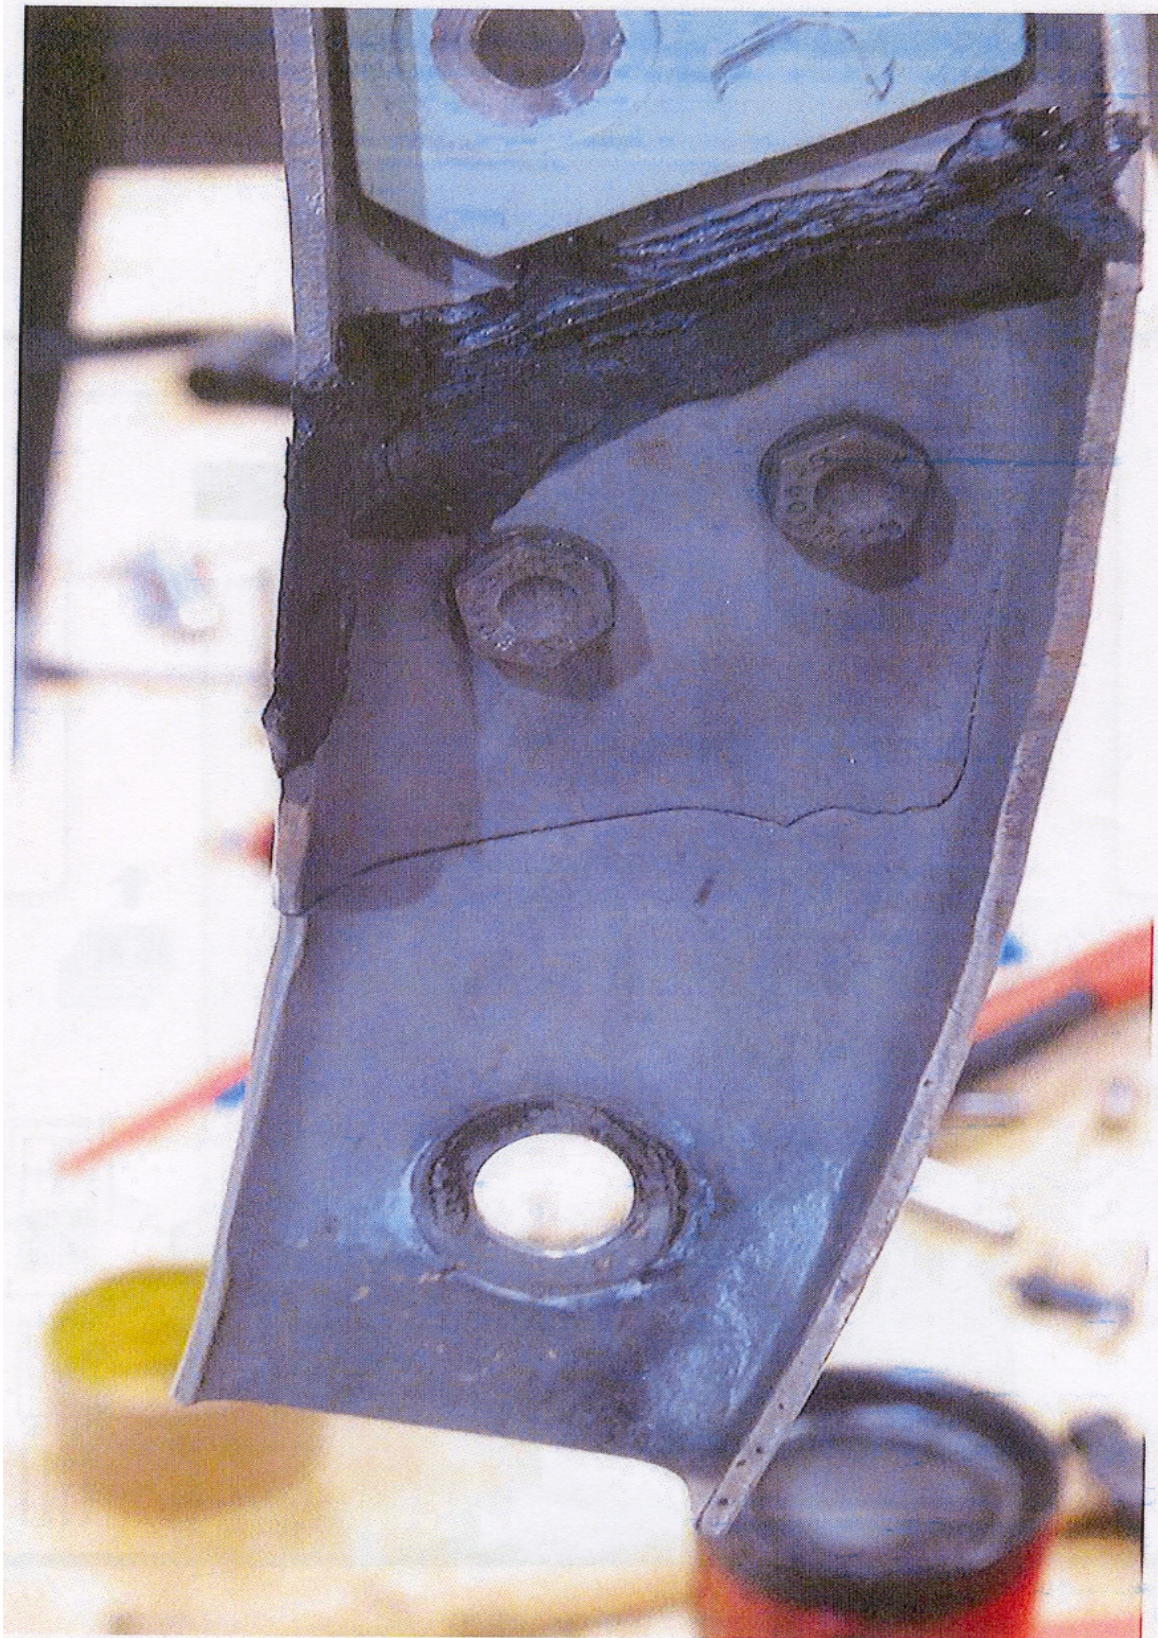
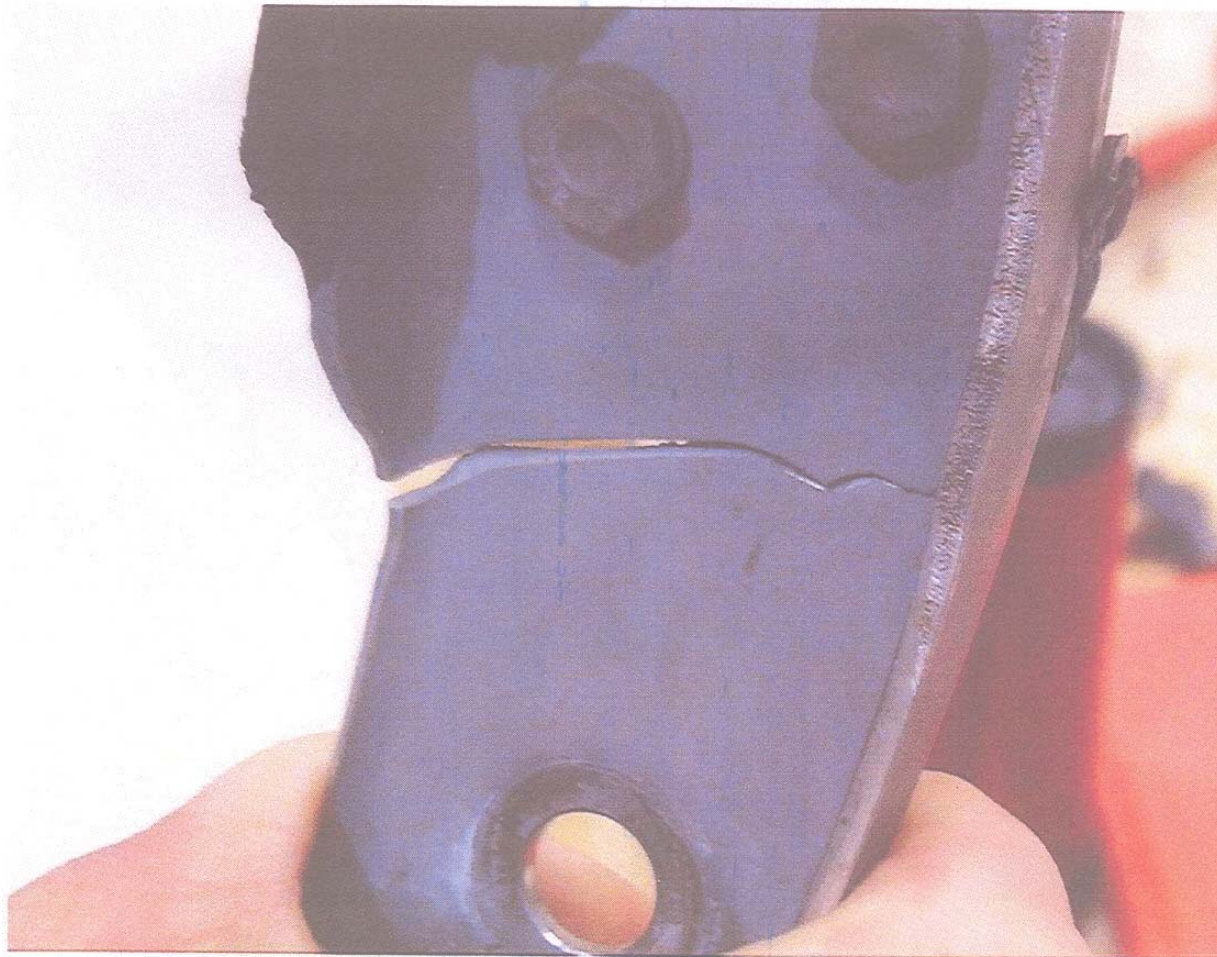
Beech: 400A; Cracked Engine Mount; ATA7120

A mechanic says, "During the removal of the L/H engine, the engine mount (*was found*) to have a large crack."

(The first two photos have been artistically "forced" to fit the page. Engine mount P/N: 45A34361005. There are at least eight such records in the SDRS database.)

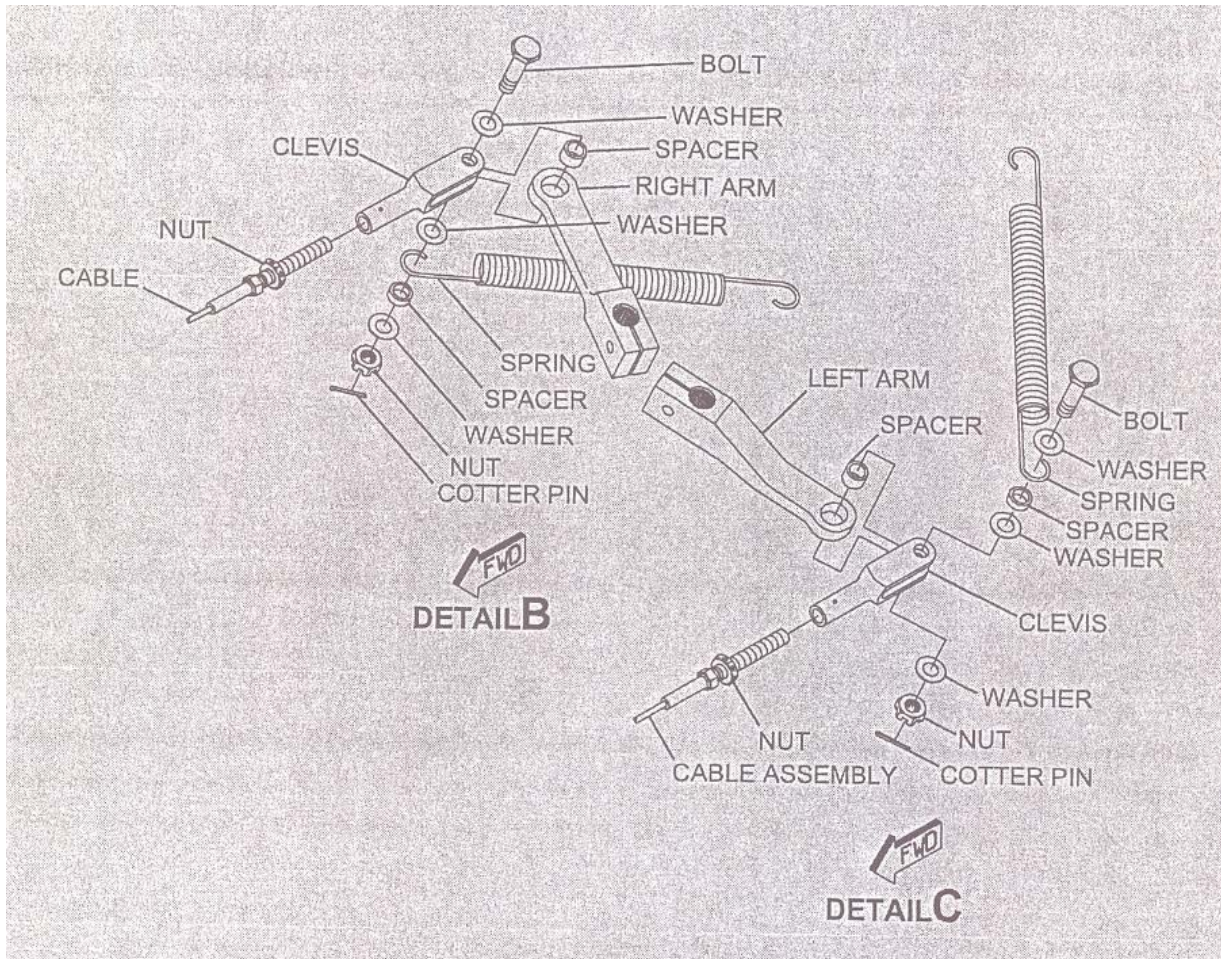
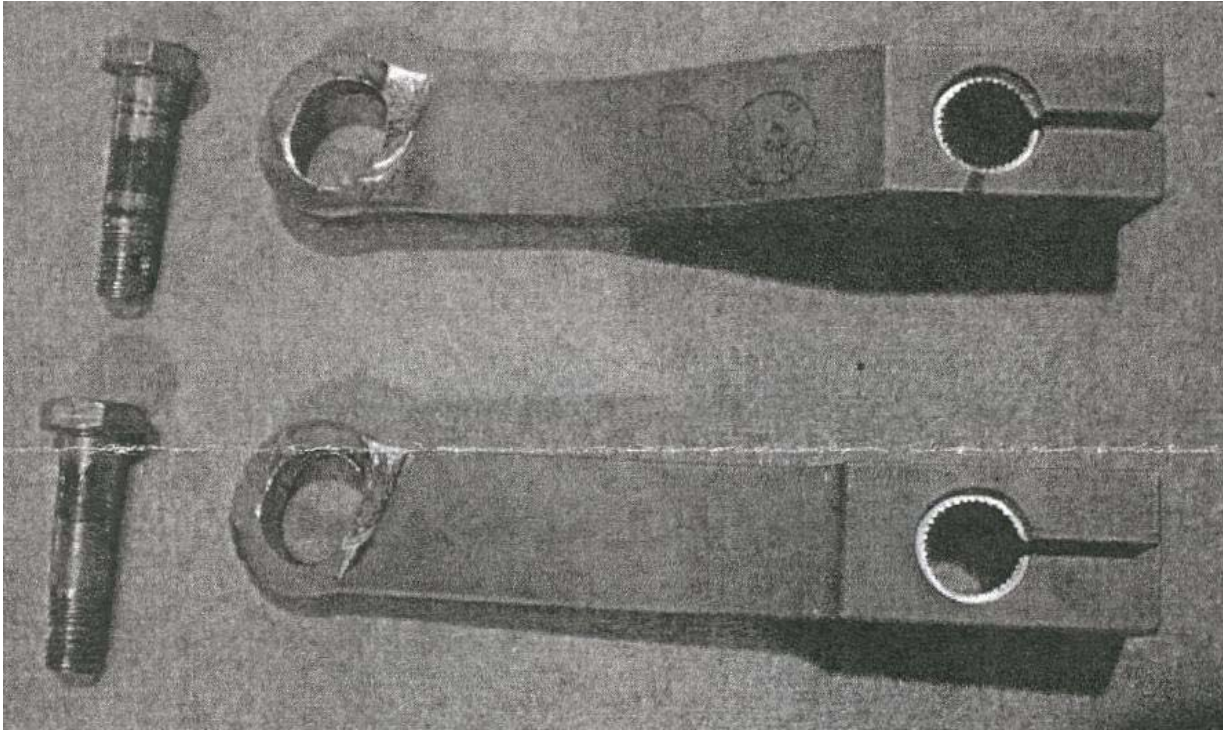
Cessna: 680CE; Worn Brake Metering Valve Arms; ATA 5310

"Upon removal of the R/H floor panel," say this repair station mechanic, "it was observed there was some fretting material on the insulation bags and the surrounding area. Further investigation revealed the R/H and L/H arms (P/N's 6964000-16 and -17) that connect the brake metering valve to the brake cable clevises were severely worn. The bolts and clevises at the attach points are wearing into the brake metering valve arms. It looks like the bushings (spacer P/N NAS43DD4-16FC) were never installed. (I) recommend during a 3A Emergency Battery Service or inspection that this panel (162ET) is removed and the (valve) arms inspected for wear and spacer installation."

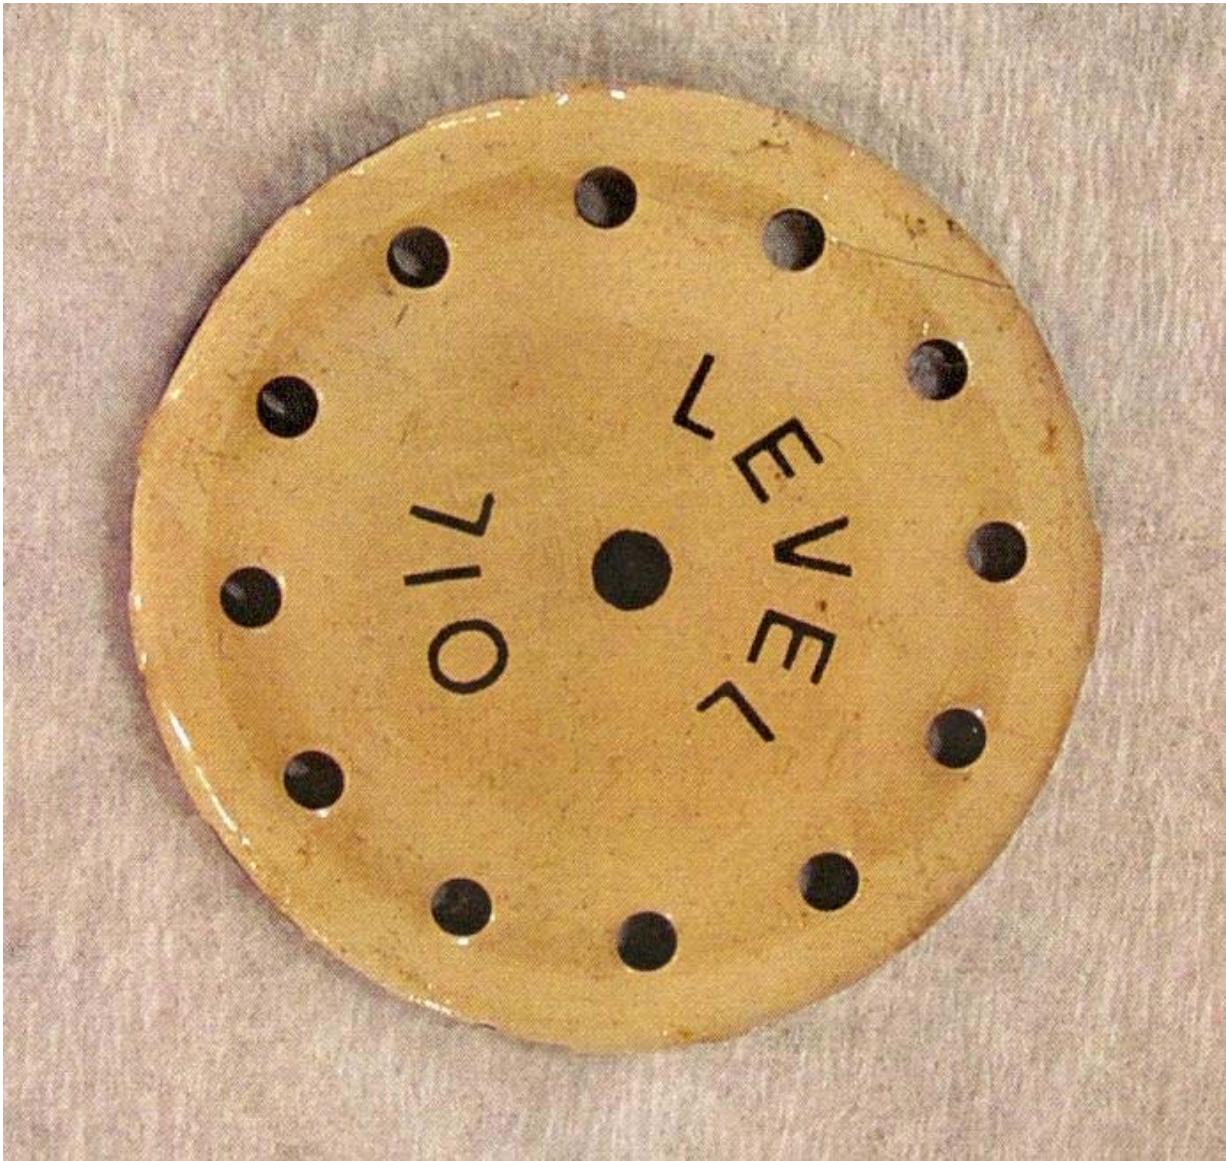
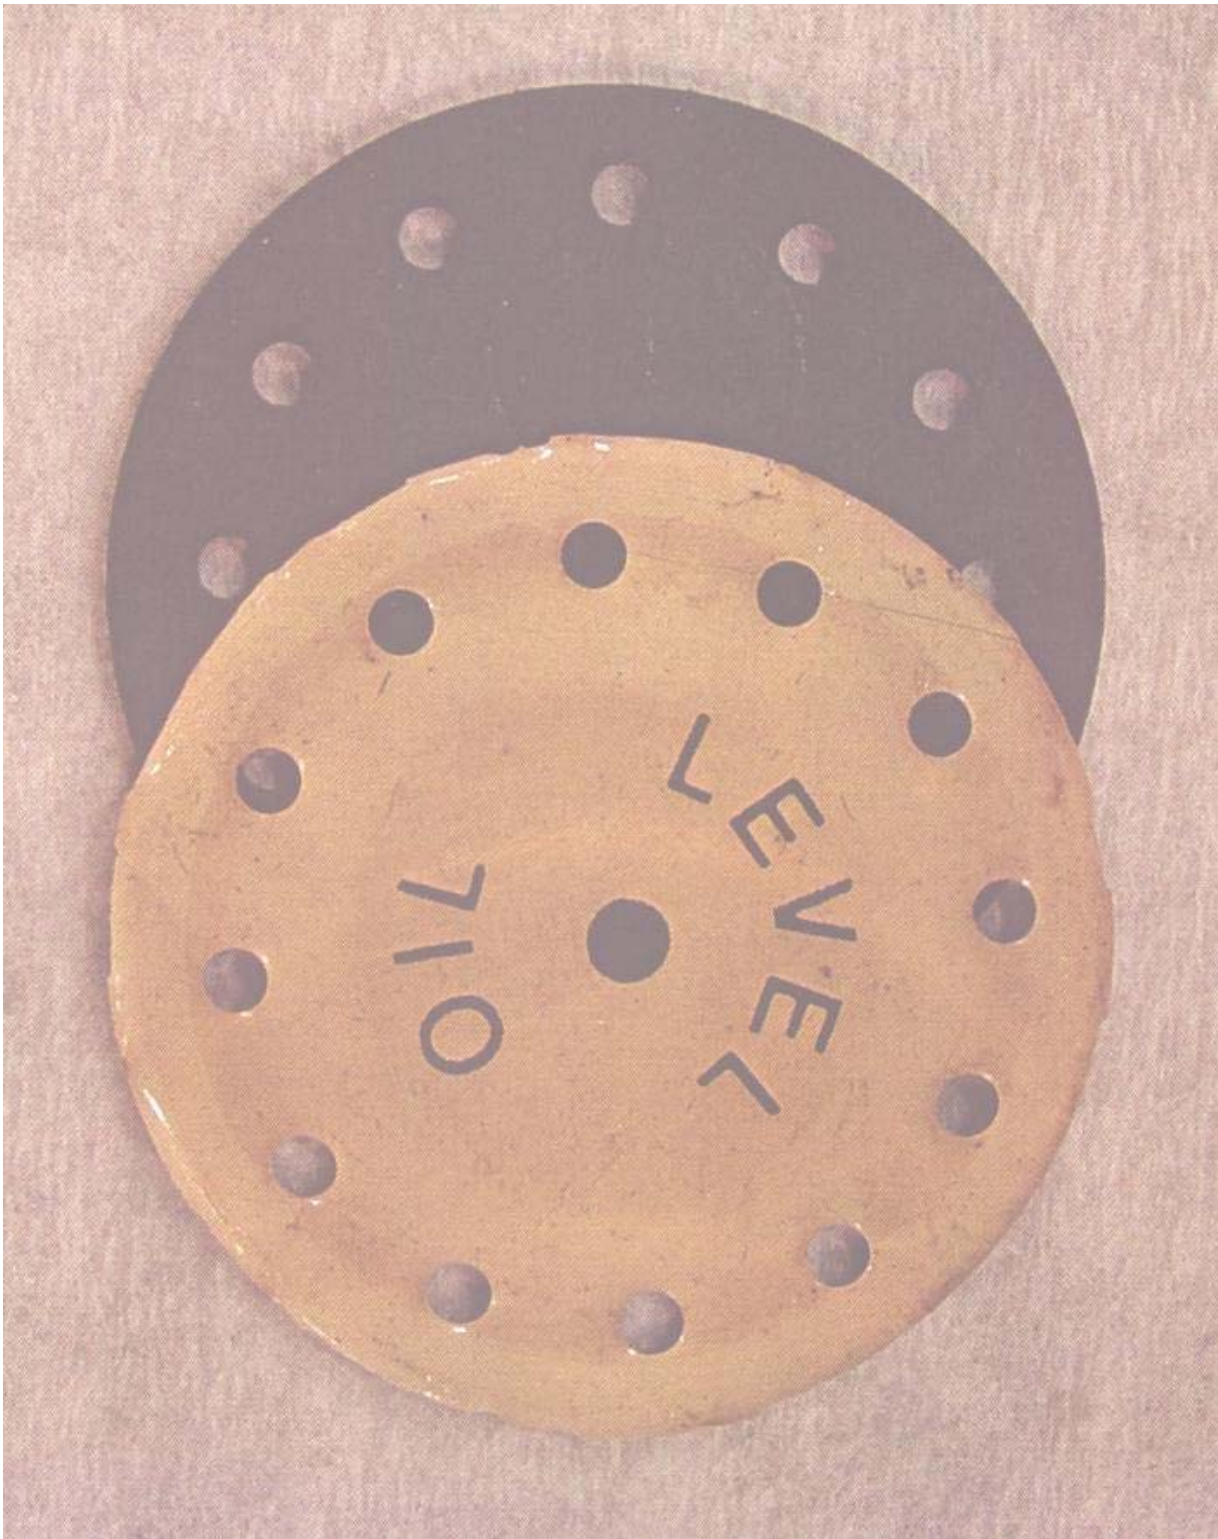
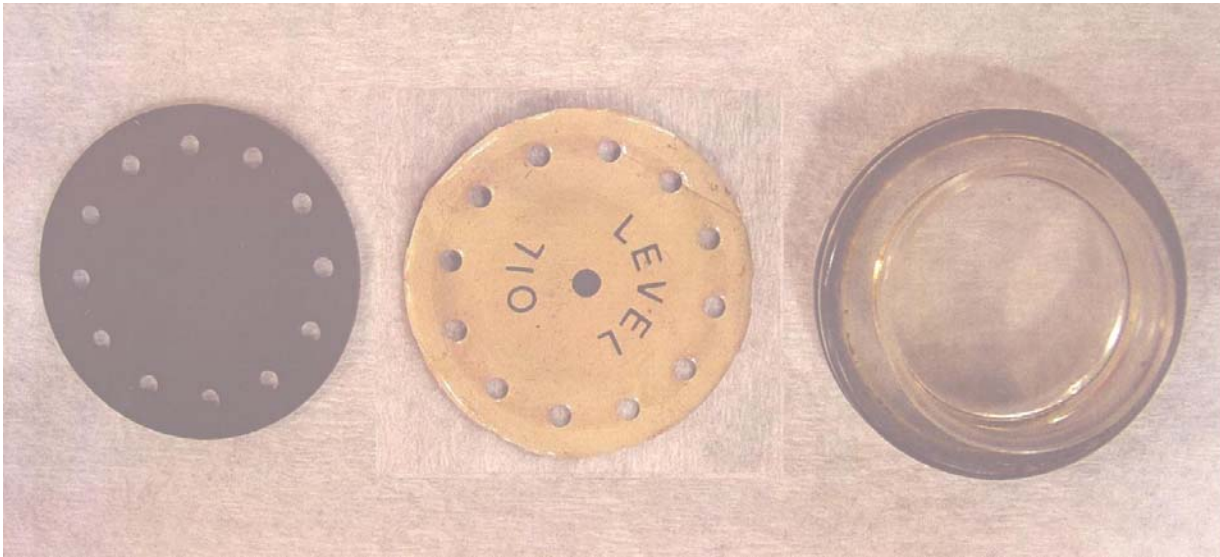
Bell: 206B; Failed Transmission Oil Sight Indicator; ATA 6320

"During a routine inspection," says this repair station submission, "(we) discovered the oil level indicated 'full'—after the main rotor transmission oil was drained. After removal, inspection of the indicator (*P/N 206040093001*) revealed the coating with the 'level markings' had separated from the metallic back plate. There is a ring of holes on the circumference of the indicator. These were not aligned with the holes in the 'level mark' coating on the back plate. This condition would not allow oil to drain from the sight glass—the only means to determine (*correct*) oil level in the main rotor transmission. Improper servicing of the transmission presents a potential for serious problems if left undetected."

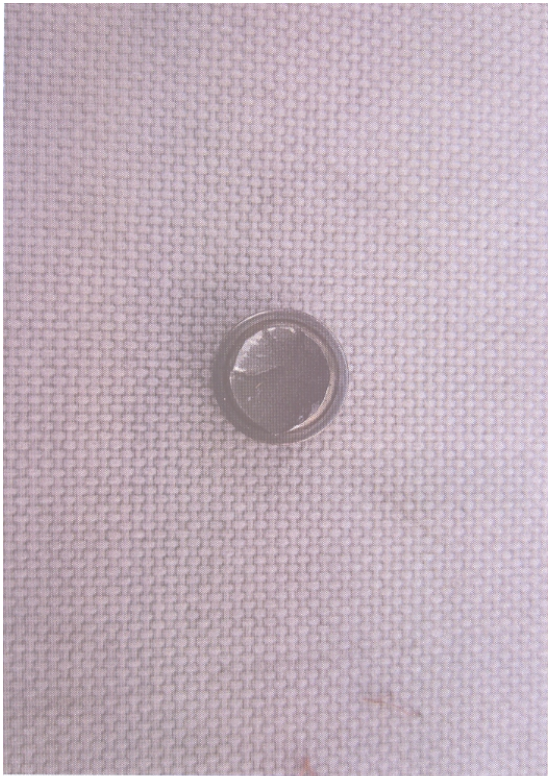
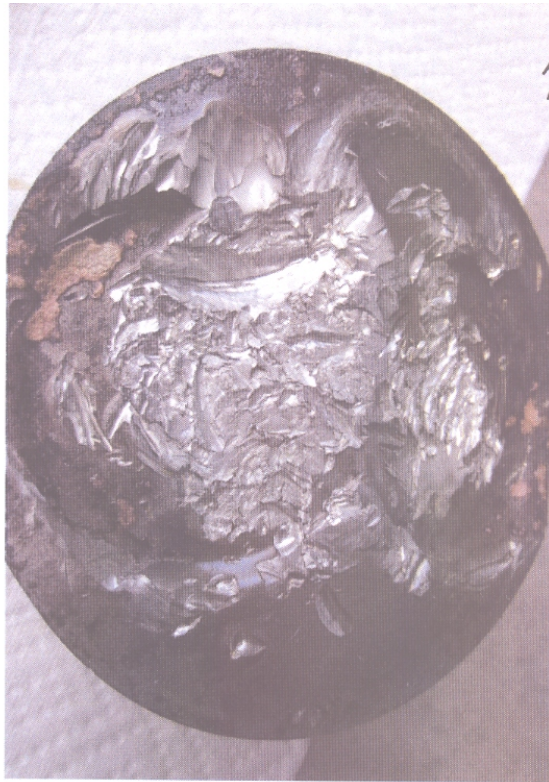
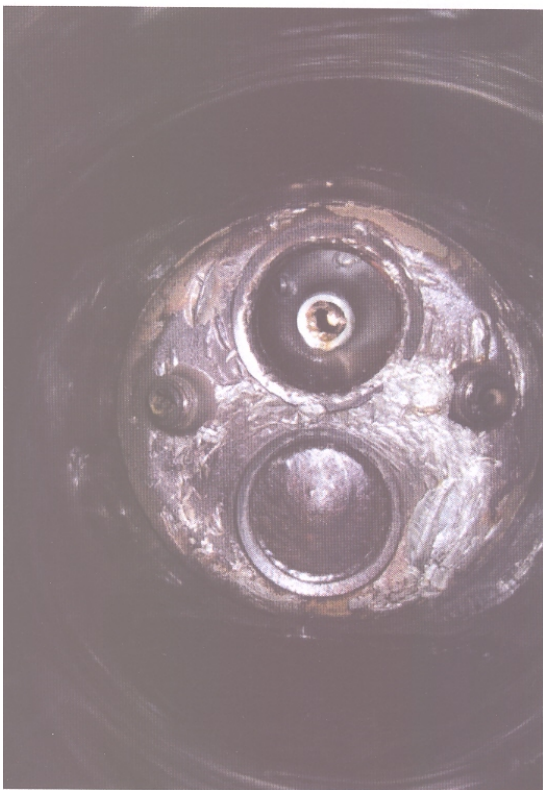
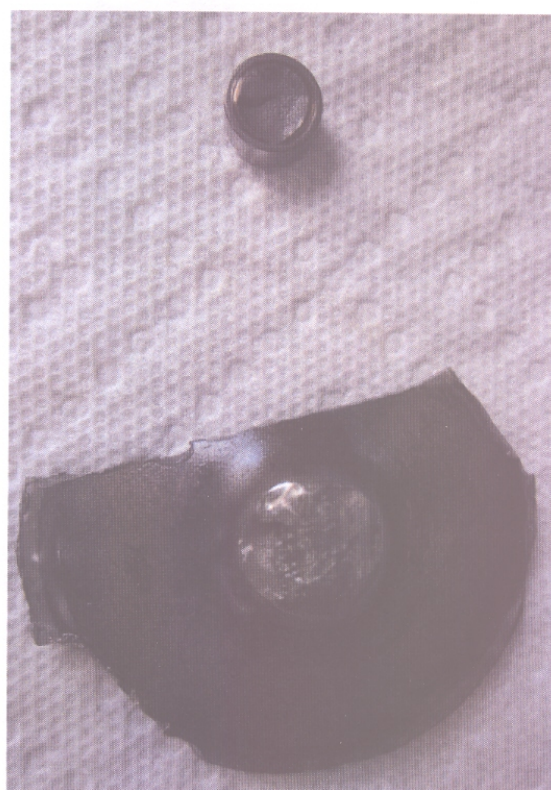
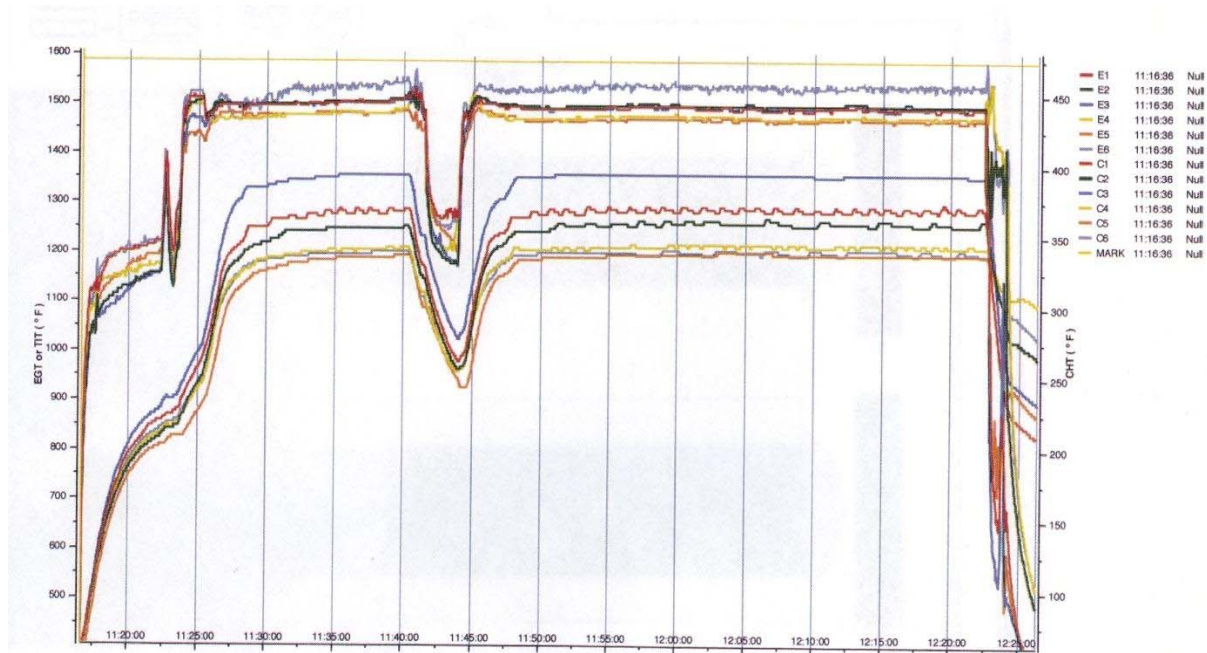
Lycoming: IO540AE1A5; Failed Intake Valve; ATA 8520

"Removal of the number one cylinder for visual inspection revealed a failure of the intake valve," says this technician. "Subsequent analysis from the data recorded by the JPI graphical engine monitor showed massive ingestion of engine oil into the remaining cylinders, causing loss of power—oil fouling the remaining (*otherwise*) unaffected spark plugs. Closer inspection of the effected cylinder showed catastrophic damage to the piston and combustion area from (*piston/valve/head*) multiple contacts. Fractured valve parts became wedged in the induction tube and in the common manifold area. When the intake rocker assembly was removed it was discovered the top portion of the valve stem above the 'keepers' was the area of separation/failure. A 30X power microscope was used for inspection. It is (*our*) opinion the failure of the intake valve may have been caused from a stress riser created during manufacturing at either the machining, heat treating process, or perhaps at the molecular level during creation of the raw material. It should be noted the aircraft was in compliance with Lycoming Service Bulletin SB388C exactly 85.8 hours earlier. No defect or abnormalities were noted at the time of the inspection."

(Intake valve P/N: LW13622. There are eleven of these part numbers reflected in the SDRS database.)

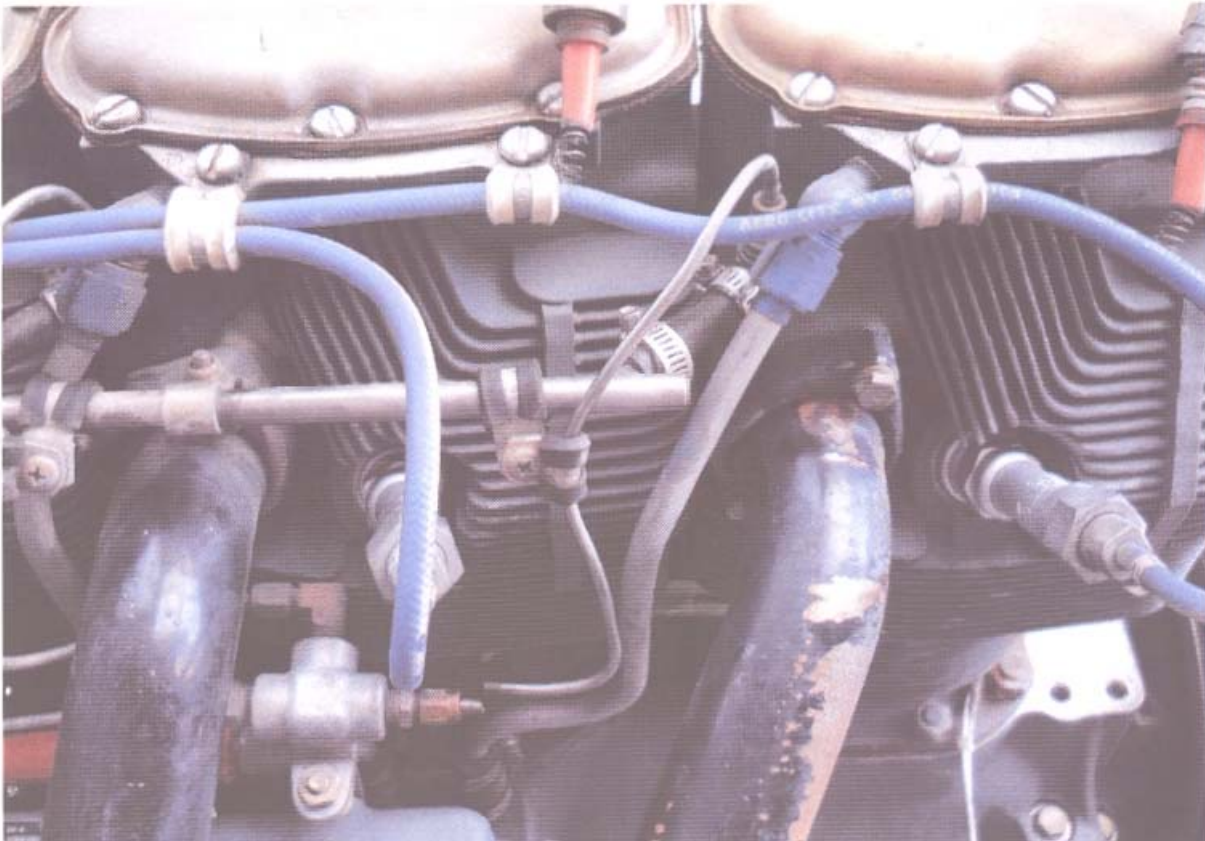
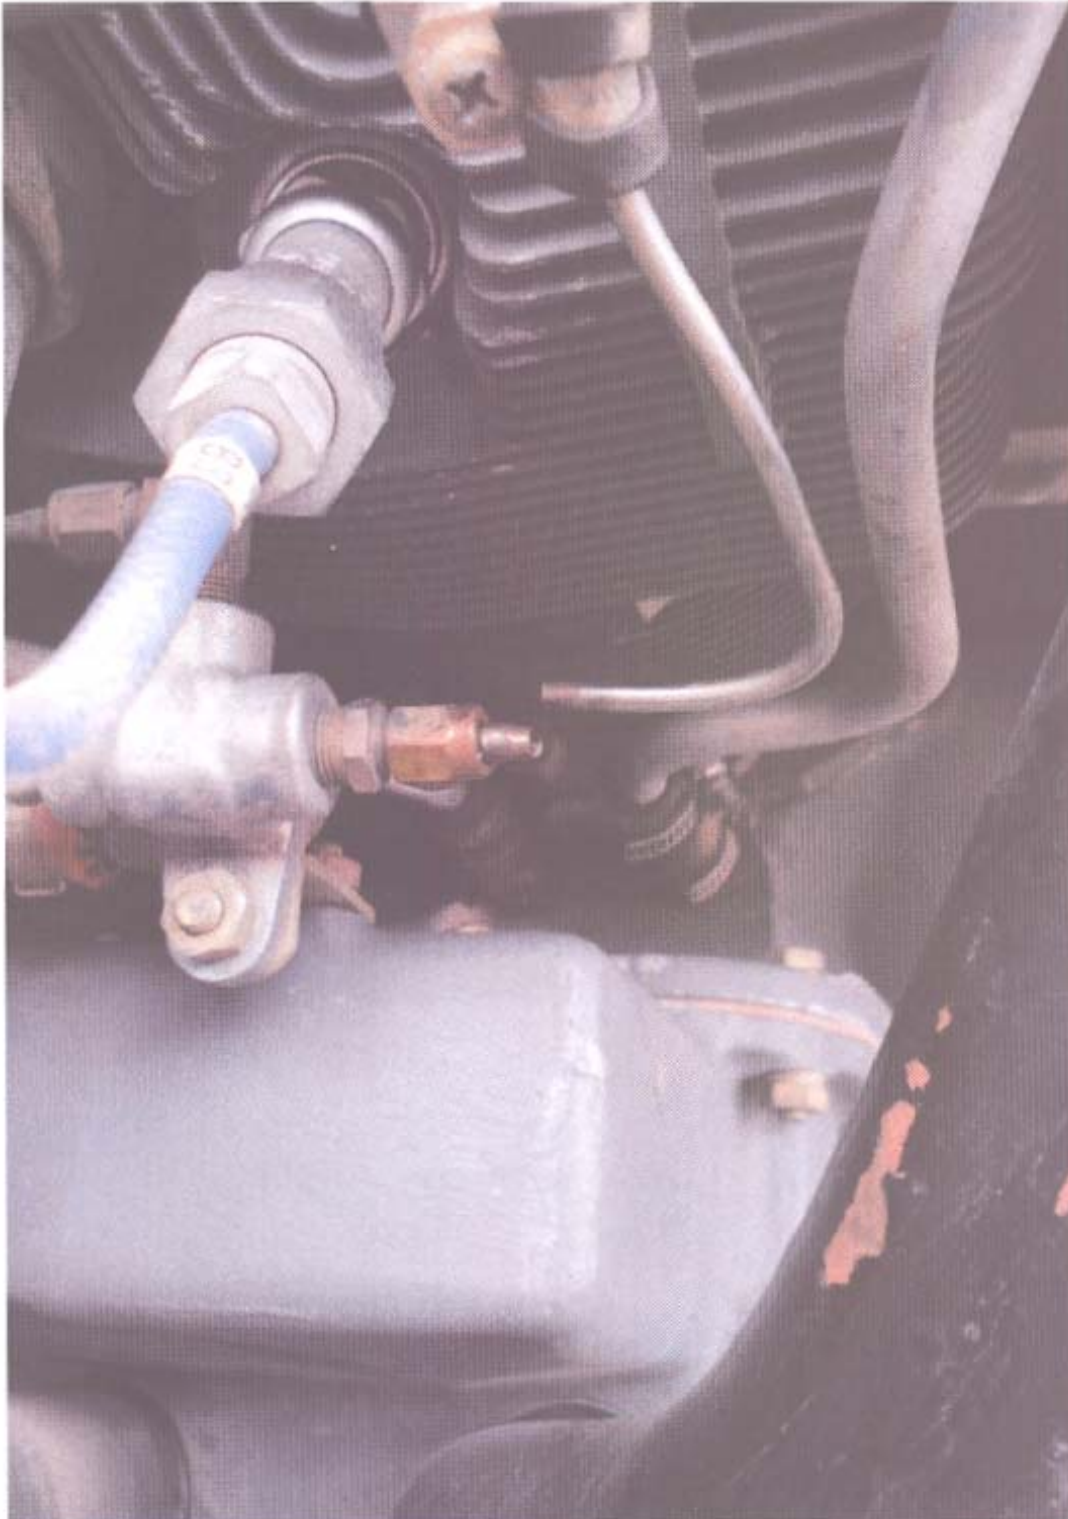
Lycoming: TIO540 SER; Broken Fuel Line; ATA 7310

This general aviation report reads, "On departure the pilot reported all engine indications were normal prior to rotation. Climbing out of 4,000 feet the right engine lost power. The pilot proceeded with the 'engine out' procedures—determining the right engine was only producing 30 inches of manifold pressure with 8 PSI fuel flow. The pilot returned to *(base)* and landed without incident." "Maintenance inspected the right engine and found the number one cylinder injection line broken. AD2011-26-04 was last complied with in May (2012). The aircraft was last inspected 67.7 hours previous to the total time (20,555.3 hours). No defects were found during the inspection."

(Fuel Line P/N: LW120980100. Nine of these part numbers can be found in the SDRS database.)

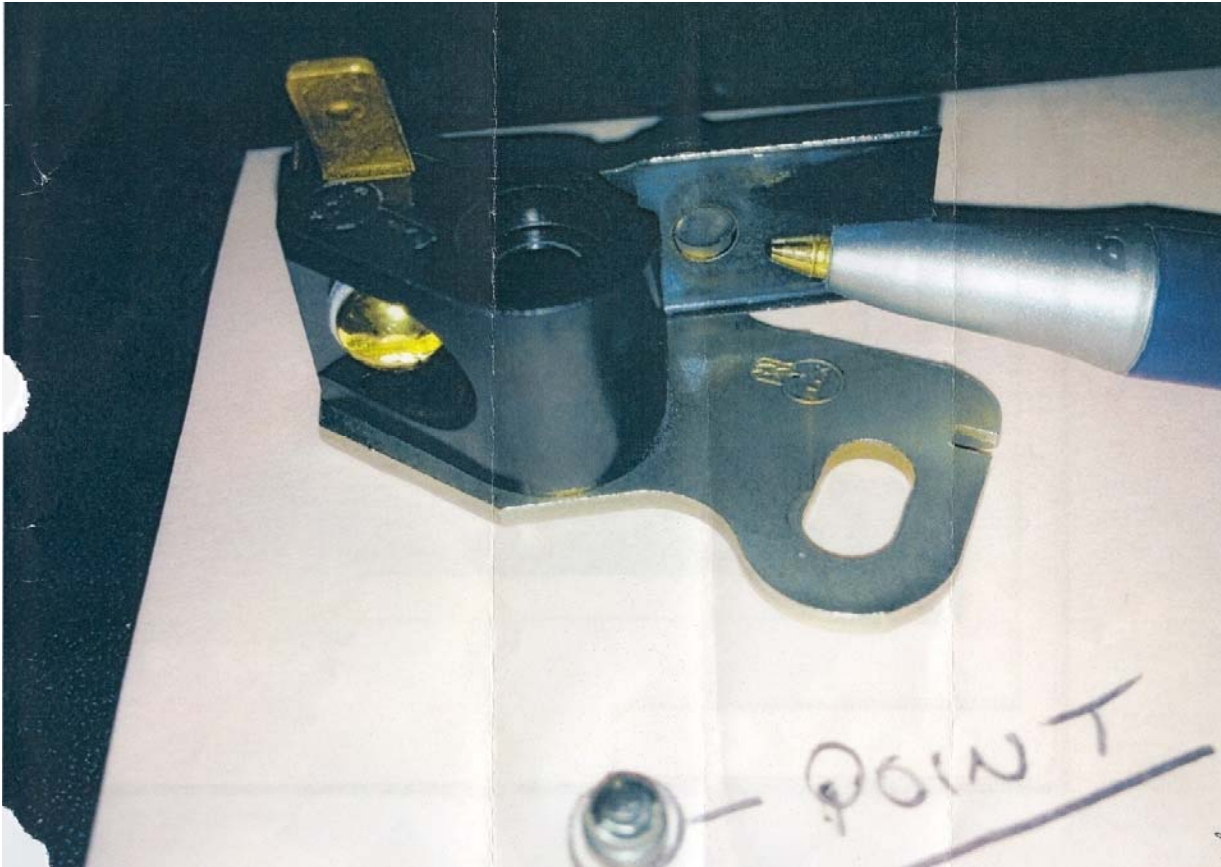
Slick Magneto: 6310; Failed Contact Point; ATA 7414

A repair station mechanic describes this failure. "This engine was running rough—when the magneto switch was moved to the R/H magneto position the engine would stall. (I) performed a run-up to verify the discrepancy. The magneto was removed from the engine and disassembled far enough to find the contact assembly's (P/N M3081) arm was missing the contact point. Further inspection found the missing point—it was removed from the magneto. (I) reassembled the magneto with a new contact assembly IAW the Component Maintenance Manual. Engine run-up was then performed with no defects noted. I suspect an improper crimp of the contact point to the arm (*at the time of manufacture as the cause of this failure*)."

(The SDRS database records P/N M3081 22 times.)
