**UNITED STATES
DEPARTMENT OF LABOR
MINE SAFETY AND HEALTH ADMINISTRATION**

REPORT OF INVESTIGATION

**Fatal Machinery Accident
March 17, 2012**

**Salt Run No. 1 Mine
Ohio American Energy Inc.
Rayland, Jefferson County Ohio
MSHA ID No. 33-04550**

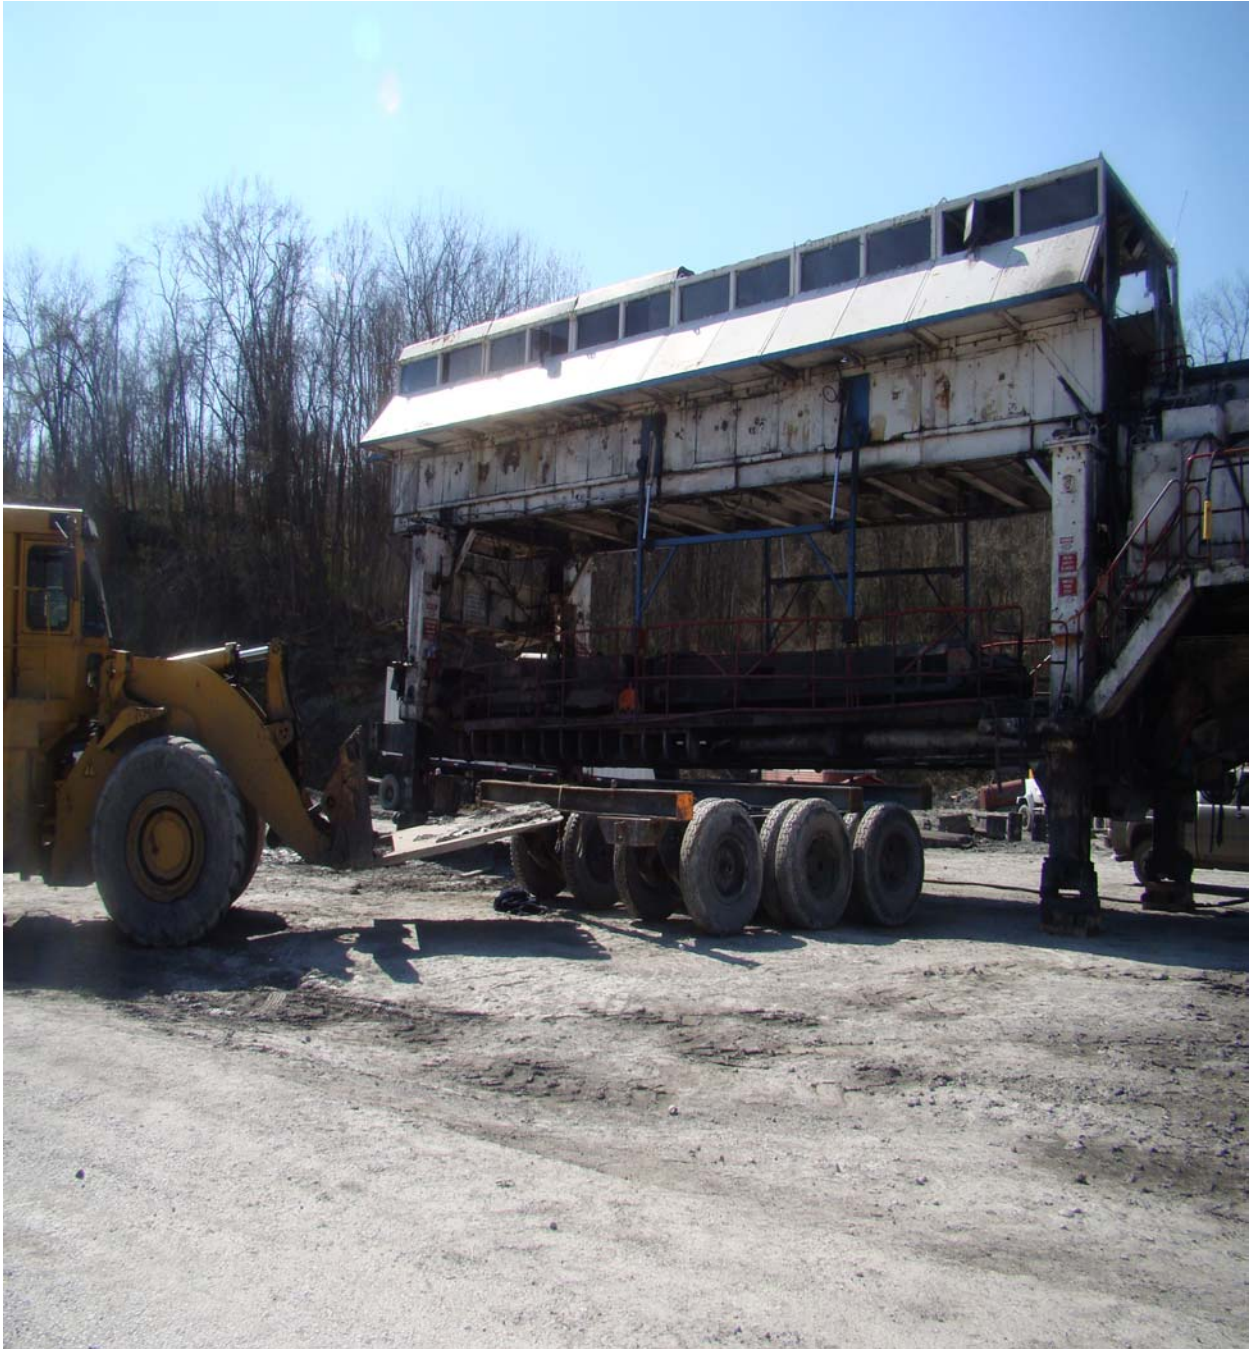
PHOTO OF ACCIDENT SCENE

Recently, the mining operation has been conducting an average of one highwall mining machine move per month. The miners working at this mine are familiar with this process and procedure. McAfee, as the Highwall Miner Operations Coordinator, was the person with the most experience associated with the highwall mining machine at this operation. He was directly supervising Merritt, who had positioned the end loader on one side of the highwall mining machine to push the transportation dolly as far as the attachment allowed, then traveled around the other side to pull the dolly out with end loader attachment. When several unsuccessful attempts were made to pull the dolly system, McAfee traveled to his pickup truck to retrieve a 6-foot nylon strap. McAfee attached the strap to the dolly and remained in front of the dolly, while holding the strap in hand. McAfee then directed Merritt to pull forward. As he was pulling forward, Merritt lost sight of McAfee. McAfee was killed as a result of being pinned between the duck bill of the Cat 988F loader and the dolly system.

While McAfee was standing somewhat off to the right, the vision of the end loader operator was obscured partially by the right side front hydraulic jack.
