**UNITED STATES
NUCLEAR REGULATORY COMMISSION
REGION IV
611 RYAN PLAZA DRIVE, SUITE 400
ARLINGTON, TEXAS 76011-4005**

SUBJECT: NRC SPECIAL INSPECTION REPORT 50-458/02-07

On November 14, 2002, the NRC completed a Special Inspection at the River Bend Station. The enclosed report documents the inspection findings which were discussed with you and members of your staff on November 14, 2002.

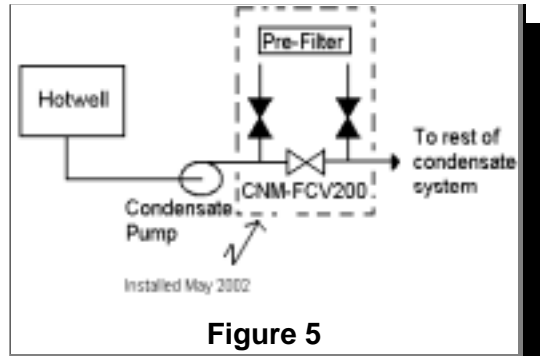
The licensee had previously developed a plant modification to install full flow filtration equipment (prefilters) in the condensate system. The licensee planned to install the modification in two phases. The first phase of the modification was installed in May 2002. The installed portion of the modification included Condensate Prefilter Vessel Bypass Flow Control Valve CNM-FCV200 (Figure 5).

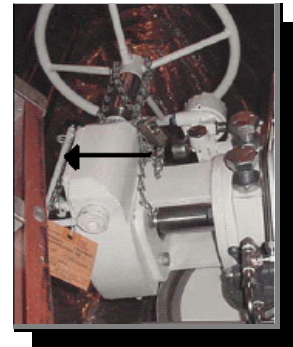
Handwheel engaged

The photos on the right were taken with the handwheel engaged and the handwheel disengaged. When the lever was in the engaged position (moved to the left as shown in the top photo), the handwheel was physically connected to the valve through gears. Chaining the handwheel would then keep the valve from moving. When the lever was in the disengaged position (moved to the right as shown in the lower photo), the valve was not connected to the handwheel.

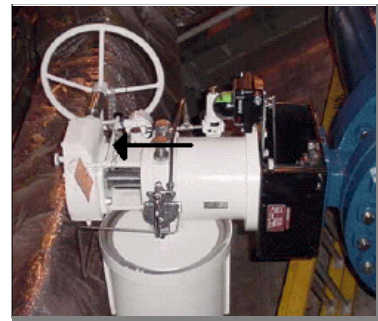
Handwheel Disengaged

Because the handwheel was disengaged, the only thing holding the valve open was friction from the packing and internal components and the weight of the disc. When flow through the valve increased suddenly, as occurred when the feedwater system tried to restore reactor water level following the scram, the force on the disc was enough to cause the valve to go closed.

An apparent violation of Technical Specification 5.4.1.a was identified when the licensee failed to lock open Condensate Prefilter Vessel Bypass Flow Control Valve CNM-FCV200, as required by System Operating Procedure SOP-0007, "Condensate System," Revision 21. The risk significance determination was still in progress when this report was completed. The final risk significance determination has yet to be determined.

The inspectors reviewed the licensee's assessment of the failure to properly lock open Valve CNM-FCV200 and the corrective action taken. The licensee appropriately used their processes to subsequently provide training to all of the operators, and made the necessary revision to Condensate System Operating Procedure SOP-007.
