AIRCRAFT ACCIDENT REPORT

UNCONTAINED ENGINE FAILURE
DELTA AIR LINES FLIGHT 1288
MCDONNELL DOUGLAS MD-88, N927DA
PENSACOLA, FLORIDA
JULY 6, 1996

**Adopted: January 13, 1998
Notation 6725C**

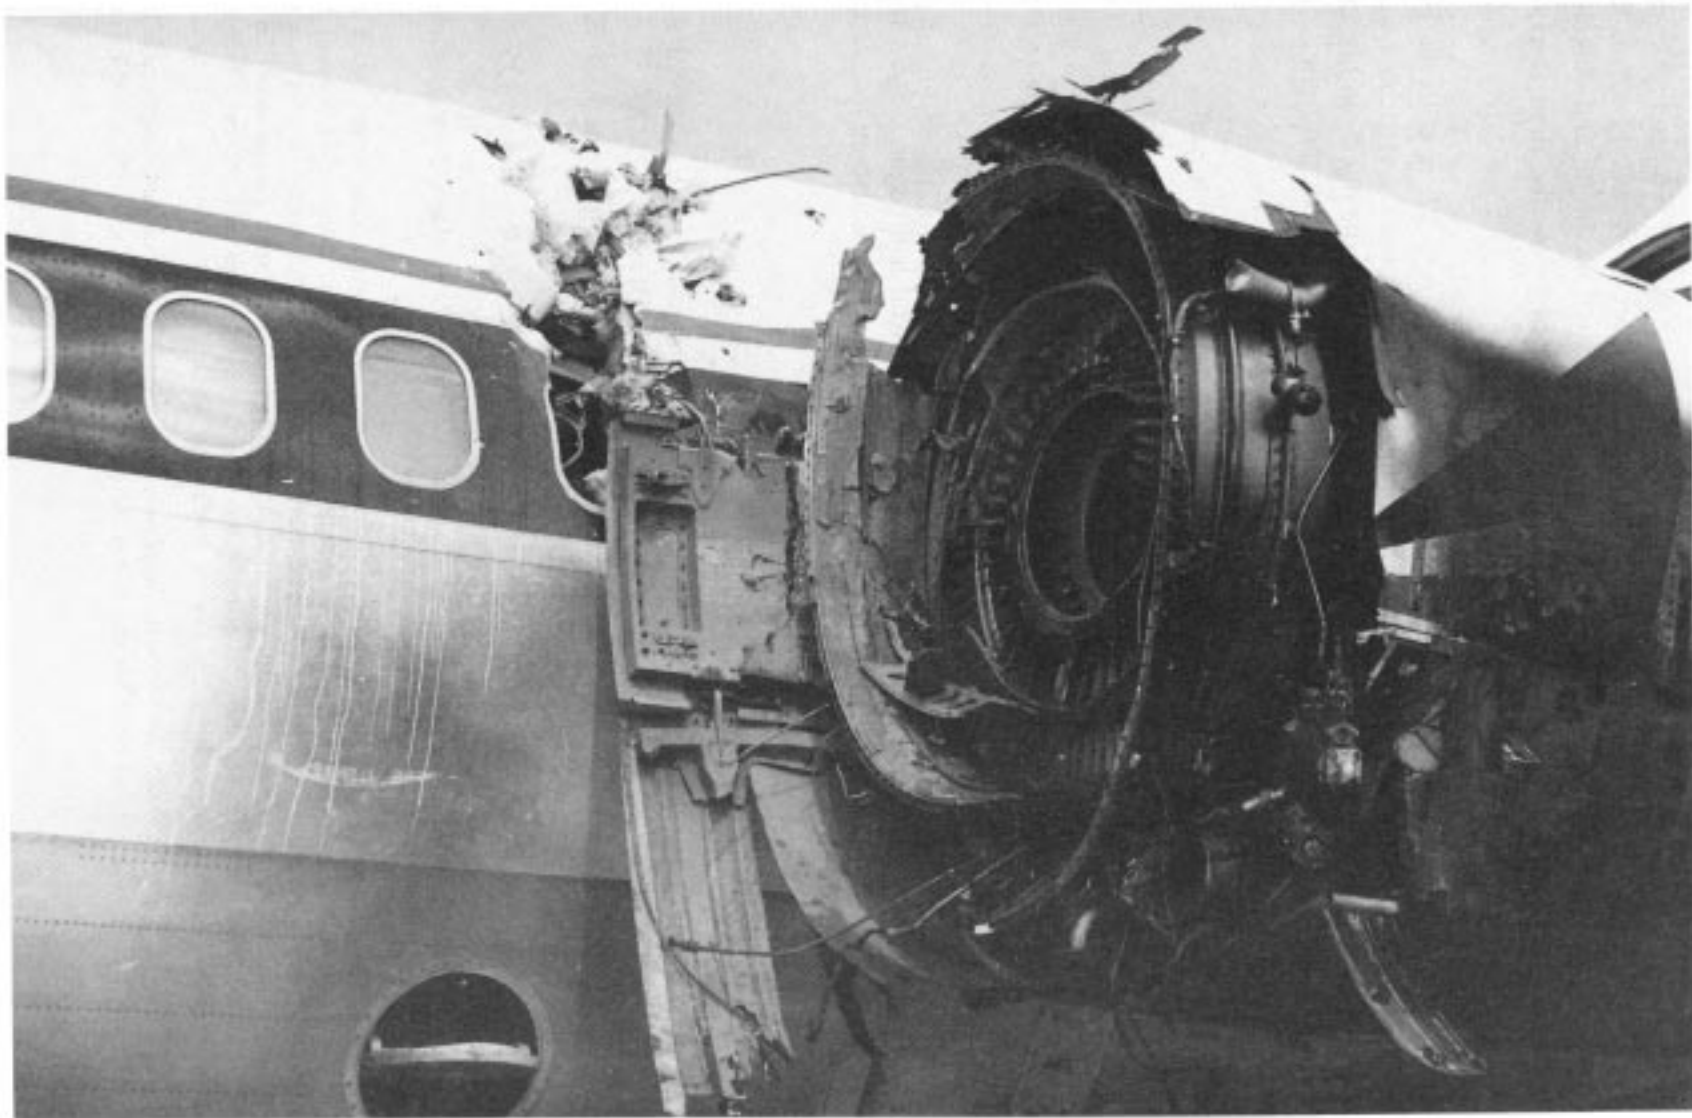
The aft left fuselage and interior of the airplane in the vicinity of the No. 1 engine were substantially damaged by debris from the engine (see figure 1). A total of 16 holes, punctures, or tears were documented on the left fuselage skin. Several large holes and tears were

Figure 1.—Damaged area of airplane near No. 1 engine.

The cabin interior was substantially damaged near seat row 37, next to the left engine. Debris from the left engine's fan hub and fan blades had penetrated the left cabin wall and overhead bin vertically from the lower left passenger window through the overhead bin and ceiling panel. Engine fan components had also pierced the side and ceiling of the right cabin wall.

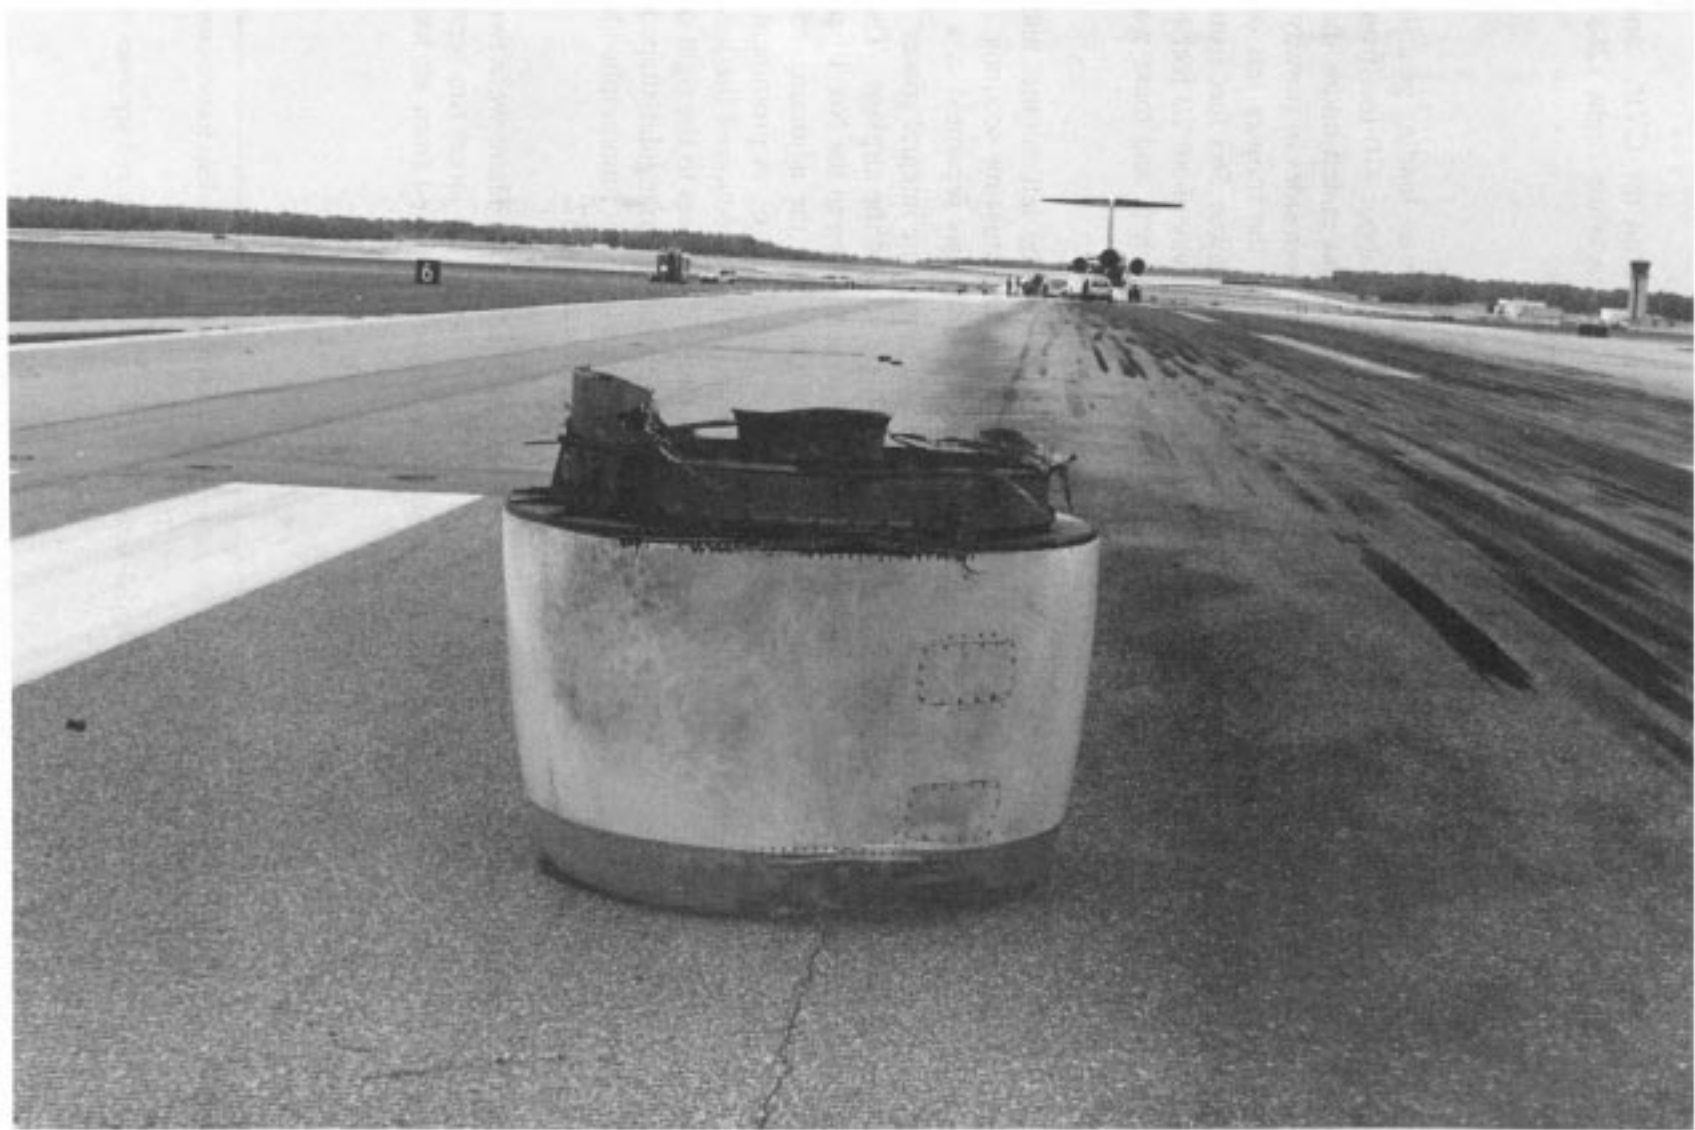
Figure 5.—Left engine nose inlet cowl.

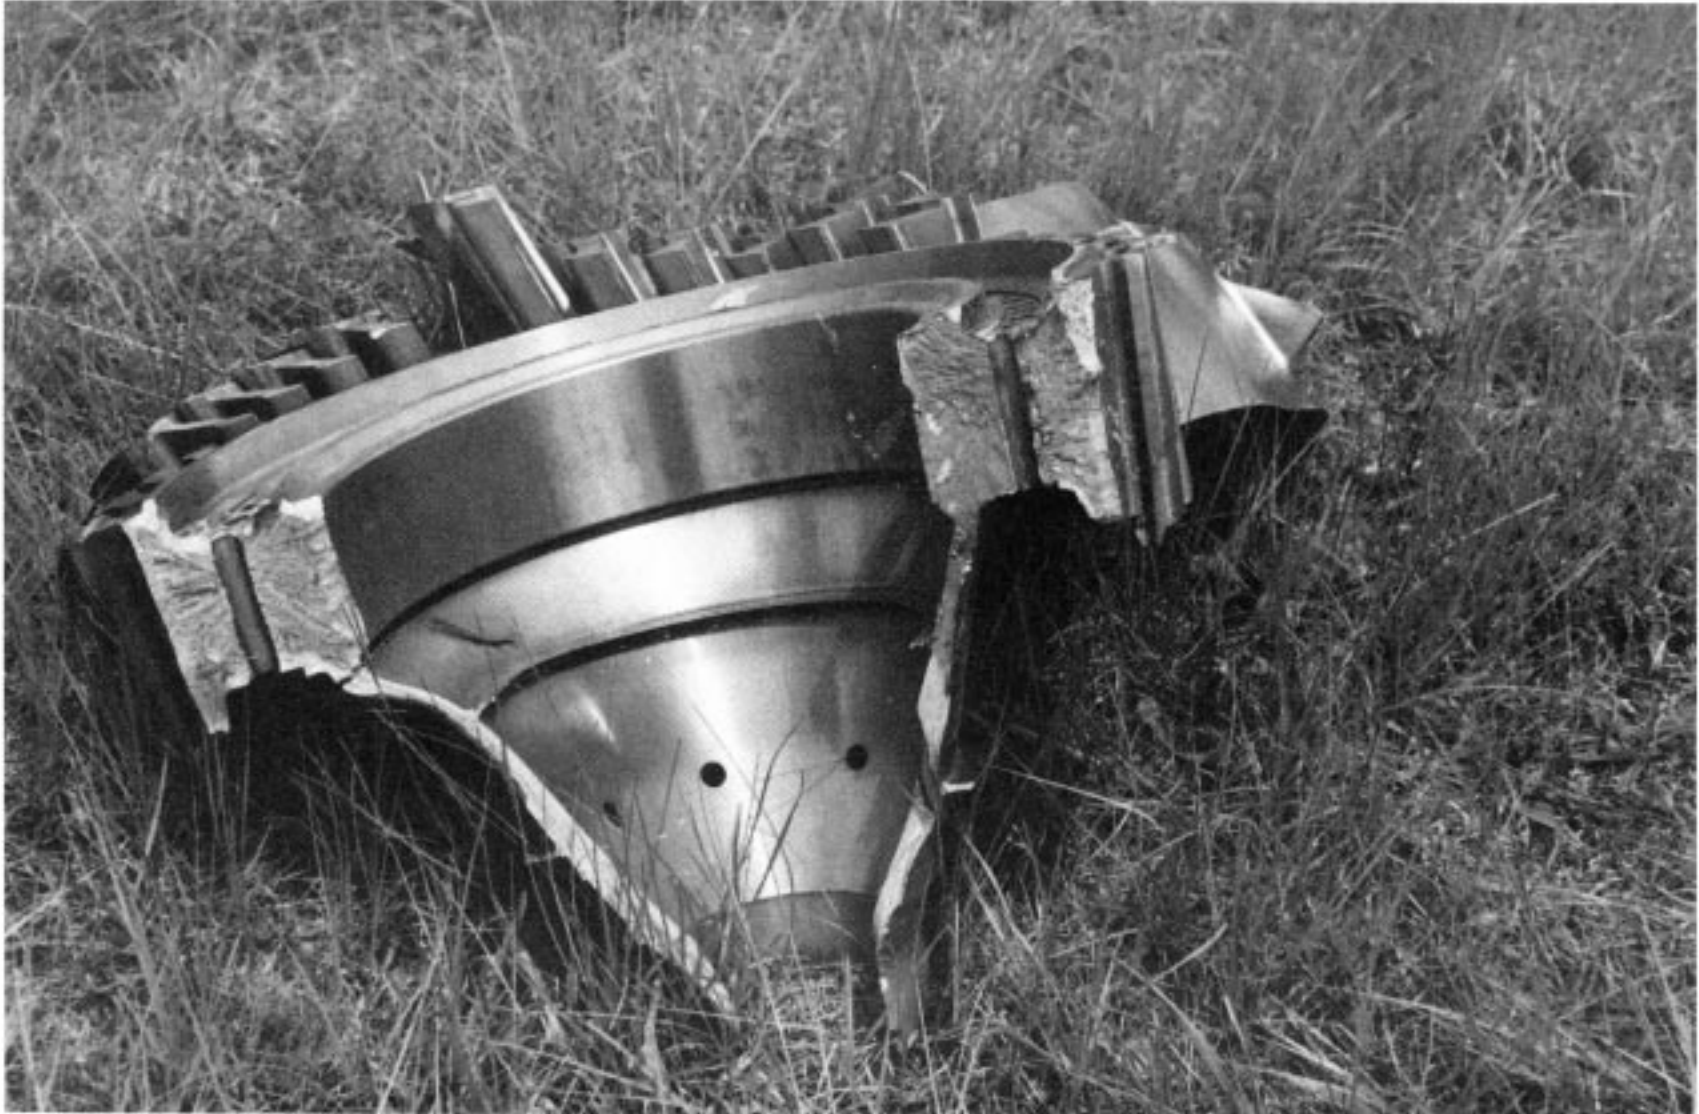
The fan hub fractured through a tierod hole and blade slot. There were two fan blade roots still in place on the small rim segment and 13 blade roots on the larger rim segment. Three of the 13 blades were full length and bent counterclockwise as viewed from aft looking

Figure 6.—Two-thirds of hub rim and adjoining conical section.

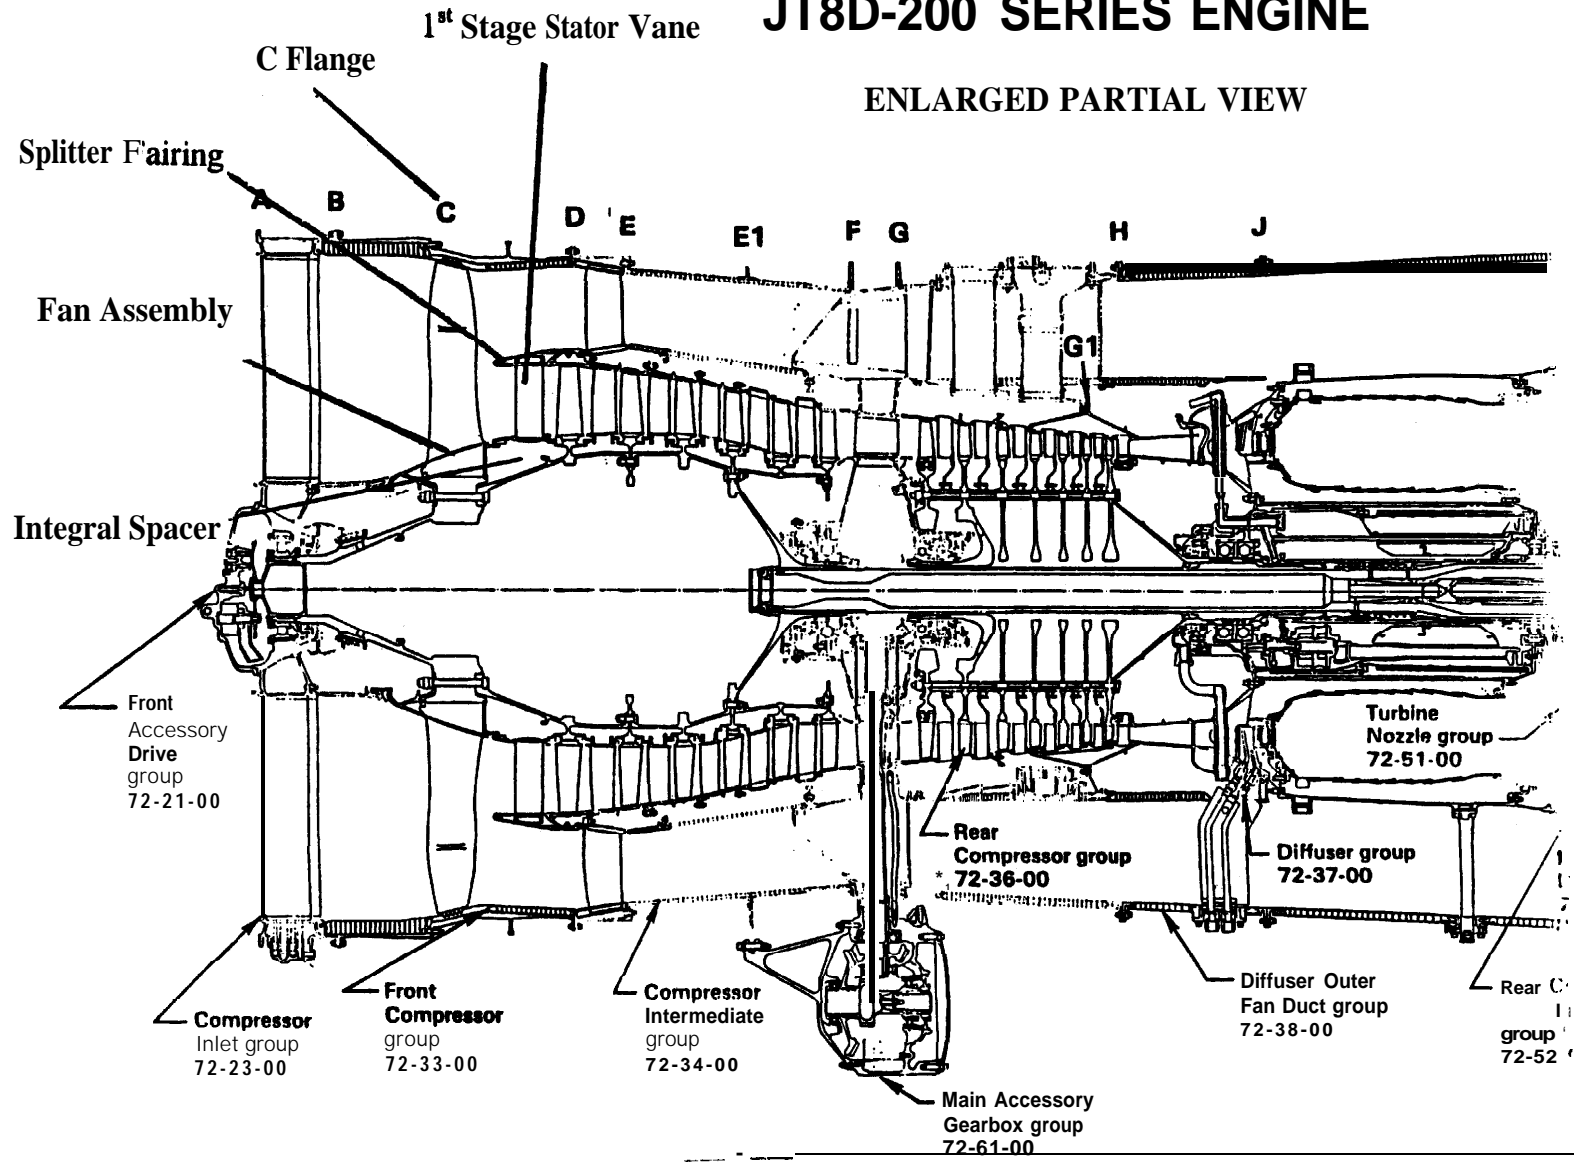
The outer engine case separated at the C flange (see figure 7).³¹ Forward of the C flange, the case remained attached to the cowl. The case was torn and fragmented in two areas (centered at the 1 o'clock and 7 o'clock positions) between the C and D flanges. The 1 o'clock position was missing a segment from the 12:30 to 2 o'clock positions. The case was intact but had been torn loose from the D flange between the 2 o'clock and 3 o'clock positions. A 14-inch circumferential part of the fan rear case was found on the runway 61 feet to the right of the centerline and 441 feet from the runway threshold. Acoustic honeycomb in the fan case area was ripped, torn, or missing in many places. The splitter fairing³² (see figure 7) was missing from the 1 o'clock to the 7 o'clock position. A torn piece of the splitter remained attached at the 5 o'clock position. Twelve first-stage stator vanes³³ were present on the remaining splitter fairing. The inner diameter ends of the vanes were separated from the inner shroud and bent in the direction of rotation.

Figure 7.—Enlarged, partial view of outer engine case of JT8D-200 series engine.

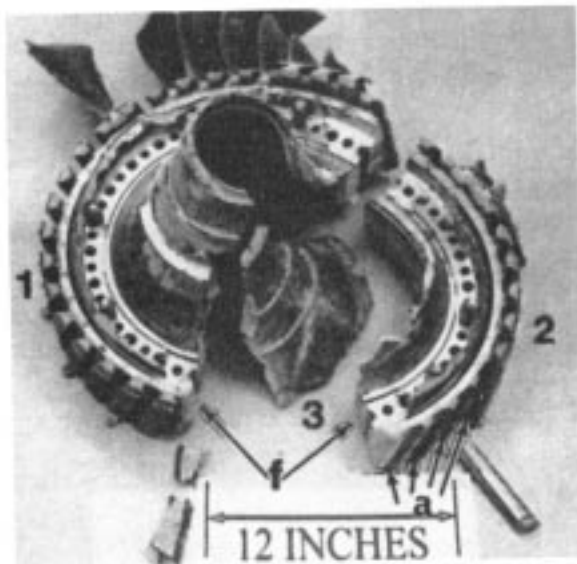
Figure 9a.—Fractured fan hub.

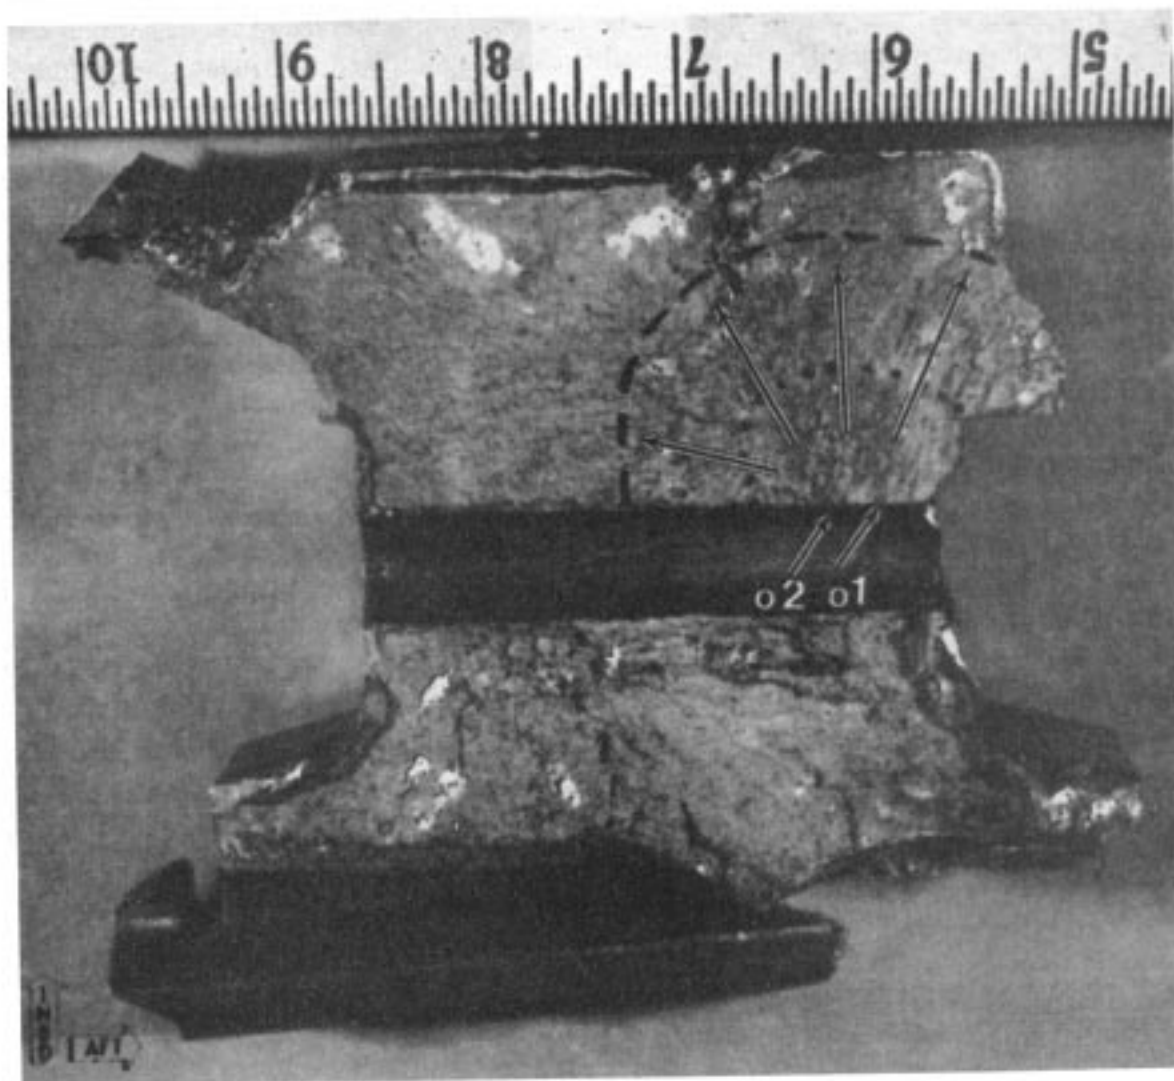
A scanning electron microscope (SEM) examination of the fracture face in the origin areas showed evidence of overstress to a depth of about 0.002 inch adjacent to the hole wall. The overstress fracture region was followed by an area about 0.006 inch deep that contained fracture features consistent with a fast-propagating fatigue crack. From a depth of 0.006 inch to the end of the fatigue region, striations were found consistent with a slower propagating fatigue crack.

Figure 9b.—View of fatigue crack.

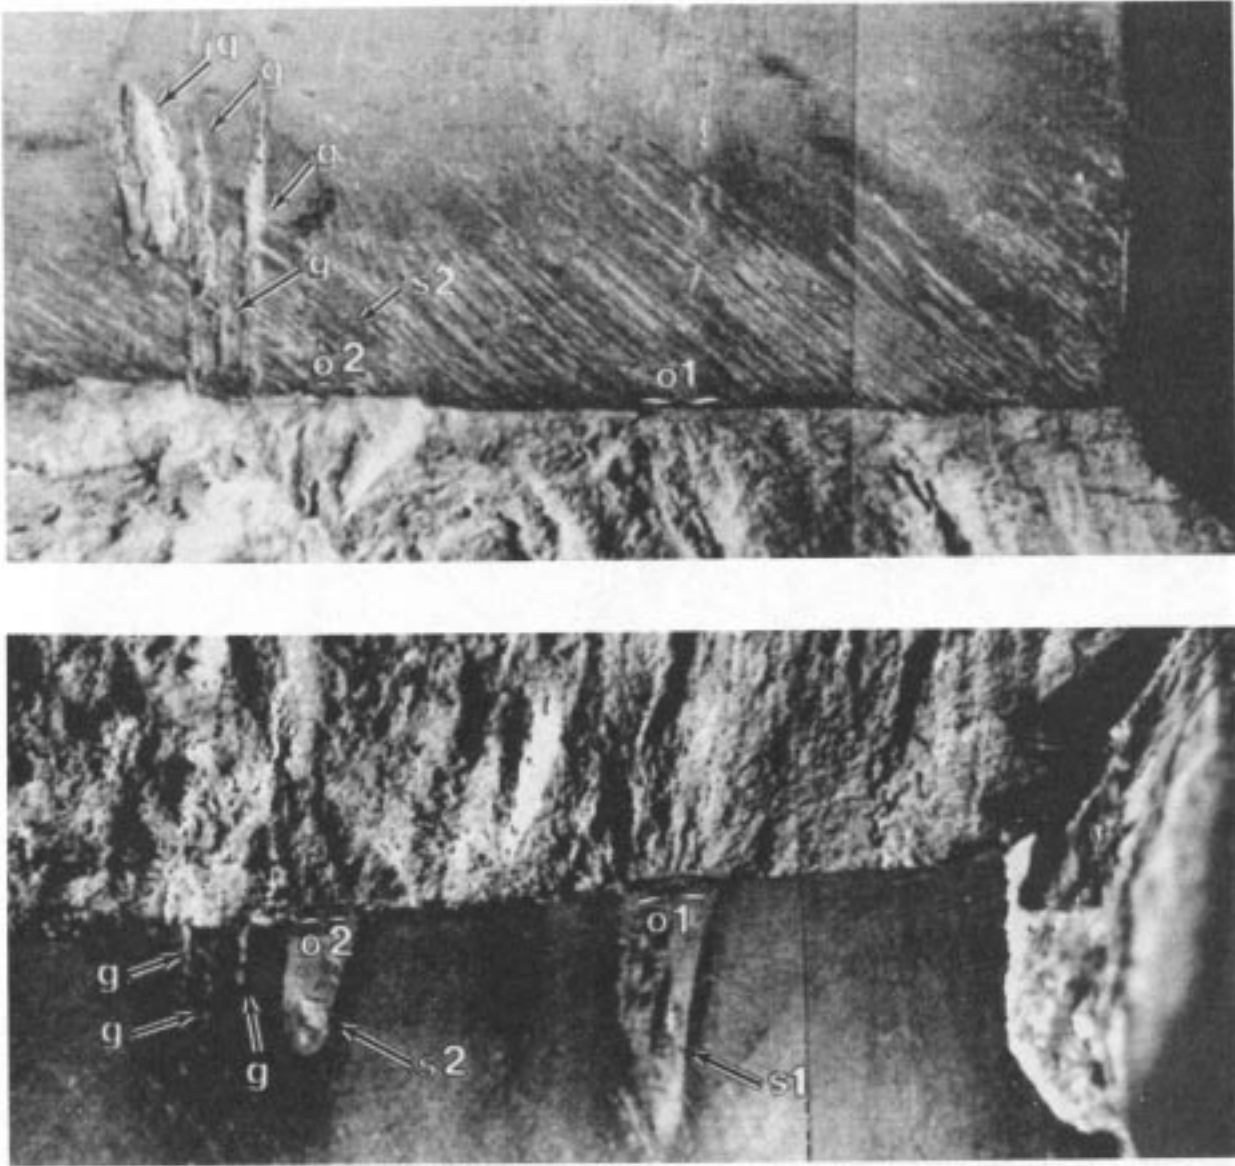
Figure 9c.—Magnified view of fatigue fracture features.

About 12,887 fatigue striations were found in the fatigue fracture region, roughly equivalent to the number of the hub's flight cycles. A portion of the fatigue fracture surface adjacent to the origin area was discolored slightly darker than other parts of the fatigue region. This discolored fracture region extended about 0.7 inch radially inboard from the origin area. At the aft face of the hub, the fracture discoloration extended about 0.46 inch inboard from the hole. Along the hole wall, this discoloration extended about 0.90 inch forward from the aft inboard corner of the hole. The number of striations in the discolored part of the fracture was approximately the same as the number of flight cycles recorded for the hub at the last FPI performed by Delta.

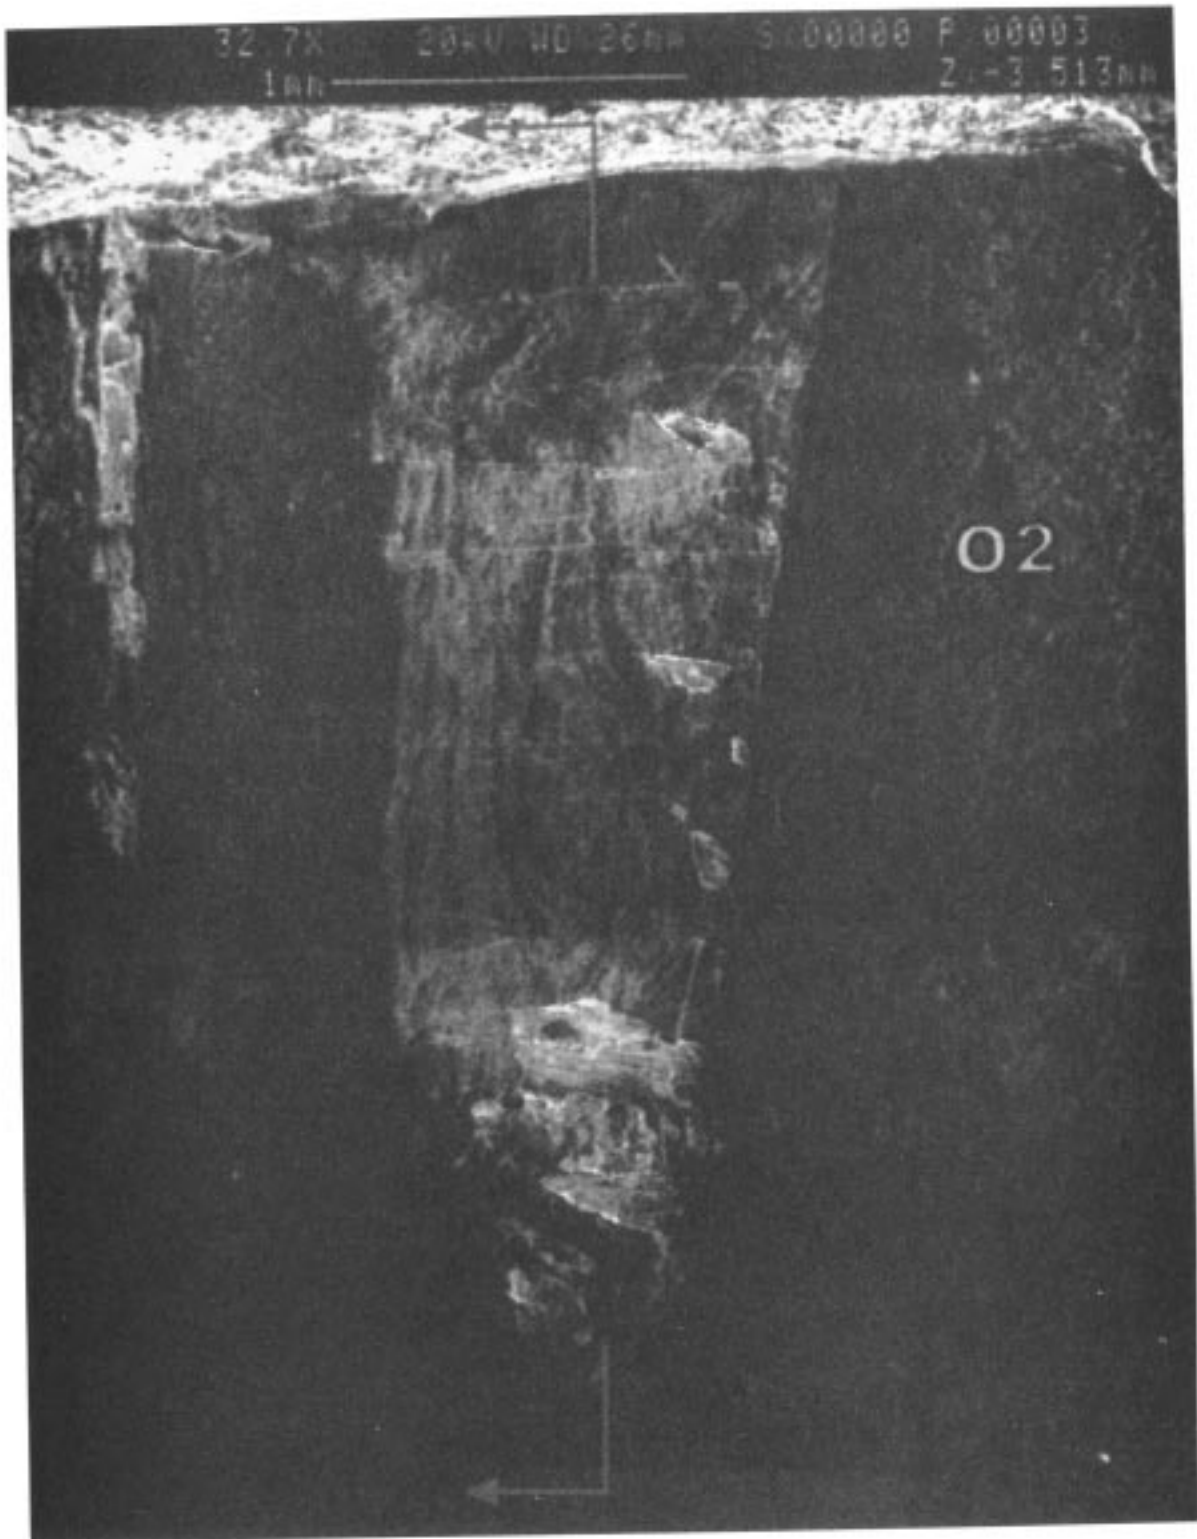
Figure 10.—Magnified view of hole wall.
