## June 2009 Collision of Two Washington Metropolitan Area Transit Authority Metrorail Trains Near Fort Totten Station, Washington, DC

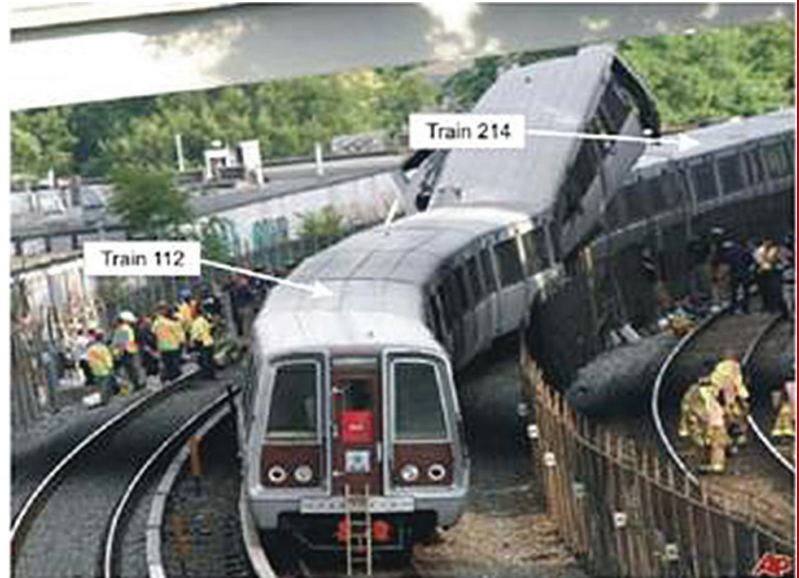
On Monday, June 22, 2009, at about 4:58 p.m. eastern daylight time, WMATA Metrorail train 112 struck the rear of stopped Metrorail train 214. The powerful impact caused the rear car of train 214 to telescope into the lead car of train 112, resulting in a loss of occupant survival space in the lead car of about 63 feet (about 84 percent of its total length). Nine people aboard train 112, including the train operator, were killed. Emergency response agencies reported transporting 52 people to local hospitals. (NTSB/RAR-10/02)

- “A failure of track circuit modules caused the automatic train control system to lose detection of one train (train 214) allowing a second train (train 112) to strike it from the rear.” (NTSB NEWS SB-10-29)
- WMATA failed to institutionalize and employ across the system an enhanced track circuit verification test procedure that was developed following a near collision in Rosslyn, VA, in 2005. **If this test procedure had been institutionalized and used systemwide, it would have identified the faulty track circuit before the accident.** (NTSB/RAR-10/02)
- Other major contributing factors were “WMATA’s lack of a safety culture” and WMATA’s failure to replace or retrofit 1000-series railcars, which were shown in a 2004 accident to exhibit poor crashworthiness. (NTSB/RAR-10/02)
