Motorcoach Roadway Departure
and Overturn on Interstate 95
Near Doswell, Virginia
May 31, 2011

NTSB/HAR-12/02
PB2012-916202

Highway Accident Report

Abstract: On Tuesday, May 31, 2011, approximately 4:55 a.m. eastern daylight time, a 2000 Setra 59-passenger motorcoach operated by Sky Express, Inc., occupied by a driver and 58 passengers, was traveling north on Interstate 95 in the right lane of the three northbound lanes near Doswell, Virginia. The motorcoach drifted from the highway to the right, struck a cable barrier, rotated counterclockwise around its vertical axis, overturned to the right, and rolled onto its roof. As a result of the accident, 4 of the 58 passengers were killed, 14 received serious injuries, and 35 received minor injuries. The driver sustained minor injuries and refused medical treatment.

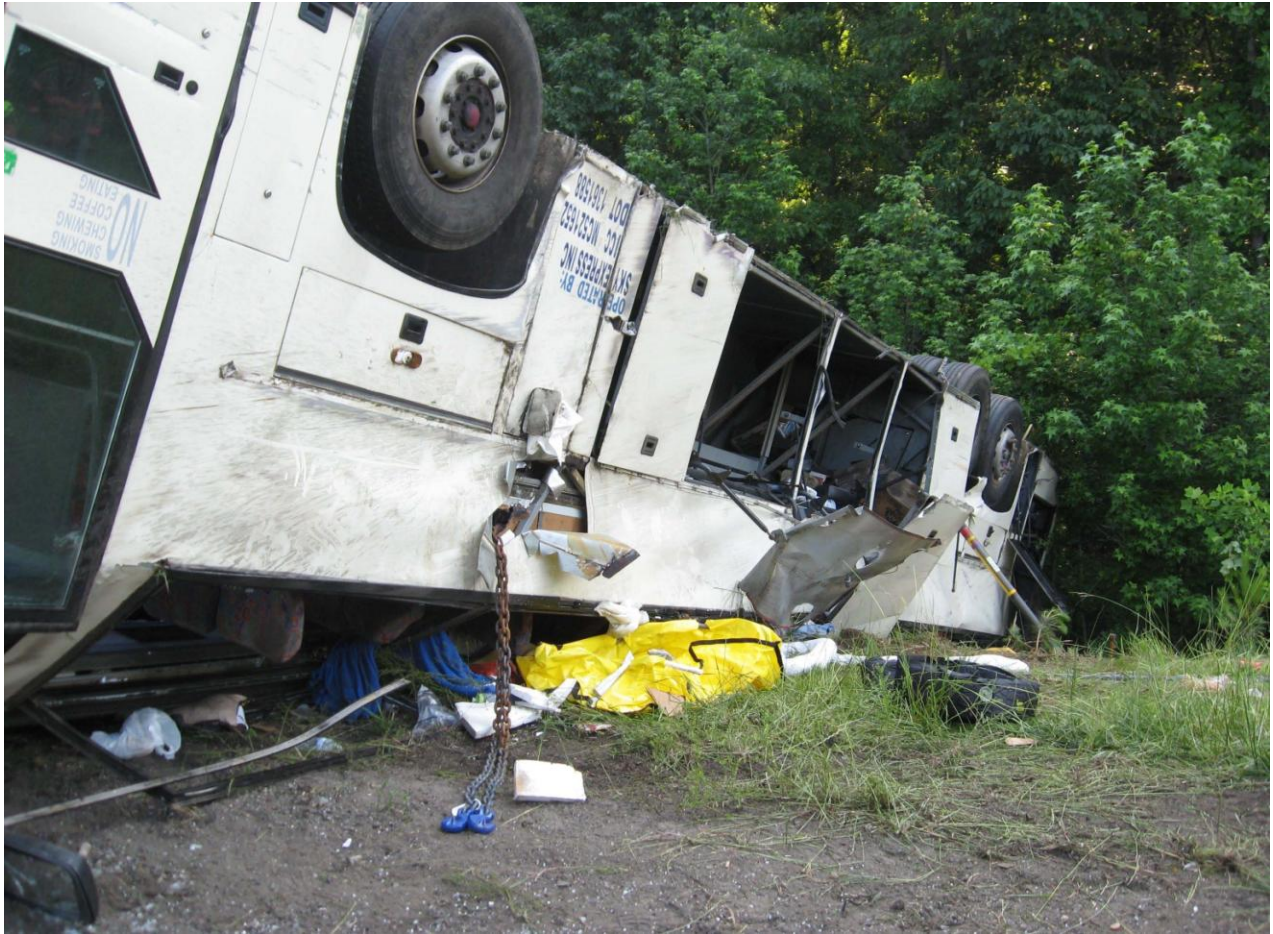
The motorcoach's impact with the low-tension cable barrier system caused a 6-foot cable deflection and displaced 21 cable posts. The maximum cable deflection occurred 273 feet from the location at which the motorcoach drifted from the road. Based on the ground scar evidence, investigators believe that, after striking the barrier, the motorcoach traveled several feet along the barrier while rotating counterclockwise (so its front was turning back toward the road) before overturning onto its passenger side, sliding, overturning onto its roof, and coming to final rest on its roof about 460 feet from where it left the roadway. (See figures 1, 2, and 3.)

Figure 1. View facing the passenger side of the overturned motorcoach at the accident scene. The front of the bus is to the left side of the photograph. (Photograph courtesy of the Federal Motor Carrier Safety Administration.)

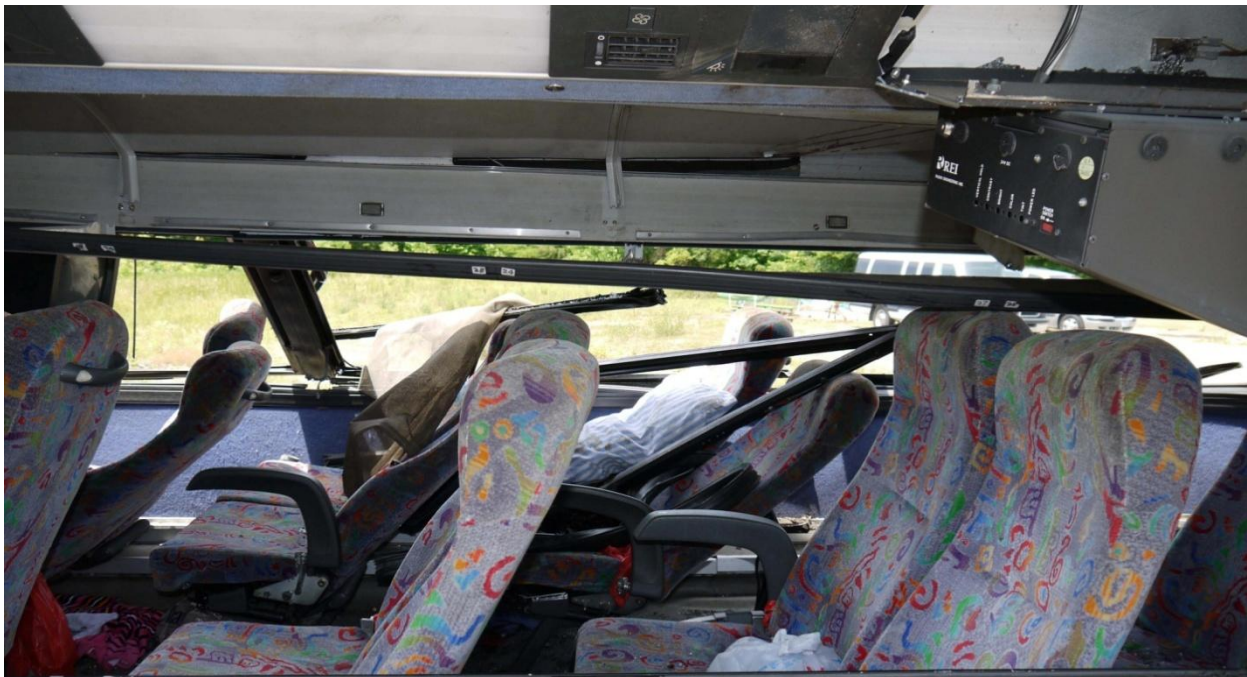
Responders located two deceased passengers trapped between the roof and the tops of seatbacks. Two other deceased passengers were found partially ejected out the passenger side of the bus. Postaccident photographs show evidence indicating that the sidewall structure at the base of the windows caused the fatal blunt force trauma to the head of one of these two passengers and to the head and chest of the other when the motorcoach roof shifted laterally and collapsed during the rollover.

The roof of the accident bus was deformed laterally toward the driver side of the vehicle and displaced vertically toward the tops of the seatbacks. In the center of the bus, in the area of maximum roof crush, the interior luggage rack and bus roof were resting on top of the seats. Due to the roof crush, the bottom panel of the overhead luggage rack on the passenger side fractured away from the roof mountings and rested on top of the seatbacks, angling from row 3 on the passenger side to row 10 on the driver side.

Figure 5. Passenger seats in rows 6 to 8 of the motorcoach after the vehicle was righted following the accident, showing the extent of the roof crush. (Note: The maximum roof crush, or roof deformation, was greater than seen here. It is common for a vehicle structure to “spring back” somewhat after an impact.)

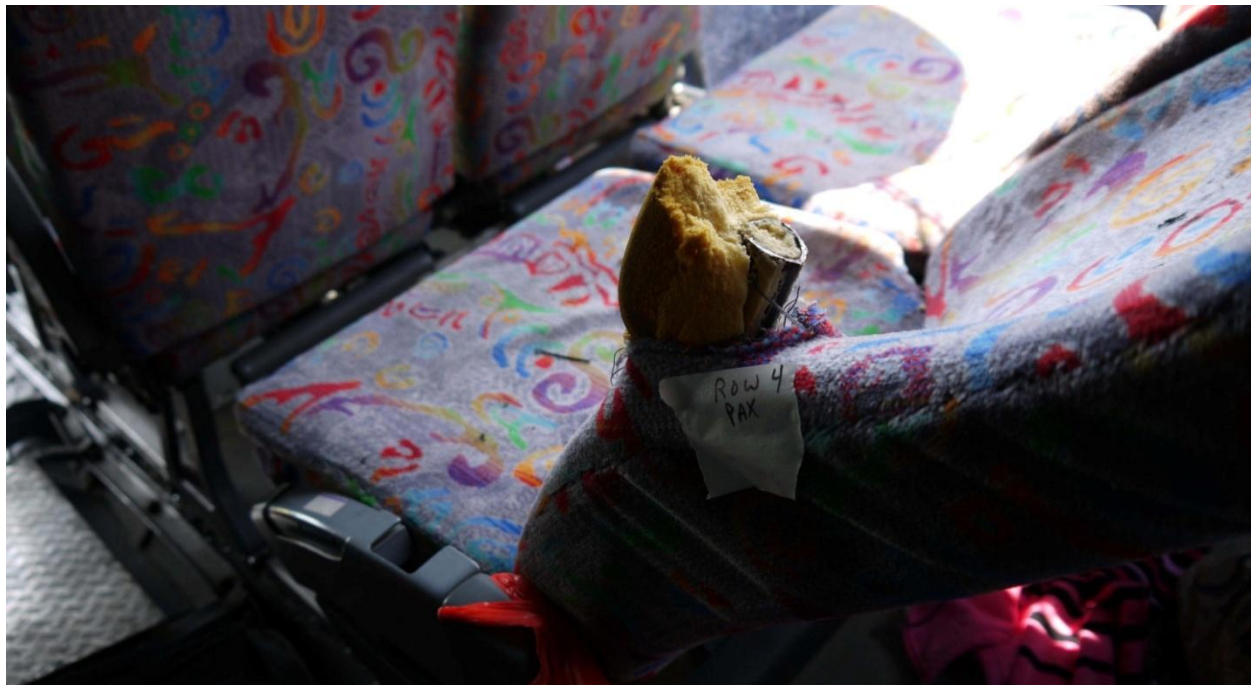
Figure 6. Damage to the aisle seat in row 4 on the passenger side of the motorcoach, showing that the collapse of the roof was so forceful it broke the seat structure.

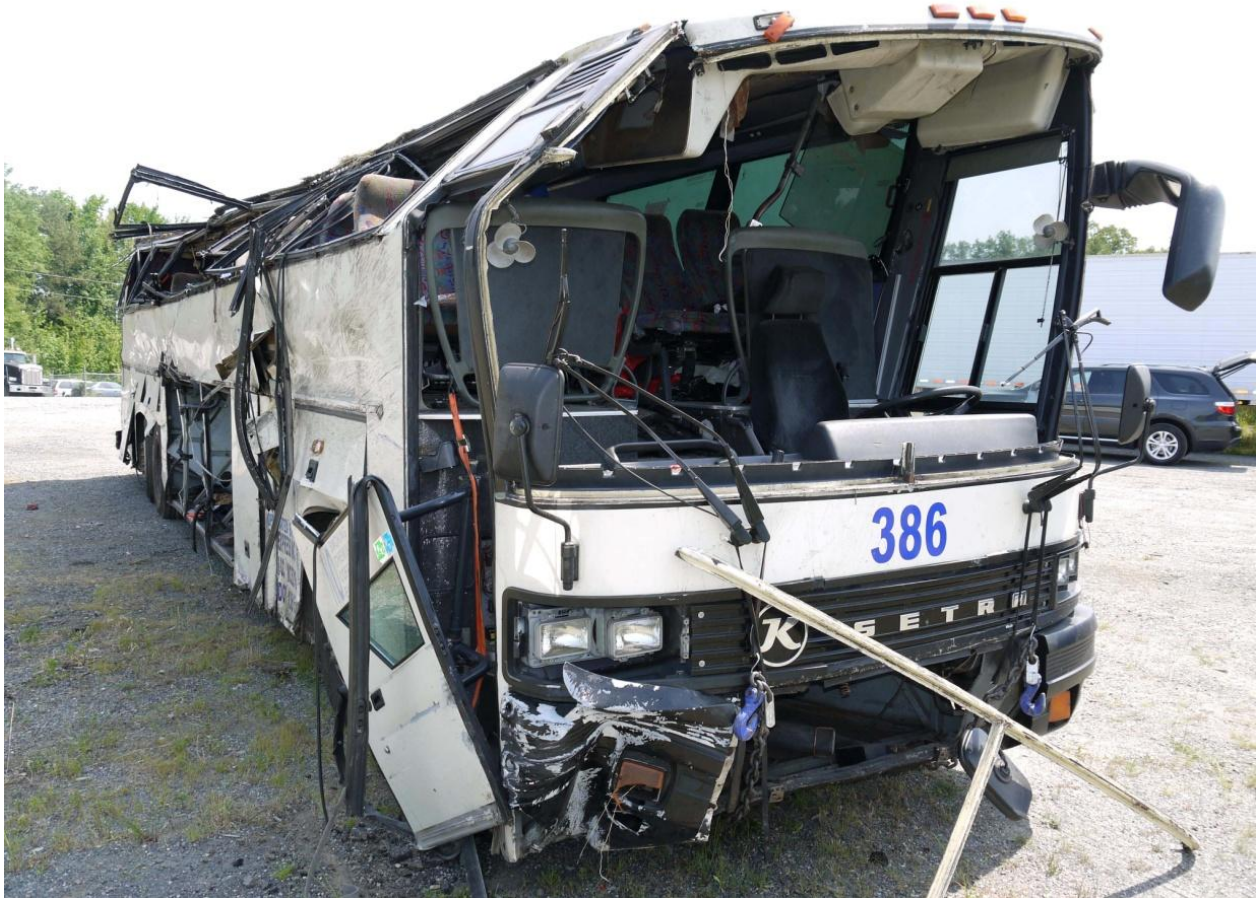
The accident bus was damaged over the extent of its front and passenger side; it also had significant roof deformation as a result of the rollover. The vehicle's initial impact with the three-strand cable barrier resulted in damage to the front end and passenger side. The direct contact damage extended from the vehicle's passenger-side front bumper corner to and along its passenger side. The approximate maximum crush to the bumper was 15.5 inches aft. Two deep parallel gouges, spaced 3 inches apart and measuring 129 inches long, were located on the passenger side of the bus, oriented at an angle of about 15 to 17 degrees counterclockwise from horizontal. Three external luggage bay compartment doors were detached from the passenger side of the bus. The boarding door located at the front passenger side of the bus retained only its bottom half; it also was only partially attached and hanging from the door frame. The rear and driver side of the bus had less damage, showing some body cracks and deformation induced from the damage to the side of the bus body. (See figure 7.)

Figure 7. Motorcoach postaccident, showing overall accident damage.

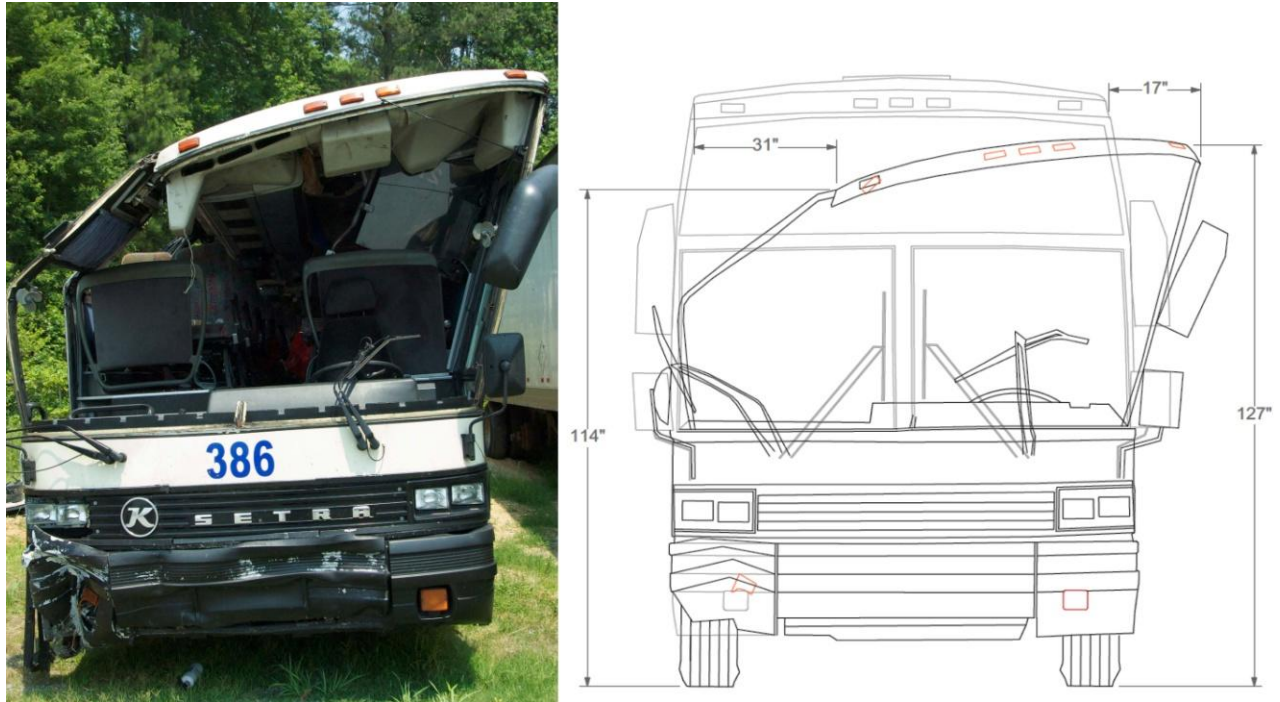
All windshield glazing, the upper boarding door glazing, and all passenger window glazing on the passenger side of the motorcoach were missing.¹³ The glazing from three of the seven passenger windows on the driver side of the vehicle was also missing. The driver's side window glazing was intact, and the window was found partially open at the time of initial postaccident inspection. (See figures 8 and 9 for additional damage information.)

Figure 8. Side-by-side images of structural deformation of the accident motorcoach viewed from the front. (The photograph on the left shows the front view of the motorcoach post-accident. The drawing on the right shows the post-accident front profile of the accident motorcoach, superimposed over the profile of an undamaged exemplar motorcoach.)

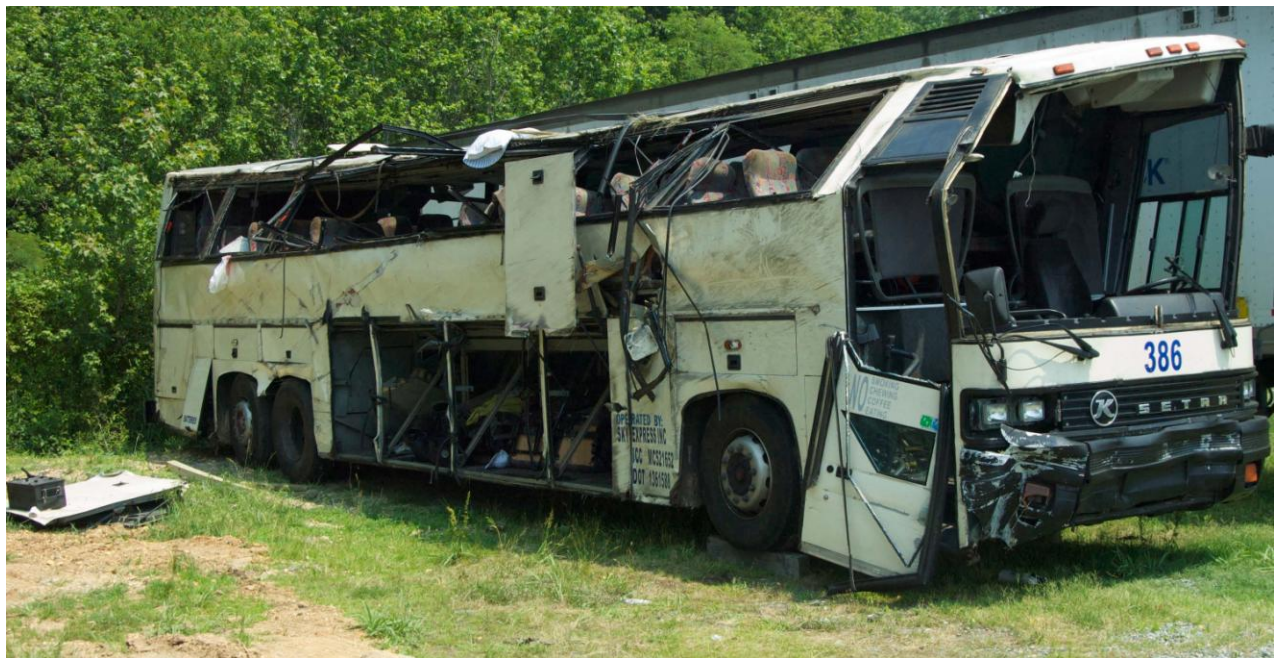
Figure 9. Damage to the passenger side of the motorcoach.

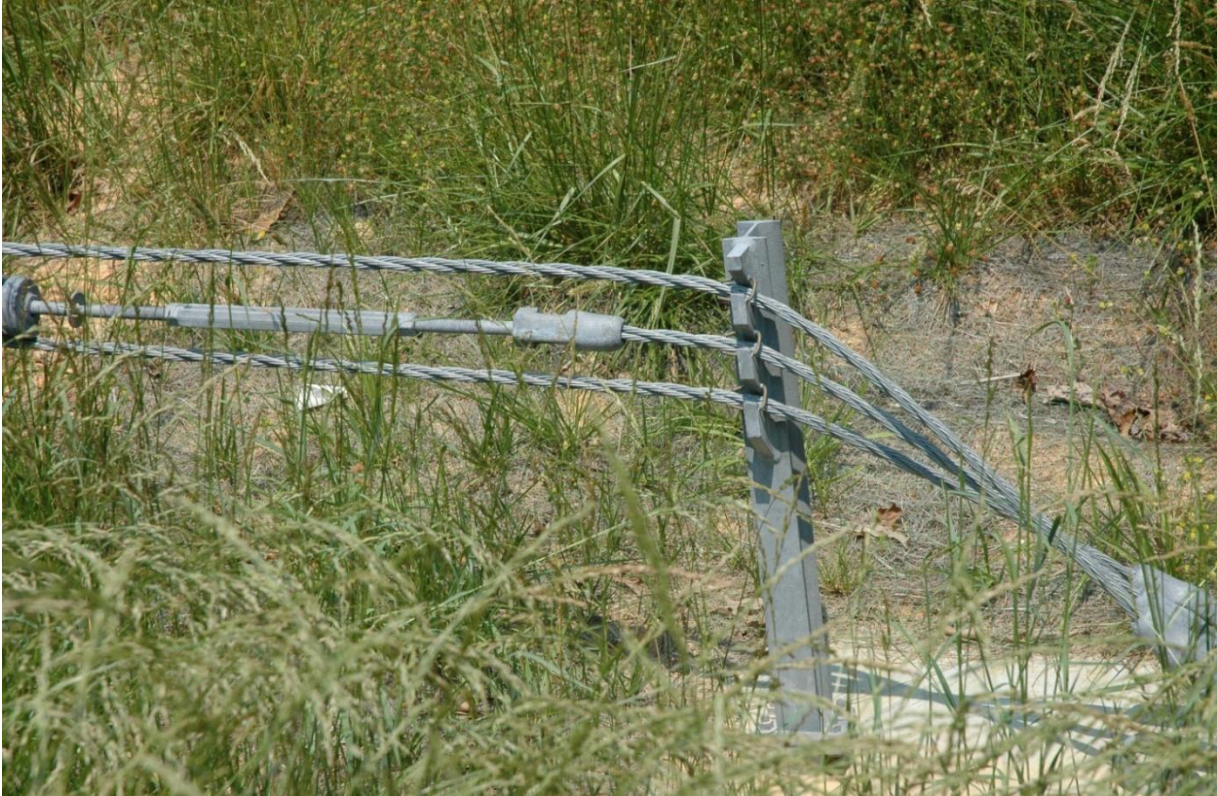
Tire marks at the accident scene indicated the motorcoach drifted from the right shoulder at an angle of about 6 degrees. The maximum engagement with the low-tension, three-strand cable barrier system occurred 147 feet after the initial impact and 273 feet after the motorcoach left the road.³¹ The barrier was located approximately 14.5 feet from the edge of the paved shoulder and 26.5 feet from the travel lane; it extended over a lateral distance of 806 feet. (See figure 11.) The motorcoach initially struck the 10th post from the south end of the installation and overran 21 posts. Evidence of tire furrows in the earthen roadside embankment began 20.5 feet from the pavement. The wire cables remained intact.

Figure 11. Three-strand cable barrier near accident site.
