BUREAU OF RECLAMATION
FACILITIES INSTRUCTIONS, STANDARDS & TECHNIQUES
Volume 5-11

# POTENTIAL HAZARD FROM MESSWANDLER-BAU INSTRUMENT TRANSFORMERS

## Potential Hazard from Messwandler - Bau Instrument Transformers

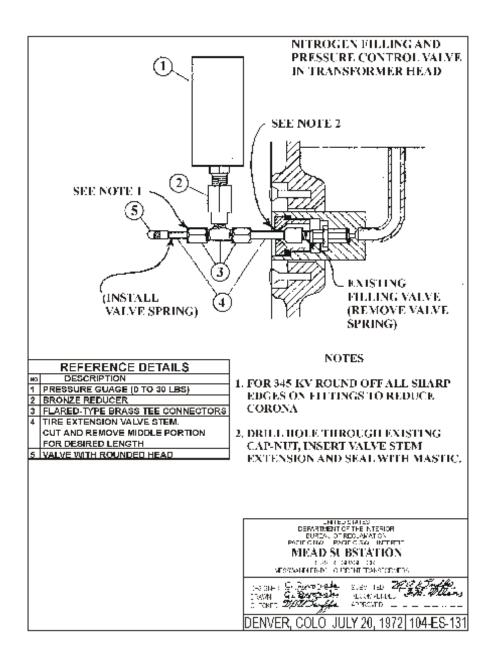
During a four year period in the late 1960's and early 1970's, Reclamation experienced five destructive explosions of Messwandler-Bau (MWB) 230-kV and 345-kV current transformers. MWB agreed to rebuild 42 JK-196 units because of a high percent of combustible gas (ranging from 4 to 32 percent), high gas pressure (ranging from 8 to over 30 psi-g), and high power factor (ranging from 0.5 percent to 3.41 percent). This experience leads us to be concerned over future explosive failures affecting the safety of our personnel and the security of nearby power equipment.

Types JK-198 and JTS-345 MWB current transformers manufactured after 1964 are the units that are most prone to failure. It is suspected that the explosive failures are the result of internal corona action which causes buildup of excessive Internal gas pressure or leakage paths and ultimate flashover across major insulation.

Install a pressure gage as shown on the attached Drawing No. 1046-ES-131 to provide for convenient periodic monitoring and recording of the internal gas pressure during routine inspections. Gas pressure in excess of that shown in table 1 should be considered as indication that the instrument transformer may be abnormal and should be tested more frequently or removed from service; however, if the pressure exceeds 15 psi-g, the transformer shall be removed from service Immediately.

- When gas pressure exceeds 10 psi-g, a combustible gas test should be performed immediately. A combustible gas content of over 4 percent indicates that the transformer may be abnormal and should be tested more frequently or removed from service.
- Perform weekly or periodic visual examination of the units for detecting oil leakage, discoloration or other abnormalities during routine inspections.
- 4. Establish a periodic Doble test schedule of 2 years for normal MWB units and perform more frequent testing on questionable units. Power factor readings exceeding that permitted by the manufacturer's instruction book (1.0 percent at 20 • C for Types UT-196 and UT-230 and 0.5 percent at 20 • C for all other types listed above) should be considered as an indication that the current transformer is abnormal and should be tested more frequently or removed from service.
