# HIGHWAY ACCIDENT REPORT

PROPANE TRACTOR-SEMITRAILER  
OVERTURN AND FIRE

U.S. Route 501,  
LYNCHBURG, VIRGINIA  
March 9, 1972

**Report Number: NTSB-HAR-73-3**

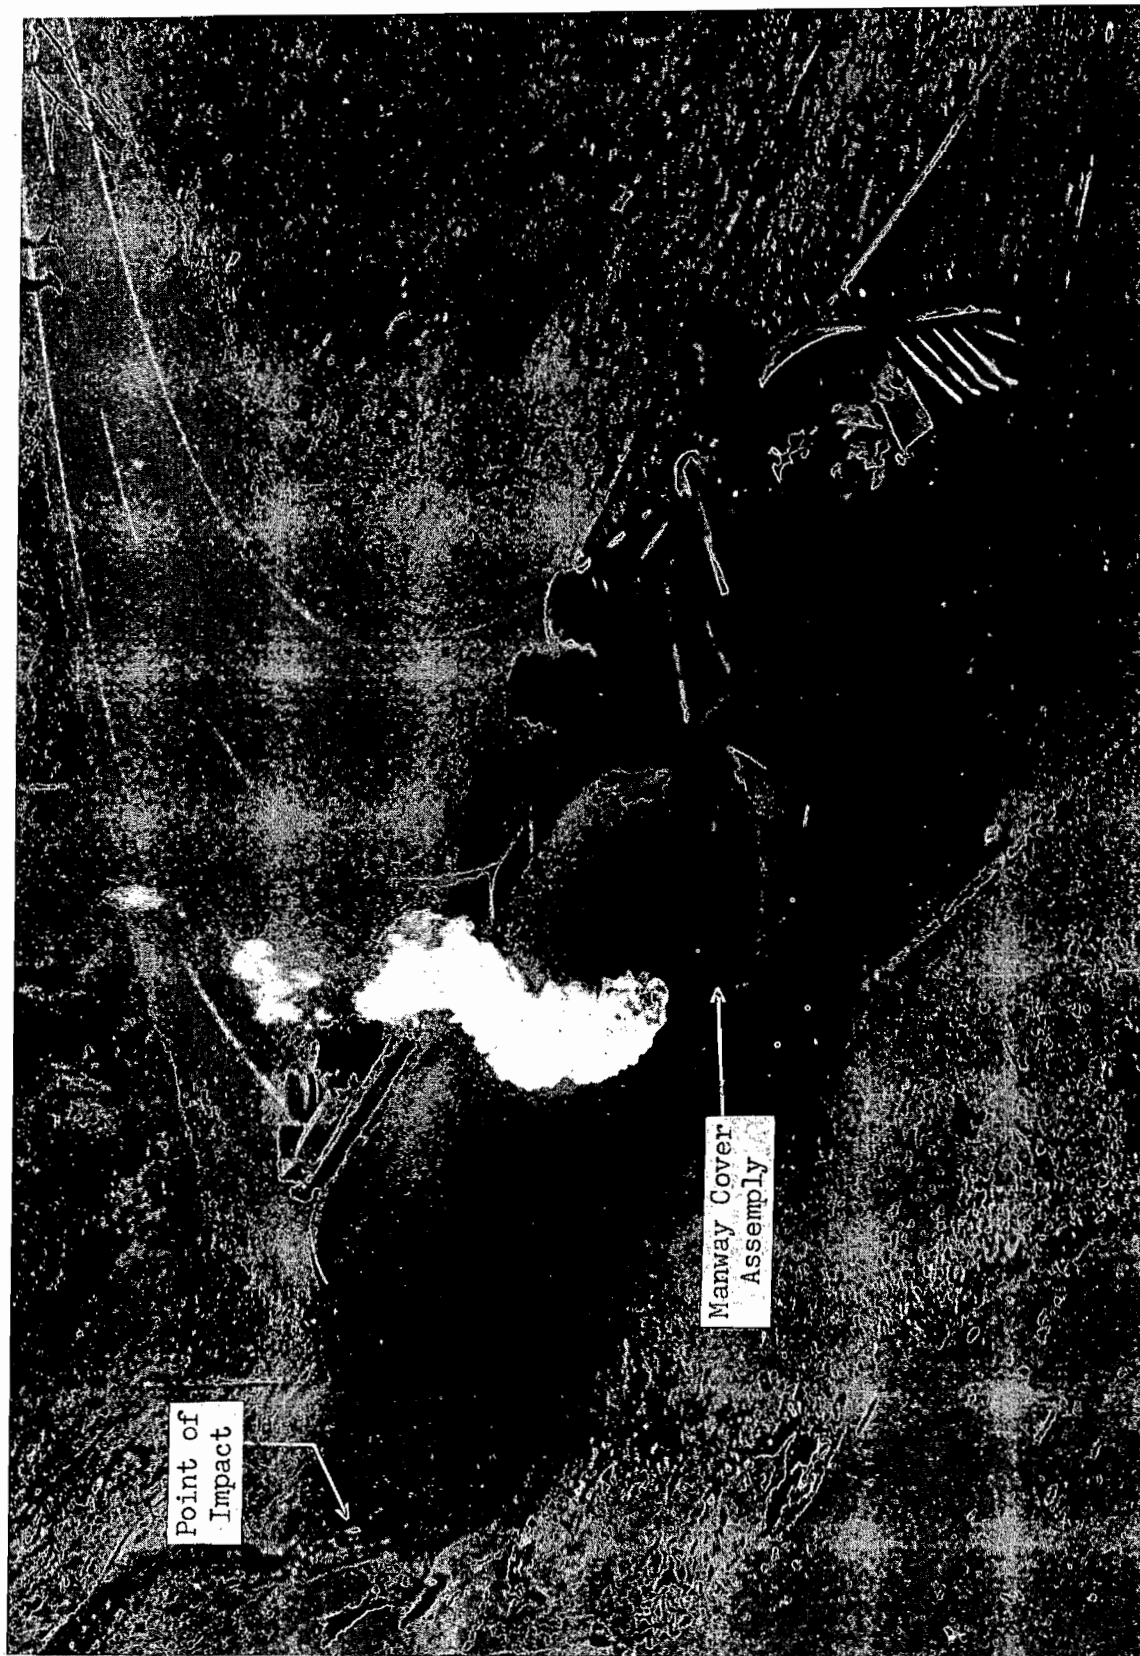
Figure 3. Final position of truck after rollover and impact with embankment. Propane-air mixture burning at tank rupture just to the rear of the manway cover.

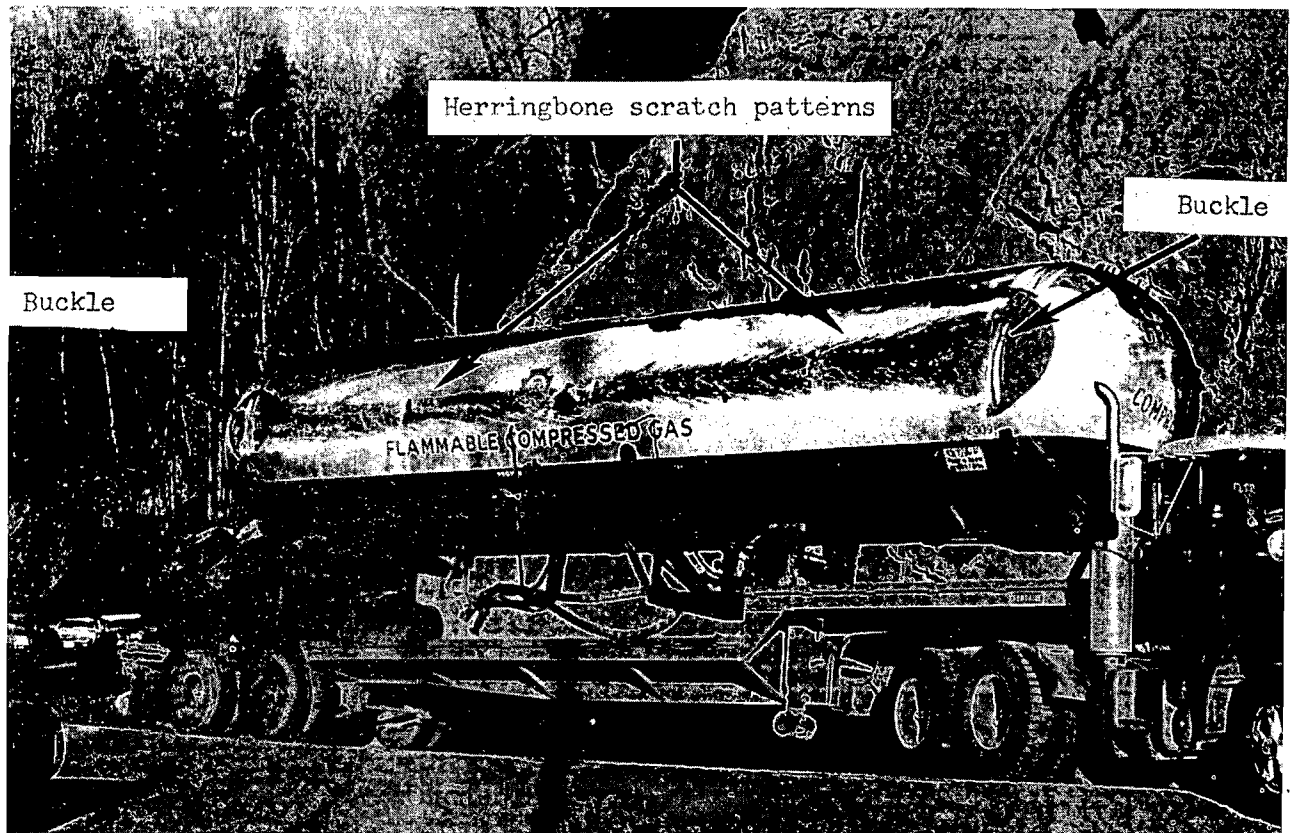
**Trailer.** A multiple-herringbone scratch pattern extended along the entire right side and slightly above the horizontal axis of the tank shell. A vertical buckle about 2 inches deep and approximately 3.5 feet long was found in the right side of the head material, at both ends of the tank, adjacent to the forward and rear head-to-shell circumferential welds. There was no material or weld failure in the area of these buckles. (See Figure 6.)

Figure 6. Right side of trailer after rollover.

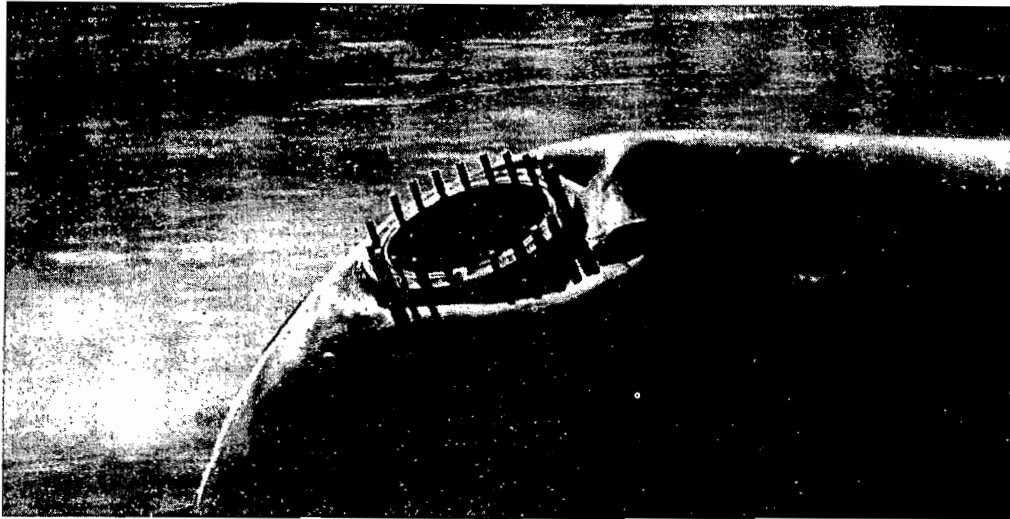
The forward-mounted manway cover assembly was pushed inward and rearward. The adjacent head and shell material was buckled inward and rearward. (See Figure 7.) The manway cover had a longitudinal scratch pattern in the

Figure 7. Forward-mounted manway. Note inward deformation and buckling of head and shell material.

Other force components, of unknown magnitude and not involved in the shearing of the studs, pushed inward and rearward on the manway cover. These forces, along with the force which sheared the studs, were transferred through the relatively stiff manway cover and manway reinforcing member into the 0.250-inch-thick head material. The resultant buckling caused by this increase of loadings onto the head material induced stresses of sufficient magnitude to rupture the material. The rupture then crossed the circumferential welds into the thicker, 0.387-inch-thick shell material.

11. The design and fabrication of the MC 331 trailer performed well in this accident with one exception. The location and design of the manway cover assembly in the front hemispherical tank-head allowed the assembly to transmit impact loadings which caused failures in the head and shell materials.

the Tank Truck Technical Council consider the desirability of amending 49 CFR 178.337-6 (Closure for manhole) to require that all manhole assemblies in MC 331 pressure vessels manufactured after a specified date be located in the upper quadrant of the rear hemispherical head to minimize the possibility of manhole-assembly collision with other vehicles or objects. (Recommendation No. H-73-20)

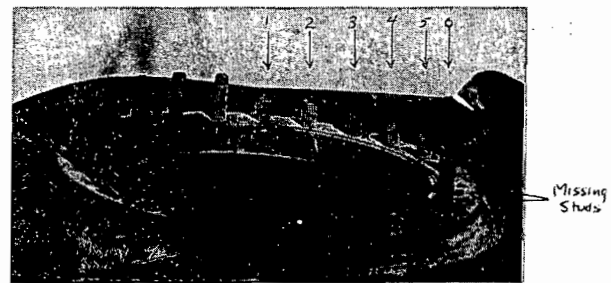
upper left quadrant which appeared to have been the point of initial impact with the rock outcropping. Six of the 24 manway cover studs were sheared off at the top surface of the manway cover. (See Figures 8 and 9.)

Figure 9. Sheared studs at manway opening. Top of manway is at stud number 1. (Missing studs were removed at time cover was taken off to flood tank.)
