HIGHWAY ACCIDENT REPORT

HOPPY'S OIL SERVICE, INC.,
TRUCK OVERTURN AND FIRE,
STATE ROUTE 128,
BRAintree, MASSACHUSETTS

OCTOBER 18, 1973

NATIONAL TRANSPORTATION SAFETY BOARD
Washington, D.C. 20591
REPORT NUMBER: NTSB-HAR-74-4

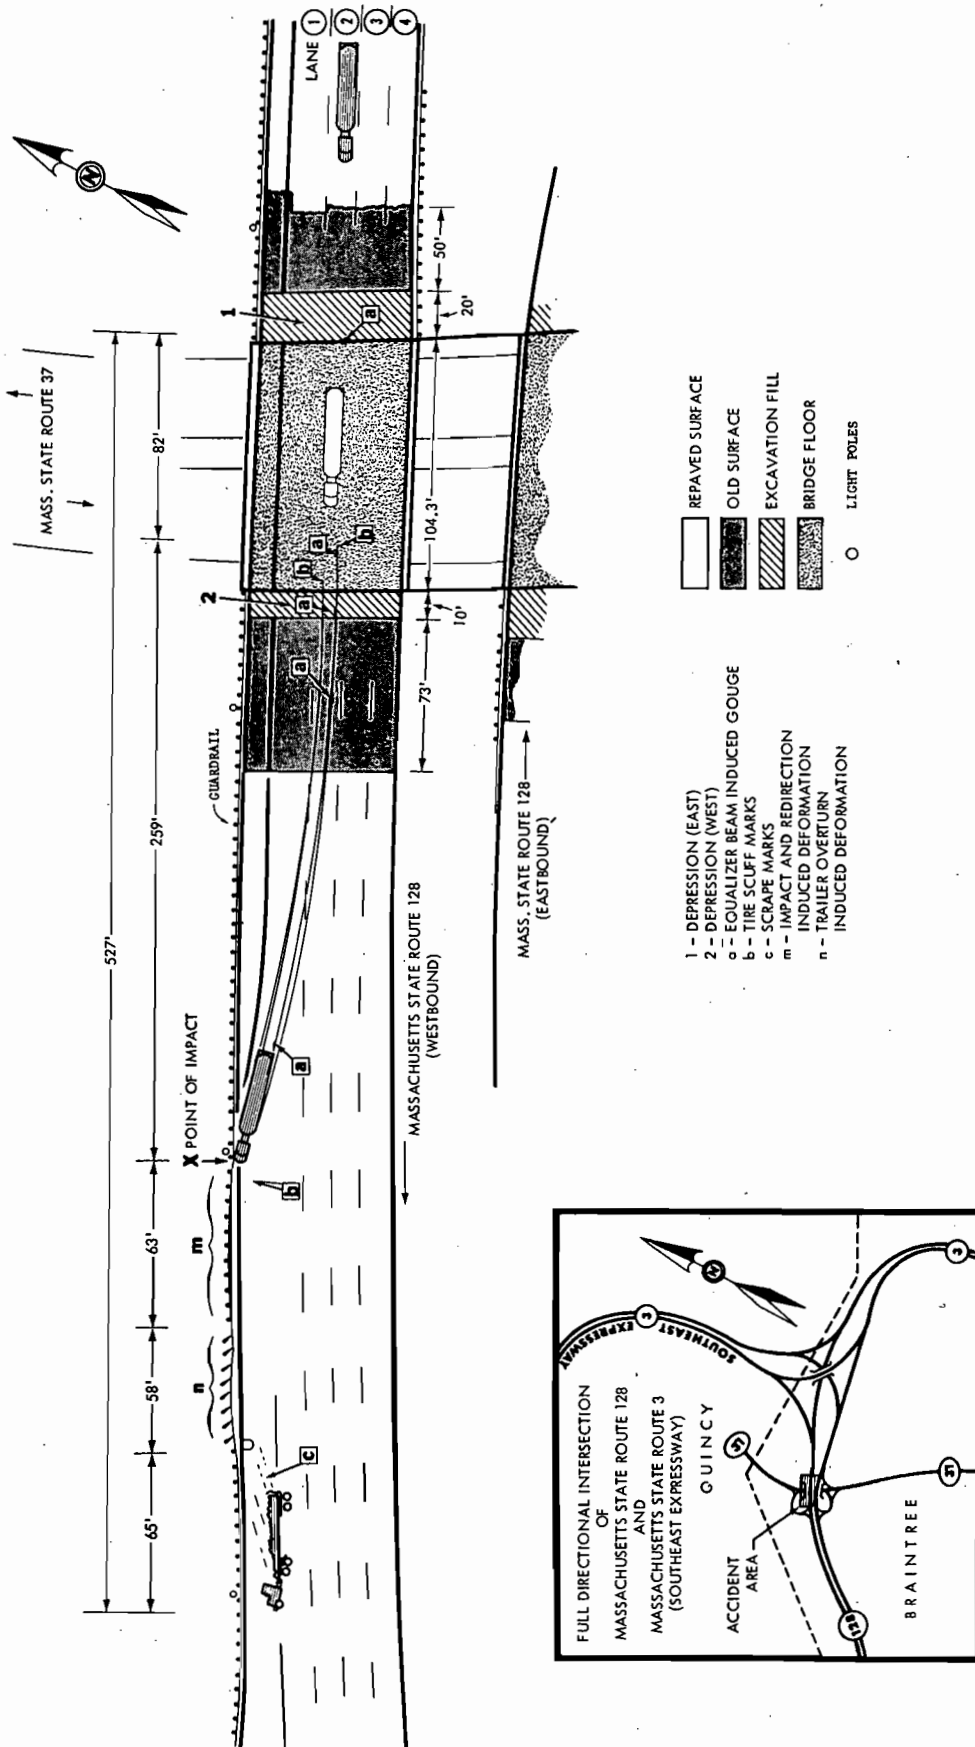
Figure 1. Accident Site.

A postaccident examination of the road revealed gouge, tire scuff, and scrape marks which began in the second traffic lane in the depression east of the Route 128 overpass bridge. (See Figure 3.) Two patterns of tire marks were observed on the roadway. The first included four parallel marks, the spacing of which were consistent with the width between tires

Highway repair activities. The resurfacing project on Route 128 started approximately 0.35 mile east of the overpass and continued several miles westward. The first course of a two-course overlay had been applied to the old road surface from the start of the project to a point 70 feet east of the east end of the overpass, then began again 83 feet west of the west end of the overpass, and continued through the accident site. (See Figure 1.) These overlays were feathered to the old road surface.

On the day before the accident, 9-inch-deep excavations were dug in the old road surface across the full width of the highway at both ends of the overpass. The excavation at the east end of the overpass was 20 feet long, and at the west end, 10 feet long. These excavations were filled with asphalt concrete, which was compacted to the level of the old road surface and the overpass floor with a mechanical roller. Traffic further compacted this material and caused a depression in the roadway, which averaged from 1 to 1½ inches in depth.

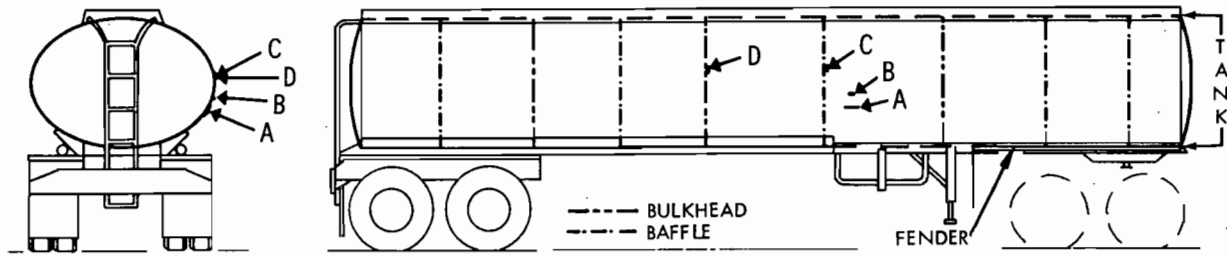
a. TRAILER DIAGRAM. LOCATION OF PUNCTURES A AND B, AND ABRASION HOLES C AND D. FENDER WAS TORN OFF DURING INITIAL PHASE OF TRAILER OVERTURN ONTO GUARDRAIL.

Trailer. The right side trailer-mounted tractor tandem suspension fender was torn from the trailer during impact with the guardrail. Two longitudinal punctures and two transverse abrasion holes were found in the remaining section of the right side of the tank shell. (See Figure 2.) One puncture, about 20 inches above the bottom of the tank, was about 8 inches long and about 0.25 inch wide. The second, about 25 inches above the bottom of the tank was about 2.75 inches long and about 0.50 inch wide. Both punctures were about 14 feet from the front of the tank. Two abrasion holes, 4 to 5 inches long and 0.125 to 0.25 inch wide, were about 36 inches above the bottom of the tank, with one about 15 feet and the other about 20 feet from the front of the tank. At least 3/4 of the aluminum alloy tank shell melted away in the fire. (See Figure 7.)

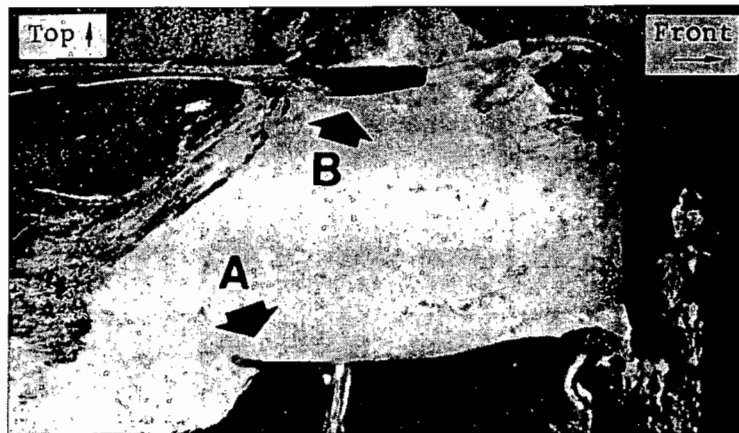
b. Punctures in cargo tank caused by guardrail posts.

9. The aluminum alloy cargo-tank shell was punctured when the truck overturned onto the guardrail and the steel posts punctured the tank material.
10. The aluminum alloy cargo-tank shell failed to resist abrasion as the truck slid along the pavement.

3. The Office of Hazardous Materials (Office of the Secretary, Department of Transportation) and the Bureau of Motor Carrier Safety (Federal Highway Administration) review 49 CFR 178.340 to determine if the regulation as presently written is intended to provide protection against puncture or abrasion of cargo tank walls during predictable accident environments. If this is not the case, consider the necessity of rewriting the regulation to provide this protection. (Recommendation H-74-33)

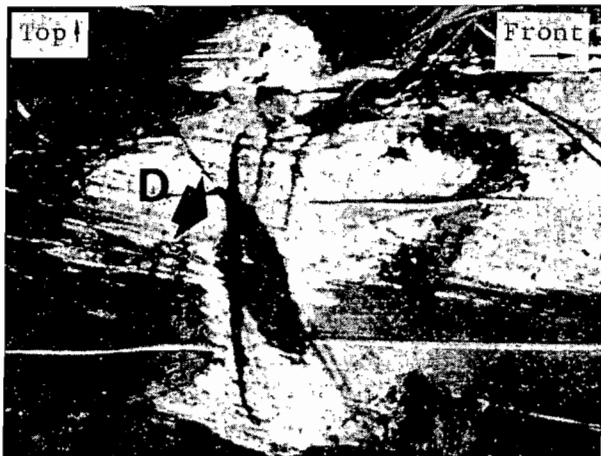
c. Abrasion failure caused by slide on roadway.

The other two openings in the tank shell were in the area of the abrasion marks which resulted from the tank's sliding on the road. These openings were located at points where the interior baffles contacted the tank shell. The edges of the baffles produced pressure points, which pressed the aluminum shell against the road surface. Some type of abrasion protection, such as rub rails, would prevent such failures.

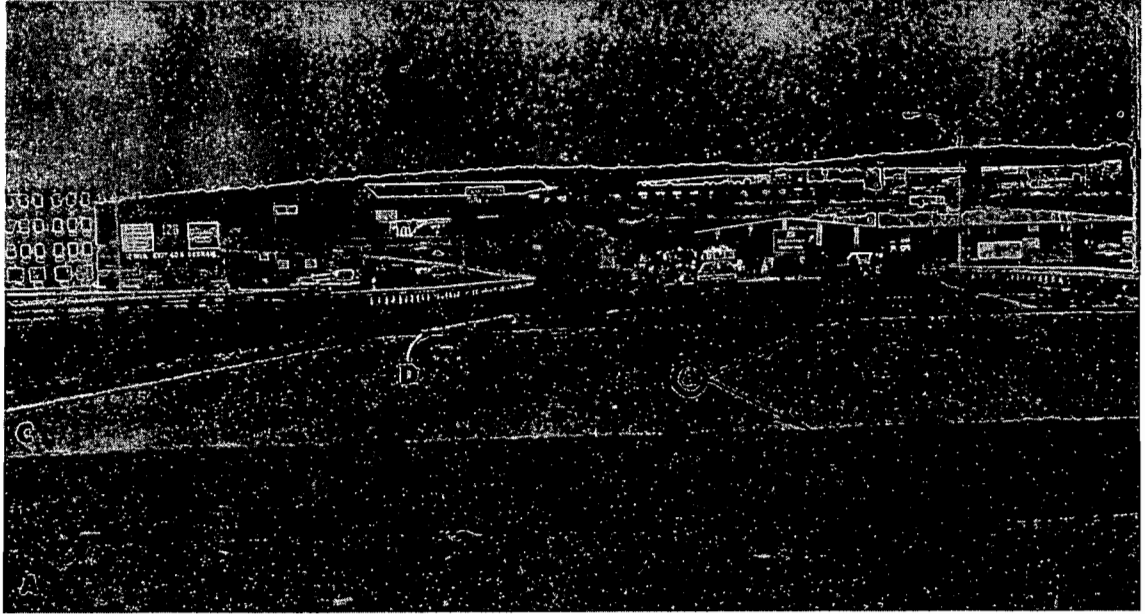
As the truck approached an overpass which carried Route 128 over State Route 37, the truck traversed a depression, 20 feet long and 1 to 1½ inches deep, which extended across the width of the roadway. As the truck crossed the depression, the rear end of the left equalizer beam of the tractor tandem suspension failed and dropped onto the roadway; the left end of the rear tractor tandem axle then pivoted rearward, which caused the vehicle to steer to the right. At that time, the truckdriver lost control of the vehicle.

Figure 3. Westbound lanes of State Route 128 east of overpass bridge.
A - old road surface. B - east depression. C - overpass floor.
D - west depression. E - old road surface. F - first course of repaving.
ⓐ First and second gouges from failed equalizer beam.

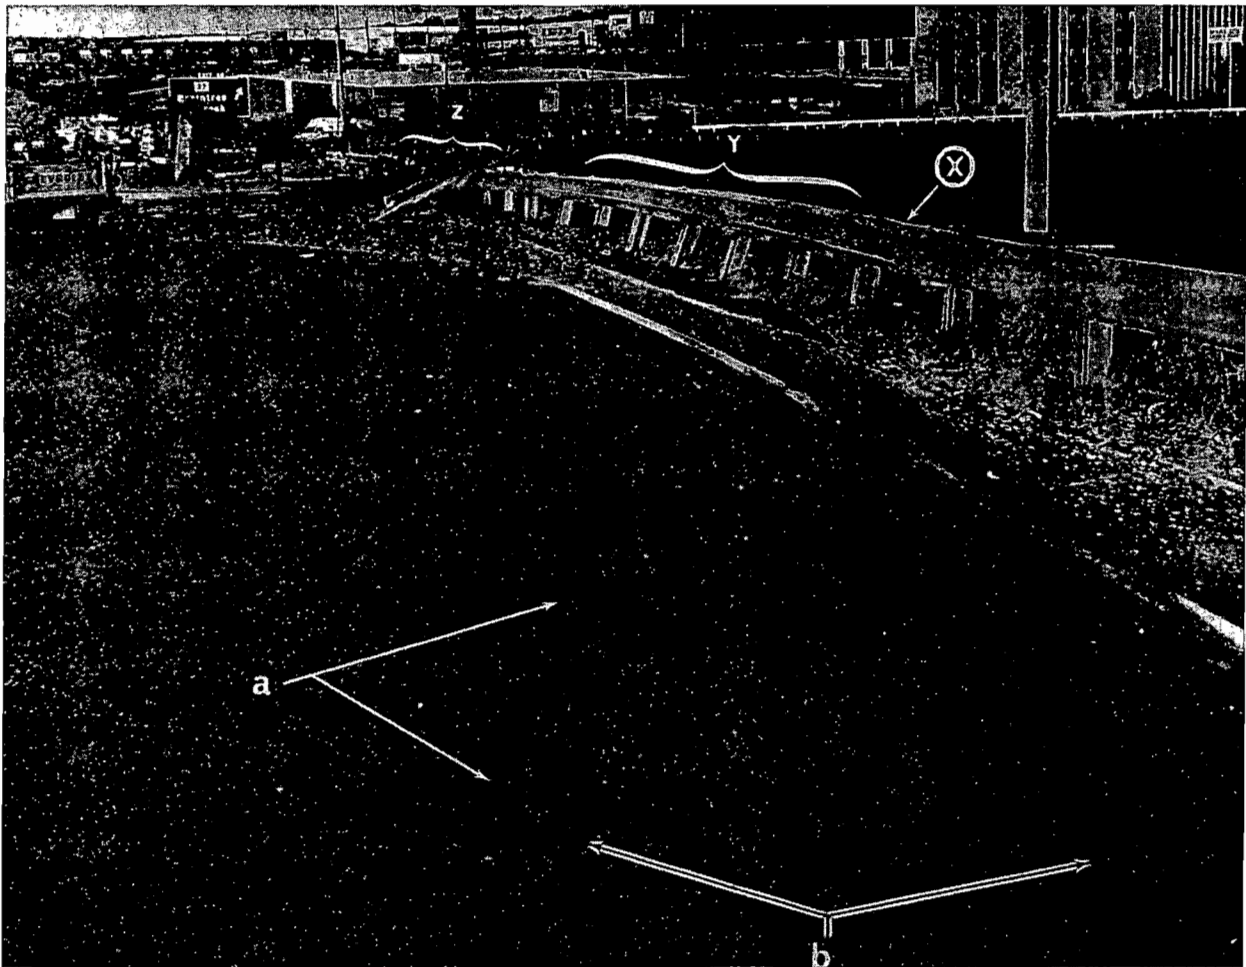
Rubber and paint transfers and scrape and gouge marks showed that the truck slid along the guardrail 121 feet. (See Figure 5.) Also, scrape marks showed that the truck slid 15 feet across the highway shoulder and 50 feet on the roadway before it came to rest. Fire damage to the roadway and guardrail extended 500 feet along the north edge of the highway and exit ramp as well as onto the grass and shrubs adjacent to the highway.

Figure 5. ① equalizer beam induced gouges. ② tire scuff marks.
⊗ impact point. ③ rubber and paint transfers and truck
redirection deformation to guardrail. ④ trailer overturn
deformation to guardrail.

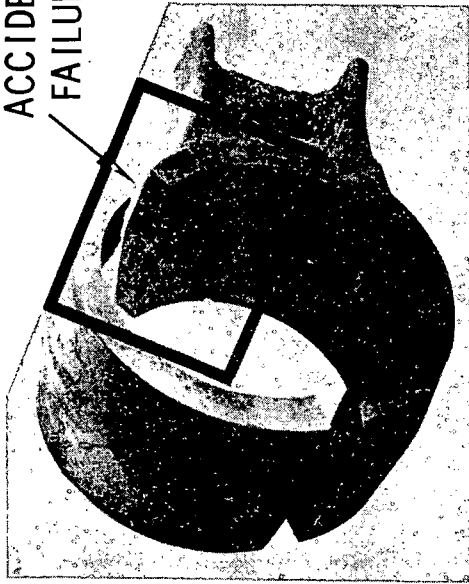
A series of cavities and pits, in groovelike alignment, were observed on the inside-diameter surfaces of the equalizer beam bushing holes, roughly parallel to the axis of the bushing holes. The bottom outside-diameter surface of the rear end of the left side equalizer beam was worn down approximately 0.25 inch. A section slightly less than half the circumference of the bushing hole of the rear end of the left side equalizer beam was broken out. (See Figure 6.)

b. Failed equalizer beam end.

Metallurgical examination of the failed beam end disclosed that the cavities on the inside-diameter surface of the equalizer beam end had been produced by heat--probably from the flame of a cutting torch. Hoppy's Oil Service bought the truck new in 1970. The maintenance records did not reveal any maintenance or repair work performed on the equalizer beams before or after March 21, 1973, when the worn bushings and sleeves were removed and replaced. The damage must have occurred during that operation. Supplement 588 to the International Harvester's Motor Truck Service Manual states that the proper method for removing worn equalizer beam bushings and sleeves and for installing new ones is by means of a press. (See Appendix C.) The use of a cutting torch or of other heat methods is not mentioned in the manual. Similarly, Hendrickson Manufacturing Company Service Bulletin AA-17730-70, which pertains to the RT-RTE series of Hendrickson tandem axle units, illustrates the proper method for removing worn equalizer beam bushings and sleeves and for installing new ones by means of a press. (See Appendix D.) The use of a cutting torch or other heat methods is not mentioned in the bulletin in connection with removing bushings and sleeves from equalizer beams or removing the bolt-type beam end mounting used on the suspension assembly involved in this accident. However, the bulletin does suggest as an alternate method, removing tube-type beam and mountings from the beam end hanger by cutting through the tube with a cutting torch. Caution in using a cutting torch is advised, because some beams are forged aluminum or nodular iron which can be damaged by heat.

1. The American Trucking Association, Inc., and the Motor Vehicle Manufacturers Association publicize the significance of proper vehicle maintenance and repair procedures with particular emphasis on the importance of not using heat of any kind in those areas where heat may adversely alter the strength characteristics of structural components. (Recommendation H-74-31)

4. That Hendrickson Manufacturing Company and International Harvester Company revise their respective maintenance and repair manuals and service bulletins to delete any reference to the use of heat-producing (ovens, burning, or cutting torch) methods in the performance of maintenance or repair operations that could in any way effect the strength characteristics of any vehicle component and further, to insure that the manuals and service bulletins carry conspicuous warnings against the use of such heat-producing methods. (Recommendation H-74-34)

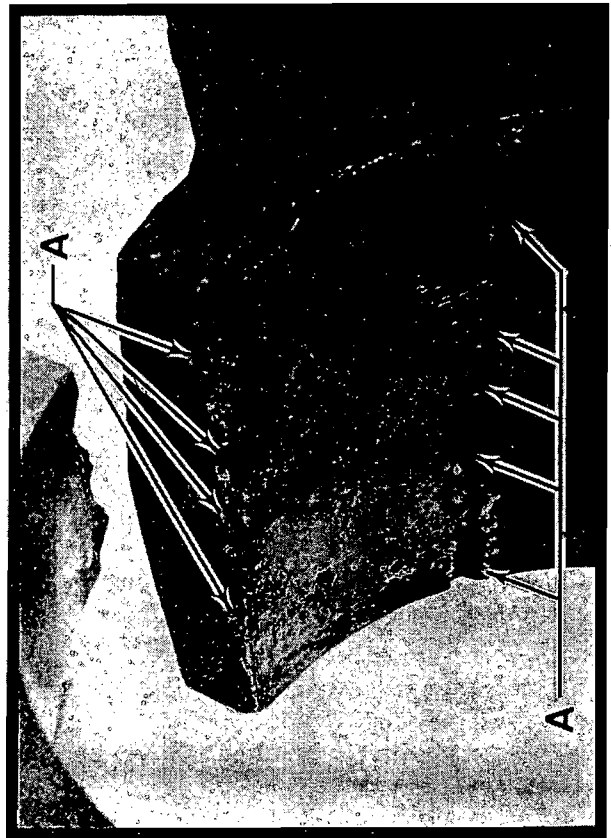
c. "A" - Cutting torch induced cavities.
(Insert from Figure 8-b.)

The joined cavities in the failed area were in a groove-like alignment roughly parallel to the axis of the bushing hole. The alignment was consistent with the configuration which would result from use of a cutting torch to remove the worn equalizer beam bushing from the bushing hole. The fact that all other bushing holes had similar alignment of cavities in the bushing holes substantiates the conclusion that a cutting torch had been used for bushing removal. The alignment of cavities created a discontinuity on the inside-diameter surface of the equalizer beam end and caused a stress concentration of sufficient magnitude to initiate failure of the beam end when it was exposed to additional dynamic loadings imposed by the road surface depression.

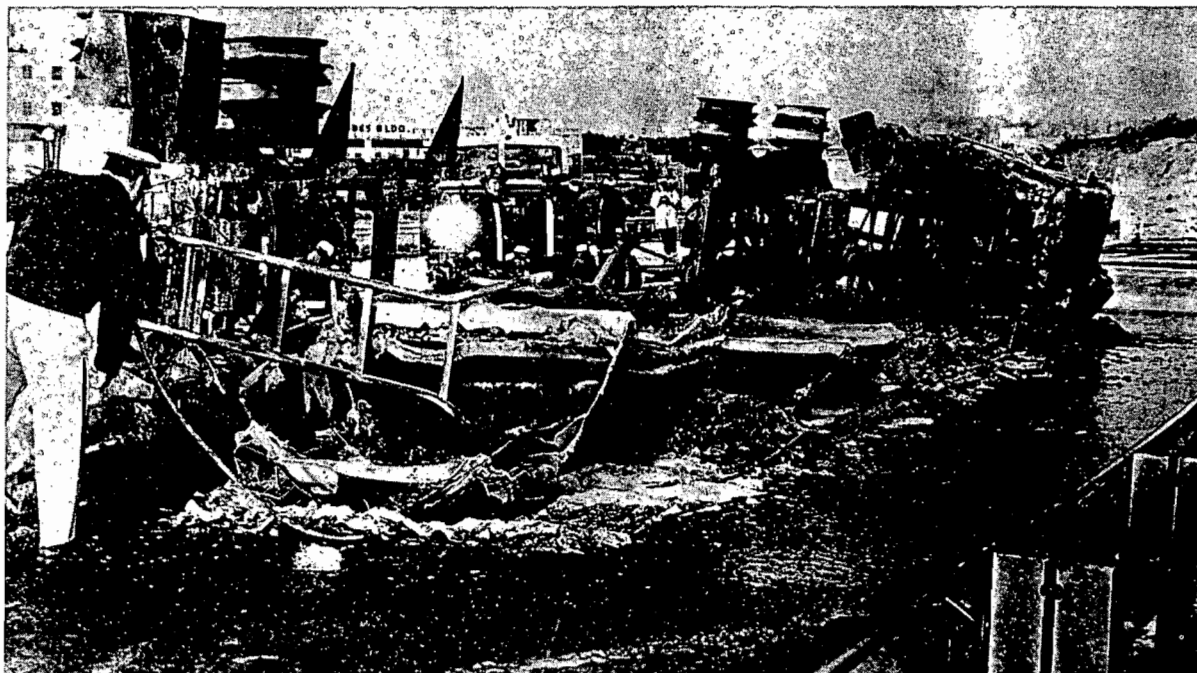
Figure 7. Final position of truck after redirection back into roadway and slide on right side along pavement, showing remaining portions of cargo tank shell material following fire.

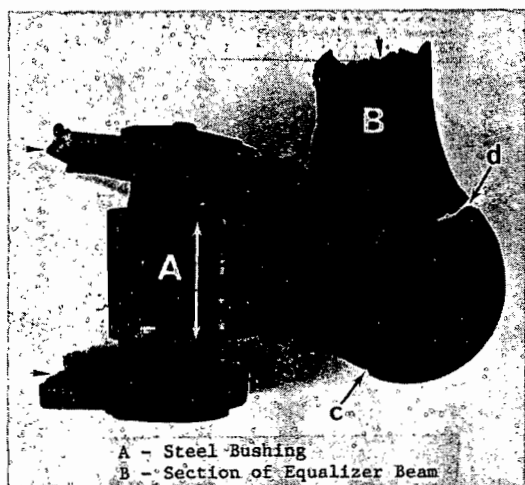
An overall view of the components examined is shown in Figure 1. The bushing at the attachment point (indicated by the letter "A" in Figure 1) was examined microscopically and found to be free of cracks.

The equalizer beam (indicated by the letter "B" in Figure 1) fractured in two places, as shown by arrows "c" and "d" in Figure 1. Examination of the fracture surfaces, with the aid of a binocular microscope, showed no evidence of fatigue or corrosion. Both fractures appeared to be typical of an overload failure.

Figure A-1. Photograph of assembly point casting and section of equalizer beam. Arrows "c" and "d" indicate the fracture locations. The arrowheads indicate surfaces which were cut in the field to facilitate examination of the parts. The white arrow denotes the orientation of shallow grooves found on the outside diameter surface of the bushing.

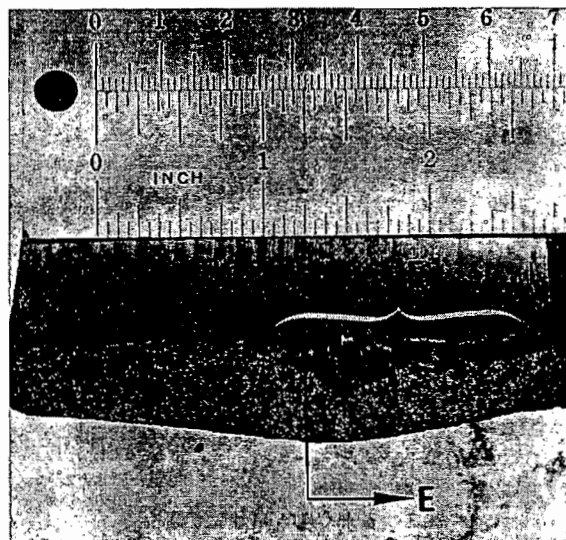
A closeup view of fracture surface "d" is shown in Figure 2. As indicated by the bracket in Figure 2, the fracture initiated along a cavity 1 3/4 inches in length on the inside diameter surface. The cavity was heavily oxidized and appeared typical of that produced by a cutting torch. The maximum depth of the cavity was approximately 3/16 inch in the area indicated by the line E-E in Figure 2. The original section thickness in this area was 3/4 inch. Thus, approximately 25 percent of the section thickness in this area was removed prior to the fracture initiation. Another cavity similar in appearance to that at the fracture was observed in a location of 1 1/2 inches from the fracture. The location of this cavity is denoted by bracket "g" in Figure 3.

Figure A-2. Surface of fracture indicated by arrow "d" in Figure A-1. Bracket denotes location of cavities. Arrowheads indicate extent of cavities from the inside diameter surface. Line E-E indicates location of metallographic microsection shown in Figure A-4.

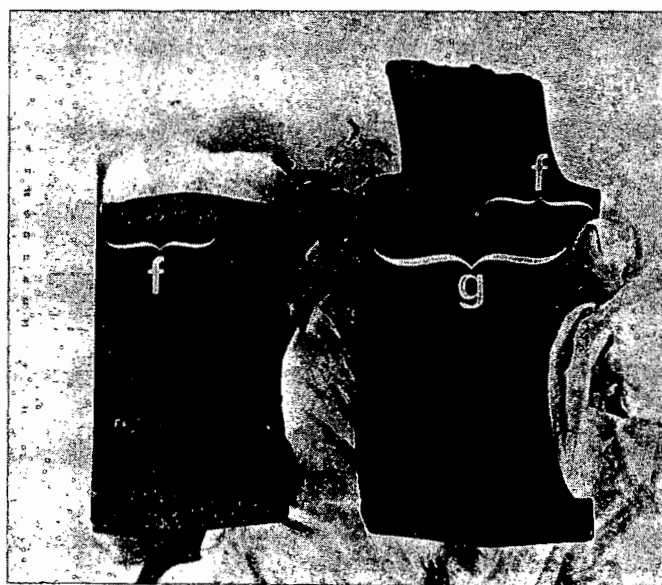
Figure A-3. Broken section of equalizer beam showing fracture surfaces and locations of cavities on the inside diameter surface. Brackets "f" and "g" denote areas of cavities.

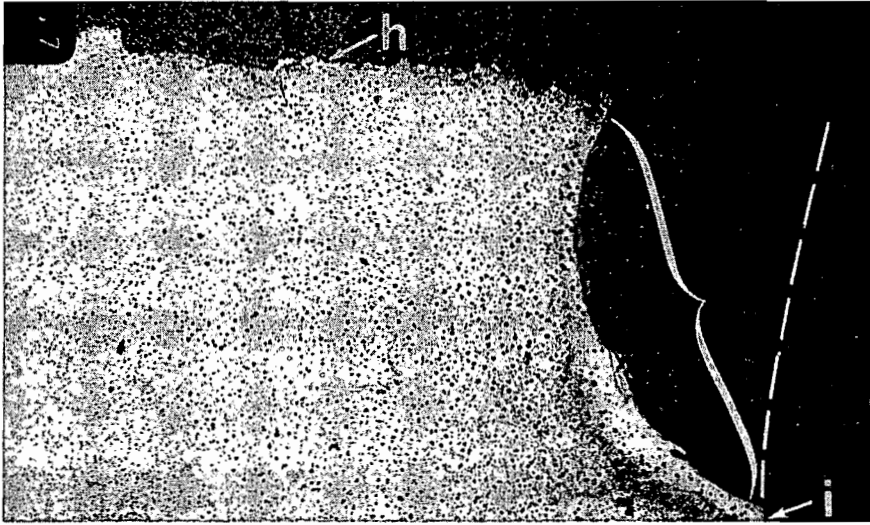
A transverse metallographic microsection through the fracture plane at the location indicated by the line E-E in Figure 2 is shown in Figure 4. The original inside diameter surface relative to the cavity is indicated by a dashed line in Figure 4. Figure 5 is a higher magnification photomicrograph of the section through the cavity surface. Two distinct zones are outlined by the brackets "j" and "k" in Figure 5. The original base metal structure, as outlined by bracket "j", is essentially composed of a pearlite matrix with a dispersion of graphite nodules which complies with the manufacturer's specifications. Bracket "k" outlines a zone having a microstructure distinctly different from that of the base metal. This layer approximately 0.009 inch thick indicates a high temperature transformation of the original microstructure. The microstructural transformations in this zone are typical of what would be expected if the material was heated to or above its melting point and cooled rapidly.

Figure A-4. Metallographic microsection through the origin area of fracture "d" along section E-E in Figure A-2. The dashed line outlines the approximate location of the original inside diameter surface. The fracture plane is marked by arrow "h". A small section of the undamaged inside diameter surface is denoted by arrow "i". The bracket outlines the cavity surface. X6

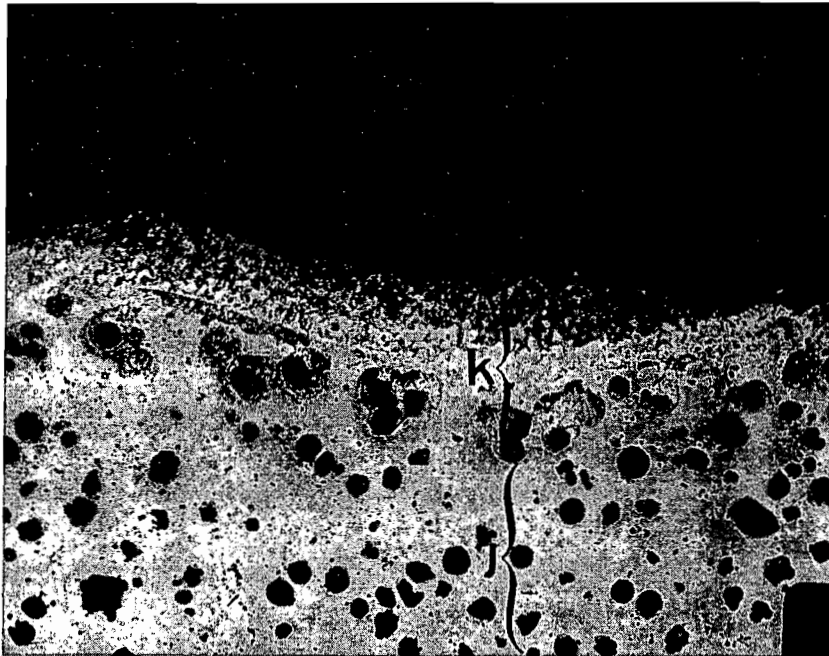
Metallographic examination of the fracture surface indicated that the cavity was produced by heating the material to its melting point. The orientation and shape of the cavities suggests they were produced with a cutting torch.

Figure A-5. Higher magnification photomicrograph of Figure A-4 at the cavity surface showing alteration of the original microstructure. Bracket "j" denotes original microstructure and bracket "k" denotes zone containing transformed microstructure. X50

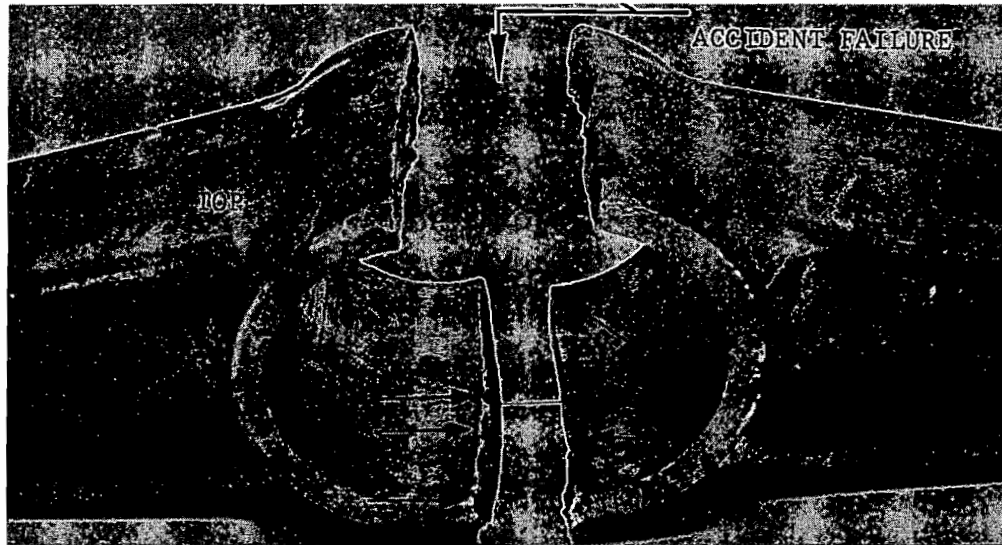
b. Failed center attachment point, arrows indicate cutting torch induced cavities.

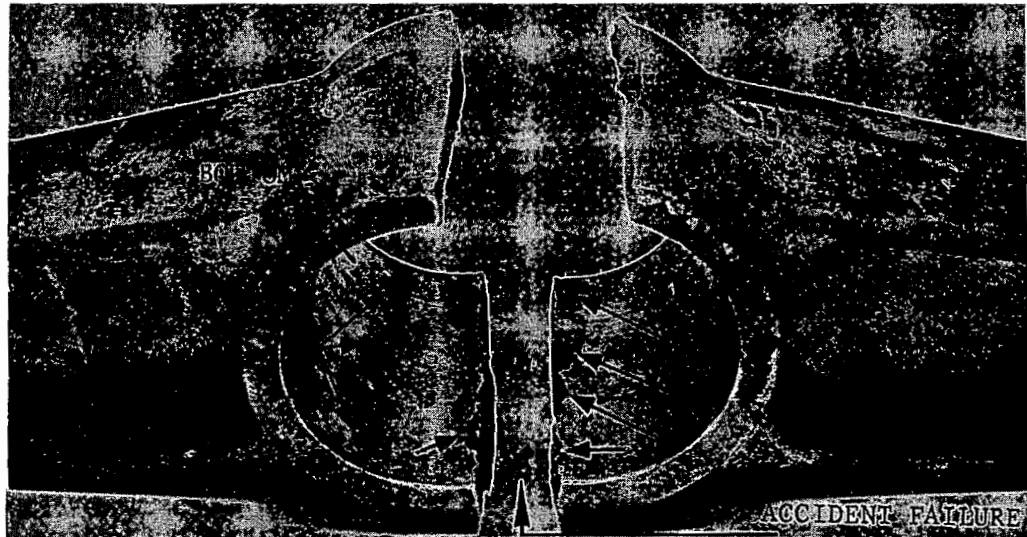
c. Failed center attachment point, arrows indicate cutting torch induced cavities.

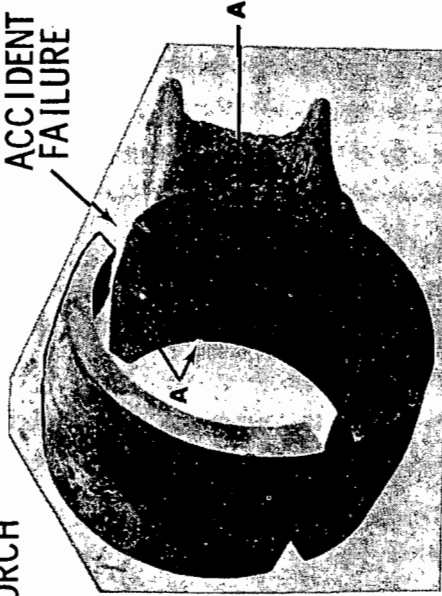
Photograph 2. Equalizer beam rear attachment point - (Braitree accident).

NOTE: Arrows on Photographs 2 and 3 indicate location of cutting torch induced cavities.

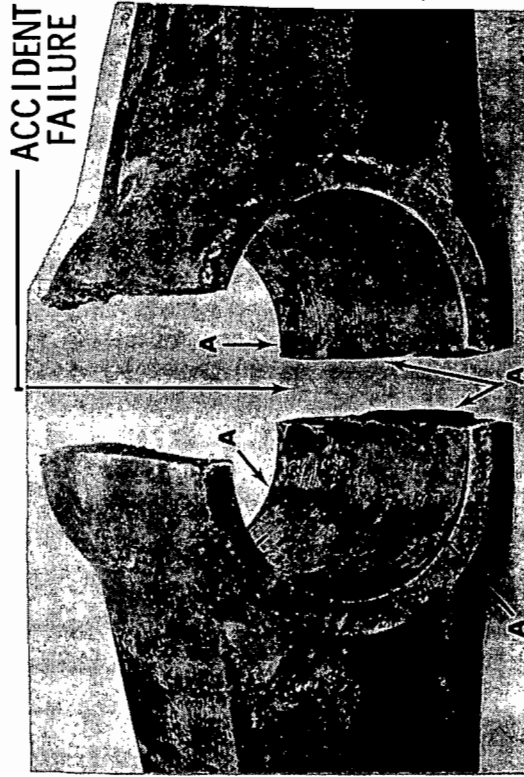
Photograph 3. Equalizer beam center attachment point - (Dunstable accident).
