**Highway Accident Report - Usher Transport, Inc.
Tractor-Cargo-Tank-Semitrailer Overturn and Fire
State Route 11, Beattyville, Kentucky, September 24, 1977**

HIGHWAY ACCIDENT REPORT

**USHER TRANSPORT, INC.,
TRACTOR-CARGO-TANK-SEMITRAILER
OVERTURN AND FIRE
STATE ROUTE 11
BEATTYVILLE, KENTUCKY
SEPTEMBER 24, 1977**

REPORT NUMBER: NTSB-NAR-78-4

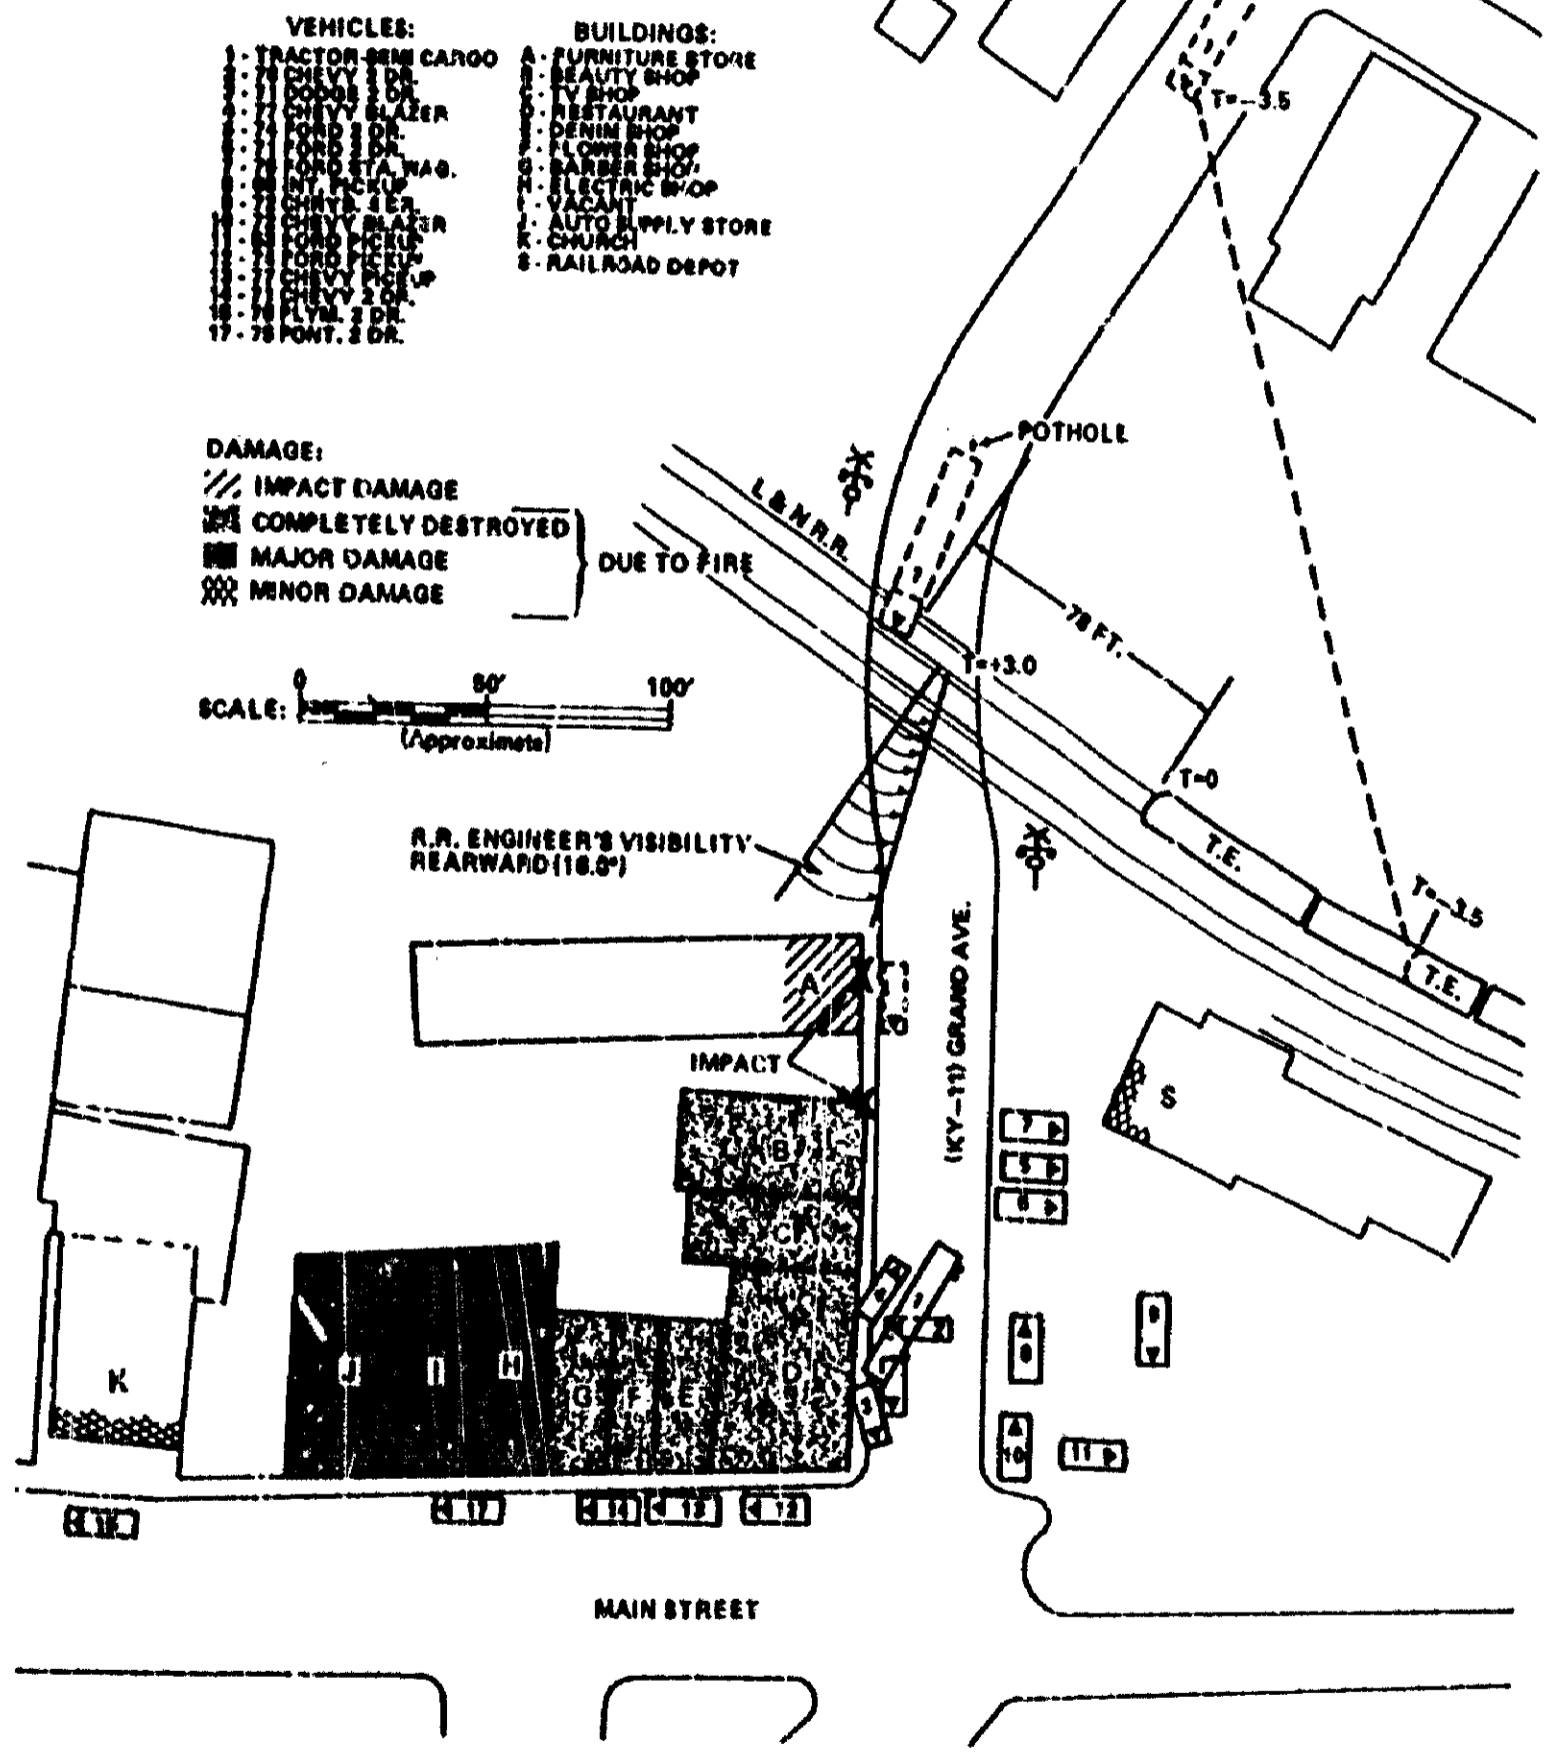
Figure 1. Location of Buildings and vehicles.

Two other witnesses, who were in the yard at the corner of the State Route 11 and East Main Street, heard a train whistle and almost immediately heard the sound of an air horn from the southbound truck. The air horn continued to blow and they surmised that the truck was out of control. The truck went past their driveway at an estimated speed of 55 to 60 mph. According to these witnesses, as the truck crossed the tracks in front of the train, the front axle of the tractor jumped up into the air; when the trailer crossed the tracks, its wheels were bouncing. After the combination vehicle crossed the tracks, the rear of the trailer swung to the right and tore through the front of an appliance store (Building A, figures 1 and 2).

Several buildings were destroyed (letter A through G, figures 1 and 2). Buildings A, B, C, and D were located on Grand Avenue; Buildings E through G were on Main Street. The buildings were of concrete construction with brick fronts. Building A was a single-story building. The two-story buildings contained businesses on the first floor and apartments on the second. Building A was erected 8 feet from the curb, while Buildings B, C, and D were 4.6 feet from the curb. Two patrons in Building A saw the truck headed for the building, alerted four other occupants, and exited out a rear door. The bodies of five females were recovered from the beauty salon (Building B). A resident and two infant children in a second floor apartment above the beauty salon escaped when the grandmother lowered the infants to rescuers and then jumped to safety.

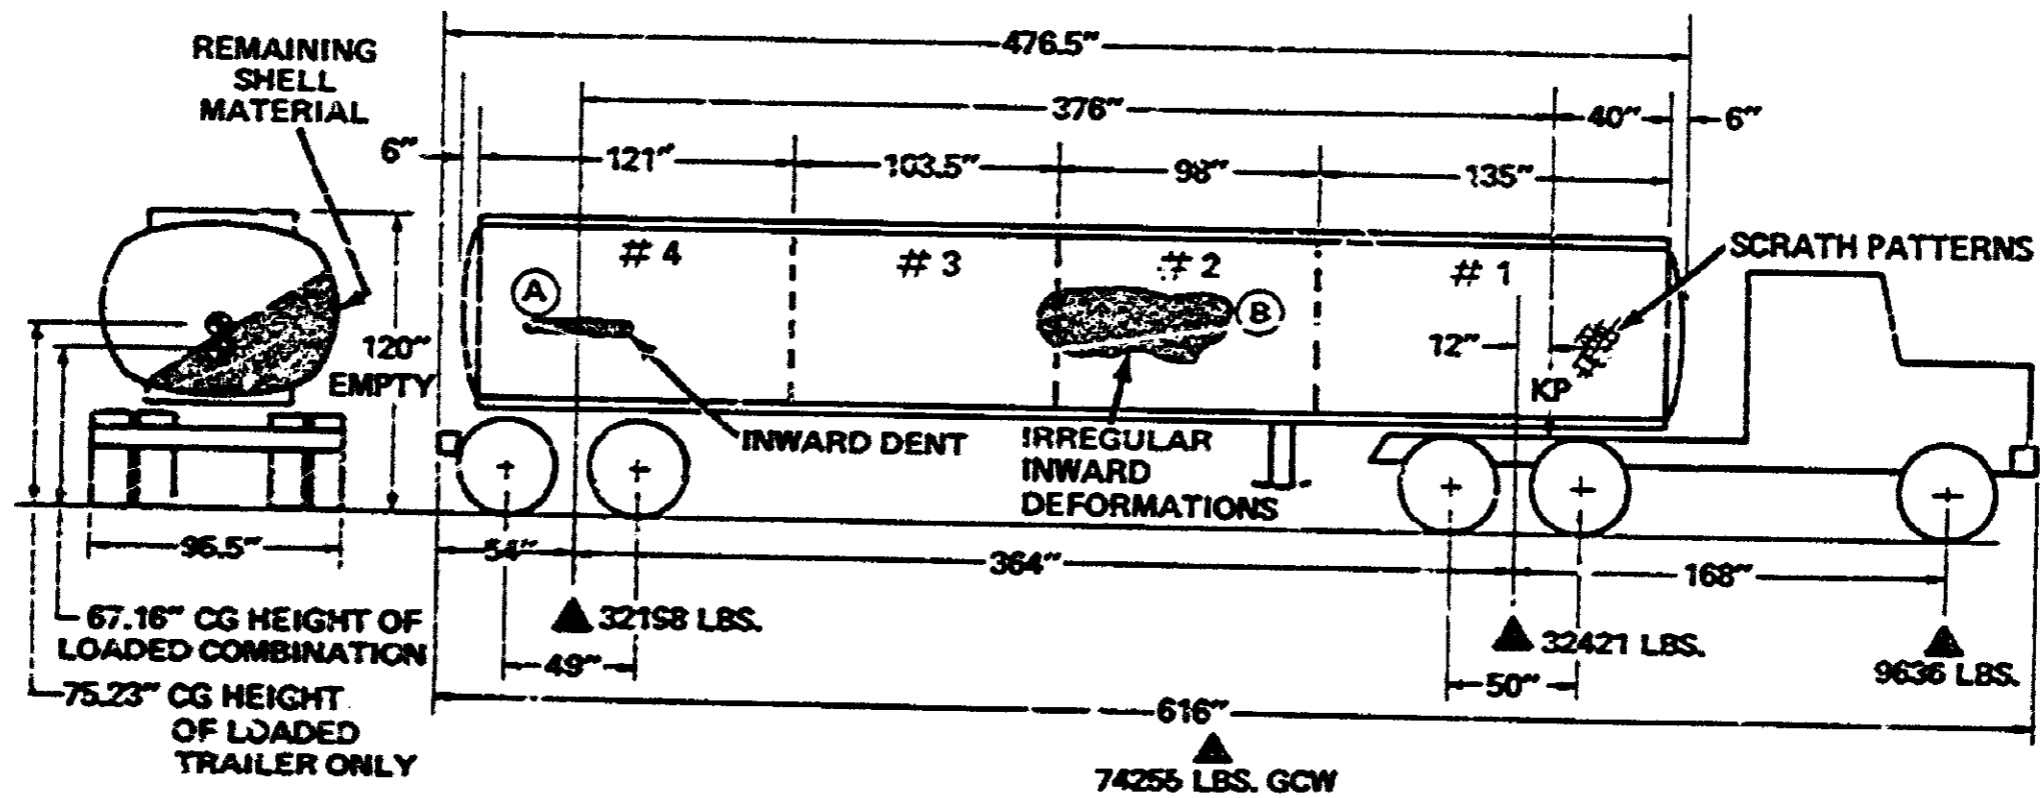
Figure 3. Drawing of tractor-cargo-tank semitrailer showing dimensions and damage areas.

There was a 41-inch-long by 6-inch-wide longitudinal dent at the right rear side of the tank shell. (See figure 3, item A.) This dent was 16 inches forward of the rear shell to head weld. A rod material was embedded in the aluminum at the forward end of the dent. A series of irregular inward deformations were located between 18 1/2 feet and 25 feet forward of the rear head seam. (See figure 3, item B.) There was no indication of mechanical puncture or other type rupture in the remaining sections of the tank material. The inside surface of the remaining shell material about 6 inches to 8 inches inboard of the edge of the melted surface was sooted; the remaining inside material was rot.

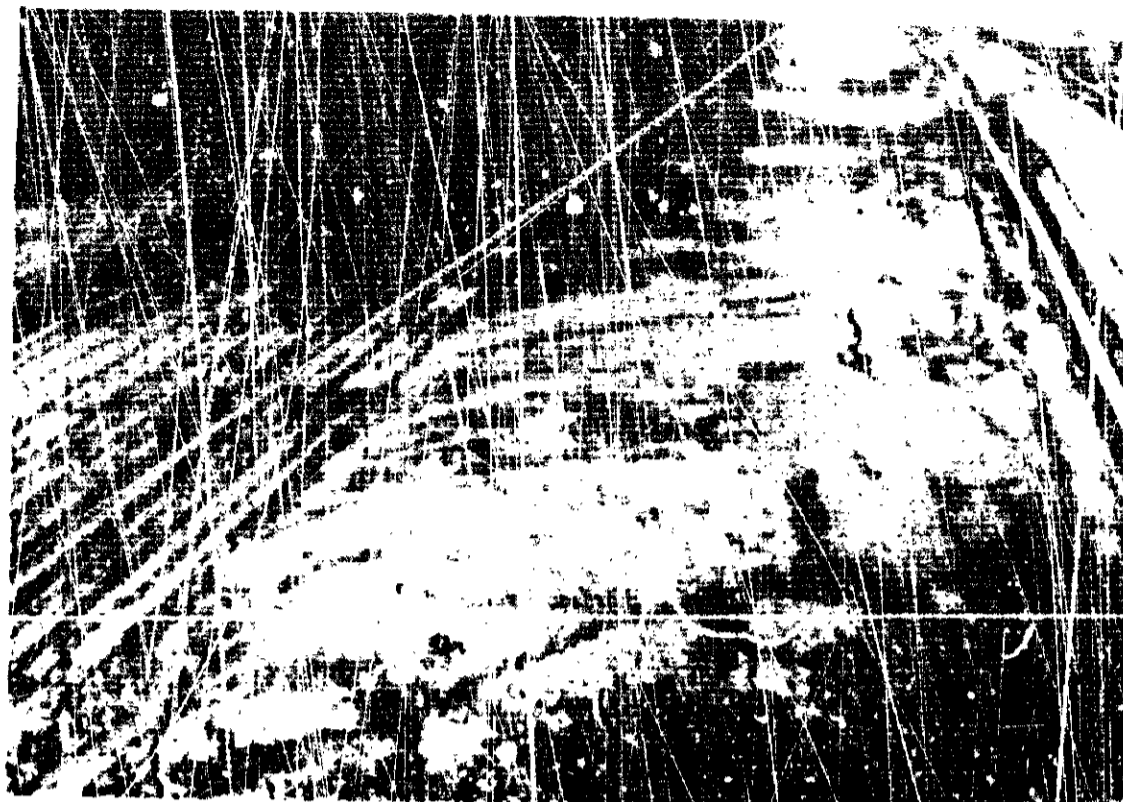
The railroad/highway grade crossing was 28 feet wide and was paved with wooden planks adjacent to the rails with areas of asphalt in between. (See figure 8.) The crossing was 35 feet wide on the diagonal traversed by the truck. The crossing was rough. The planking contained numerous gouge marks that may have been made by other vehicles. The crossing was protected by an advance warning sign 680 feet north of the crossing, and 8 3/8-inch railroad/highway flashing lights mounted on a railroad cross-buck sign 12 feet north of the crossing. Attached to the crossbuck was a sign announcing "2 tracks." The red flashing lights were activated by a pre-empt contact located 1,113 feet east of the crossing. The red flashing signals were visible to and recognized by the driver when he created the grade from the north. Witnesses stated that the signals were flashing before the truckdriver started his descent.

Figure 8. Railroad/highway grade crossing on KY 11, view to the west.
