National Transportation Safety Board Washington, D.C. 20594

Highway Accident Brief

Accident No.: HWY-99-FH012

Accident Type: Motorcoach loss of control and overturn

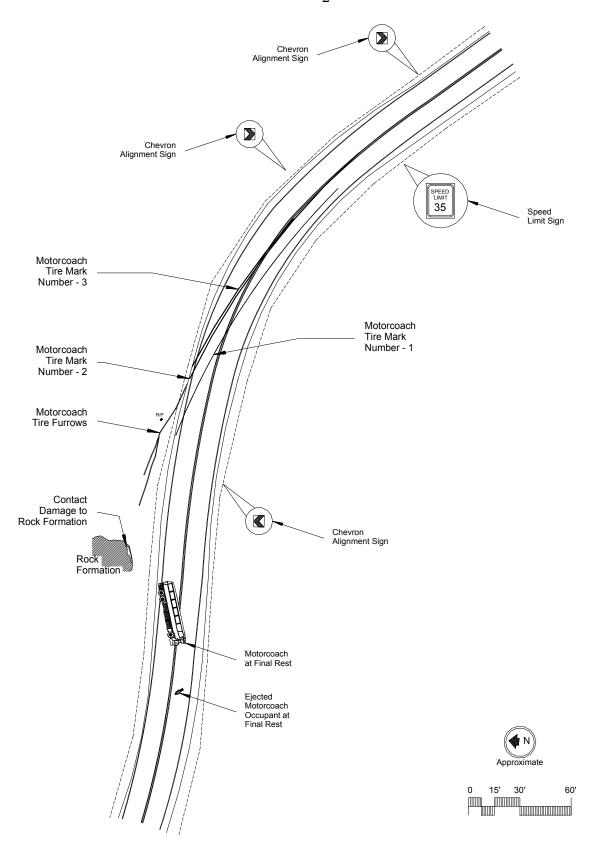
Figure 1. Diagram of motorcoach loss of control and overturn.
