**Motorcoach Run-Off-The-Road Accident
Tallulah, Louisiana
October 13, 2003**

Highway Accident Report

NTSB/HAR-05/01

**NTSB/HAR-05/01
PB2005-916201
Notation 7711
Adopted April 19, 2005**

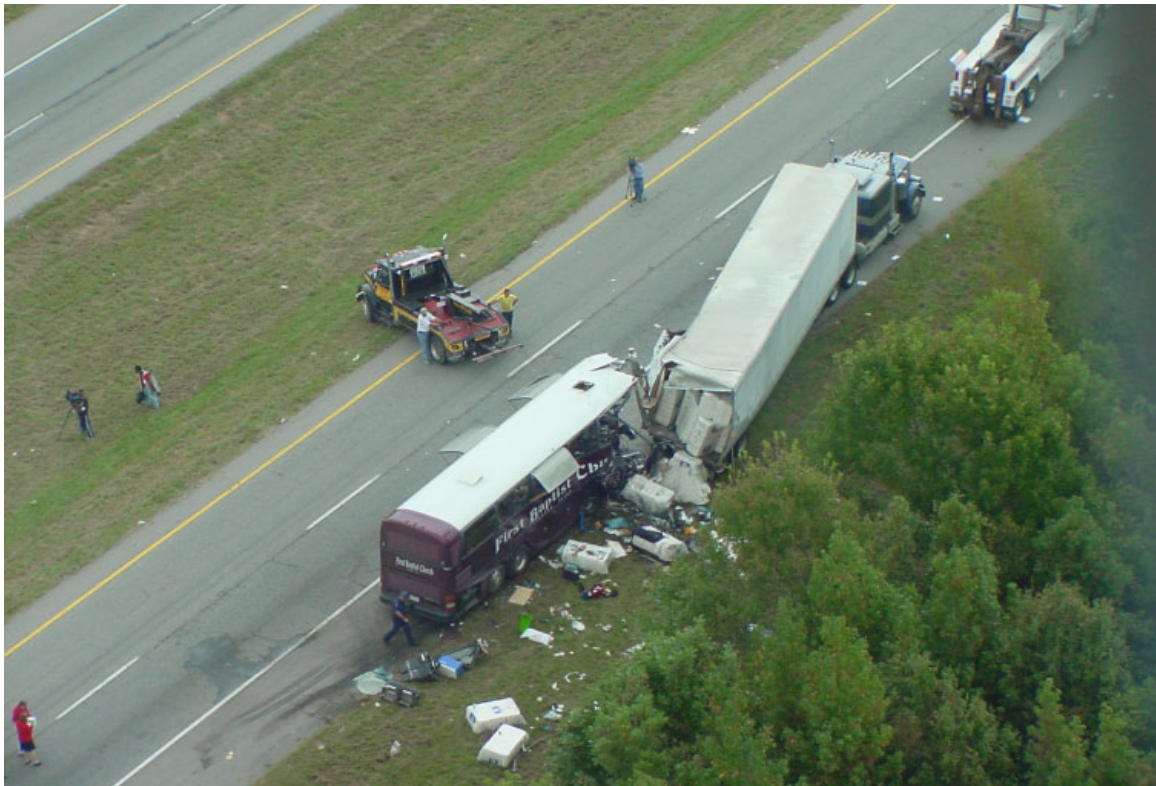
Figure 3. Damaged motorcoach and tractor semitrailer on shoulder following accident.
(Source: Louisiana State Police)

General. The motorcoach sustained massive damage and rearward crush to the front end, with most of the crush damage just to the right of the driver's area. The right front wheel and associated suspension system were pushed rearward about 15 inches. The motorcoach frame front cross member support was moved rearward about 64 inches. The main longitudinal frame members that comprised the left- and right-side spines of the motorcoach's monocoque⁹ frame were deformed. The accident motorcoach's right-side tubing frame was moved rearward about 38 inches. The interior right-side intrusion, measured at the right-side modesty panel, was 124 inches. The leading edge of the forward, right-side luggage compartment, adjacent to the passenger compartment floor panel, had a rectangular indentation, similar in configuration to the rear of the combination vehicle's semitrailer. The intrusion measured at this location was 155 inches.

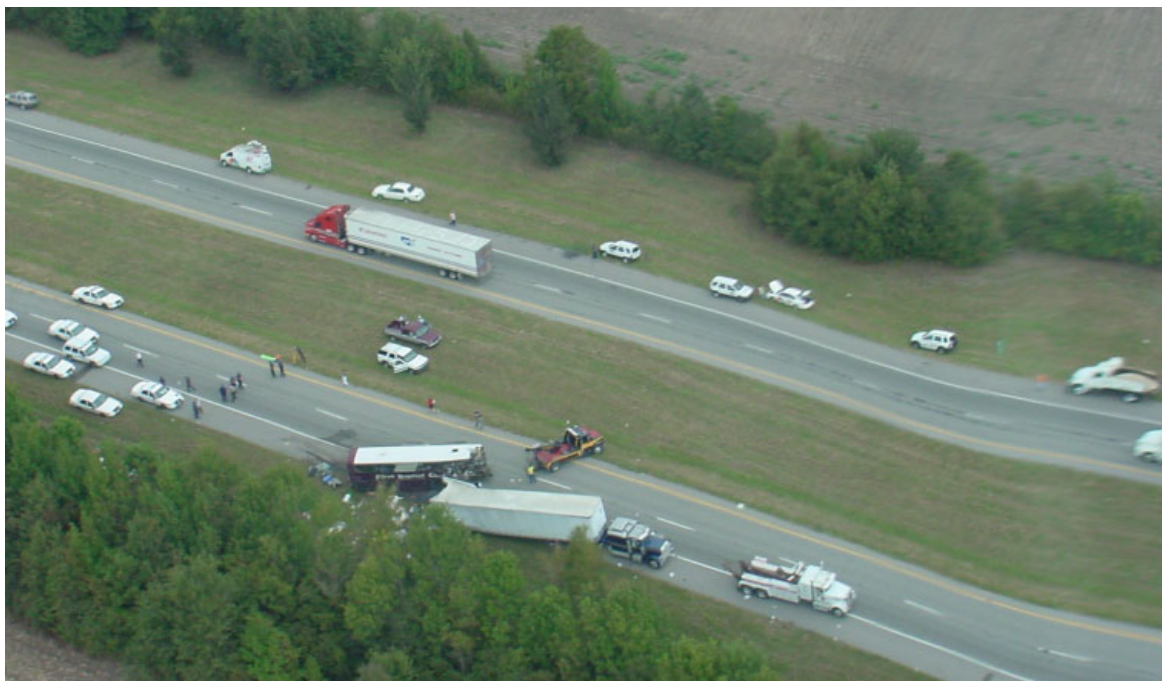
Figure 5. Motorcoach and Peterbilt tractor semitrailer at accident site. (Source: Louisiana State Police)

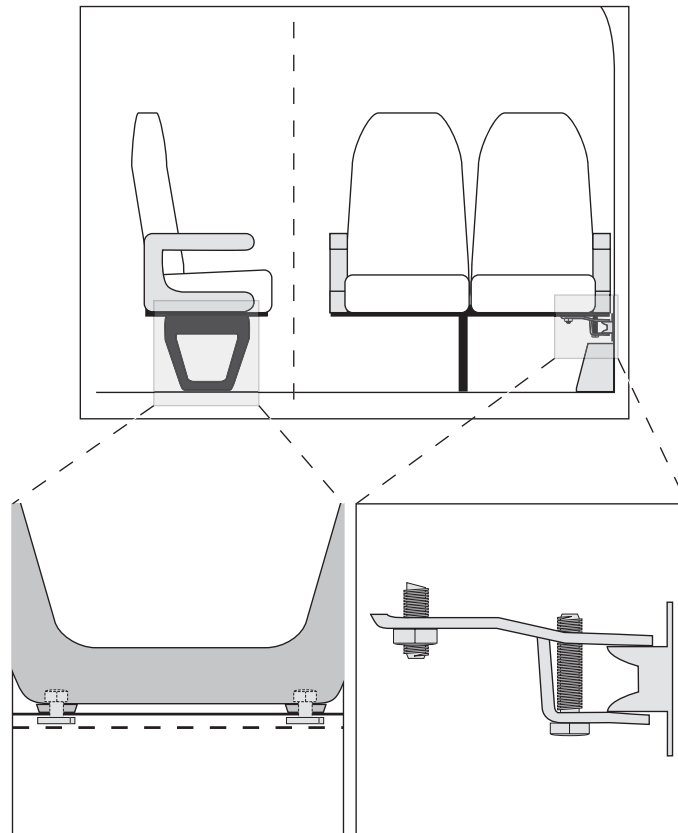
The passenger seat assemblies were composed of a seat frame containing two individual seat positions; each position had a seat bottom cushion, a seat back cushion, a headrest, an armrest, and a footrest (attached to the seat frame ahead). The seat frame was attached to an aluminum track on the interior sidewall by two C-clamps. A single pedestal slightly offset from the frame center was attached to a stainless-steel floor track by two T-bolt fasteners. The seating was designed so that the owner of the motorcoach could adjust the seating arrangement (number of seats and distance between rows). To move seats within the coach, the seat pedestal T-bolts had to be turned parallel in the track, the sidewall C-clamps had to be loosened, and the seats had to be removed or slid along the floor track. Then, once placed and arranged as desired, the seats had to be re-secured by tightening the C-clamps and turning the T-bolts nearly perpendicular in the track. (See figure 7.)

Figure 7. Representative diagram of motorcoach passenger seat. On the LEFT: side view with close-up of pedestal, showing T-bolts and floor track attachment. On the RIGHT: front view with close-up of forward C-clamp and sidewall track.

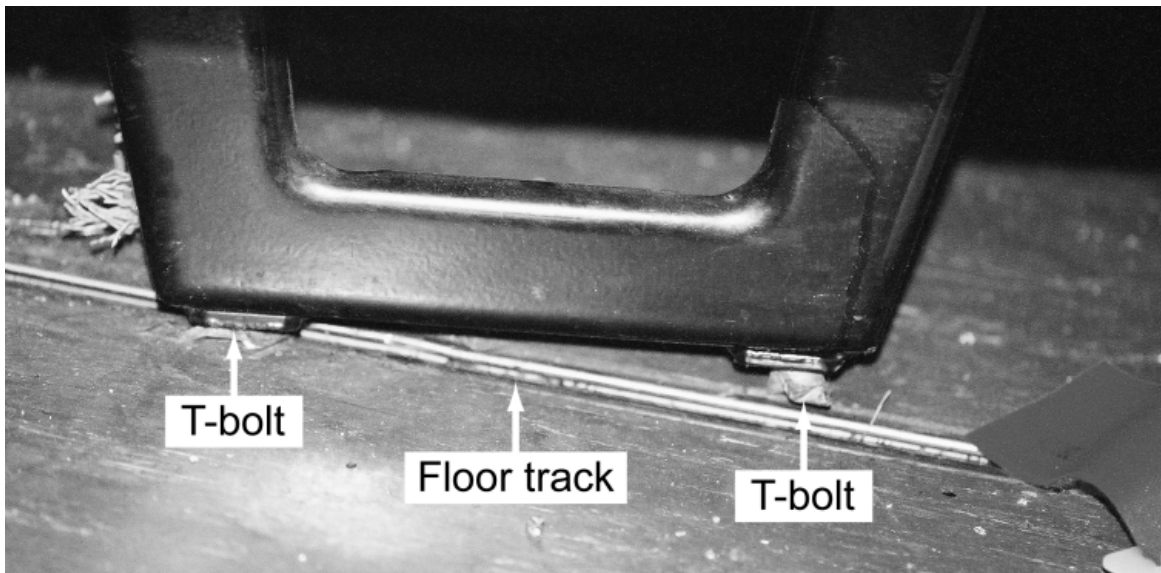
The 16 seat frames found outside the motorcoach had a total of 32 T-bolts, and the heads on 25 of these T-bolts exhibited substantial deformation. The heads on the remaining 7 T-bolts did not exhibit substantial deformation and were found to be aligned approximately parallel to the direction of the floor track. Fifteen of the 32 C-clamps were deformed or missing from the seat frames as a result of accident damage or damage caused while the passengers were extricated. On the 17 seats (8 seat frames) that remained in their original positions within the motorcoach, 5 C-clamps were deformed, 1 frame pedestal was torn from the floor track at the T-bolt, and the rest of the seat C-clamps and T-bolts were intact. (See figures 8, 9, and 10.)

Figure 8. Close-up of floor track and T-bolt fasteners.

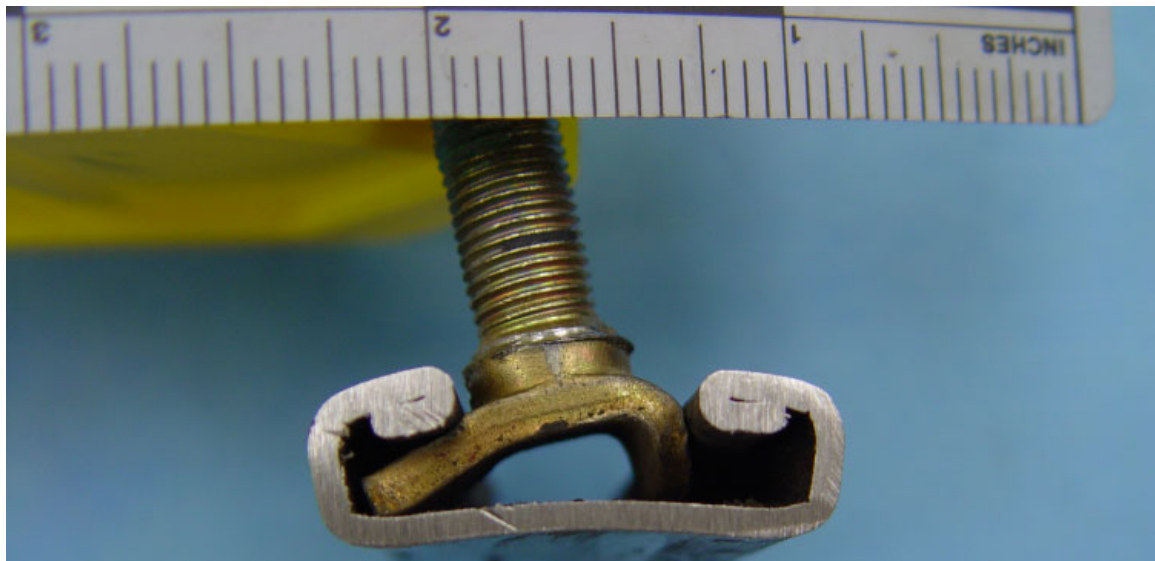
Figure 9. Damaged T-bolt in floor track.

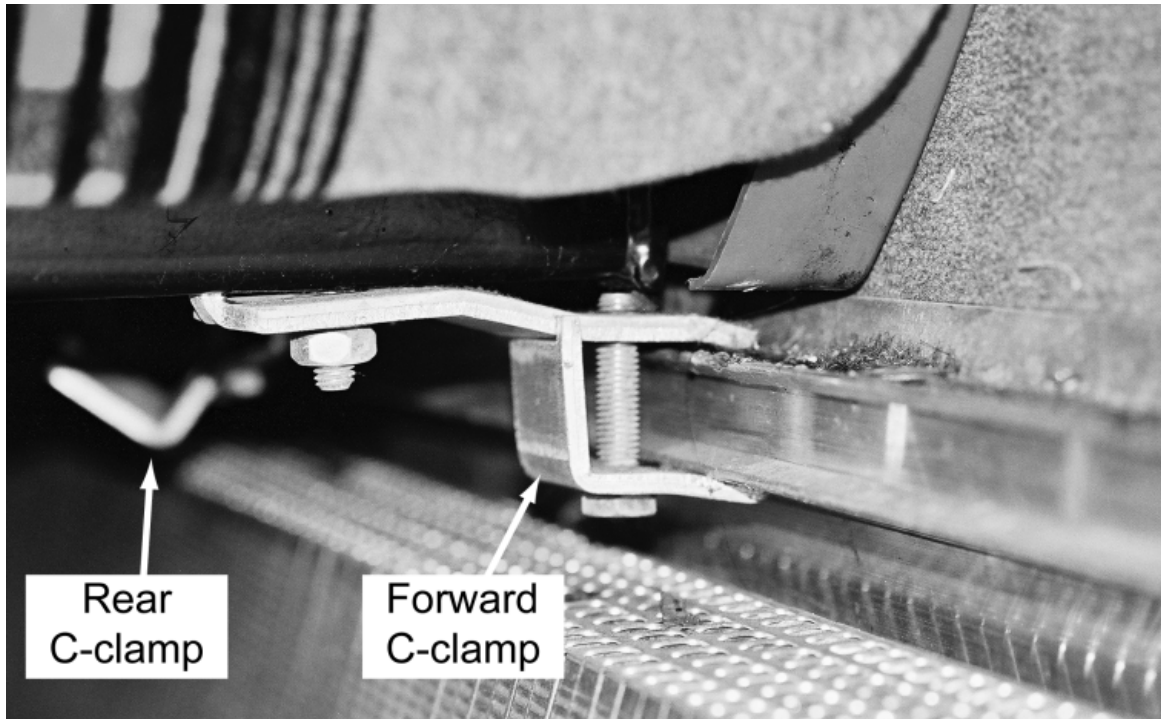
Figure 10. C-clamps attaching seat to sidewall track.

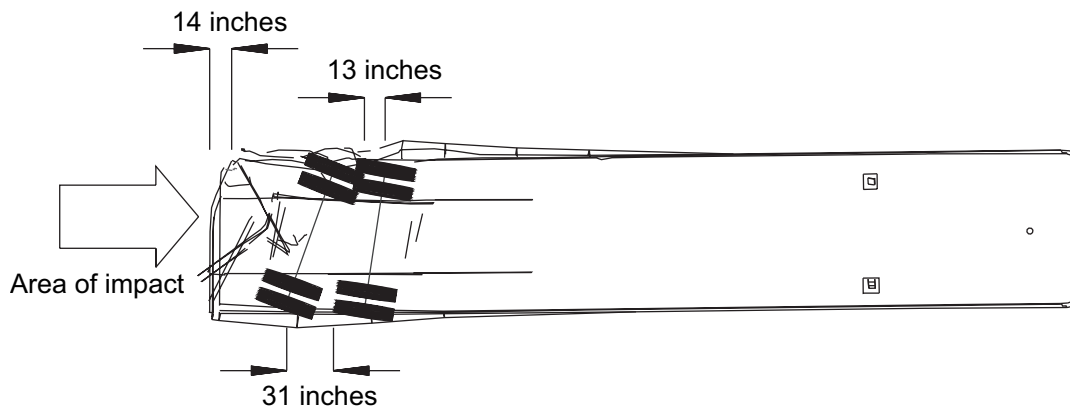
The Peterbilt tractor sustained no observable collision-related contact damage. The semitrailer sustained damage from being struck by the motorcoach. The semitrailer's left wheel on the number four axle was moved forward 13 inches, and the left wheel on the number five axle was displaced 31 inches. The semitrailer's rear frame cross member on the left side was moved forward about 14 inches. (See figure 11.)

Figure 11. Topographic view showing variation between axle assemblies and crush damage to rear of semitrailer.

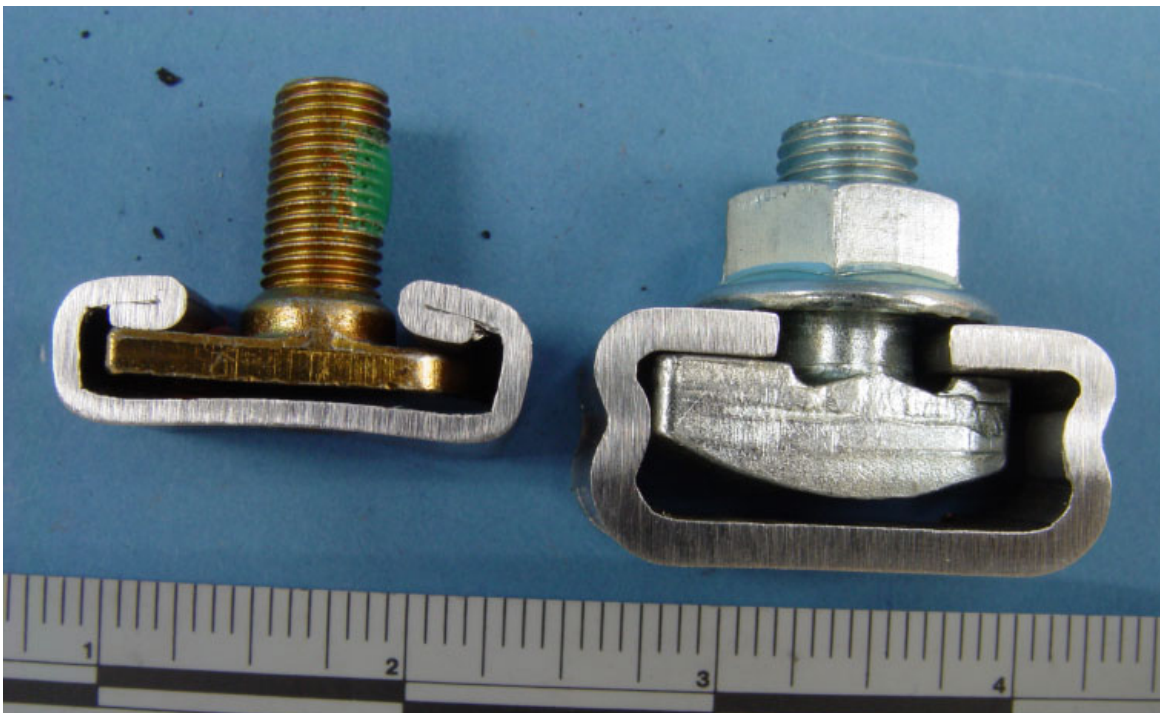
Multiple passenger seat frames, including those outside the intrusion area, were found separated from the floor and sidewall following the accident. Components of the seating system, including the sidewall and floor anchorage systems, a seat frame pedestal, and pieces of sidewall and floor track, were sent to the Safety Board's Materials Laboratory for testing and comparison with exemplars. In addition, Neoplan sent new exemplar T-bolts to the Materials Laboratory for testing and comparison purposes. Hardware from another seating manufacturer, National Seating, was also obtained for comparison. The hardware from National Seating provided a good basis for comparison because this manufacturer's seats were involved in a motorcoach accident in Burnt Cabins, Pennsylvania,⁵⁵ which was similar to the Tallulah accident. The two accidents involved motorcoaches of similar sizes and weights, which departed the roadway at similar speeds, and then impacted parked semitrailers. The passenger loading and the amount of intrusion were similar in the Tallulah and Burnt Cabins accident motorcoaches. Yet in the Burnt Cabins accident, unlike the Tallulah accident, all the seats outside the intrusion area remained secured. (See figures 12 and 13.)

Figure 12. Exemplar T-bolt and floor track hardware for Neoplan (left) and National Seating (right).

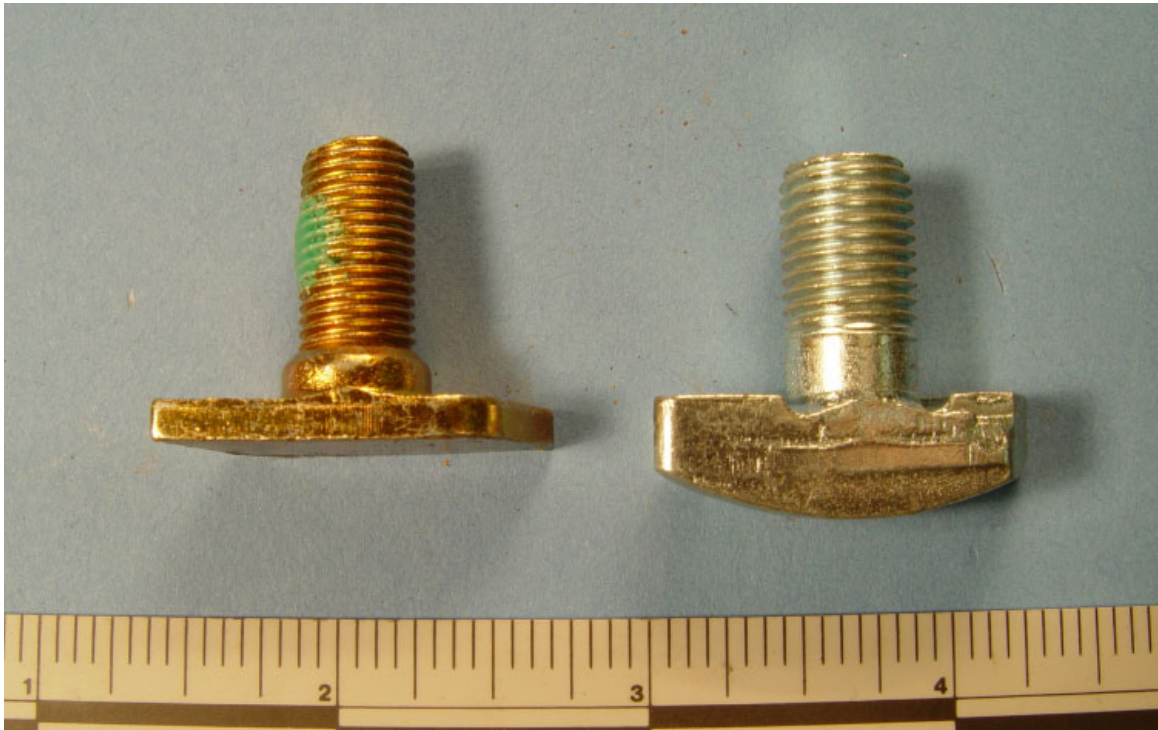
Figure 13. Exemplar T-bolt top section and length measurement for Neoplan (left) and National Seating (right).
