Motorcoach Override of Elevated Exit Ramp  
Interstate 75  
Atlanta, Georgia  
March 2, 2007

NTSB/HAR-08/01  
PB2008-916201

# Highway Accident Report

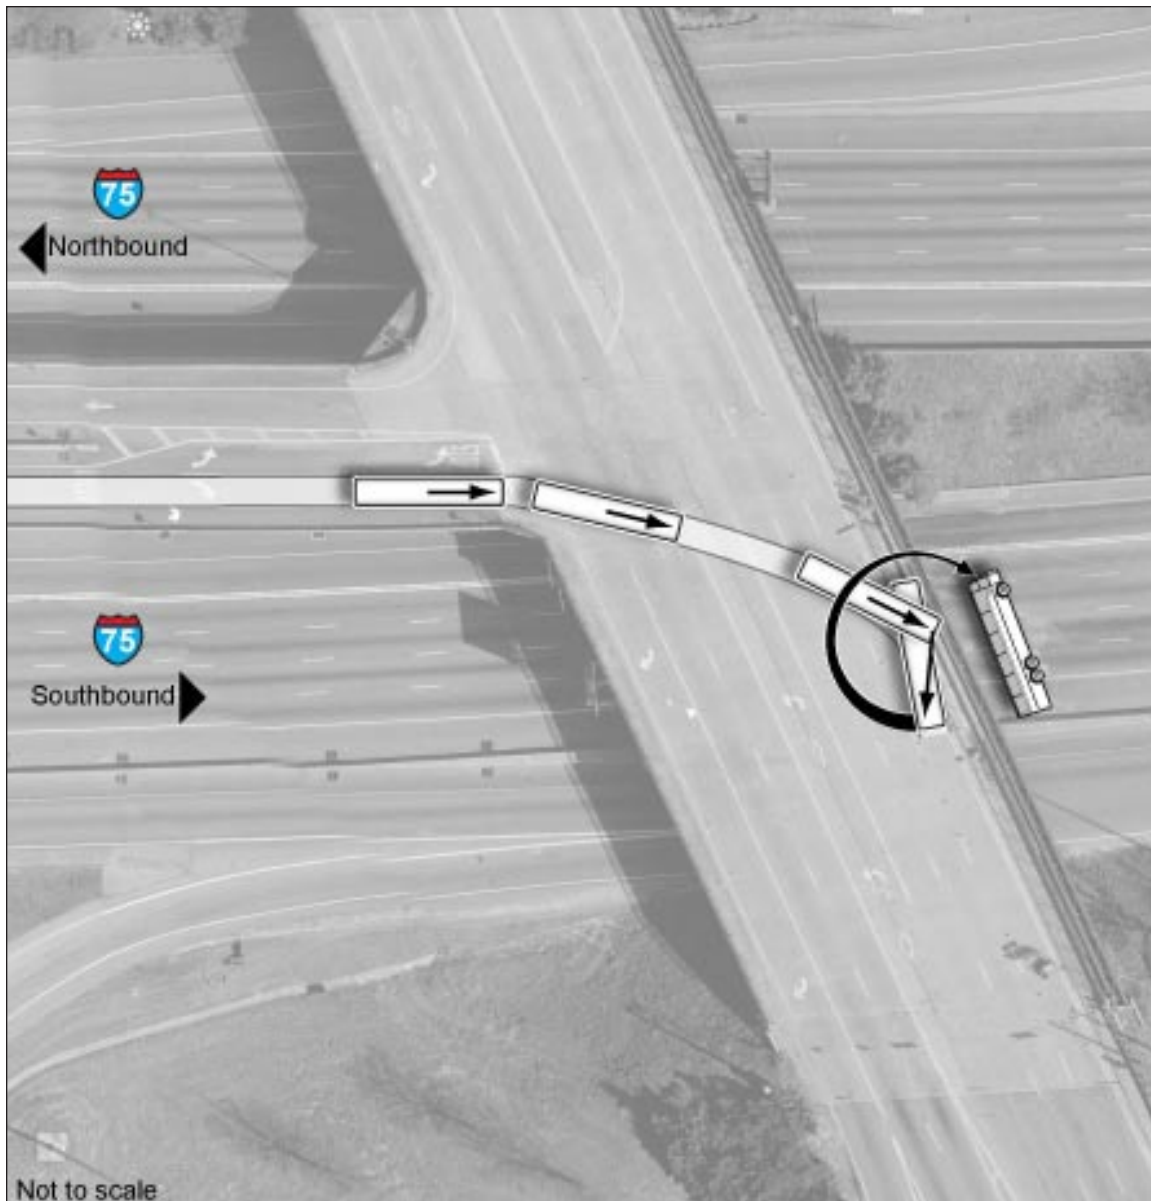
**Figure 4.** Photo illustration of the motorcoach accident sequence.

Figure 4 shows the sequence of collisions in this accident. The motorcoach traveled up the 1,120-foot HOV-only left exit ramp at Northside Drive, through the elevated T-intersection, and collided with the reinforced portland cement concrete bridge wall and security fence located along the southern edge of the eastbound lanes of the overpass. While crossing the intersection at an estimated speed of 50 to 60 mph, the driver steered to the right. The left-front corner of the motorcoach impacted the concrete bridge wall, and four passengers were ejected onto Northside Drive. The motorcoach overrode the bridge wall, rotated clockwise (270 degrees), and fell onto the interstate below, ejecting six passengers and partially ejecting two additional passengers onto I-75.

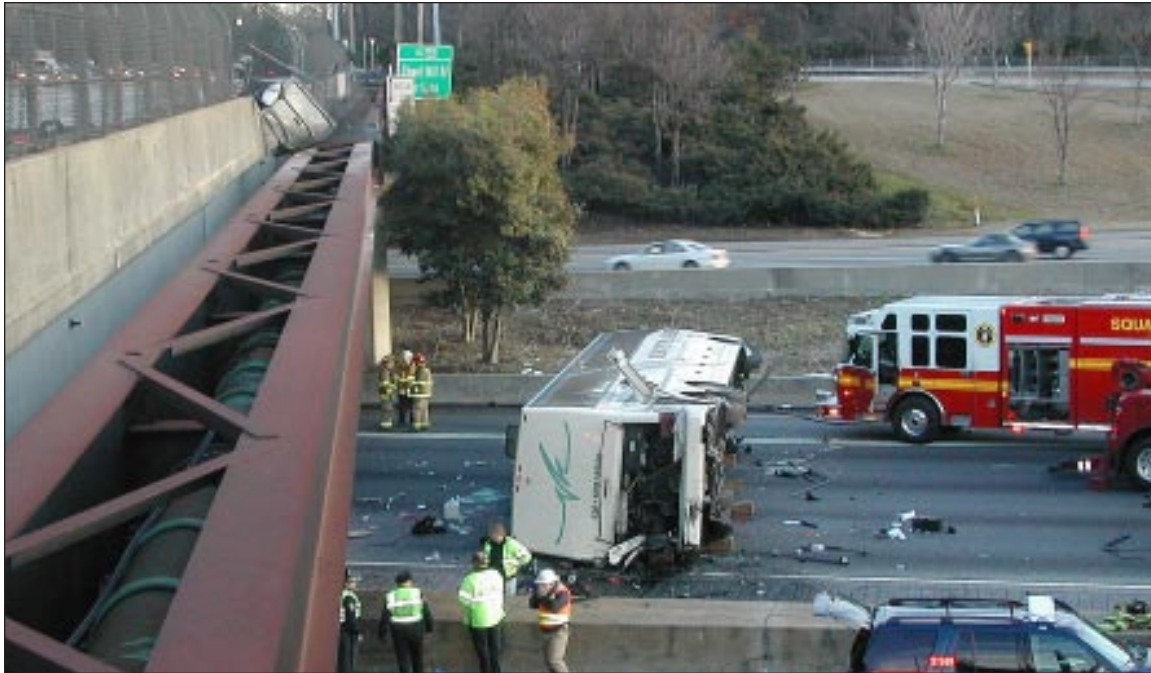
**Figure 5.** Accident scene with Northside Drive in the upper-left corner and the motorcoach at rest on I-75.

The motorcoach came to rest on the driver's side in a 90-degree rollover orientation, pointing east, and blocking the southbound lanes of I-75, as shown in figure 5. Two southbound passenger vehicles, a 2005 Chevrolet Equinox and a 2003 Ford F150 pickup truck, received minor damage after being hit by debris from the motorcoach as it fell from the overpass onto I-75; no passenger vehicle occupants were injured.

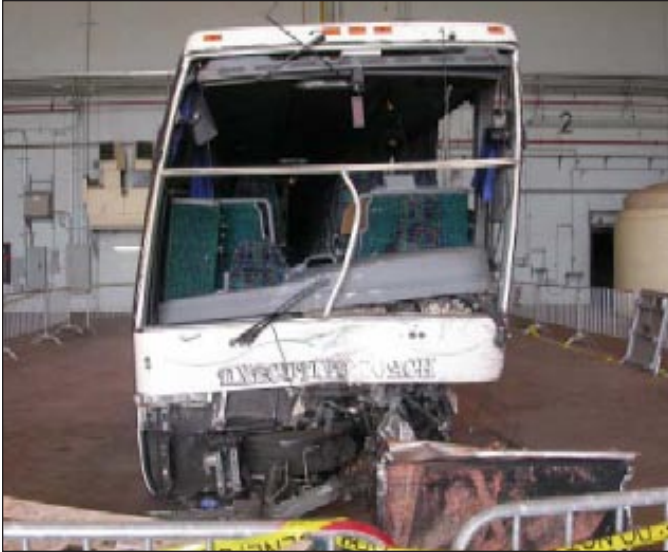
**Figure 8.** Accident motorcoach, front view.

The motorcoach sustained the majority of damage to the left-front corner (driver's side), left side, and left-rear corner (see figures 8 and 9), and there was interior deformation in the area of the driver's station and front boarding door. The structural frame of the motorcoach was deformed, leaning toward the left. All of the windows along the left side were shattered; all of the windows along the right side remained intact, including the windows on and above the boarding door. Deformation of the motorcoach did not intrude into the passenger space.

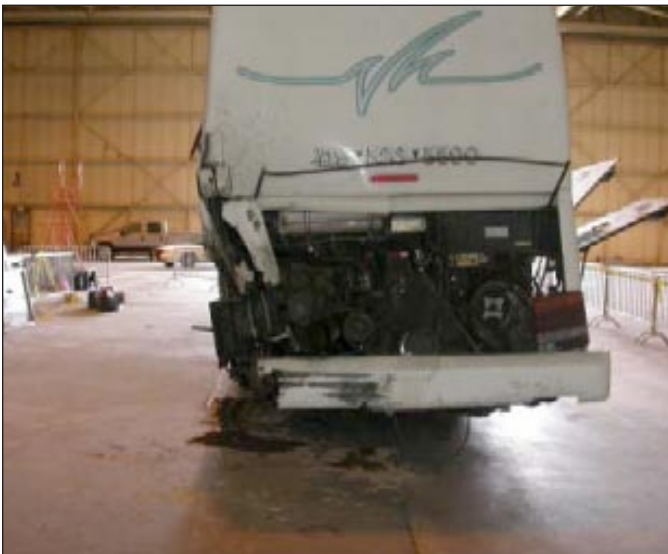
**Figure 9.** Accident motorcoach, rear view showing engine compartment.

The engine compartment in the rear of the motorcoach was partially crushed, more so on the left side than the right, as shown in figure 9. The engine and transmission were displaced right and upward with the engine partially knocked off the engine mounts. The left steer axle tire and the left outside drive axle tire were both damaged and deflated.

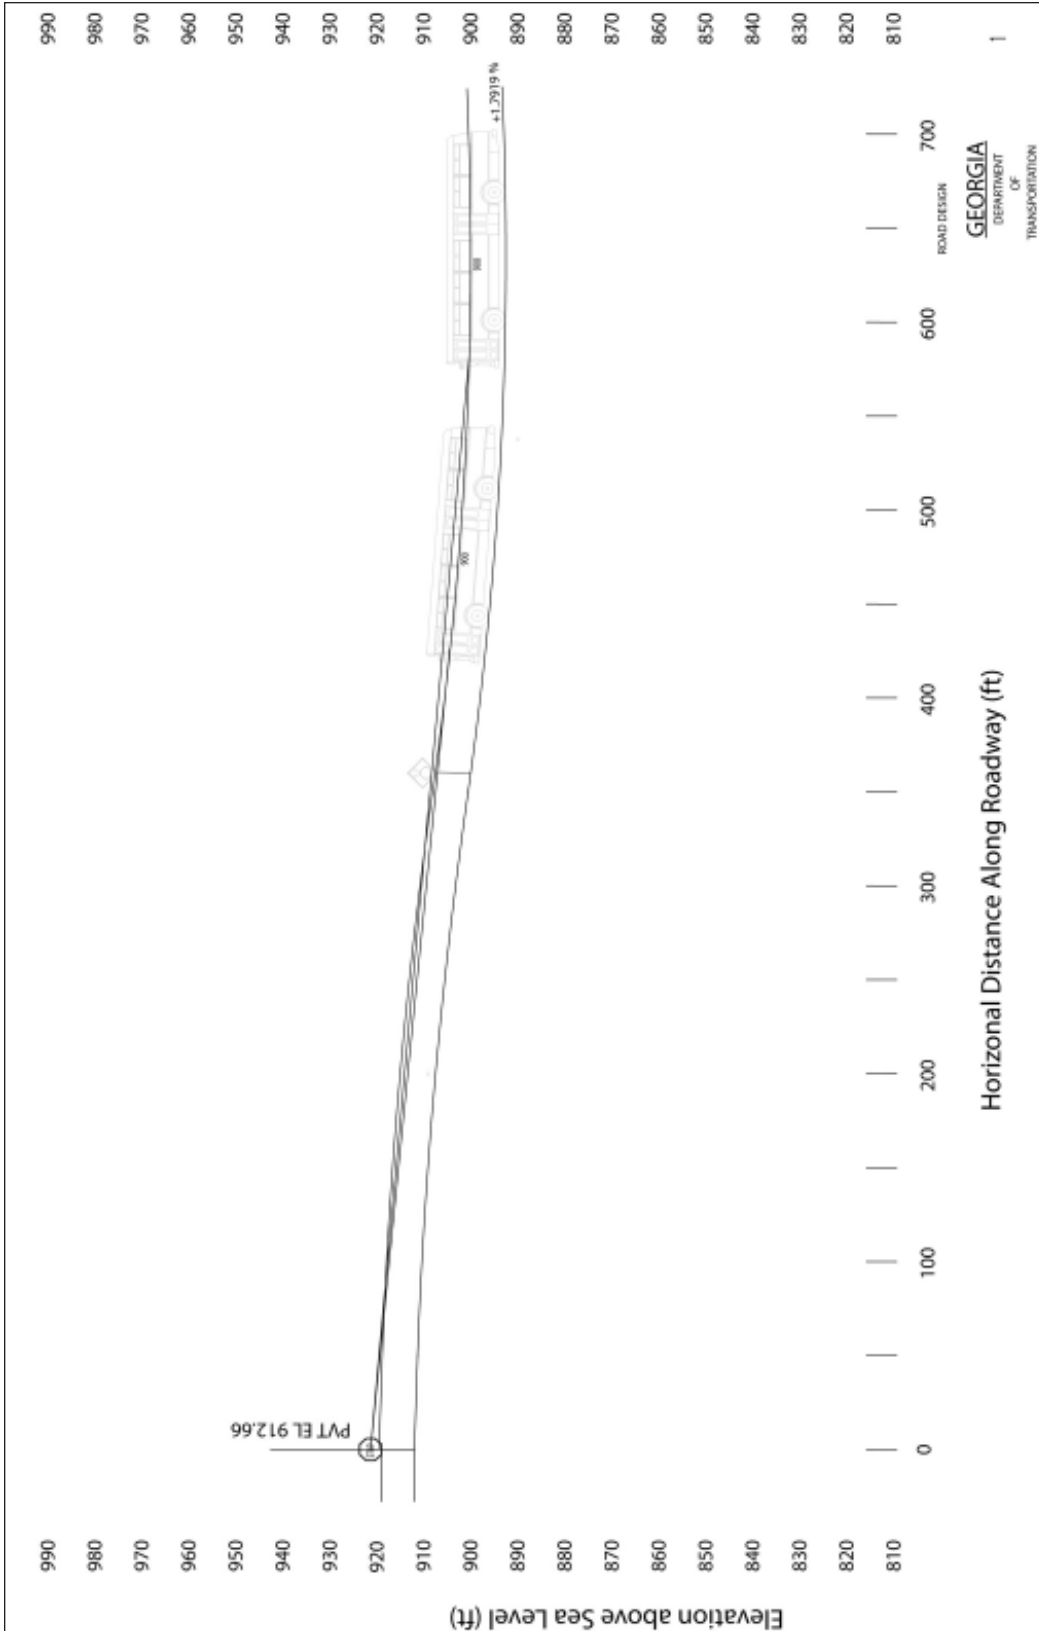
Figure 10. Exit ramp elevation.

elevation of the ramp is shown in figure 10. The vertical curve<sup>26</sup> elevation of the roadway occurs approximately 475 feet past the exit gore,<sup>27</sup> or approximately 950 feet into the exit ramp. The exit ramp has no posted warning speed sign. According to GDOT engineers, a warning for a slower speed was unnecessary because interchange lighting mitigated the visibility limitation caused by the vertical curve.<sup>28</sup>

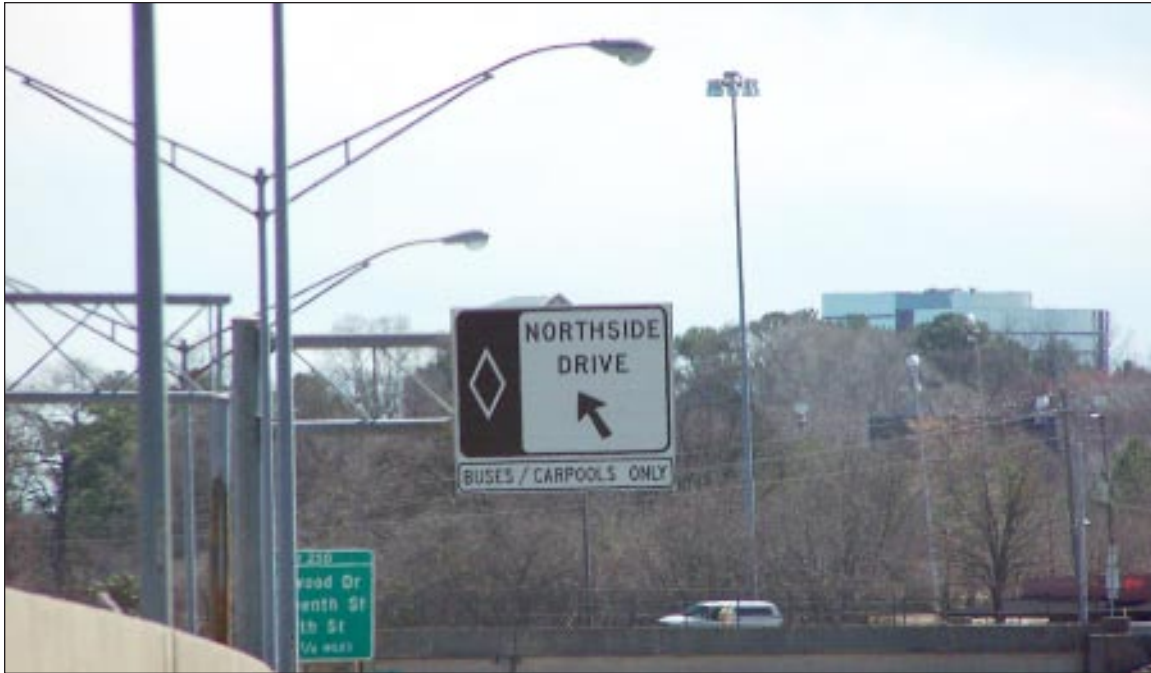
<sup>38</sup> The MUTCD standard for this sign states that it should carry the exit number, if used; route number; cardinal direction; and destination, when appropriate. The overhead guide sign did not display the word "EXIT."

Figure 16. Overhead directional sign for Northside Drive.

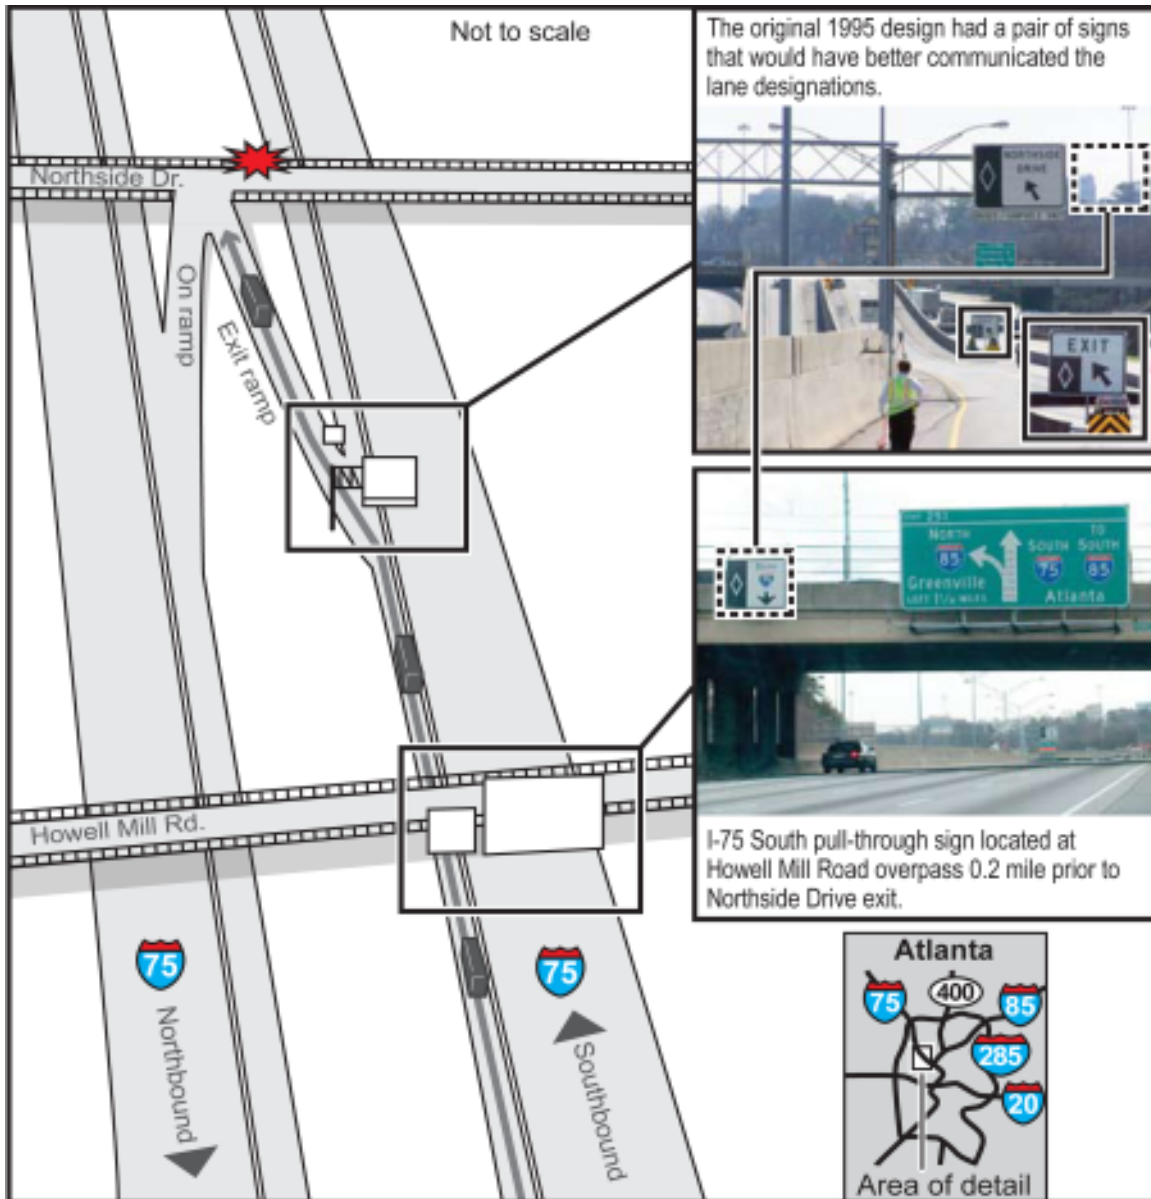
The design for placement of the signs was changed in August 1995. Because of structural failures in the base plate bolts on type II cantilevered dual-sign structures, GDOT had adopted a policy to eliminate them. To support dual signs (both an exit sign and a pull-through sign), a sign support over the entire roadway would have been needed. GDOT indicated that a sign support over the entire roadway would limit sight distance to other signs ahead. GDOT's design change was partially documented in interdepartmental memorandums reviewed during the course of the Safety Board's investigation. GDOT's solution was to separate the two signs, placing the HOV-only left exit sign in its original location and moving the I-75 HOV South pull-through sign 0.2 mile north, mounted to the Howell Mill Road overpass. Figure 18 shows the Northside Drive exit sign separated from the I-75 pull-through sign, and figure 19 shows the original design plan positions for the signs mounted side-by-side.

**Figure 18.** Pull-through sign for the I-75 HOV lane positioned at the Howell Mill Road overpass instead of mounted next to the Northside Drive exit sign.

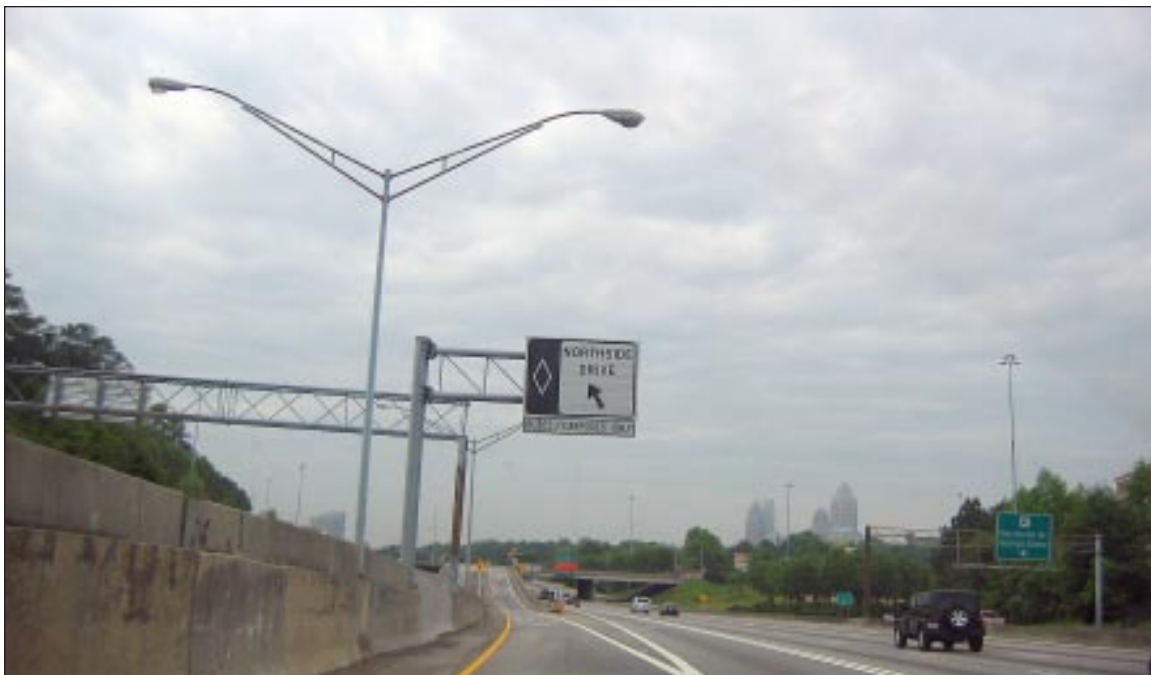
**Figure 20.** Exit roadway markings at Northside Drive.

The FHWA advised in its August 2007 information memorandum to Division Administrators that when extra emphasis is needed to differentiate between exit and travel lanes, a legend pavement marking *EXIT* or *EXIT ONLY* should be considered for use in the parallel or tapered deceleration lane for the direct exit and/or on the direct exit ramp itself just beyond the exit gore. At the time of the accident, the Northside Drive exit ramp was not marked with *EXIT* pavement markings.
