Arizona-Southern California Outages on September 8, 2011

Causes and Recommendations

Prepared by the Staffs of the
Federal Energy Regulatory Commission
and the
North American Electric Reliability Corporation

April 2012

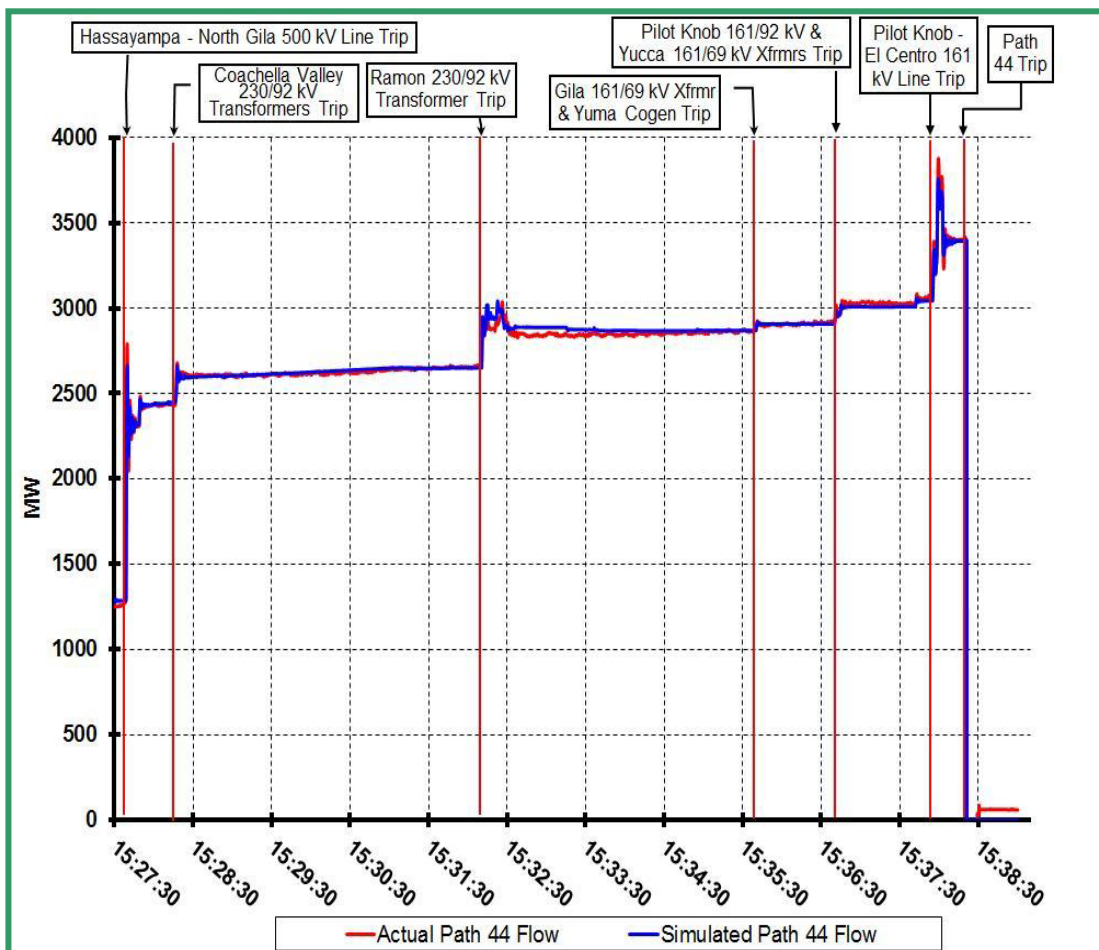
Figure 1: Comparison of Actual and Simulated Path 44 Flows

As the first step in performing power flow and dynamic stability analyses, the Modeling and Simulation team developed and benchmarked a modeling case of system conditions prior to the event. The team started with the WECC heavy summer base case and made adjustments based on State Estimator snapshots, EMS data, actual generation and schedules, PMU data, and a base case prepared by a separate team (led by CAISO) that studied the event. The team further adjusted and benchmarked the base case using SCADA and PMU data to match the system conditions for the entire event. The team devoted considerable time and effort to resolving discrepancies between the various sources of data to best calibrate the modeling case to actual measured data. As illustrated by **Figure 1**, on the next page, and described in more detail in Appendix D, the Modeling and Simulation team achieved a significant degree of accuracy. This figure compares Path 44 flows simulated by the Modeling and Simulation team to actual Path 44 PMU data.

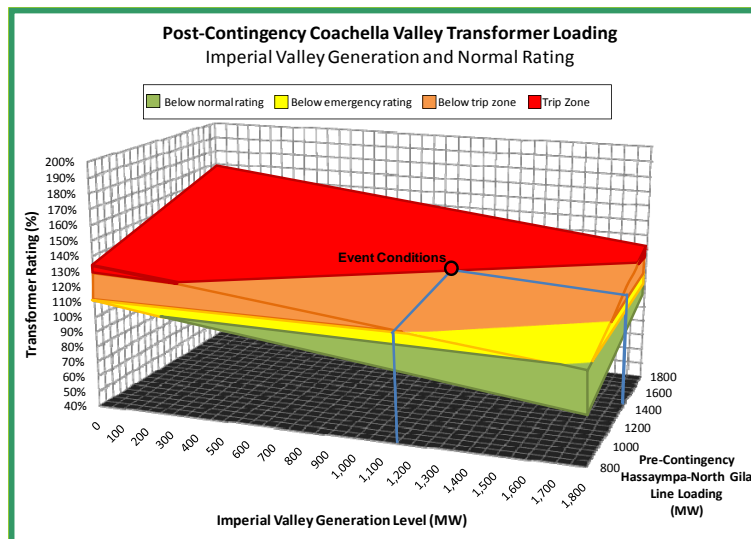
Figure 7 : Post-Contingency CV Transformer Loading Based on Imperial Valley Generation

In general, adding generation in San Diego, CFE, or Imperial Valley and backing down generation in APS’s system (east of Path 49) would reduce the loading on IID’s 92 kV system for the loss of H-NG. For example, an additional 600 MW of generation at Imperial Valley and a reduction of generation in APS’s system by the same amount would have reduced the pre-contingency loading on H-NG by 20% and improved the post-contingency voltage in WALC’s Blythe area by approximately 4%. Under this condition, the loading on the CV transformers for the loss of H-NG would be approximately 111% of their normal rating (166 MVA), well below their trip setting of 127%. This is a further demonstration of the importance of including all facilities when deriving SOLs.

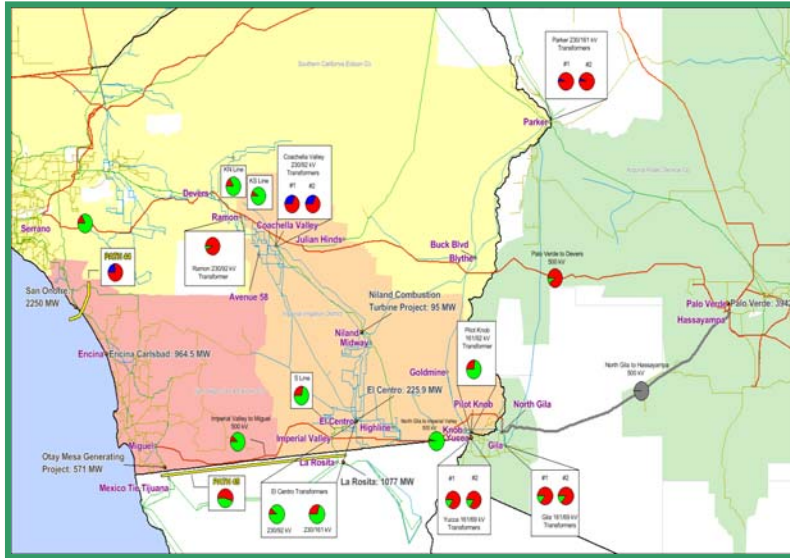
15:27:39 – The Hassayampa- North Gila 500 kV line tripped.

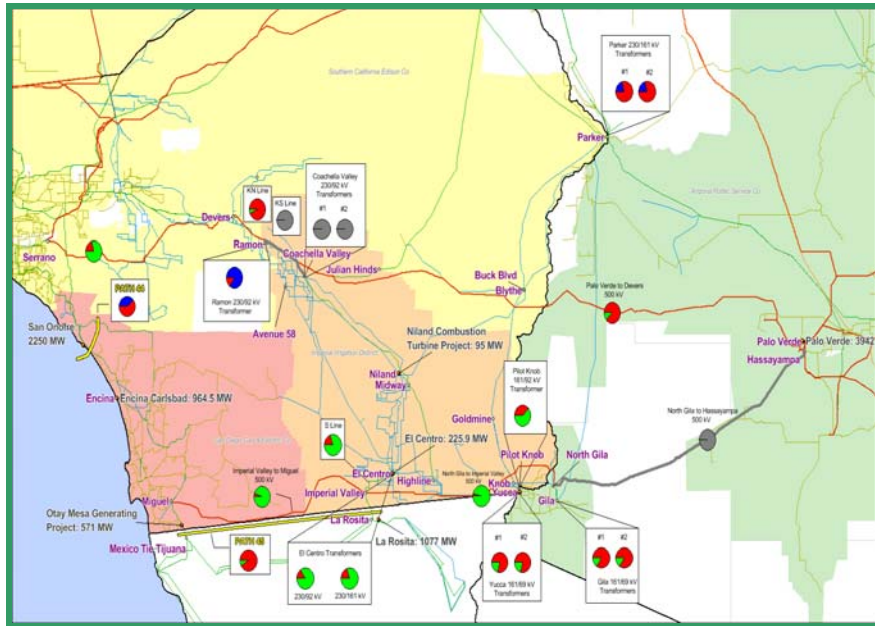
15:28:17 – Two Coachella Valley 230/92 kV transformers and the Coachella Valley Ramon 230 kV “KS” line tripped. (030)

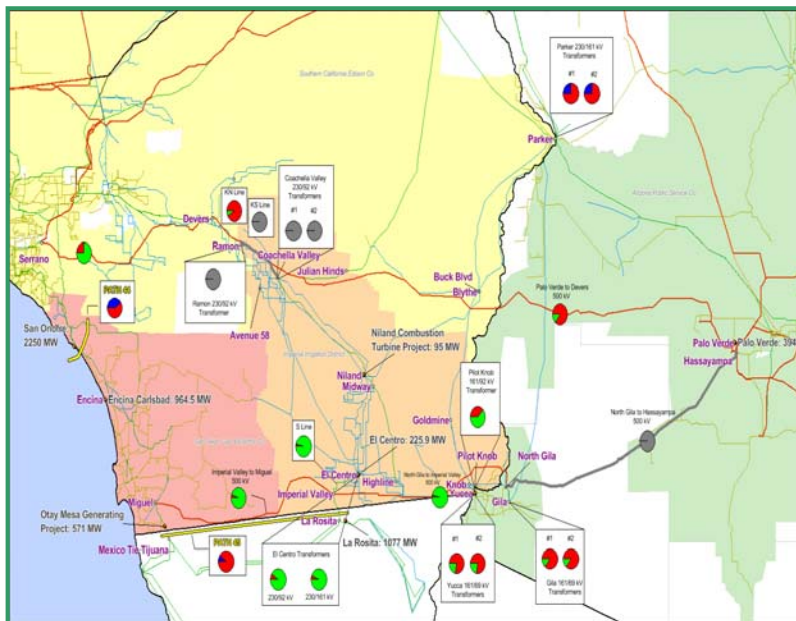
Time: 15:32:10 – The Ramon 230/92 kV transformer tripped and IID shed 444 MW of load. (110)

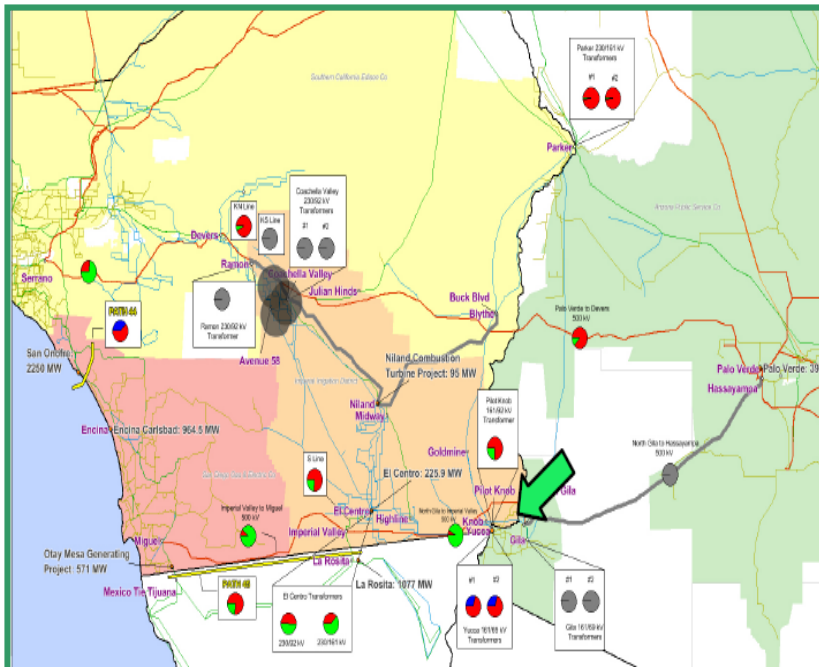
Time: 15:35:31 – Yuma Cogen (YCA) tripped. (180)

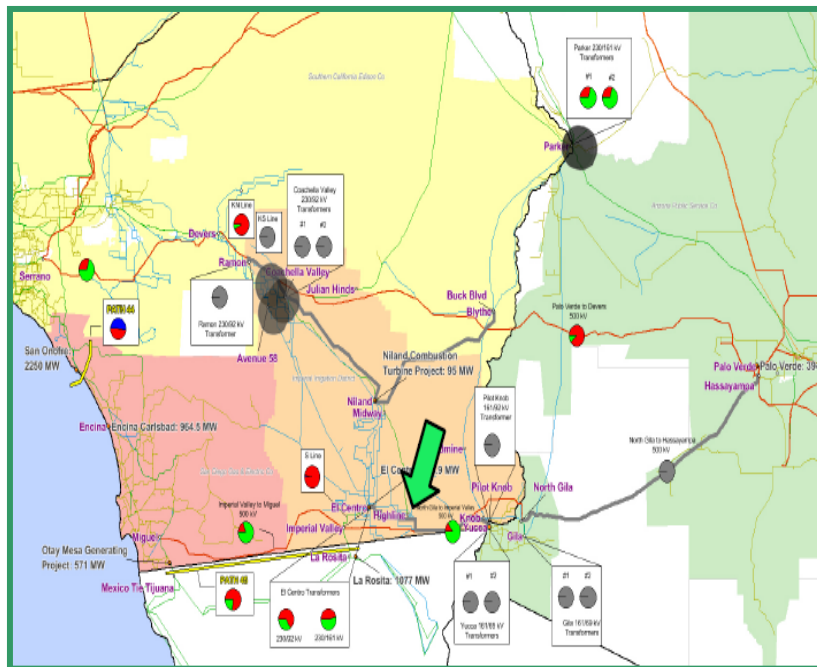
Time: 15:37:55 – The El Centro-Pilot Knob 161 kV line tripped. (230)

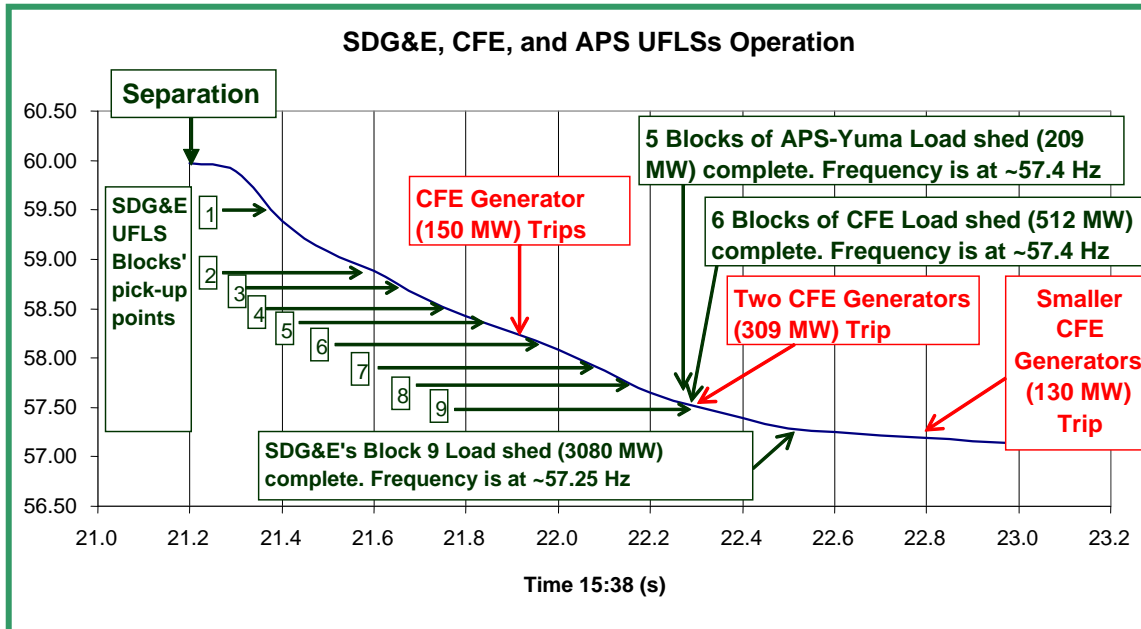
Figure 11: Frequency Performance in the SDG&E/Yuma/CFE Island

The CFE island separated from SDG&E after their only two remaining ties tripped in rapid succession. At 15:38:22.2, the Otay Mesa-Tijuana 230 kV transmission line open-ended at Tijuana in CFE's territory due to underfrequency protection.⁵⁵ Less than a second later, at 15:38:23.13, the Imperial Valley-La Rosita 230 kV transmission line open-ended at Imperial Valley in SDG&E's territory by underfrequency protection.⁵⁶ According to CFE, its UFLS program was not designed for the operation of a SDG&E/CFE/Yuma island, but for the operation of a "southern WECC island."

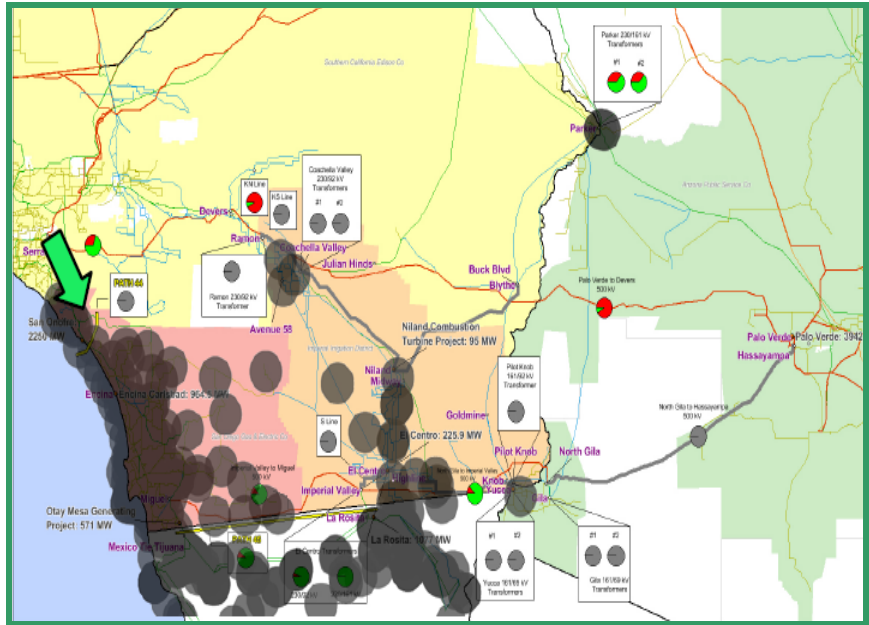
Time: 15:38:30 – The South of SONGS Separation Scheme operates and both SONGS units tripped. (300)

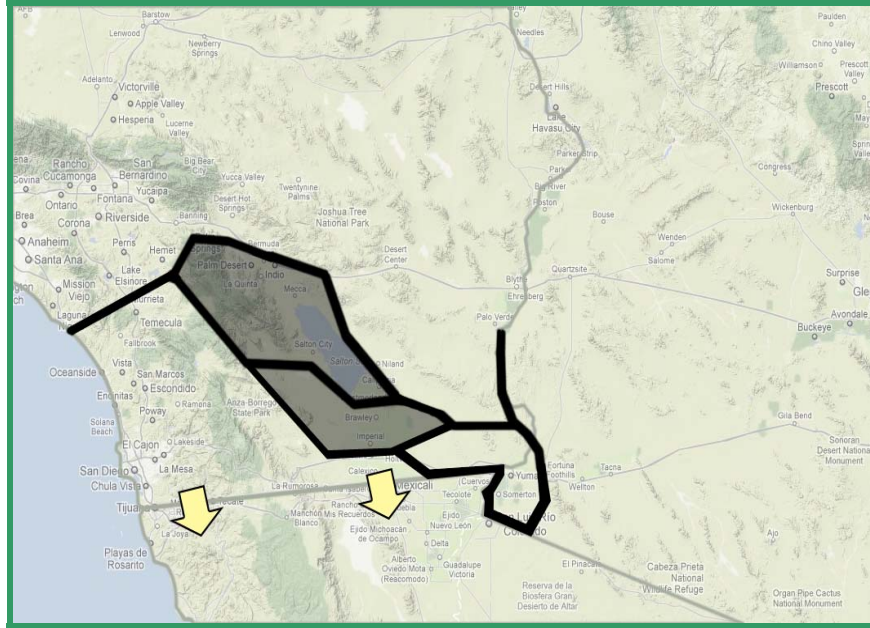
Yuma Separates (Time: 15.38.23.12)

The Yuma island separated from SDG&E at 15:38:23.12, when the Imperial Valley-North Gila 500 kV transmission line tripped by underfrequency protection. APS's UFLS operated on 26 out of the 28 feeders in the Yuma area prior to the loss of the local Yucca steam generators that were on line. However, there was insufficient local generation to stabilize the load pocket in Yuma. At 15:38:38, the Yuma island internal units tripped on underfrequency protection.

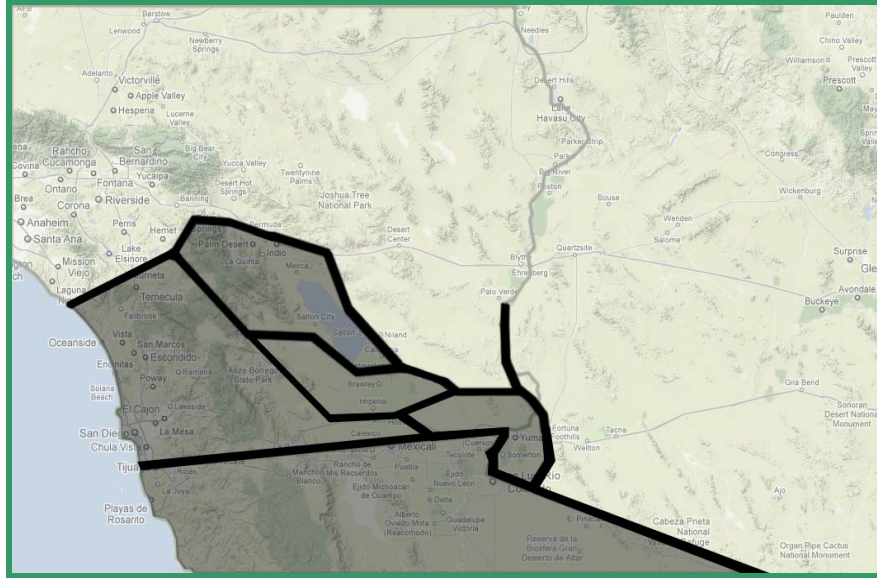
SDG&E, CFE, and Yuma Blackout (by 15.38.30)

By 15:38:38, the SDG&E, CFE and Yuma islands had all collapsed, leaving approximately 2.7 million customers without power.

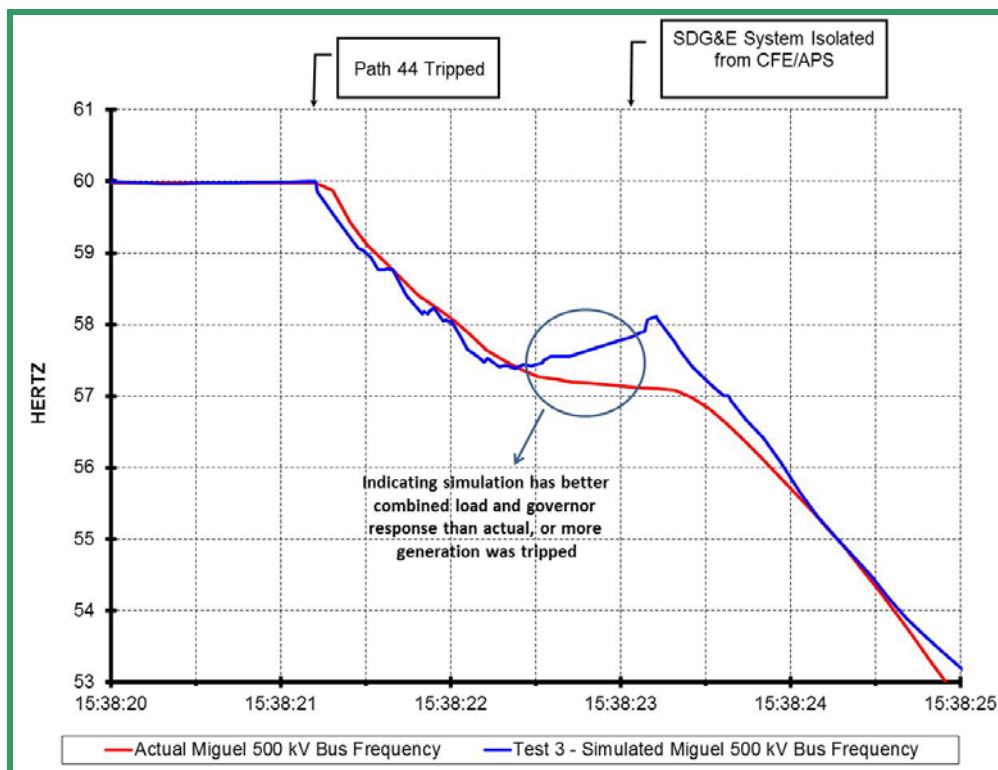
Figure 15: Miguel Frequency Actual and Simulated for “Test 3”

The simulation studies explain the ineffectiveness of the UFLS program, despite up to 75% of SDG&E load that was shed within 1.3 seconds of the SONGS separation scheme operating. The simulation analysis confirmed findings in the inquiry’s SOE that the frequency collapse was caused by generation trips and UFLS misoperations within CFE shortly after Path 44’s separation, followed by additional generation trips within SDG&E around the time it separated from CFE/APS.

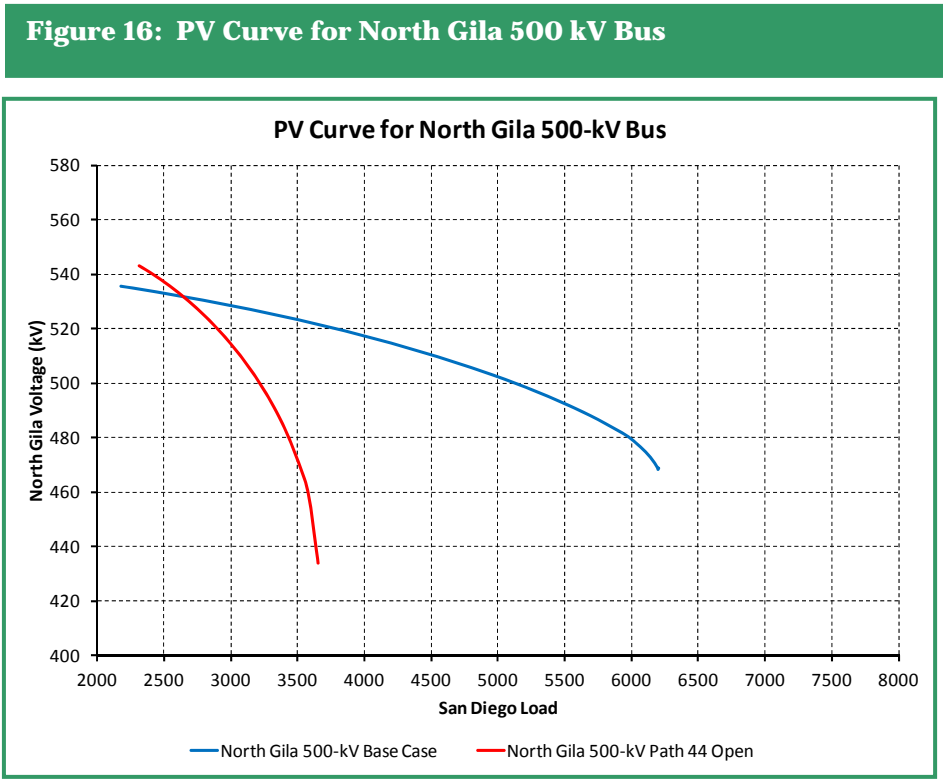
The inquiry conducted a simulation to evaluate what would happen if the SONGS separation scheme inadvertently operated during normal system operations (e.g., in the absence of any outages, overloads, or SOL violations). Based on this simulation, the inquiry determined that under certain high load conditions, the operation of the scheme could result in voltage collapse and a blackout in SDG&E’s and CFE’s territories. The inquiry conducted a voltage stability study using a Power-Voltage (P-V) curve to estimate the amount of SDG&E load that could reliably be supplied after an inadvertent operation of the SONGS separation scheme. The P-V curve below in **Figure 16** demonstrates that such operation would lead to a voltage collapse and a blackout in the SDG&E and CFE territories under certain high load conditions.

Specifically, the system is most likely to collapse when the SDG&E load exceeds 3,500 MW. In 2010, SDG&E’s load exceeded this amount for 851 hours,⁹⁷ meaning that

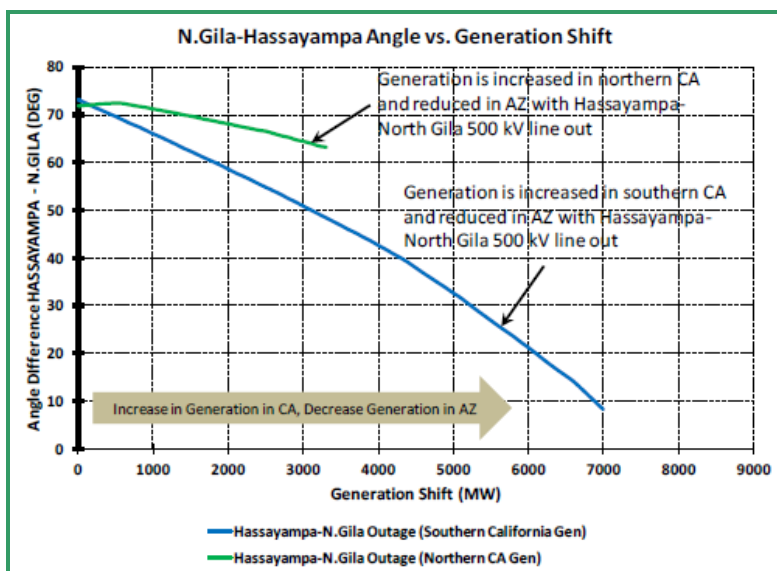
Figure 17: Phase Angle of H-NG vs. Generation Shift

The blue line in Figure 17 illustrates that with the particular conditions of the September 8th event, approximately 1,800 MW needed to be redispatched on both ends of H-NG (and close to the terminals, in Southern California and Arizona) in order to close the voltage phase angle from 72 degrees to 60 degrees (i.e., to within the permissive 60 degree setting of the synchro-check relay). The green line shows that more generation—more than twice as much—must be redispatched if units are chosen in Northern California to close the angle between Hassayampa and North Gila.

While system operators could redispatch generation from available spinning reserves or commit units in the Southern and/or Northern California area, it is questionable how quickly 1,800 MW could be dispatched.
