National Transportation Safety Board

Safety Recommendation

Date: September 4, 2012

In reply refer to: A-12-48 and -49

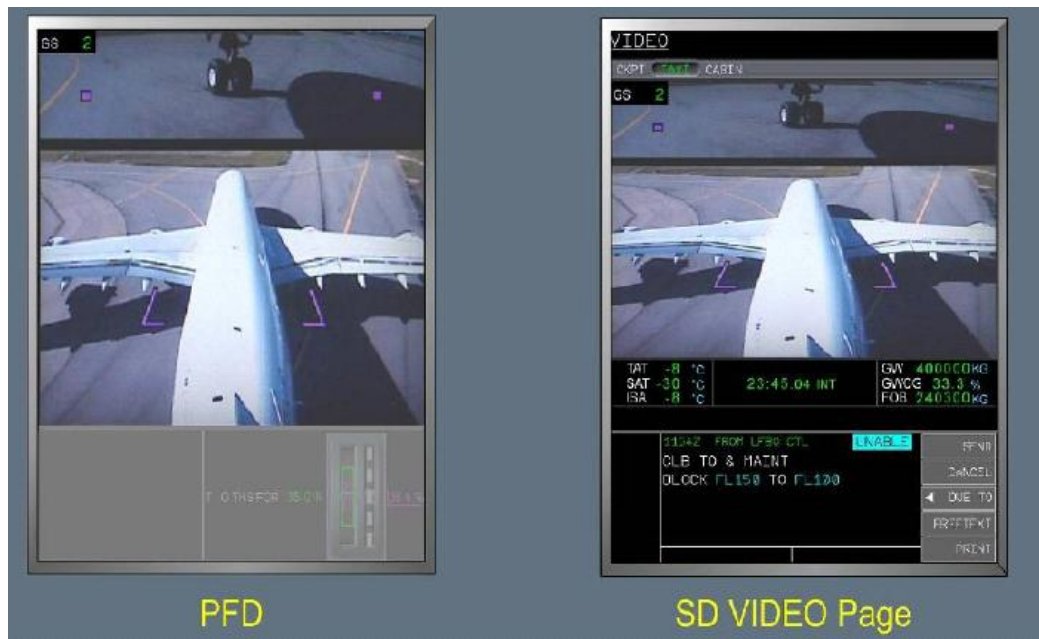
Camera [FTAC]), which display the nose and main landing gear positions before and during taxi for the pilots in the cockpit, and an external landscape camera.⁷ The BTACS, which is located on the underside of the fuselage just aft of the nosewheel, displays a picture of the nosewheel and the taxiway and is used by the pilots to verify their position on a taxiway centerline or the condition of the nosewheel. The FTAC is located on the vertical tail and displays a view of the airplane that extends from just outside the number one outboard engine to just outside the number four outboard engine to show the location of the outer edge of each of the main landing gear. However, neither camera shows the airplane's wingtips; thus, several feet of the outboard portion of the wings are not visible to the cameras.

The live views from these cameras can be displayed on either primary flight displays (PFD) or on the system display (SD) when the airplane is on the ground and below 60 knots.⁸ The figure shows the view from the A380's BTACS and FTAC as shown on the PFD and SD.

Figure. Live camera views on an A380 as shown on the PFD and SD.

The NTSB notes that the A380 and other large airplanes do not currently have camera systems that display wingtips or wingtip paths. The NTSB is concerned that pilots of large airplanes where the wingtips are not visible from the cockpit may have difficulty determining wingtip clearance and path. The NTSB concludes that an anti-collision aid, such as a camera system that displays the airplane's wingtips, would give pilots of large airplanes a clear

Require the installation of an anti-collision aid, such as a camera system, on all newly manufactured and newly type-certificated large airplanes and other airplane models where the wingtips are not easily visible from the cockpit to provide a cockpit indication that will help pilots determine wingtip clearance and path during taxi. (A-12-48)

Require all existing large airplanes and other airplane models where the wingtips are not easily visible from the cockpit to be retrofitted with an anti-collision aid, such as a camera system, to provide a cockpit indication that will help pilots determine wingtip clearance and path during taxi. (A-12-49)
