Section 3 Historical Performance of Upper Reservoir

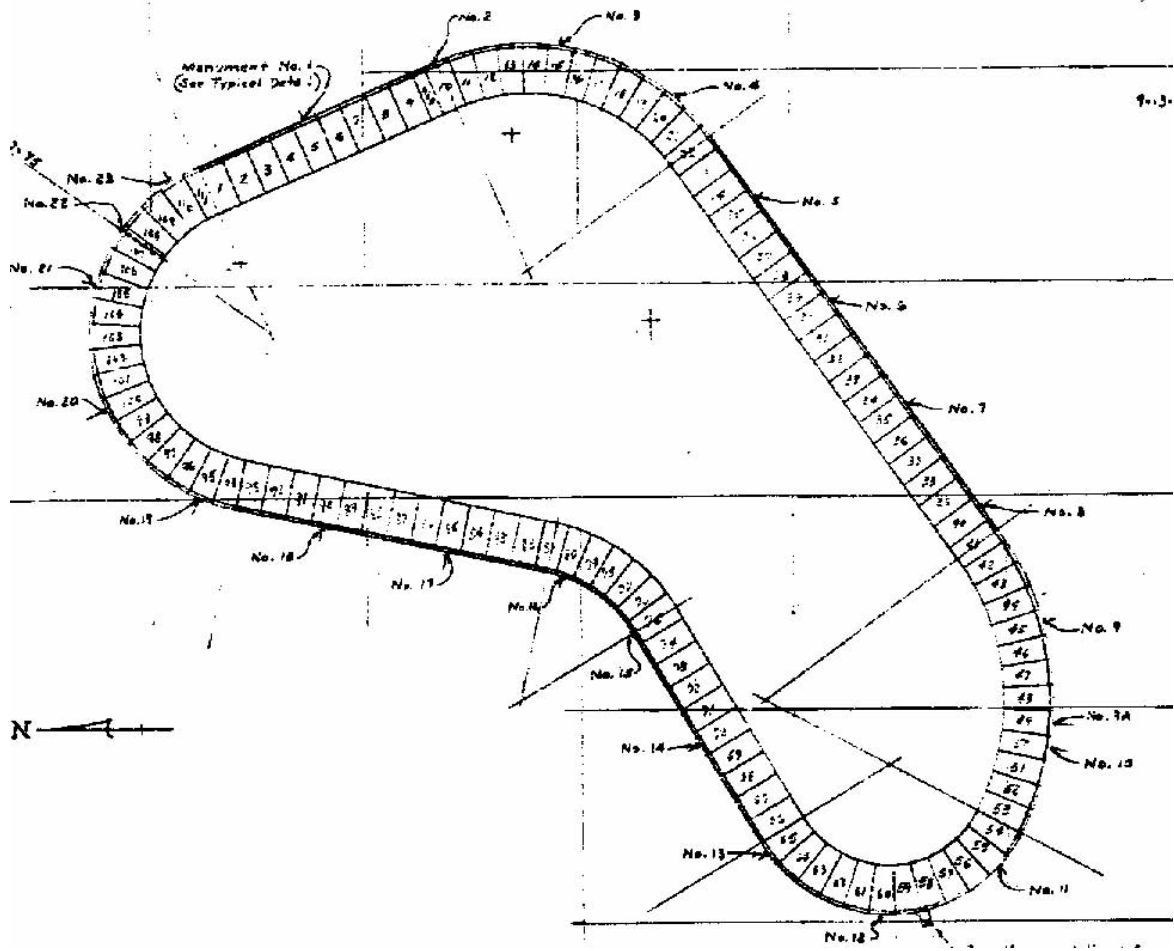
Figure 3.1 - Location of Settlement Survey Pins in Parapet Wall Footer

Settlement of the Upper Reservoir Dam was monitored by a survey of 24 survey monuments located on the base of about every fifth parapet wall section and six monuments on the gaging station platform (Figure 3.1). The survey monuments were installed in 1962 and consist of 1/2 inch by 6 inch bolts embedded in the concrete footings of the parapet wall.

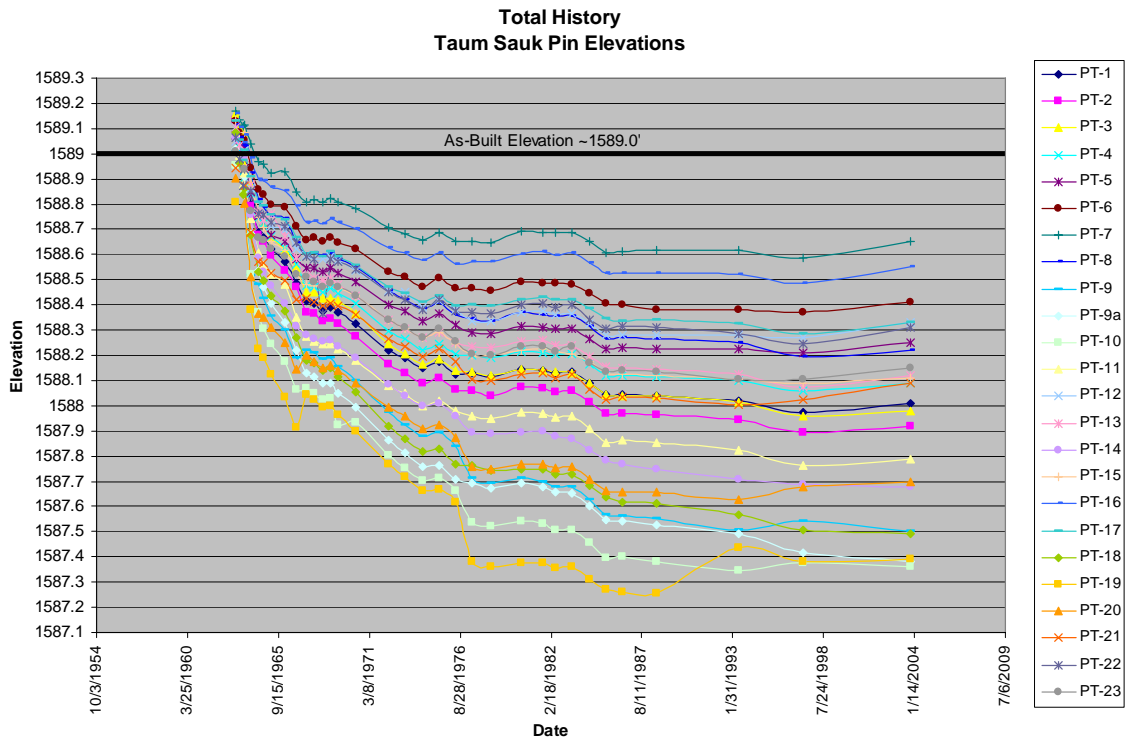
Figure 3.2 - Total History Settlement Data

A correction was made early in the history of the monitoring to account for a number of pins that were damaged, reducing the elevations from the original survey. It appears that the correction that was applied may have been to add the difference rather than subtract the difference. Hence, some of the settlements shown may be slightly more than the actual settlement. Figure 3.2 shows that the primary settlement occurred prior to August 1976. Apparent movements following this time were very small from year to year and generally fall within the accuracy of the surveys. Figure 3.3 shows a more detailed view of settlement that has occurred during the past 24 years. For reference, Point 19 is within the breach area.

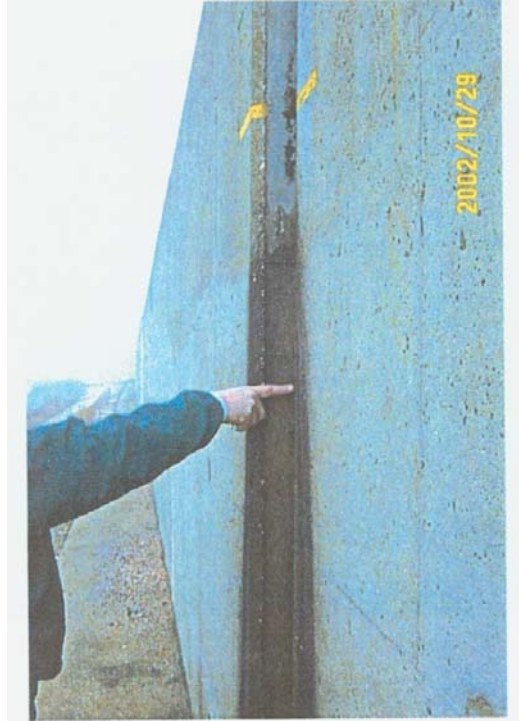
"The maximum horizontal movement observed was at joints 89/90 and 106/107, with about 4-5 inches of translation and rotational movement. Photograph 3 (*of the report – see below Figure 3.4*) shows panel 90 having moved downstream relative to panel 89. The copper waterstop was visible in the joint. This magnitude of movement is likely sufficient to tear the waterstop, but probably does not affect the wall stability."

Figure 3.4- Movement at Upper Dam Parapet Wall at Joint 89/90 from 2003 Eighth Part 12D Report

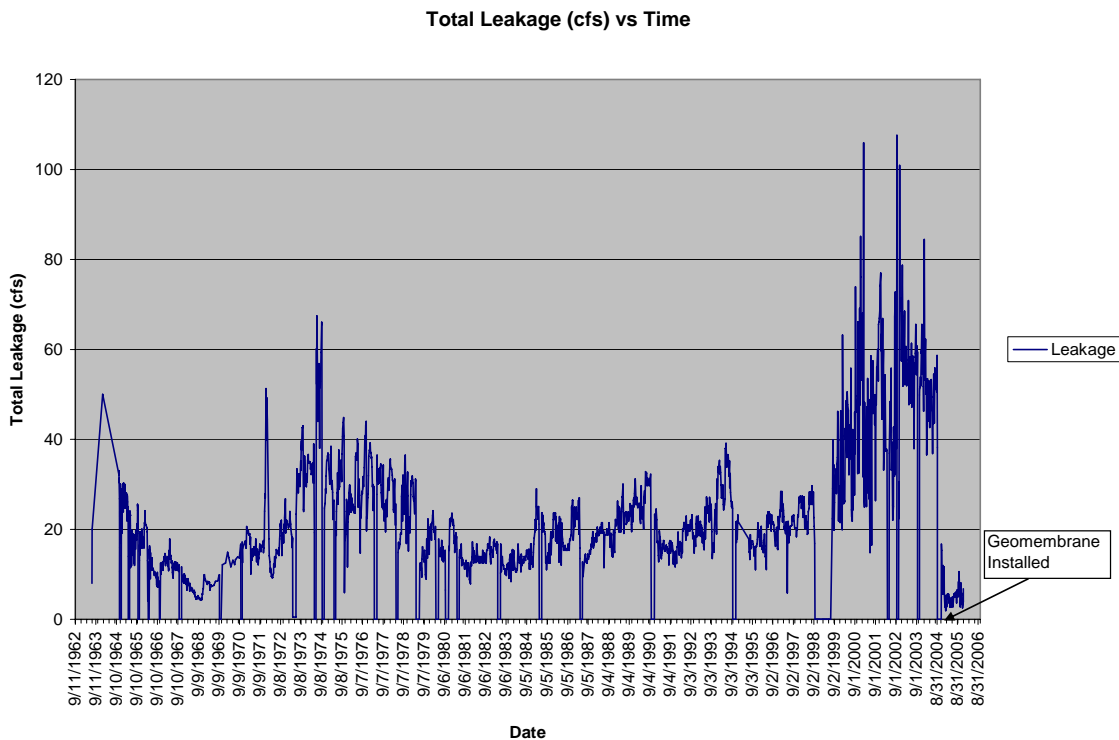
Figure 3.5- Historical leakage Rates

Higher rates of leakage began in 1999 following an extended outage. A geomembrane liner was subsequently installed in 2004, which significantly reduced the leakage for the 12 months prior to the breach. Figure 3.5 shows the history of leakage and the periods of repairs (illustrated by periods of zero leakage).

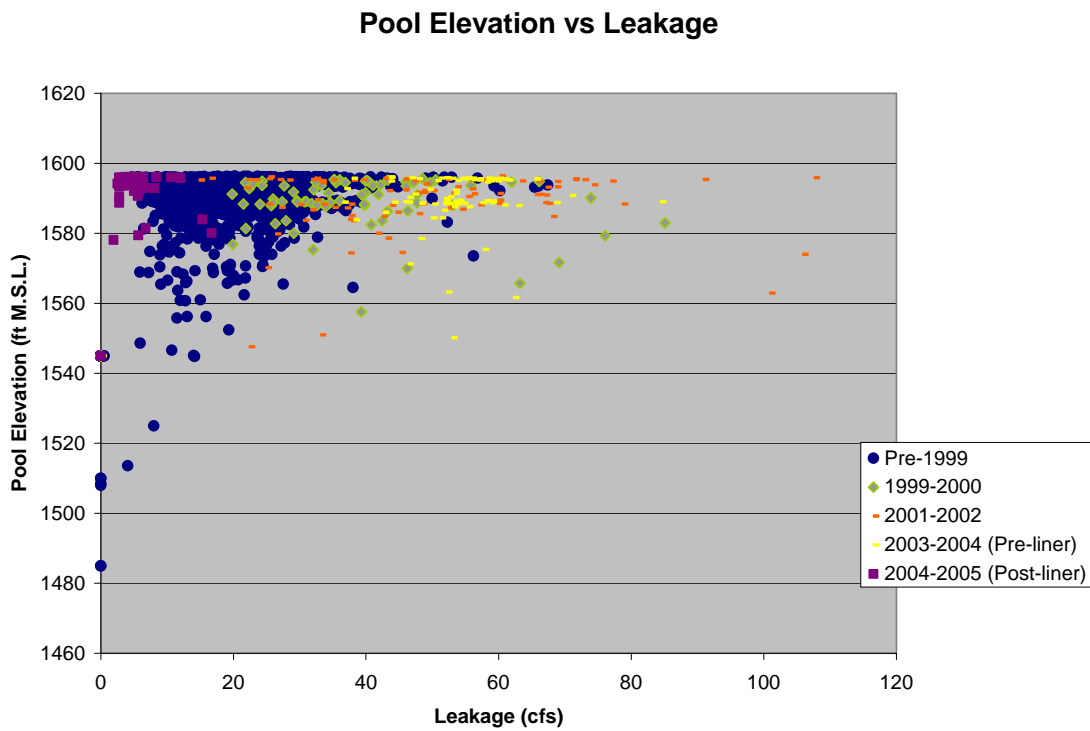
Figure 3.6- Leakage verses Upper Reservoir Pool Elevation

There were no significant trends between pool elevation and leakage rate for reservoir operating ranges above 1589 (Figure 3.6). However, total leakage appears to drop rapidly when the reservoir elevation was dropped below 1540 feet.

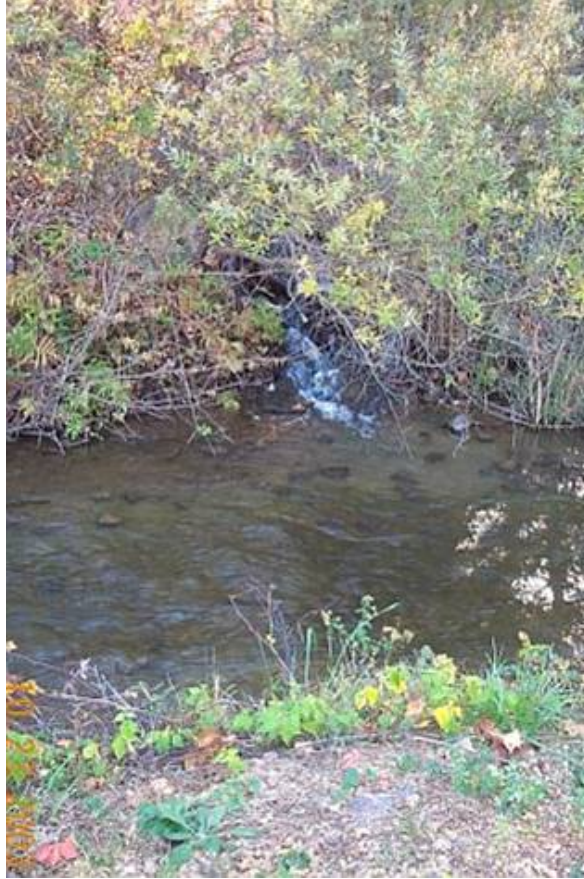
**Figure 3.7 - Concentrated Seep Before liner installation
(2003 FERC Operation Inspection Report)**

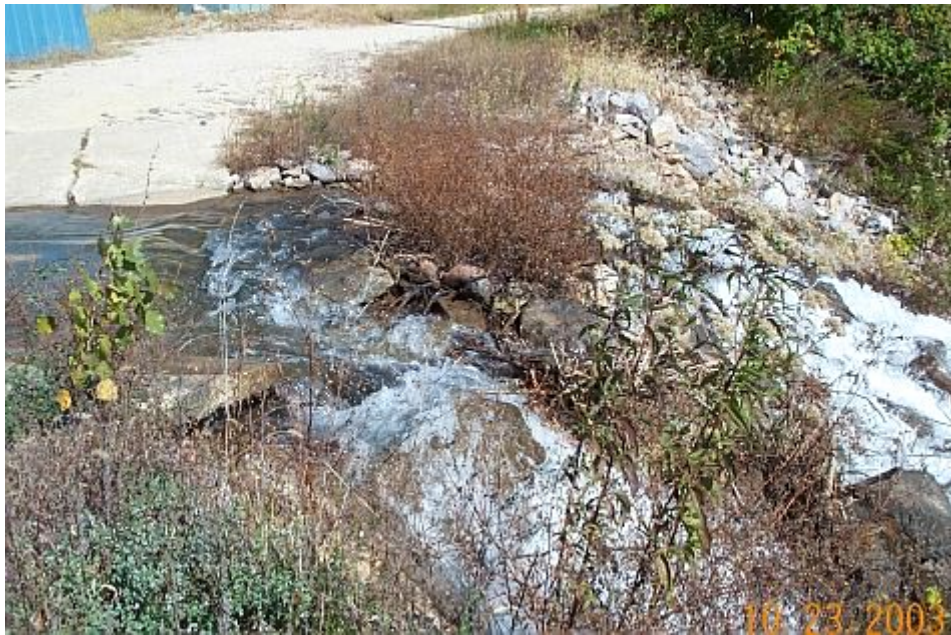
**Figure 3.8 - Overflow of the seepage collection Pond before liner installation
(2003 FERC Operation Inspection Report)**
