**Fire On Board U.S. Small Passenger Vessel  
*Express Shuttle II*  
Pithlachascotee River Near Port Richey, Florida  
October 17, 2004**

**Marine Accident Report**

**NTSB/MAR-06/02**

The National Transportation Safety Board determines that the probable cause of the fire on board the *Express Shuttle II* was a fractured, improperly installed fuel injection line on the inboard side of the starboard engine that allowed diesel fuel to spray onto the engine and ignite. Contributing to the cause of the fire was the failure of Paradise of Port Richey to have a preventive maintenance program, which could have identified the company's ongoing problem with the vessel's fuel lines before a failed line led to the fire. Contributing to the extent of the damage were the vessel's faulty fire detection system and the crew's failure to employ proper marine firefighting techniques.

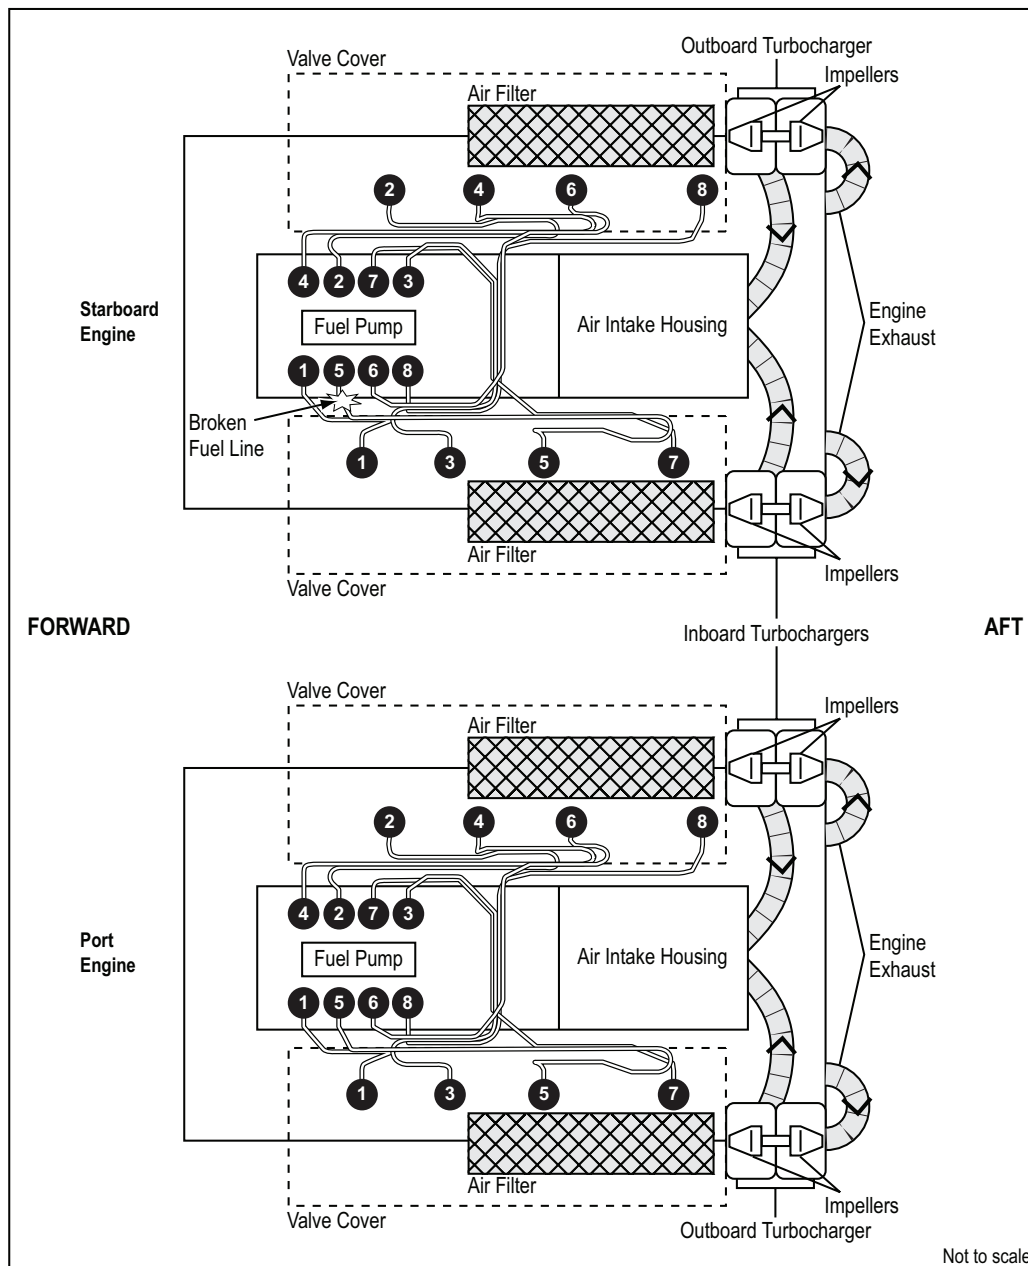
**Figure 5.** Layout of the *Express Shuttle II*'s engines. Arrow points to the broken fuel delivery line identified during the accident investigation (see "Wreckage" and "Tests and Research" sections).

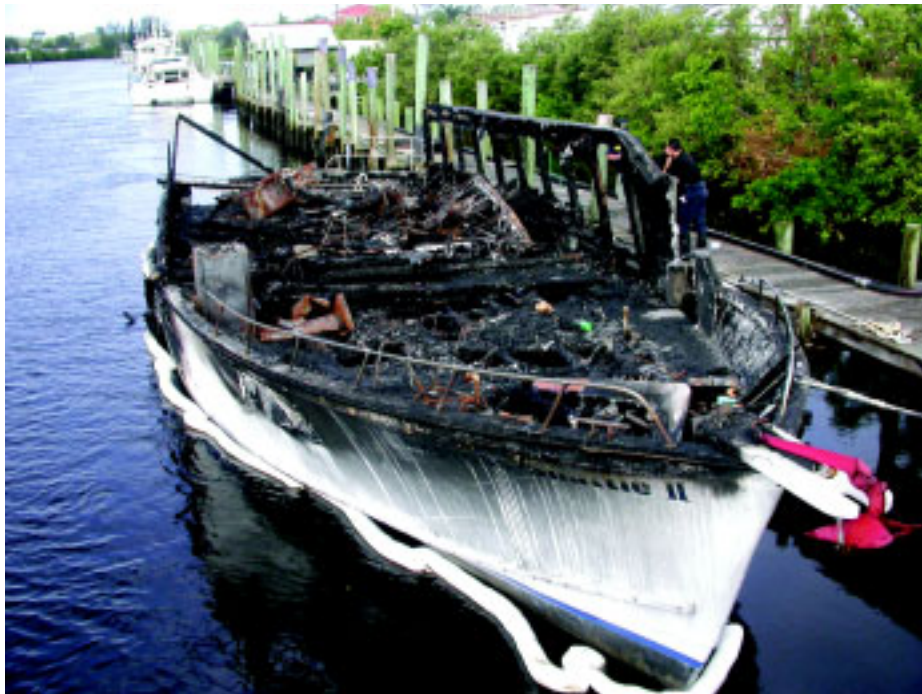
On October 21, Safety Board investigators examined the damage to the *Express Shuttle II* at a marina in Tarpon Springs. The fire had destroyed the vessel's top deck and main deck and severely damaged the belowdecks area (figure 8), including both engines and both generators. The investigators found it necessary to remove charred debris from the engines before they could conduct their postaccident examination.

**Figure 8.** Wreckage of *Express Shuttle II* as it appeared when Safety Board investigators examined it 4 days after the fire.

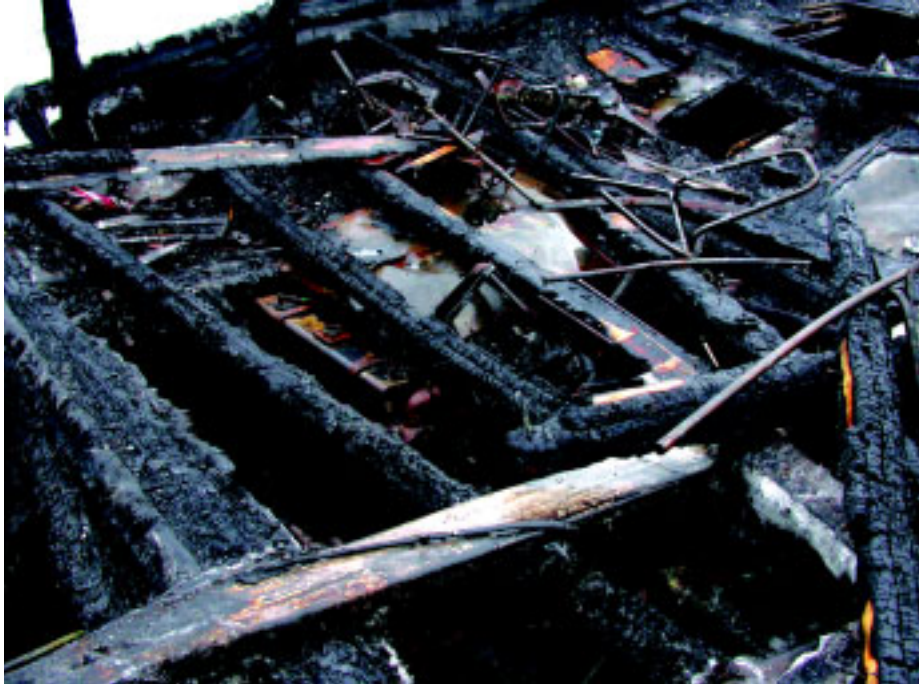
The fire burned through most of the main deck, especially in the area of the engine compartment (figure 9). Wooden structural components of the main deck were heavily charred and fiberglass components were brittle, with most of the resin burned out of the

fiberglass matrix. All items on the main and upper decks (chairs, tables, and other items) were completely destroyed. All decking over the engine space, including the stringers supporting the decks, was destroyed. The destroyed sections of the upper deck had collapsed onto the main deck and fallen into the bilge and engine compartment. The only remaining upright structure was a charred section of the port cabin bulkhead. The inside of the hull below the main deck was charred but intact.

**Figure 9.** Debris over the engine compartment that investigators had to remove before they could examine the *Express Shuttle II*'s engines and generators.

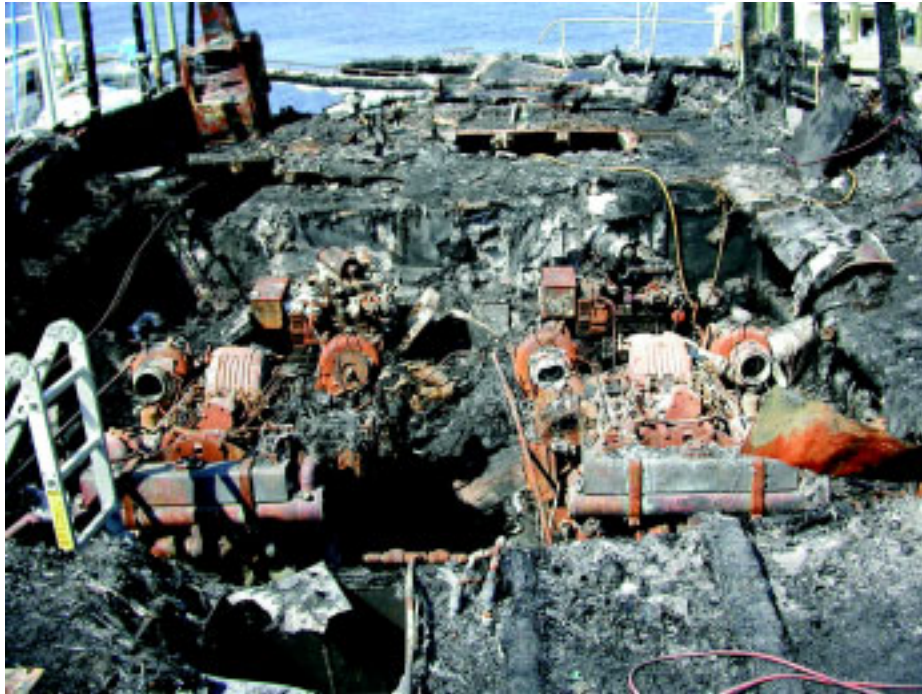
The engine compartment was heavily damaged by the fire. Both engines and both generators were destroyed, and most of the aluminum engine components (such as valve covers) were melted.<sup>24</sup> The starboard engine sustained more damage than the port engine (figure 10). The inboard sides of the engines showed intense heat damage, particularly near the starboard engine valve cover. Both engines were protected from impact damage by their overhead heat shields, which had collapsed on top of them.

**Figure 10.** Looking aft toward the *Express Shuttle II*'s engine space after the fire. The starboard engine (left) was more severely damaged than the port engine (right).

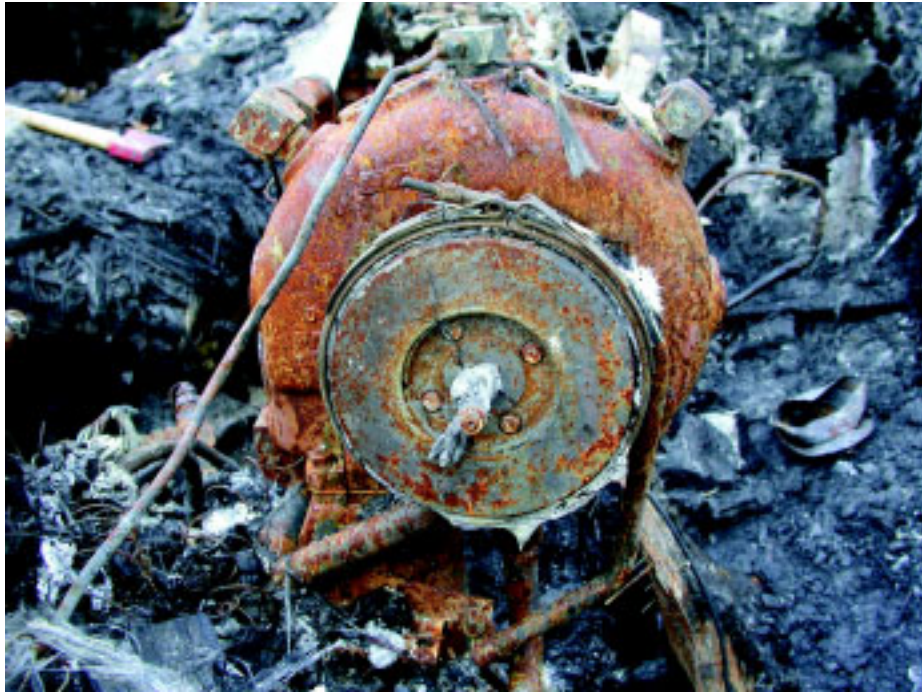
**Starboard Engine.** Investigators found that the fire destroyed the aluminum impeller<sup>26</sup> on the compressor (air inlet) side of the engine's inboard turbocharger (figure 11), but that the impeller on the exhaust side of the turbocharger was intact. Both impellers on the outboard turbocharger were also intact. The fuel filters on the inboard side of the engine were destroyed, and the aluminum inboard valve covers were melted.

**Figure 11.** Photograph showing destruction on starboard engine's inboard turbocharger.

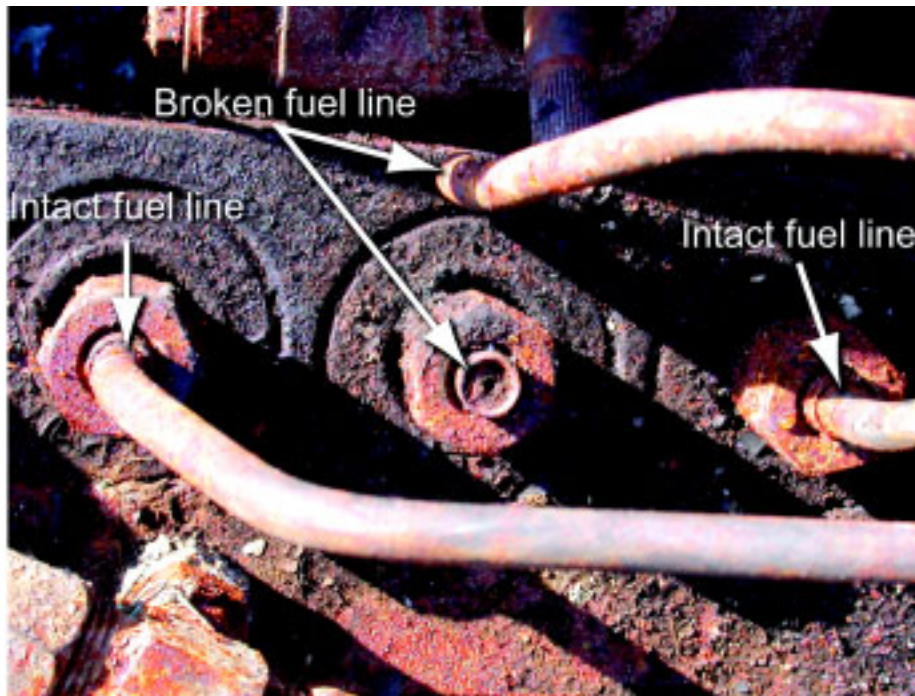
Investigators found that the steel delivery line leading from the fuel pump to cylinder 5 of the starboard engine had broken at the end nearest the fuel pump, at the upper end of the metal sleeve, or ferrule, attaching the line to the fuel pump (figure 12). Investigators found no evidence, such as dents or punctures, which might indicate that the break was caused by falling fire debris. Investigators further discovered that the entire length of the cylinder 5 fuel line was without support clamps.

**Figure 12.** Closeup showing where the fuel line (center) to cylinder 5 of the starboard engine broke away from its attachment at the fuel pump.

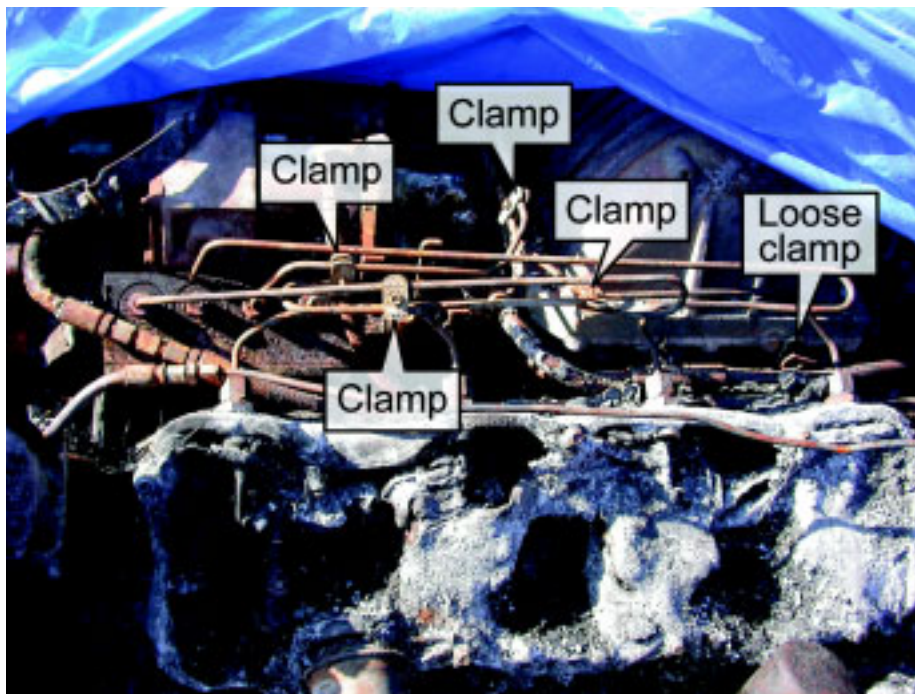
Investigators found one support clamp in the debris, on top of the inboard side of the starboard engine block between cylinders 5 and 7. The screw was loosened almost completely, to the extent that the end threads were flush with the outer surface of the end plate. No fuel lines were fastened to the clamp. Investigators found a total of seven other clamps supporting the fuel delivery lines on both sides of the starboard engine, but none of the clamps was secured to the engine block (figure 13).

**Figure 13.** Photograph of fuel lines on the inboard side of the starboard engine block showing lines clamped together, and the loose clamp found between cylinders 5 and 7.

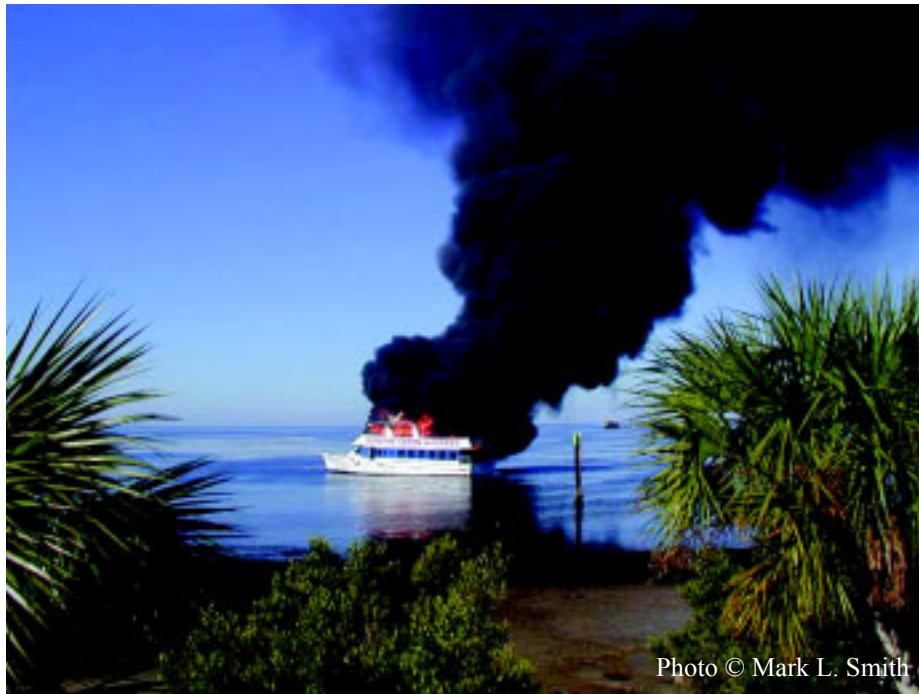
**Figure 14.** When firefighters arrived at the scene, the entire deck structure of the *Express Shuttle II* was on fire and a thick plume of black smoke rose hundreds of feet into the air.

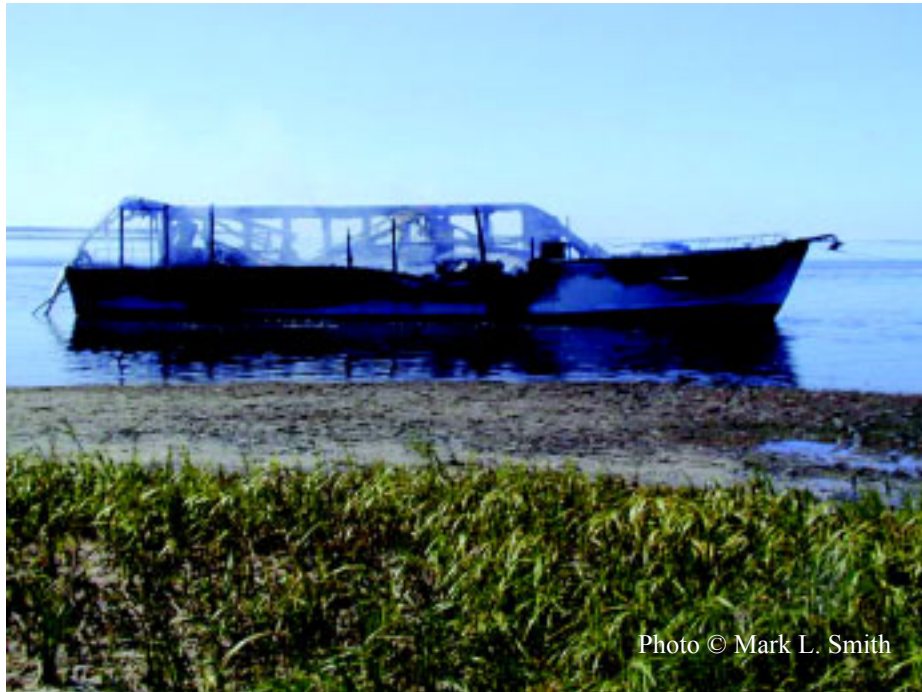
**Figure 16.** By the time the fire was extinguished, the *Express Shuttle II* was a total loss.

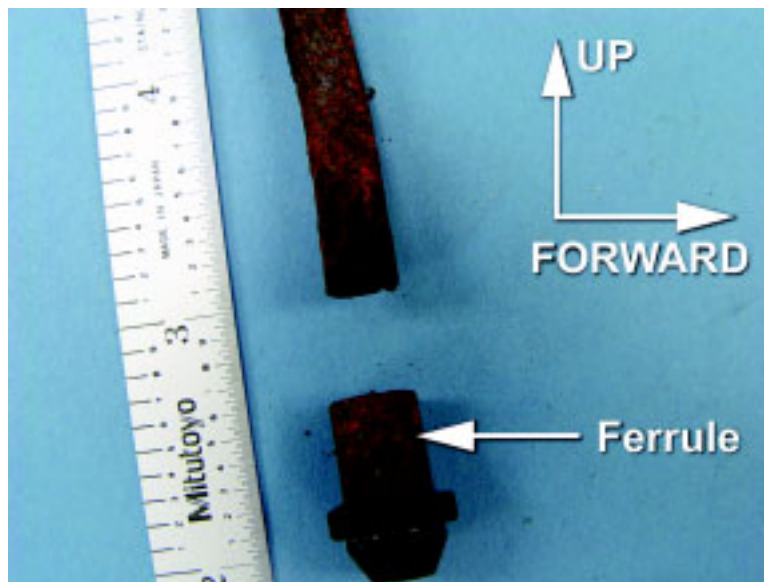
The Safety Board materials engineers measured the location of each clamp on the fuel injection lines from the starboard engine and the material hardness of the fuel injection line for engine cylinder 5 (it was within the specified range). The engineers examined in detail the fracture area on the fuel line at the ferrule's upper edge (figure 17).

**Figure 17.** Closeup of the fracture area on fuel injection line 5 of the vessel's starboard engine. Up and forward arrows are in relation to the starboard engine.

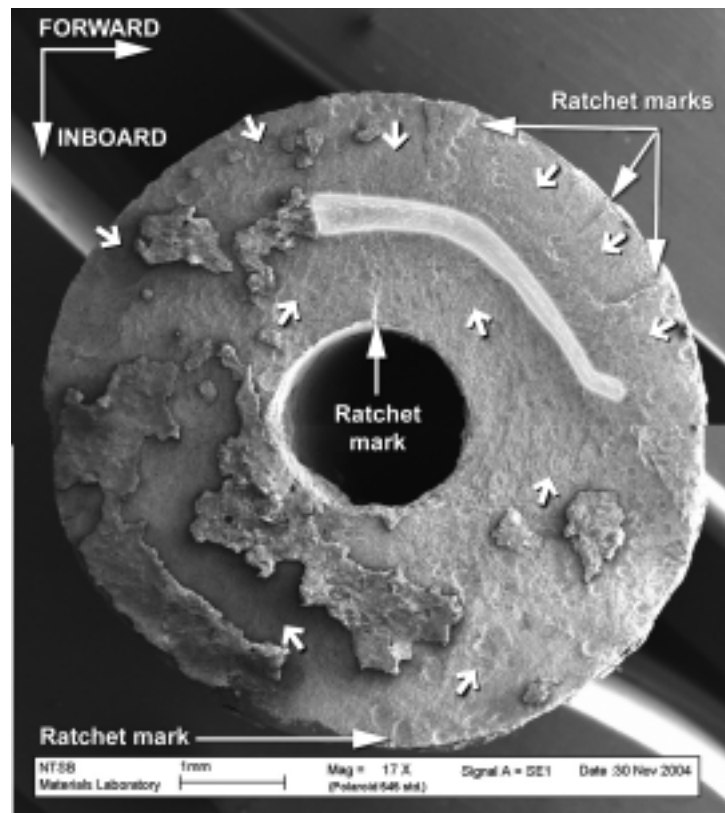
In their report, the Safety Board's engineers characterized the fracture mechanism as "macroscopically brittle"<sup>39</sup> and stated that the fracture area on the steel fuel line exhibited features "consistent with fatigue fracture across approximately 95 percent of the fracture surface" (figure 18). The metal fatigue originated mostly at a single area on the inboard surface of the fuel line. The remainder of the fatigue had multiple origins on the outboard surface of the line. As shown in figure 18, the outer circumference of the fracture surface on the fuel line showed numerous ratchet marks, indicating fatigue cracking in different, slightly offset planes in the metal. The materials engineers observed "no evidence of crimping damage from the ferrule" on the fuel line next to the fracture.

**Figure 18.** Scanning electron microscope view of the fracture surface on fuel injection line 5 (perspective is upward through the line, which was perpendicular to the engine at the fracture location). Shaded area indicates the "final fast fracture region," that is, the last region to give way. Unlabeled arrows indicate the approximate direction of fatigue propagation. Fatigue originating at the inboard surface of the fuel injection line traveled around the center and formed a ratchet mark on the opposite side (arrow at center). Ratchet marks form where cracks in offset planes meet and generally indicate multiple fracture origins.
