**Multiple Vehicle Collision on Interstate 95
Fairfield, Connecticut
January 17, 2003**

Highway Accident Report

NTSB/HAR-05/03

Abstract: On Interstate 95 (I-95) near Fairfield, Connecticut, two consecutive accidents occurred within 11 minutes in the early morning hours of January 17, 2003. At the time of the accidents, light snow was falling, the roads were wet and icy, and snow covered the roadway shoulders. About 4:50 a.m., a 1996 Freightliner tractor flatbed semitrailer was involved in a nonfatal multivehicle accident. The truck was traveling in a work zone on I-95 north, near milepost 26.6, at a driver-estimated speed of 50 mph, when it slid out of control. The vehicle entered the median, overturned and overrode the portable concrete barrier, and collided with a southbound 1997 Dodge Avenger sedan. A southbound 2001 Freightliner tractor/refrigerated trailer combination unit struck the Dodge sedan and then struck the 1996 Freightliner tractor. The three vehicles came to rest blocking the southbound lanes of the highway. During the accident sequence, the flatbed semitrailer separated from the 1996 Freightliner tractor. The semitrailer came to rest perpendicular to the roadway,

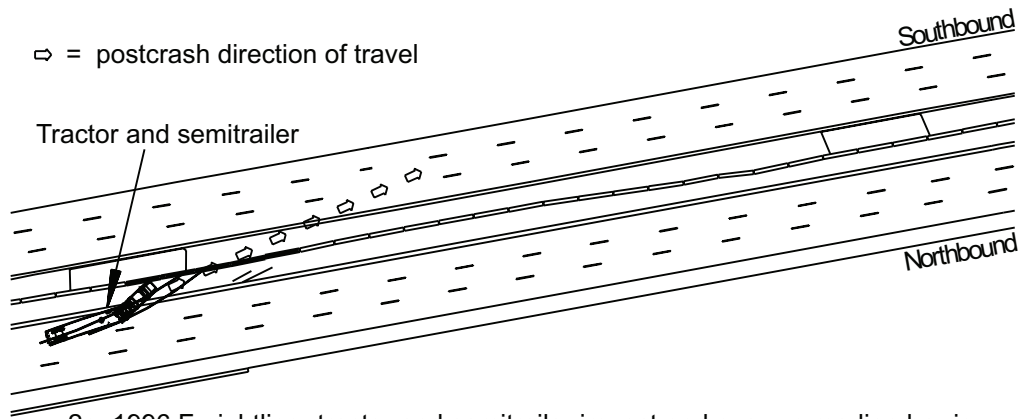
2a. 1996 Freightliner tractor and semitrailer impact and overrun median barrier.

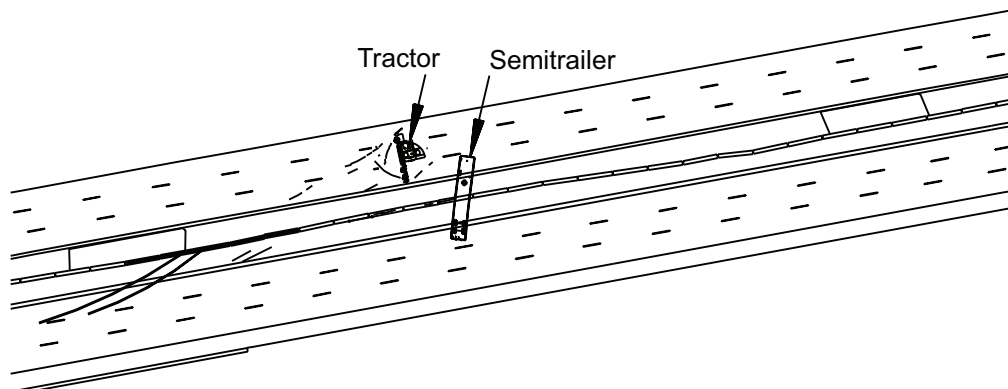
2b. Tractor and semitrailer separate, causing semitrailer to encroach into northbound traffic lanes.

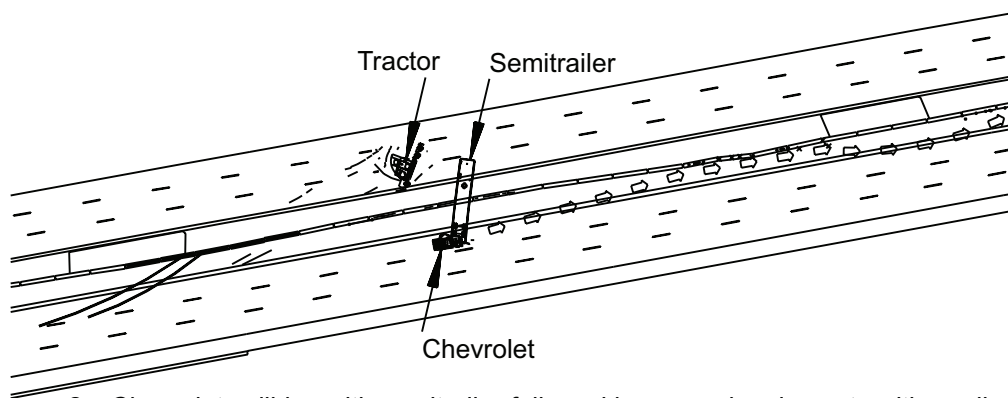
2c. Chevrolet collides with semitrailer followed by secondary impacts with median barrier.

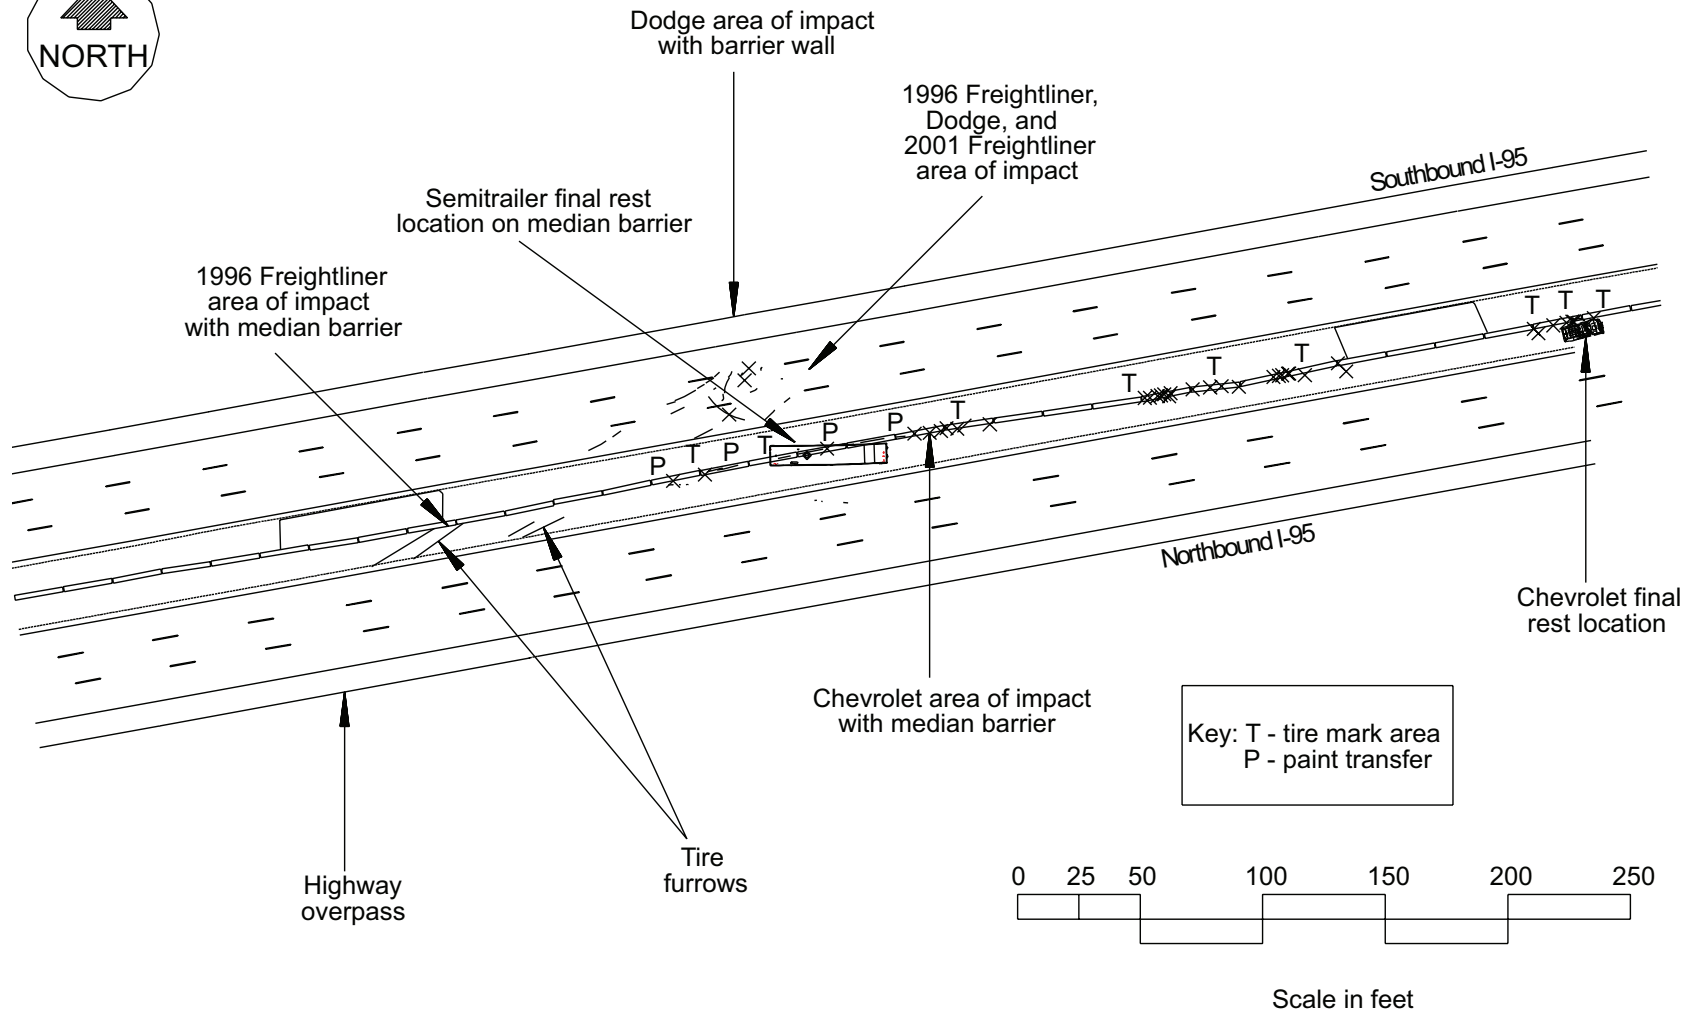
Figure 4. Highway forensic evidence from 4:50 a.m. and 5:01 a.m. accidents.

Physical evidence of the initial accident involving the 1996 Freightliner consisted of furrow marks on the northbound side of the median, contact damage to the concrete median barrier, and pavement scrape marks in the southbound lanes. (See figure 4.) The furrow marks began in the median adjacent to the left lane, veered off toward the concrete median barrier at approximately a 23° angle, and then continued into the southbound traffic lanes. The pavement scrape marks traversed the three southbound lanes and extended a distance of approximately 63 feet. Additional contact damage to the top of the concrete median barrier consisted of green paint transfer that began about 80 feet beyond the furrow marks and continued for a distance of 101 feet.

The Chevrolet left pavement scrape marks on the left lane at the point of impact with the 1996 Freightliner flatbed semitrailer; additional forensic evidence included intermittent contact damage to the median barrier beyond the impact with the trailer. (See figure 4.) The pavement scrape marks were 10 feet long and were located approximately 150 feet north of the furrow marks. The contact damage to the median barrier—consisting of tire marks that extended about 500 feet—was located 215 feet north of the furrow marks.

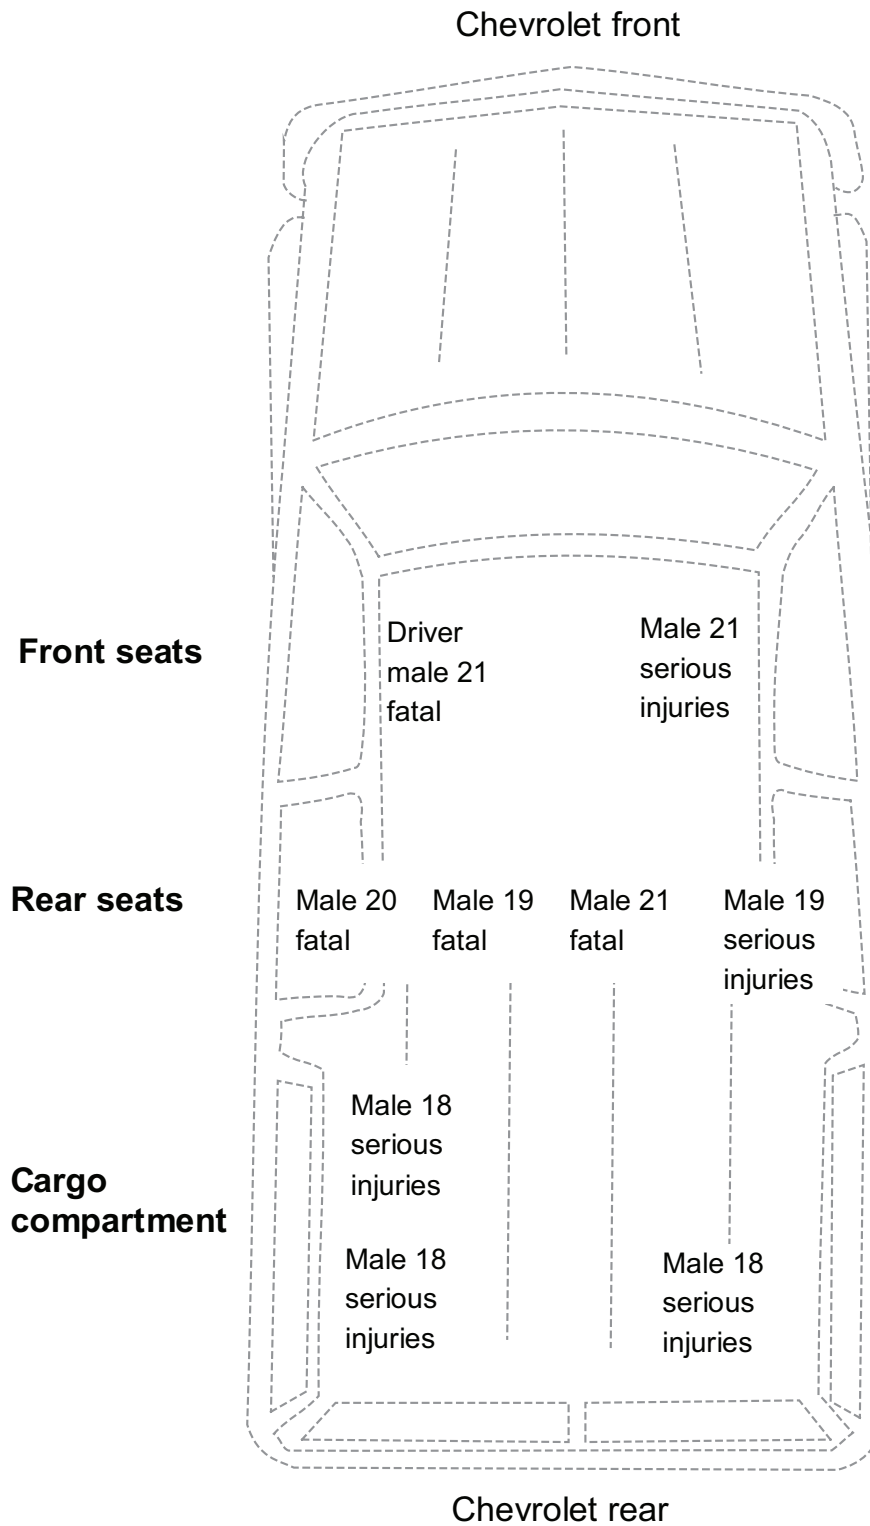
Figure 5. Chevrolet Tahoe seating chart.

The Chevrolet was designed to accommodate a maximum of five passengers. It included seat belts for the two front seats and the three rear seats. Figure 5 shows the seating arrangement at the time of the accident. According to survivor testimony, only the driver and front-seat passenger wore their seat belts. Four passengers sat in the rear seat; and three passengers sat in the rear cargo area, which had no restraints and was not configured for seating. Physical evidence was used to confirm restraint use within the vehicle.

All of the Chevrolet occupants, except for the left rear-seat passenger, were contained in the vehicle. According to an American Medical Response emergency medical technician, the left rear-seat passenger was found with his upper body protruding between the B-pillar and the rear left door. The Chevrolet was equipped with a driver's side airbag, which was found intact and not deployed.

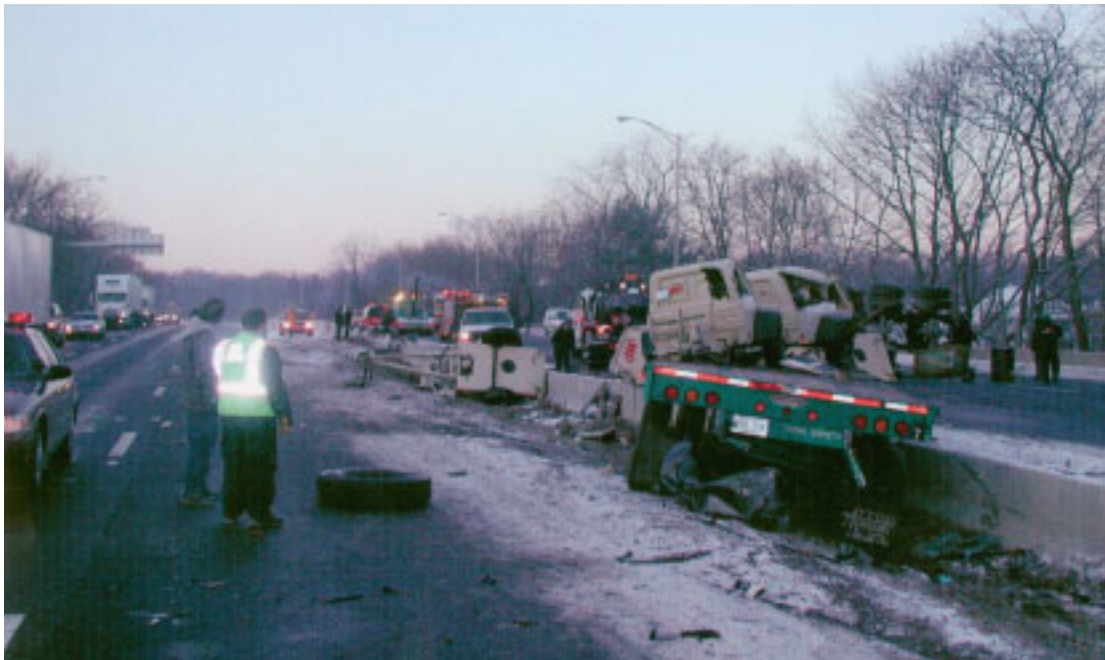
Figure 7. Retroreflective tape on rear of flatbed semitrailer.

Retroreflective tape on the semitrailer was 3 inches wide and ran down both sides in 18-inch segments spaced 17 inches apart. (See figure 7.) It also ran fully along the rear of the semitrailer and rear impact bar. Each segment of the tape consisted of 7 inches of white material and 11 inches of red material. The left side of the semitrailer—the area impacted by the Chevrolet—also included two circular light covers. The smaller of the two covers was amber, about 2 inches in diameter, and cracked and damaged. The larger light cover was red, about 3 inches in diameter, and undamaged.

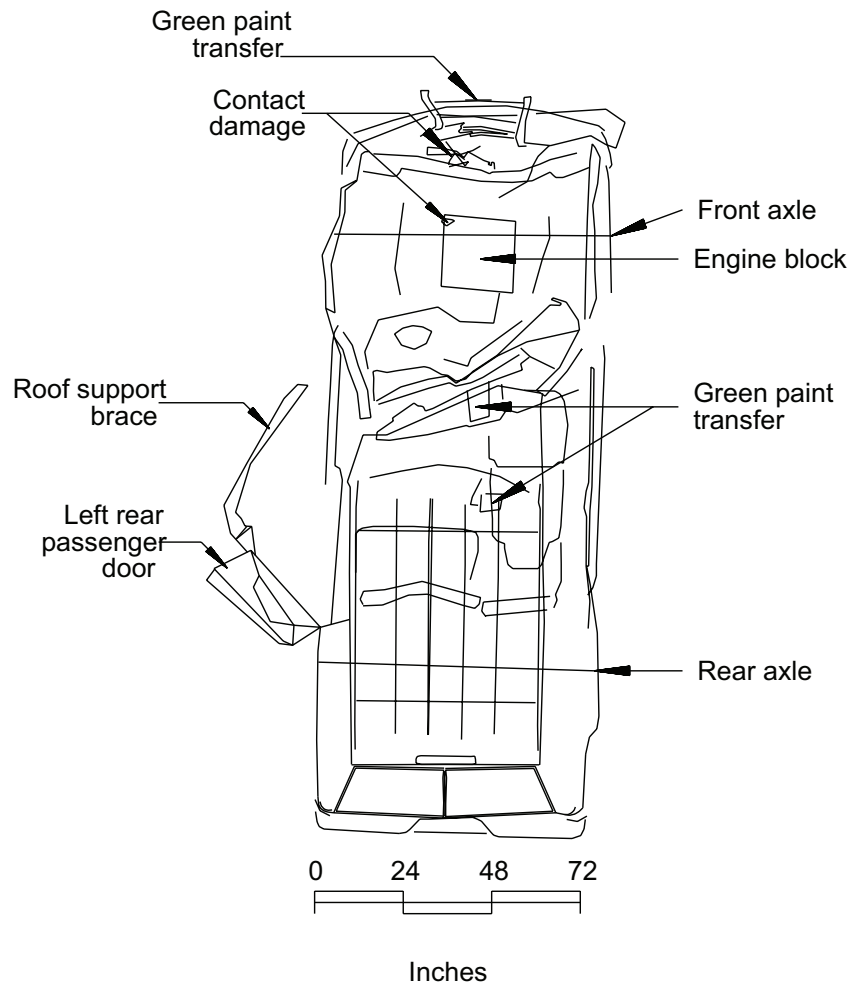
Figure 8. Diagram of Chevrolet Tahoe wreckage.

The rear impact bar of the semitrailer was embedded in the Chevrolet's radiator and engine compartment, approximately at the center of the vehicle. The engine hood was detached from the vehicle and deformed. The top portion of the engine compartment was severely damaged, as were various components mounted above the engine—the air conditioning unit, brake booster, ECM, throttle, air filter, and air intake. The windshield was broken and detached from the vehicle. The engine compartment firewall was pushed rearward and down toward the passenger compartment. The left side A-pillar was deformed and pushed rearward. The front portion of the roof was peeled back. The driver's side door was detached. The left rear door was pushed rearward into the left rear quarter panel and was in contact with the left rear tire. (See figure 8.)

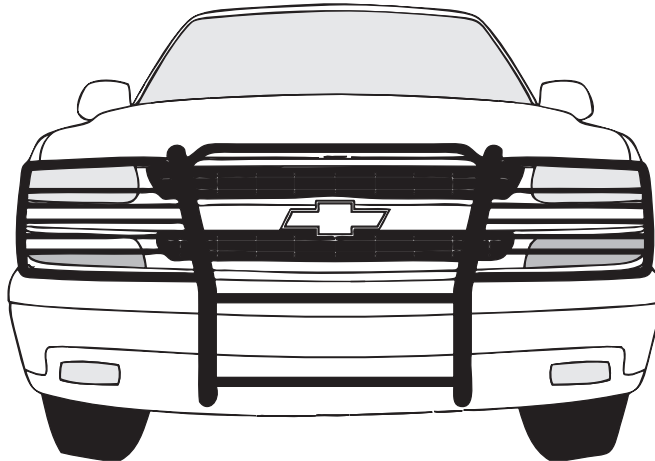
Figure 9. Chevrolet Tahoe with brush guard.

Materials Laboratory for testing. Inspection of the headlight bulbs revealed that the high beams were on at the time of the accident, as evidenced by hot stretching on the bulb filaments.¹² The Chevrolet was equipped with an after-market brush guard over the front exterior lighting area. (See figure 9.) The upper and lower metal bars on the guard were approximately 1 1/2 inches in diameter, separated by five smaller metal bars of approximately 3/8 inch diameter. One of the smaller diameter bars and a small portion of the thick upper bar were directly in front of the headlight lenses.

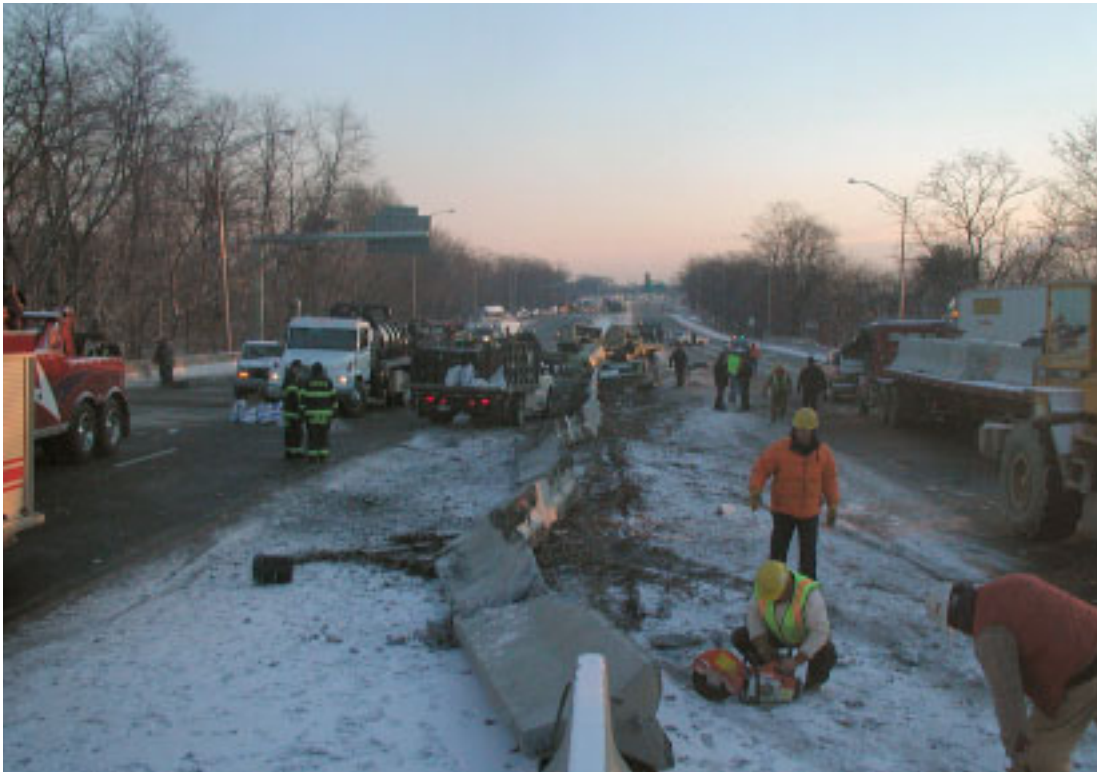
Figure 10. Overturned portable concrete barrier segments viewed from northbound lanes of I-95.

Furrow marks in the northbound median indicated that the 1996 Freightliner tractor flatbed semitrailer struck the concrete median barrier at an angle of about 23°. The vehicle overturned and overrode the 32-inch-high barrier, deflecting the five overturned barrier segments as much as 3 feet toward the southbound lanes. One segment was visibly cracked and separated down the middle. Postaccident photos of the damaged concrete barriers revealed that the pins holding segments together were severely deformed; in most

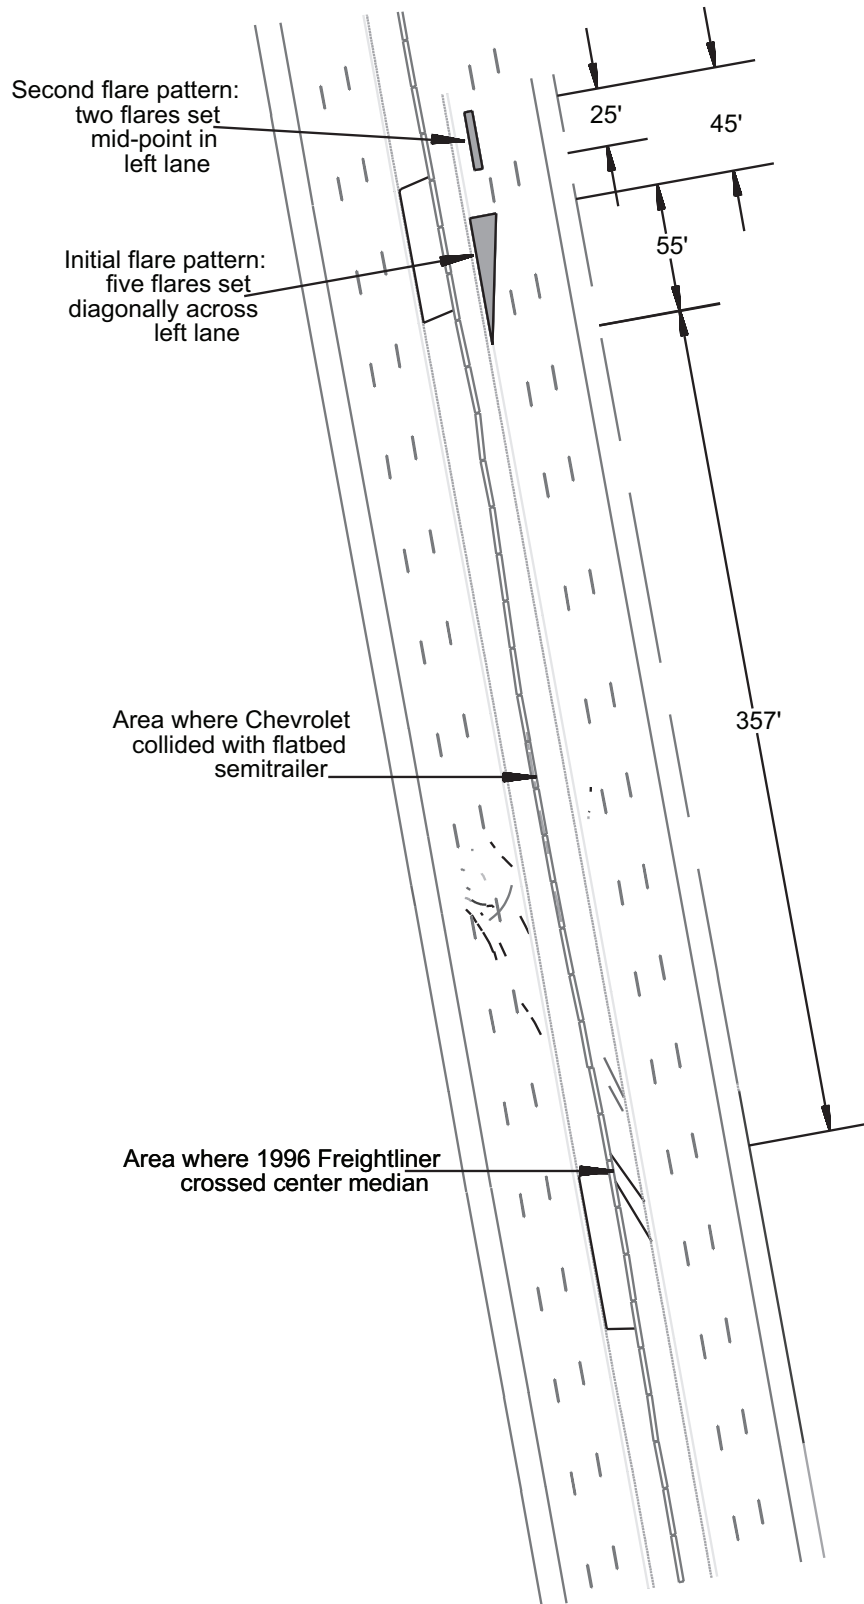
Figure 11. Diagram of flare placement.

The two abandoned flares were located in the left lane of I-95 north; the 1996 Freightliner driver was traveling in the center lane. A wide right curve preceded the approach to the flares, and Safety Board investigators examined the possibility that the curvature of the roadway caused the driver to perceive the flares as being in his lane. Based on sight distance measurements, investigators determined that the driver would have been between 1,033 and 1,063 feet (about 0.2 mile) from the flares when they appeared to be directly in front of him.

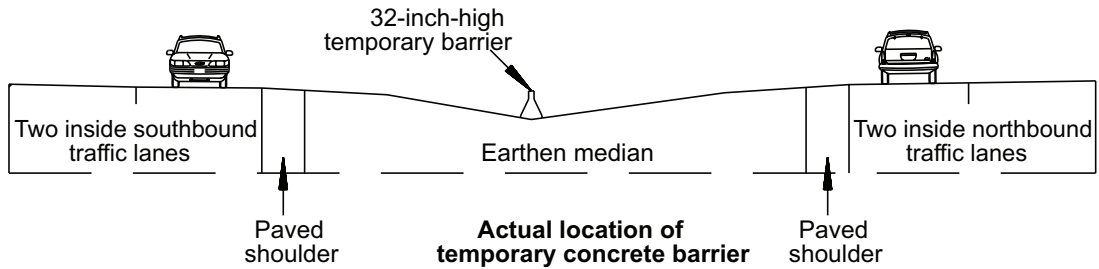
This two-stage approach would have required the barrier to be moved only once and would have prevented the flooding that might occur from milling the adjacent roadway. Figure 12 shows a cross-section of the positioning of the portable concrete

Figure 12. Cross-section of positioning of portable concrete barrier at time of accidents.

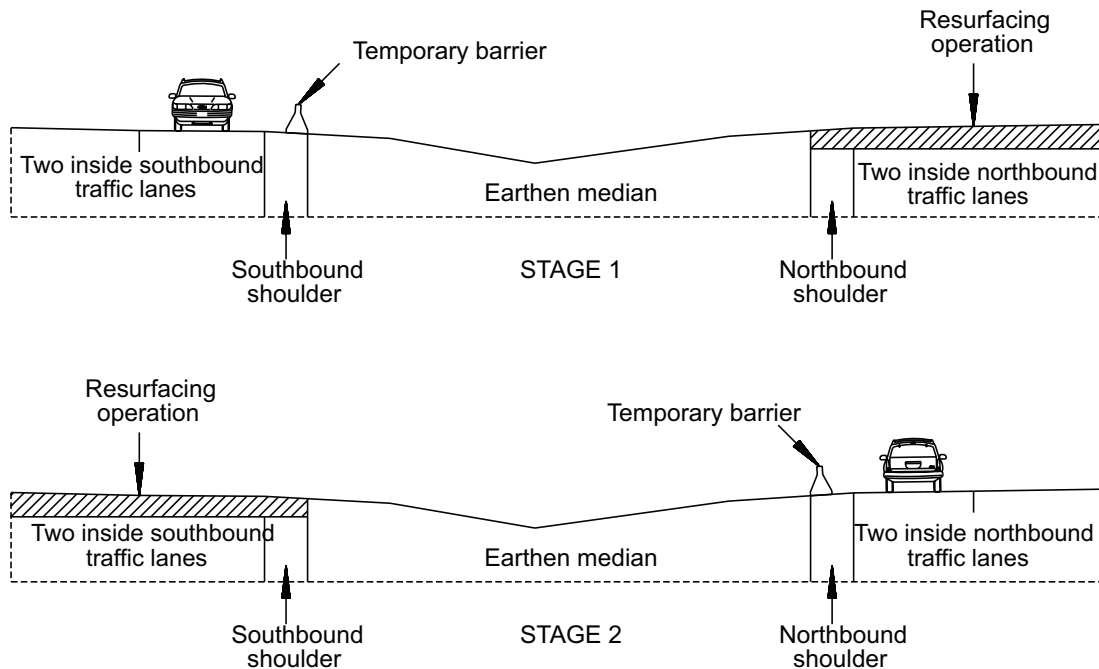
Figure 13. Cross-section of I-95 illustrating exemplar stages 1 and 2 of resurfacing project. (Not to scale. View limited to two inside lanes for clarity.)

barrier prior to the Fairfield accidents. Figure 13 illustrates how a two-stage process would have avoided placing the barrier on the unpaved median.

As a result of the Fairfield accidents, ConnDOT has adopted a procedure for reviewing and approving revisions to construction projects. This new procedure requires that the Offices of Construction and Engineering explicitly approve any proposed revision to a construction contract. All construction revision submissions must include reasons for the change, proposed procedures, affected locations, cost estimates, and a completion date. Requiring that highway engineers, knowledgeable in State and national guidelines, review proposed revisions to construction projects should mitigate practices that contradict, or are not covered by, established guidelines for highway construction.
