# **EPA CHEMICAL ACCIDENT INVESTIGATION REPORT**

**Pennzoil Product  
Company Refinery  
Rouseville, Pennsylvania**

## Executive Summary/Overview

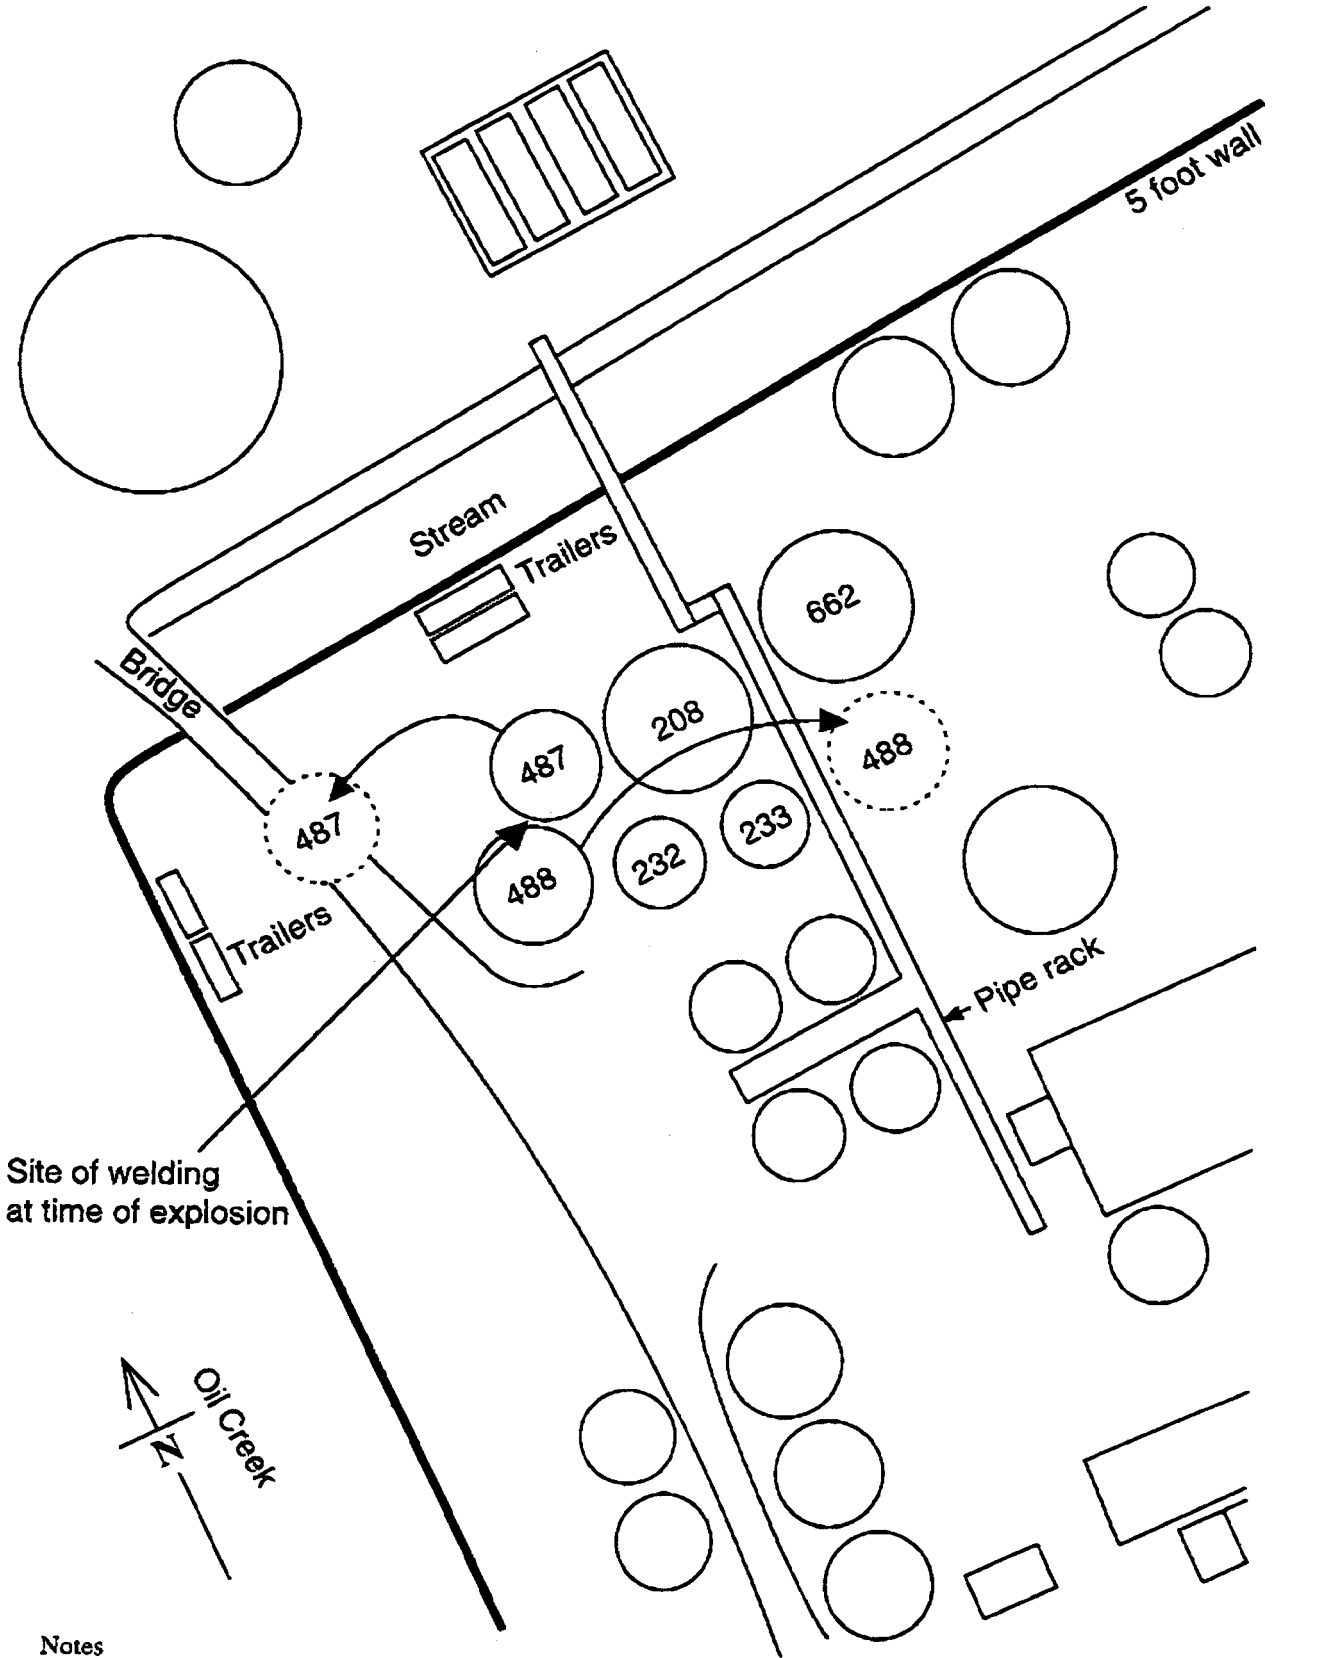
Exhibit 3  
Area of Explosion and Fire at Pennzoil Refinery

Curved lines indicate trajectory of tanks 487 and 488

Tank 208: Naptha; burned in place

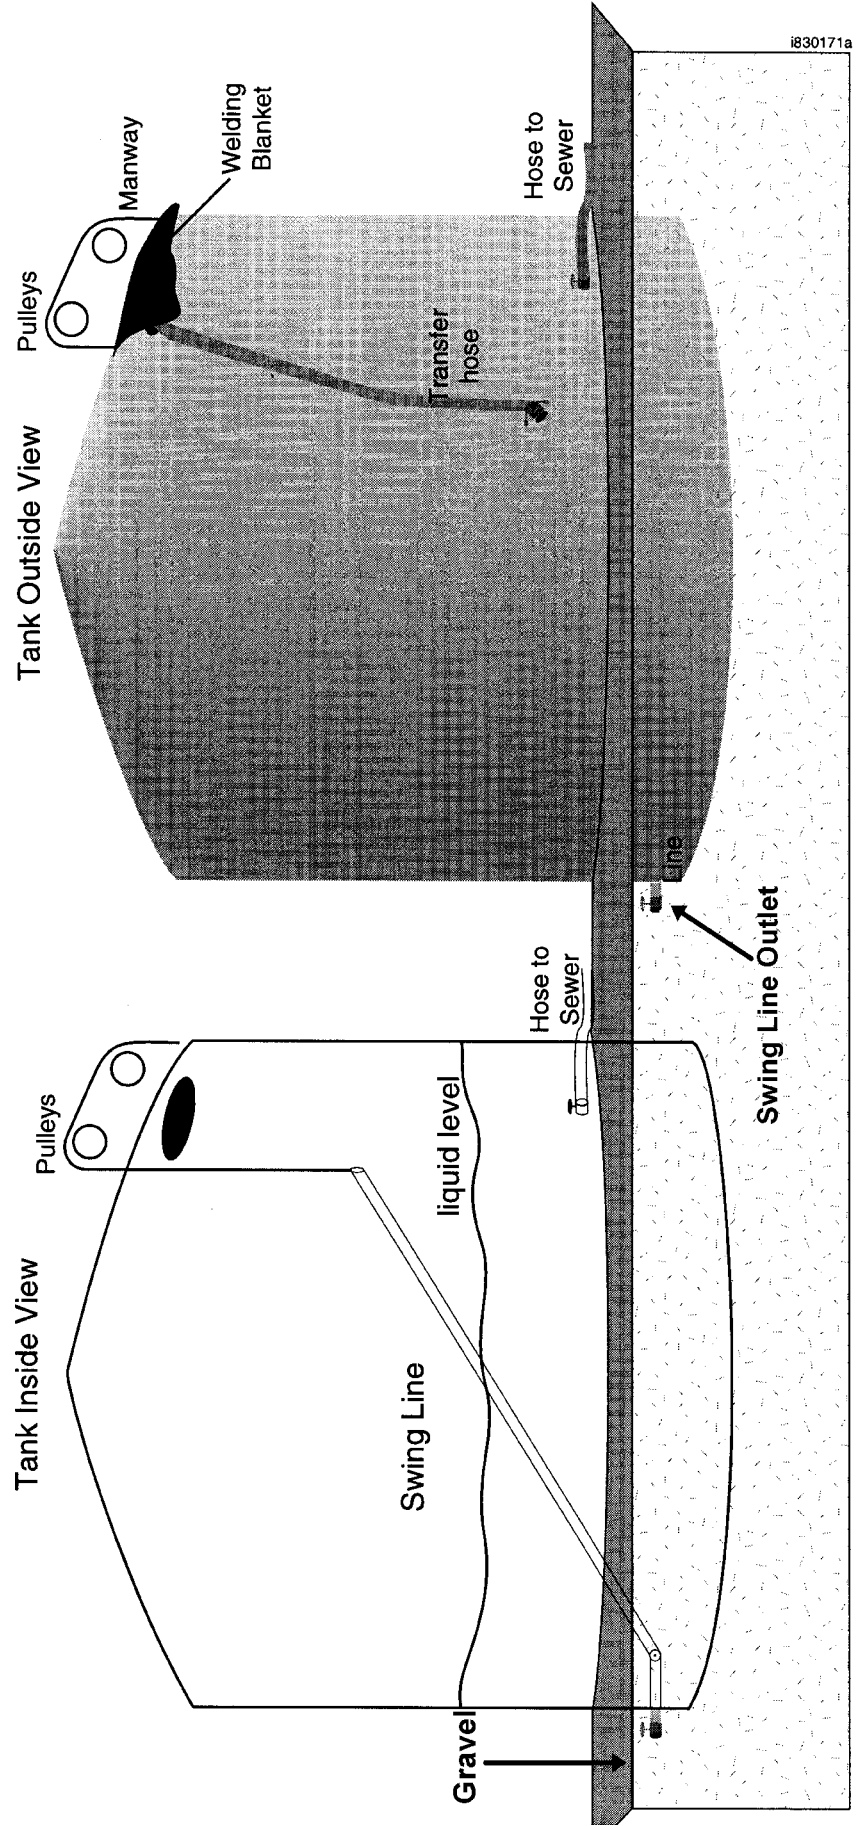
Exhibit 4  
Inside and Outside Views of Tank 487

Tanks 487 and 488, which were similar in size and design, were 30 feet in diameter with 25-foot high sidewalls and five-foot high domes. The tanks, built in 1937, were constructed of steel plates riveted together. The riveted "umbrella" domes were replaced in 1950. The tanks were about four feet apart and shared a common set of stairs leading to the top for employee activities such as gauging the volume of liquid in the tank or inspections. These tanks were not individually diked; i.e., they did not have a secondary containment wall around them. However, they were located in a general tank farm area that had walls and berms to prevent any spilled materials from reaching the Oil Creek.

**Vapor Escaping from Holes in Tank.** After the explosion and fire, investigators discovered some holes up to a quarter inch in diameter, presumed to be from corrosion, near the top of the tank. If these holes were present before the explosion, they could have provided a route for vapor release and flame front flashback (see Exhibit 7). However, ignition sources would need to be very close to ignite the small amount of diluted vapor expected from this

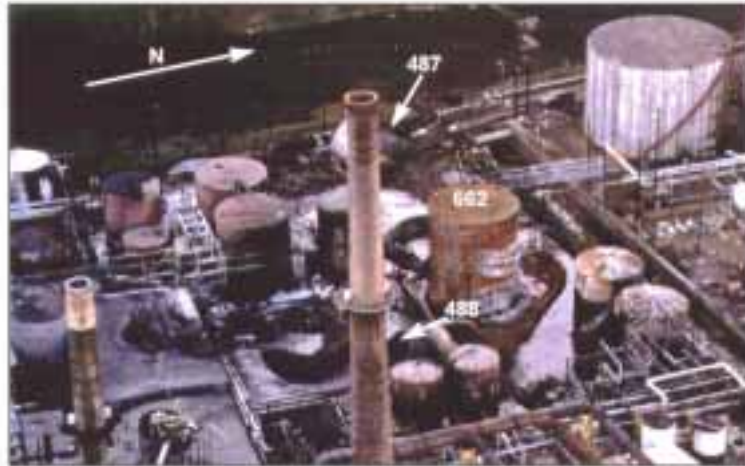
A. Overhead view of explosion area.

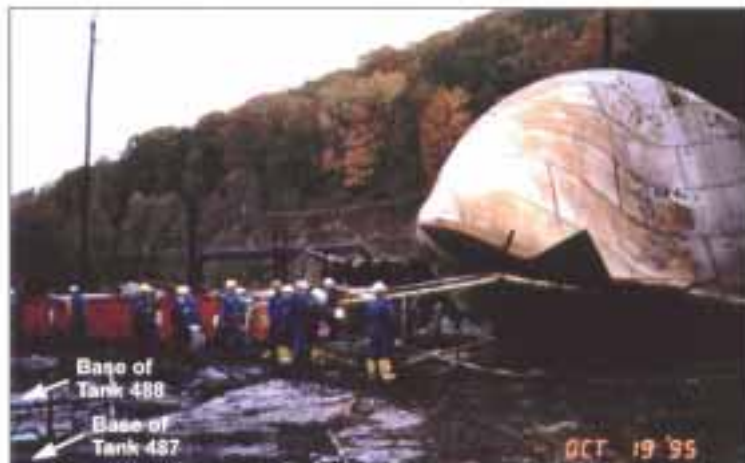
B. Dips in ground showing the original site of tanks 487 & 488. Tank 487 in background.

- The bottoms of the tanks at the shell wall seam may have been weakened through corrosion. The tanks generally contained water at the bottom. Gravel was also built up around the bottoms and sides of the tanks, which may have allowed moisture to collect on the outside, on the bottom and tank wall edge, leading to corrosion and weakening of the bottom seam at the shell wall. (Evidence of this gravel can be seen in Exhibit 5-B, which shows the indentations left in the ground by tanks 487 and 488.)

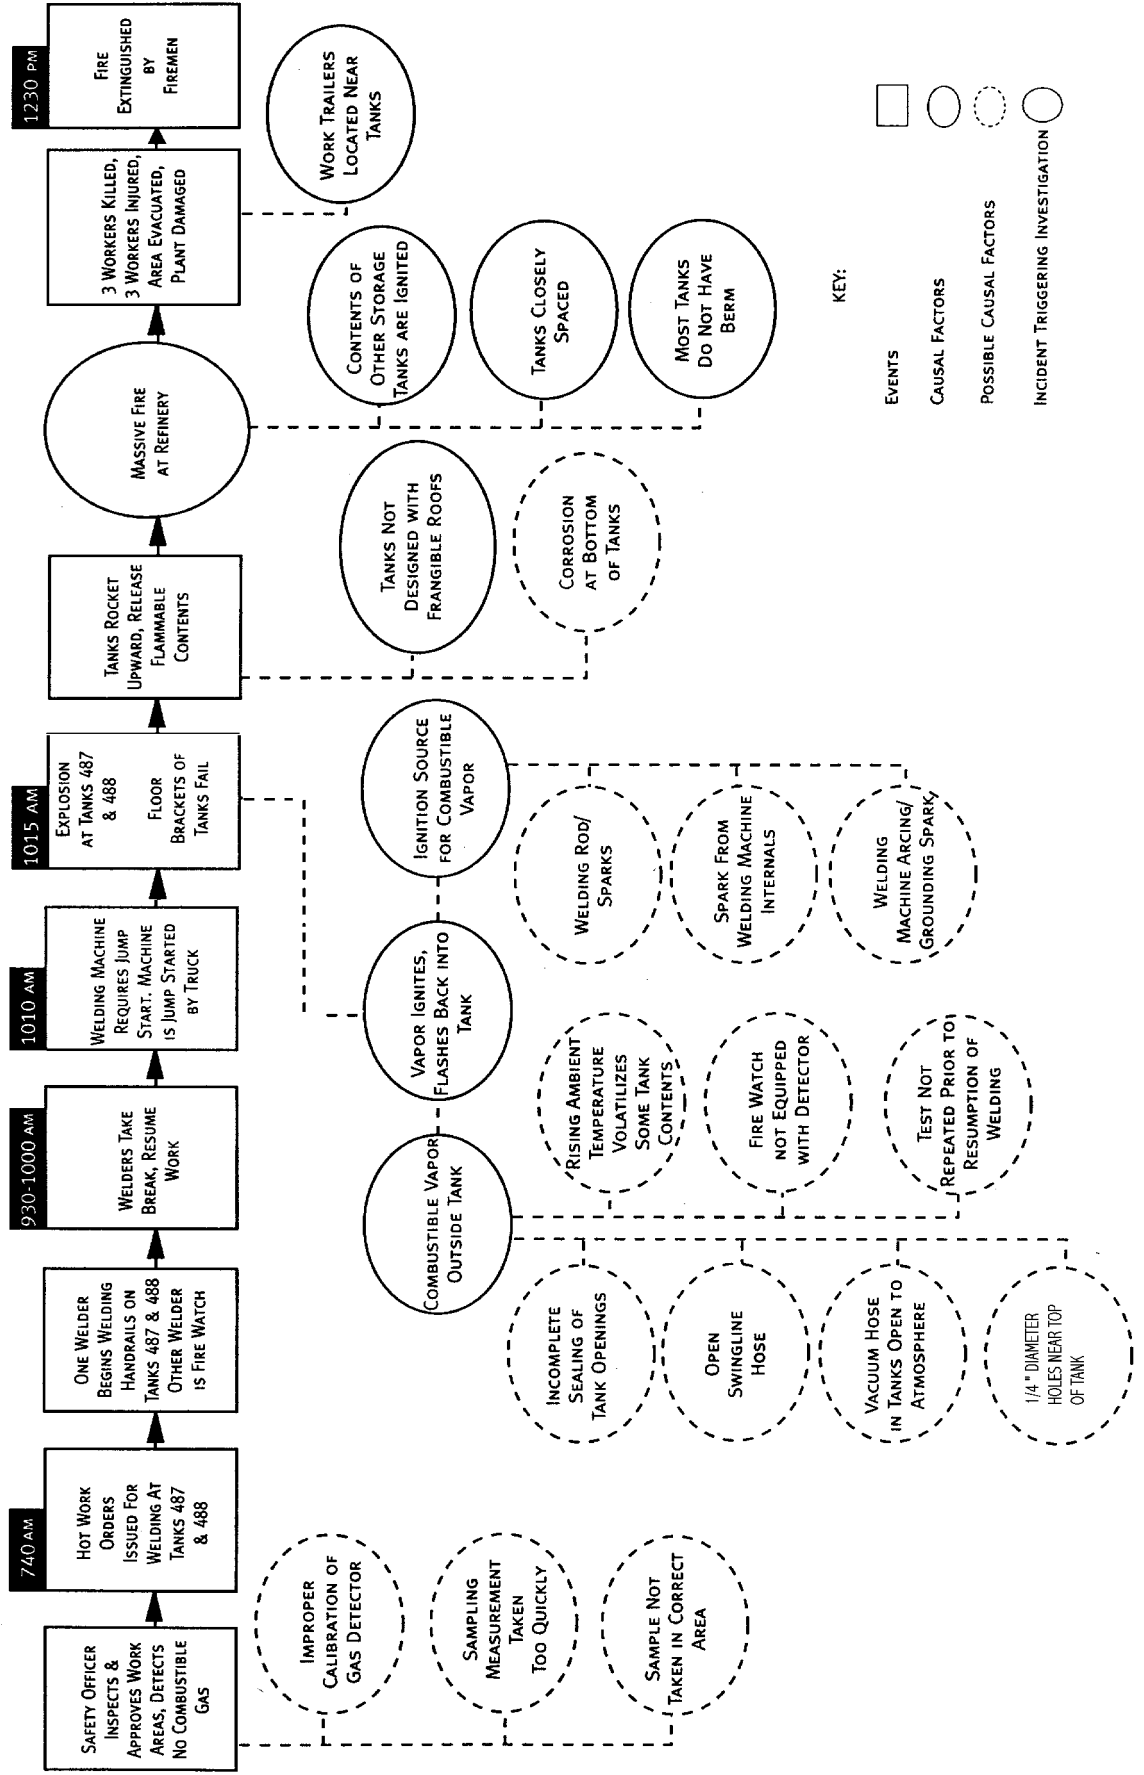
## EVENT AND CAUSAL FACTORS DIAGRAM

The CAIT used the information collected to develop an Event and Causal Factors Chart (described below). The Event and Causal Factors Chart combined with the factual information collected in addition to professional and engineering judgement were used to determine the causes of this accident.

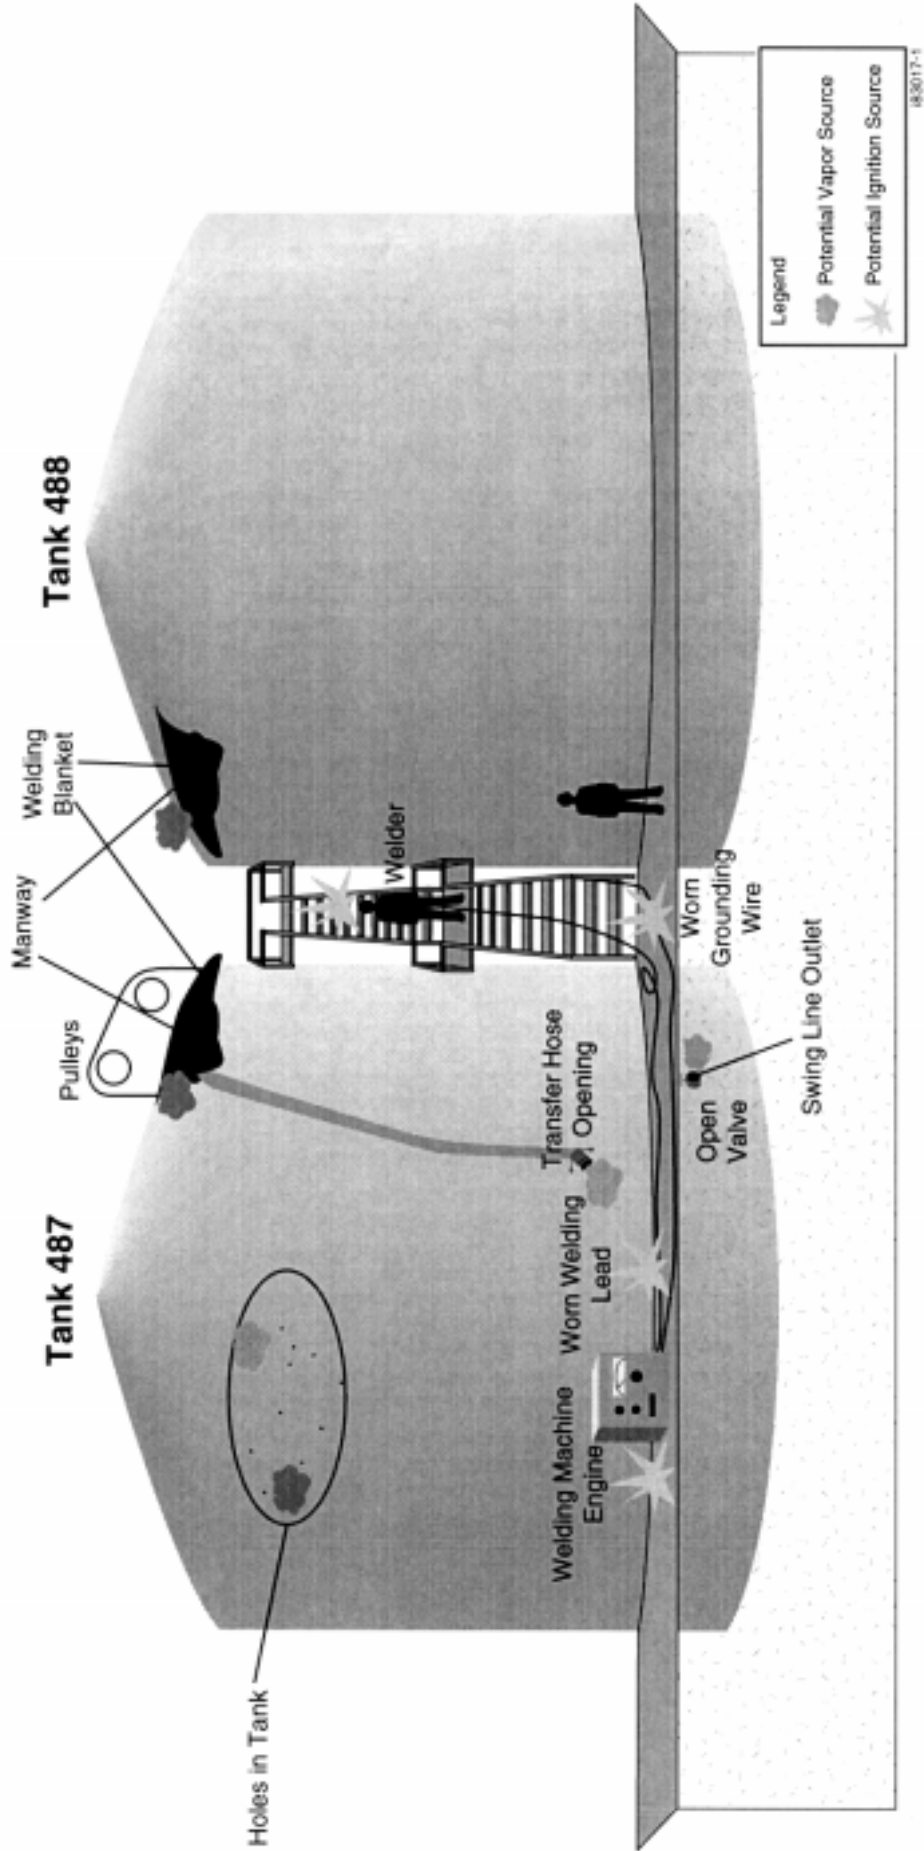
Exhibit 7  
Pennzoil Tank Explosion:  
Potential Vapor and Ignition Sources at Tanks 487 & 488

**Vapor Escaping from Swingline.** The swingline could have provided a route for vapor release (see Exhibit 7). The swingline portion inside the tank was raised above the liquid level in the tank vapor space. Investigators found after the accident that the outside valve near the base of the tank connected to the swingline inside the tank was open. As above, as the tank warmed, if sufficient driving force was present, undiluted heavier-than-air flammable vapors could have been pushed out through the swingline and open valve. If there was little or no wind, these dense vapors could have collected at grade level near ignition sources (see below). After ignition, the flame front could have flashed back through the swingline, igniting vapors in the tank. However, the end fitting on the swingline valve outside the tank was buried under the soil. Further, inspection of the inside of the swingline, after the accident, revealed no evidence of burn or scorch marks.

- The welding rod or sparks from hot slag or spatter possibly could have caused ignition of vapors present, if welding had been started (see Exhibit 7 for employee accounts of the position of the welder). During welding, flux coating the welding rod burns off. The welding rod being used by the welder was found after the accident and inspection revealed that flux on the tip was not burned off; however, there could have been an instantaneous arc, which could have caused ignition, but could have been of such short duration that the flux was not burned off. Or, the welding gun may have been dropped or kicked against the stairway causing an arc. However no evidence was discovered (e.g. arc marks) to support this scenario. Flammable and combustible materials are often ignited during hot work; generally, the material ignited is in the equipment being worked on. It is relatively rare for hot work to ignite a vapor cloud (Lees, 1996).
