EPA/OSHA JOINT CHEMICAL ACCIDENT INVESTIGATION REPORT

Shell Chemical Company Deer Park, Texas

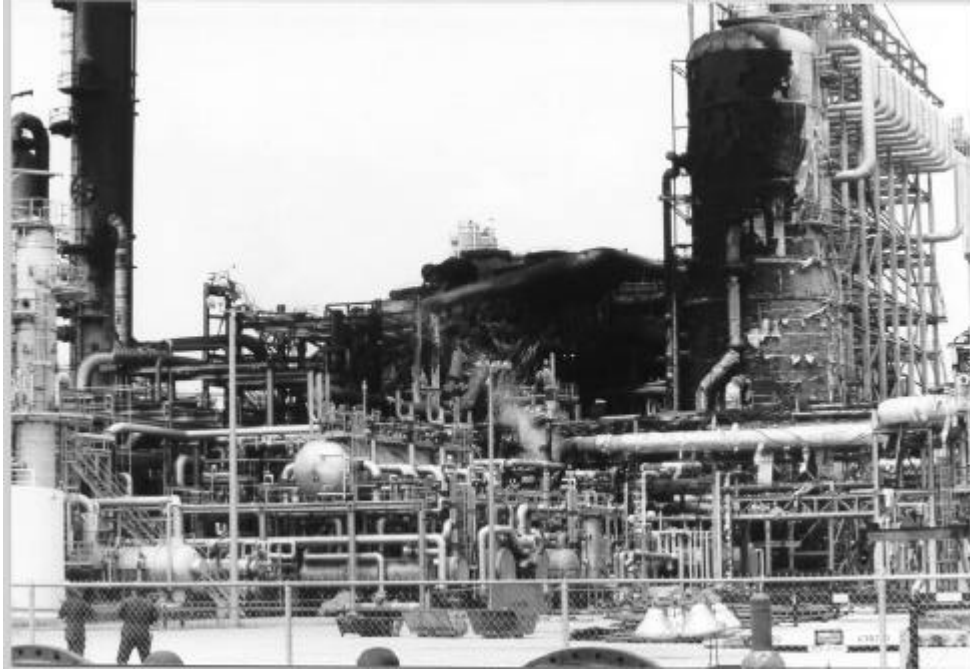
Figure E-1: Photograph of the damage resulting from the explosion and fire at Shell Olefins Plant Number 3 (view from west of blast area). Note the heavy structural damage in the rear center of the photograph.

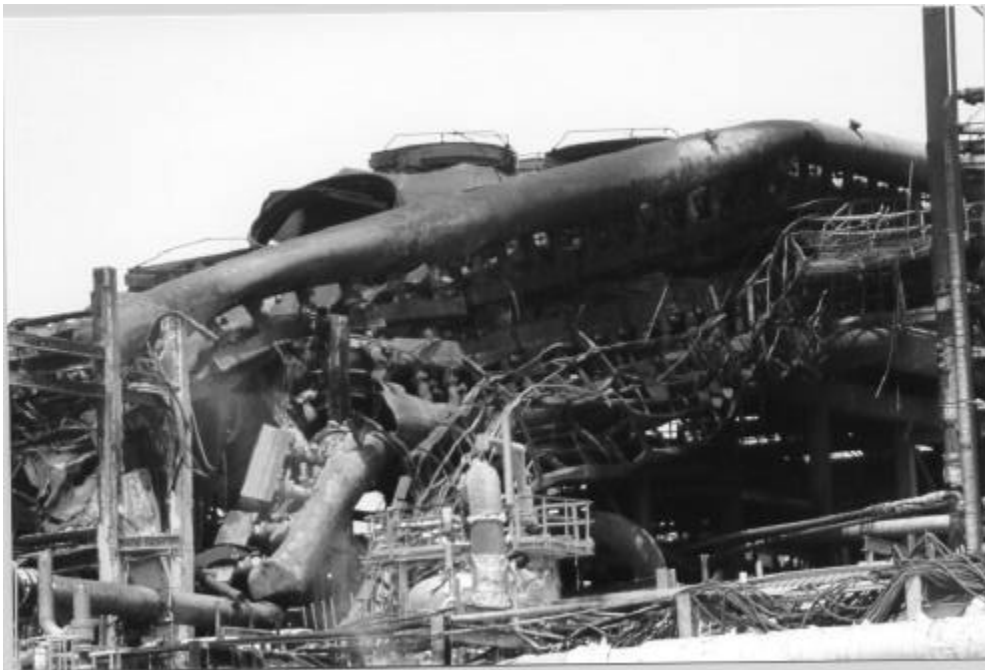
Figure E-2: Close-up of OP-III damage. The structure supporting the overhead cooling fans melted due to the intense heat of the fire and collapsed on top of the pipe rack.

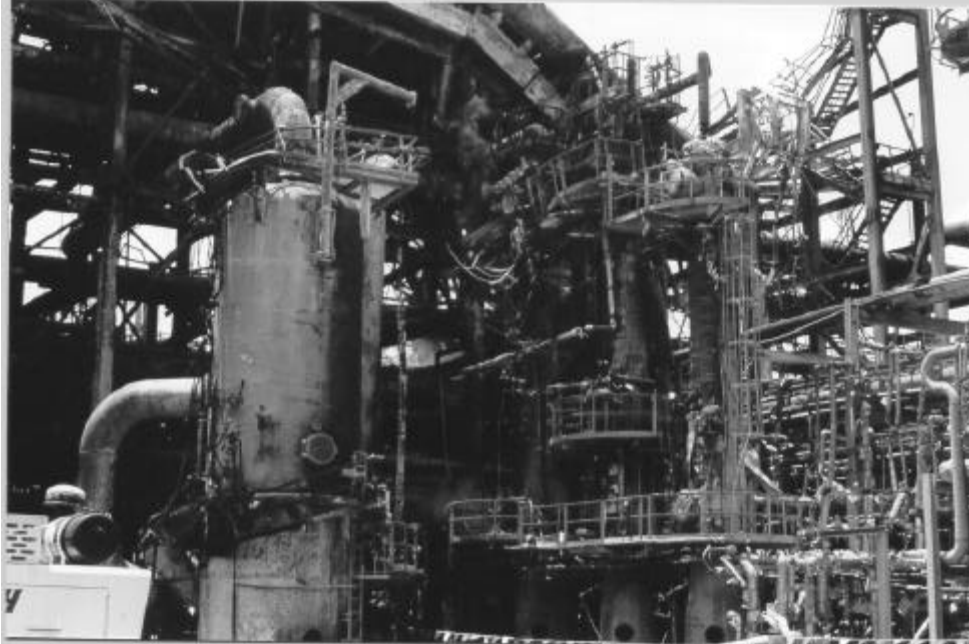
Figure E-3: Photograph of explosion and fire damage at OP-III as seen from the north side of the blast zone.

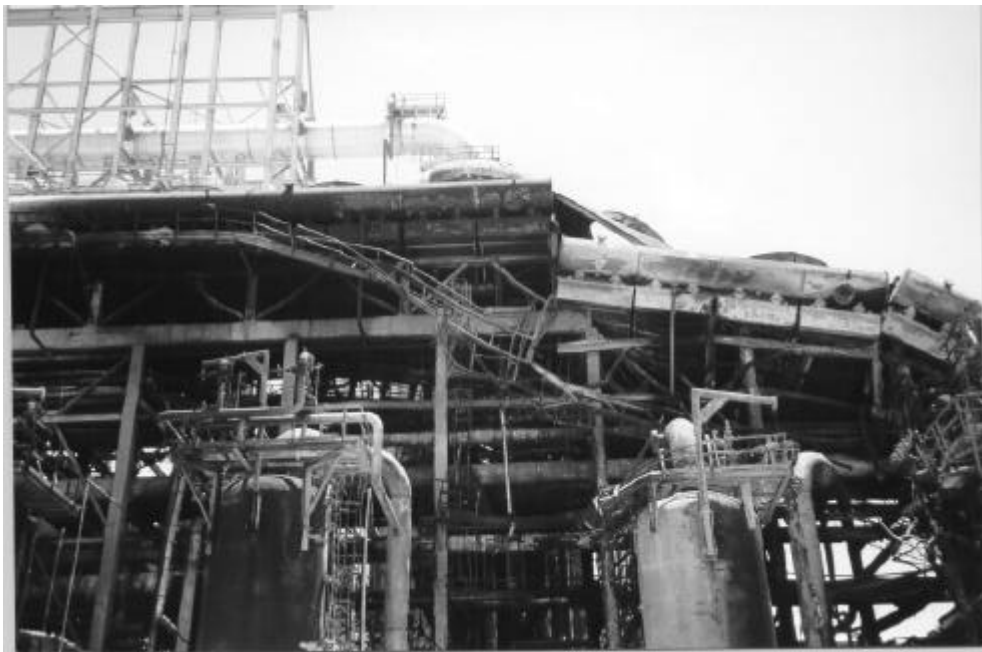
Figure E-4: Photograph of explosion and fire damage at OP-III as seen from north side of pipe rack, looking upward.

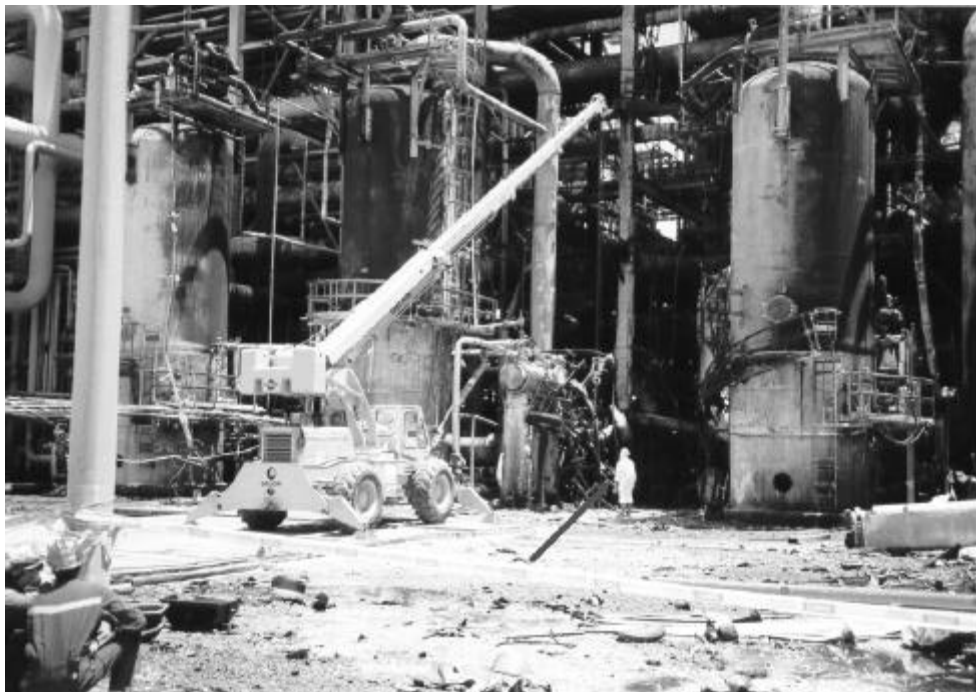
Figure E-6: Photograph of explosion and fire damage in the area of the PGC fifth stage suction and discharge drums (viewed from the north). The man in the lower center provides a reference to the scale of the surrounding structures. The failed check valve was located behind the drum to the man's right.

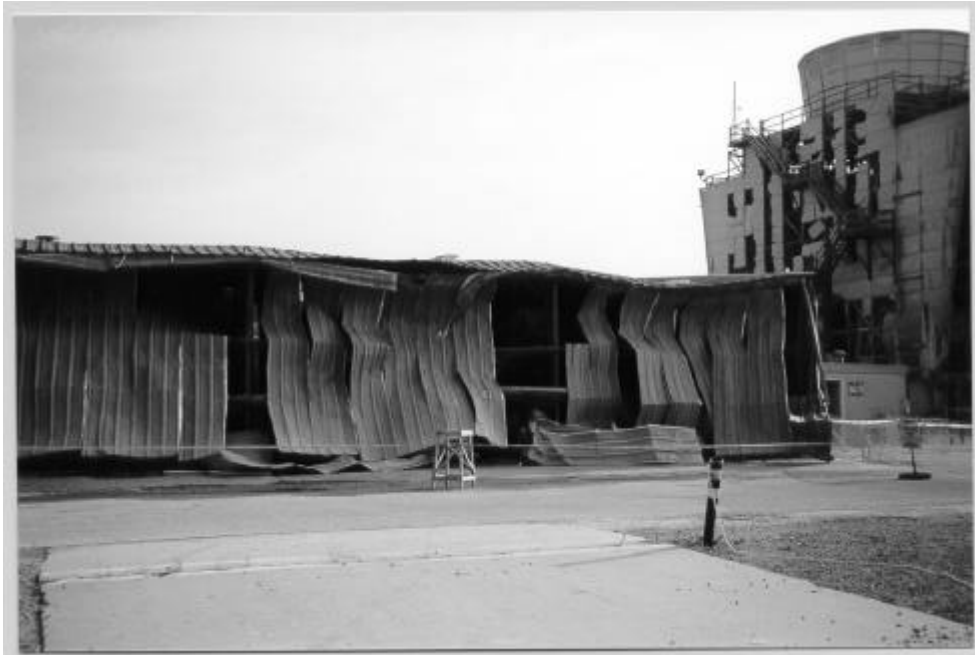
Figure E-7: Photograph of blast damage to buildings and structures in the vicinity of the explosion. Note the buckled metal walls of the storage building in the center and the panels missing from the cooling tower on the right. These buildings were located approximately 500 feet north of the blast center.

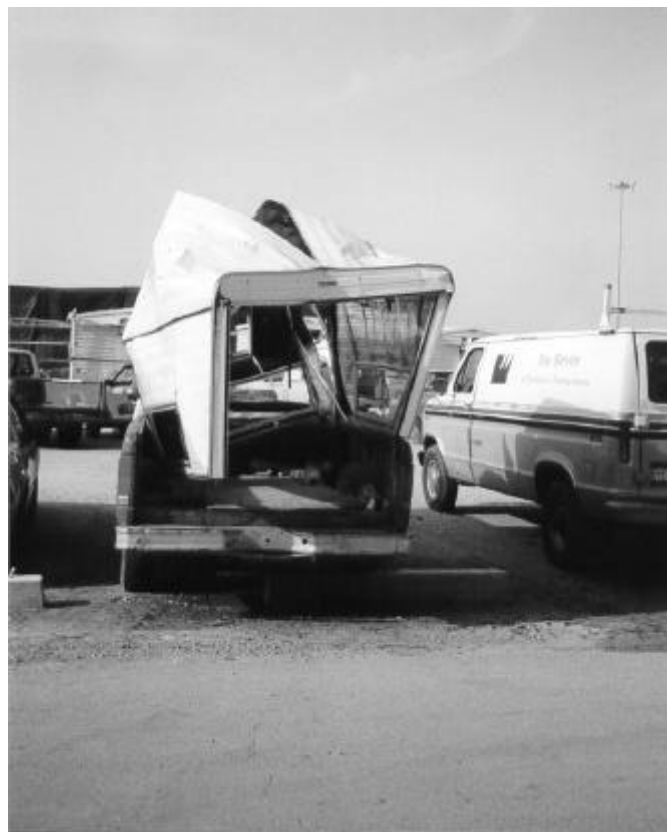
Figure E-8: Photograph of damage to a pickup truck parked near the blast site. Most automobiles parked in this company lot during the accident suffered damage.

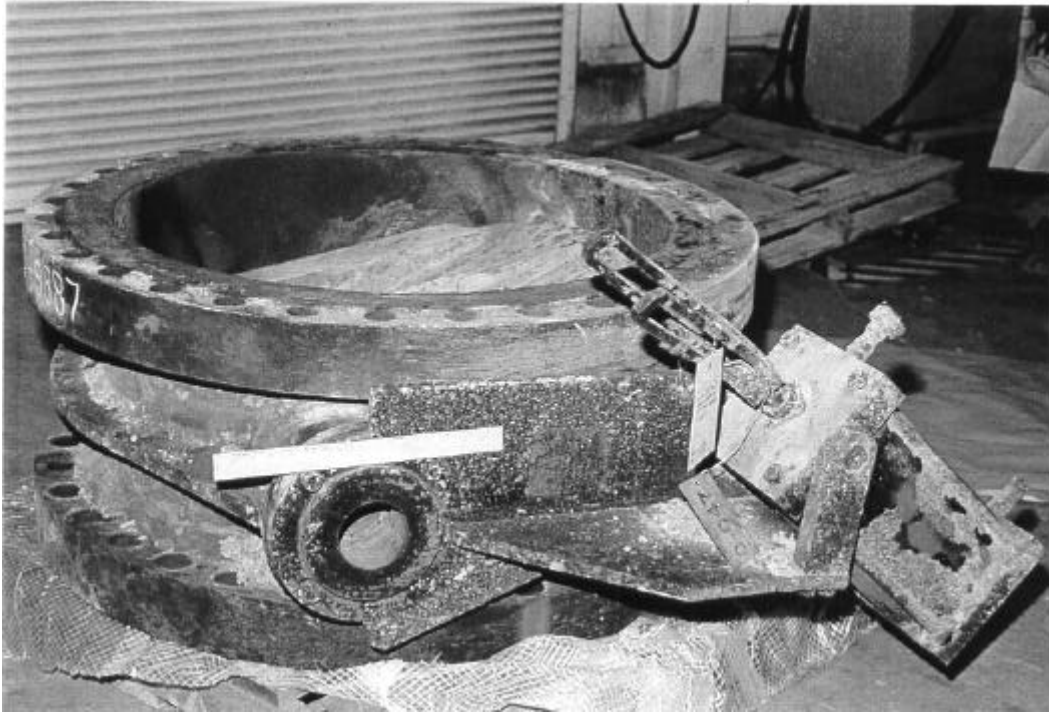
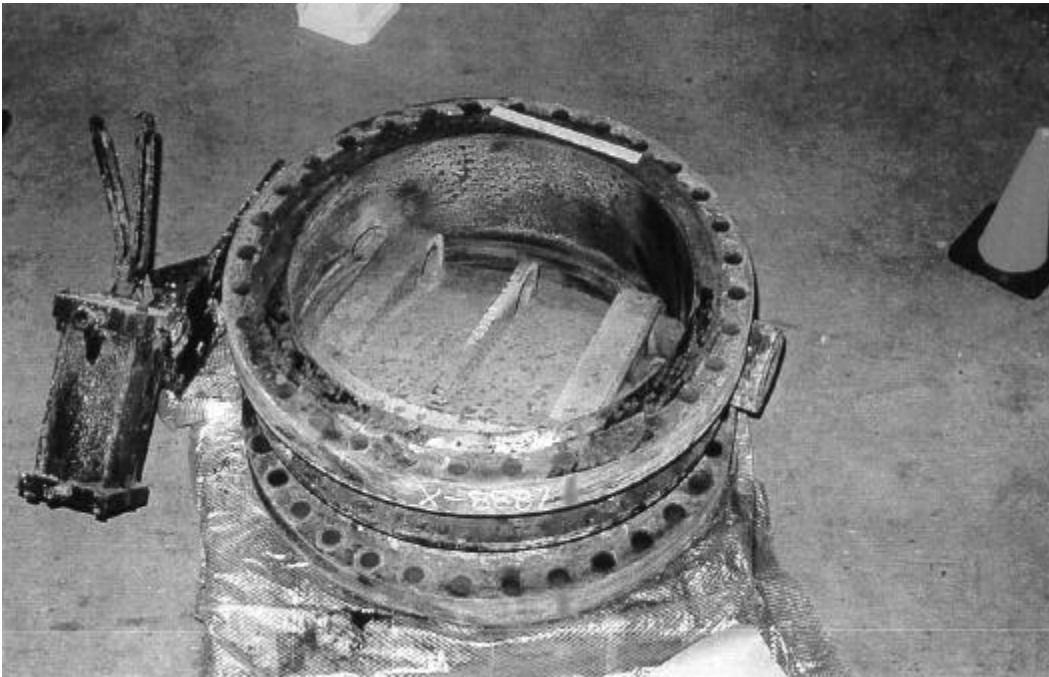
Figures E-9 and E-10: Photographs of two views of the disassembled subject 36" Clow check valve. The pneumatic actuator assembly can be seen in both views. In the lower photograph, the hole directly below the 12-inch ruler formerly contained the valve's drive shaft. This is where the shaft blow-out and flammable gas release occurred.

- Prior to restarting OP-III, Shell Chemical Company should replace all Clow Model GMZ check valves installed in the unit with valves not susceptible to shaft blow-out. Other Shell facilities and other companies as appropriate should review their process systems to determine if they have valves installed that may be subject to this hazard, and modify or replace those valves as necessary to prevent shaft blow-out. Companies should consult valve manufacturers or other appropriate design authorities to ensure any modifications made are safe. [Editor's note: Prior to this report being published, Shell Chemical Company replaced all Clow Model GMZ check valves installed in OP-III with valves not susceptible to shaft blow-out.]

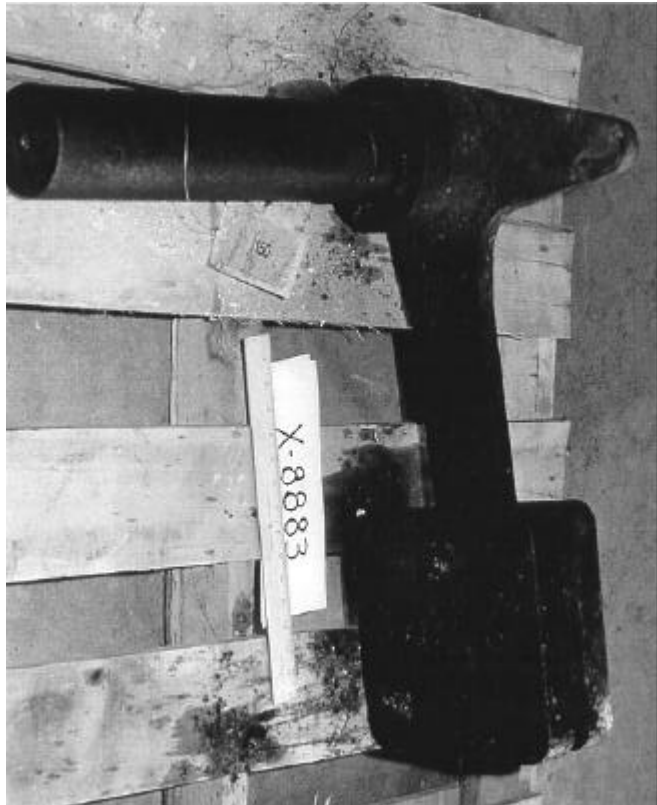
Figure E-11: Photograph shows the drive shaft and counterweight that were ejected from the 36" Clow check valve.

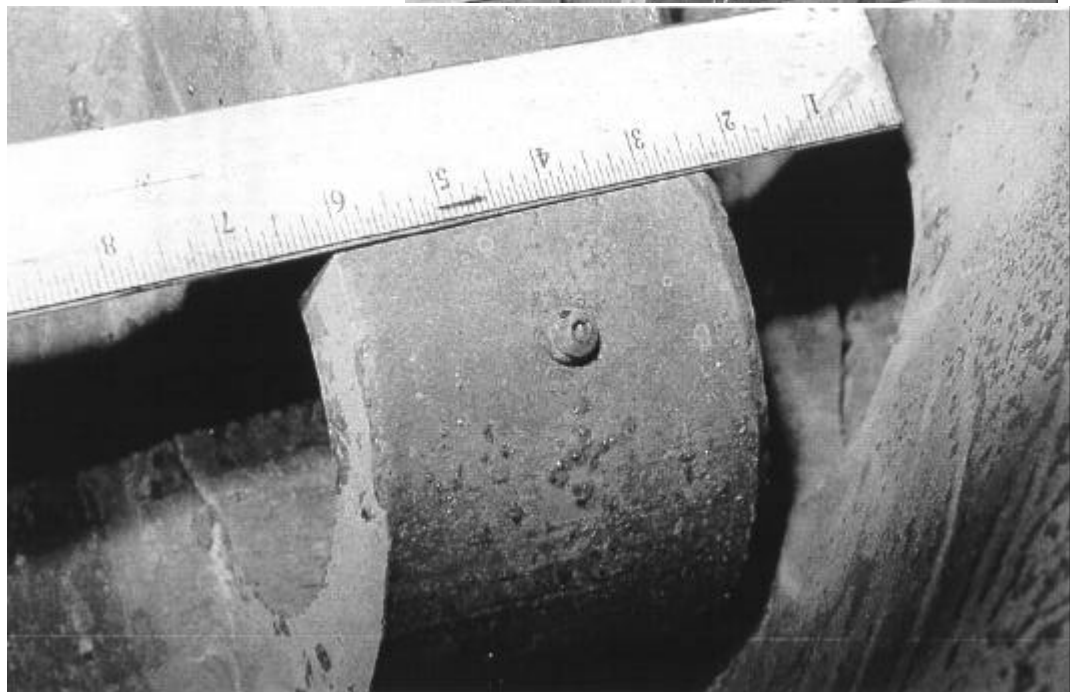
Figure E-12: Photograph shows the head of the machine screw protruding from the portion of the fractured pin. The pin is shown extended slightly out from the surface of the flange, or disk “ear”, from which the valve shaft was ejected.

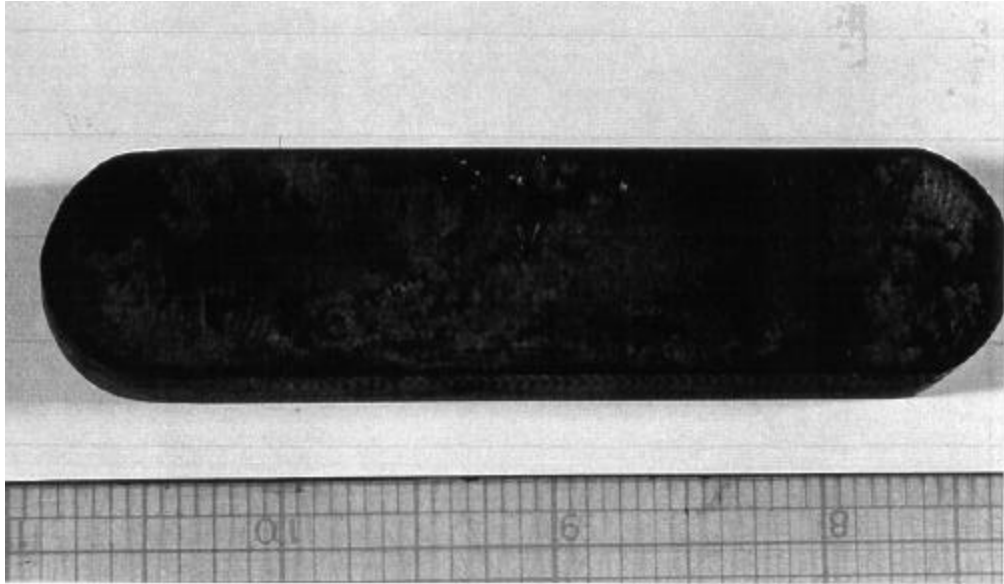
Figure E-13: Photograph shows the metal key intended to help mechanically connect the drive shaft to the valve disk.

Figure E-14: Photograph depicts the measured looseness of the key within its machined slot, or keyway. The key was intended to transfer torque between the shaft and the valve disk, but the key's loose fit forced the much smaller dowel pin to transfer virtually all drive shaft torque. The key eventually fell out of its slot as the drive shaft moved outward after the dowel pin fractured.

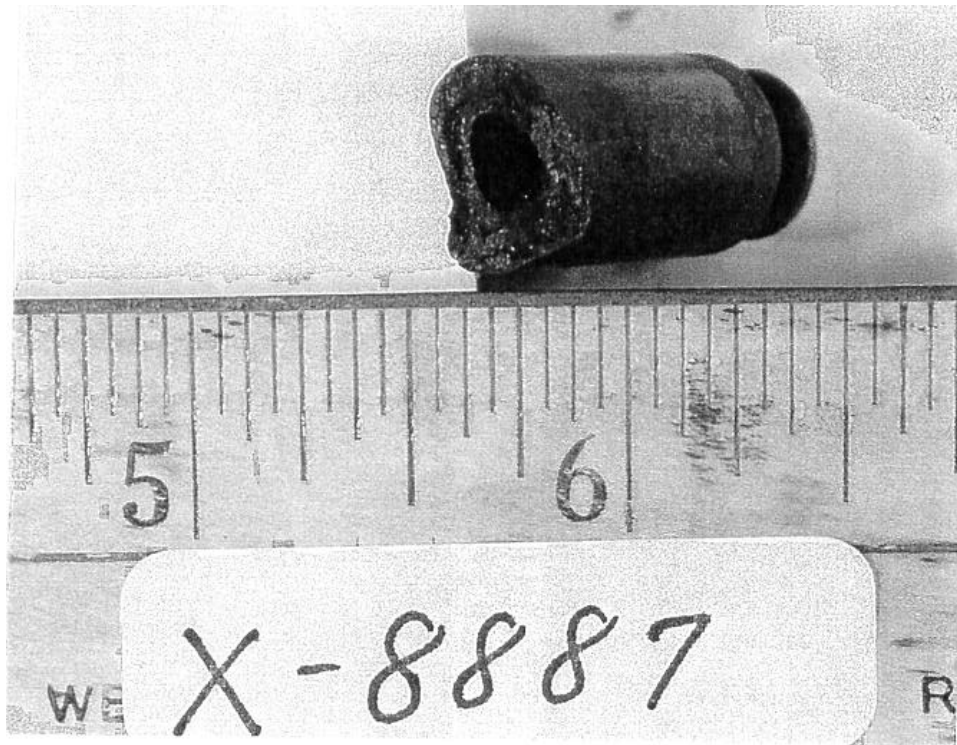
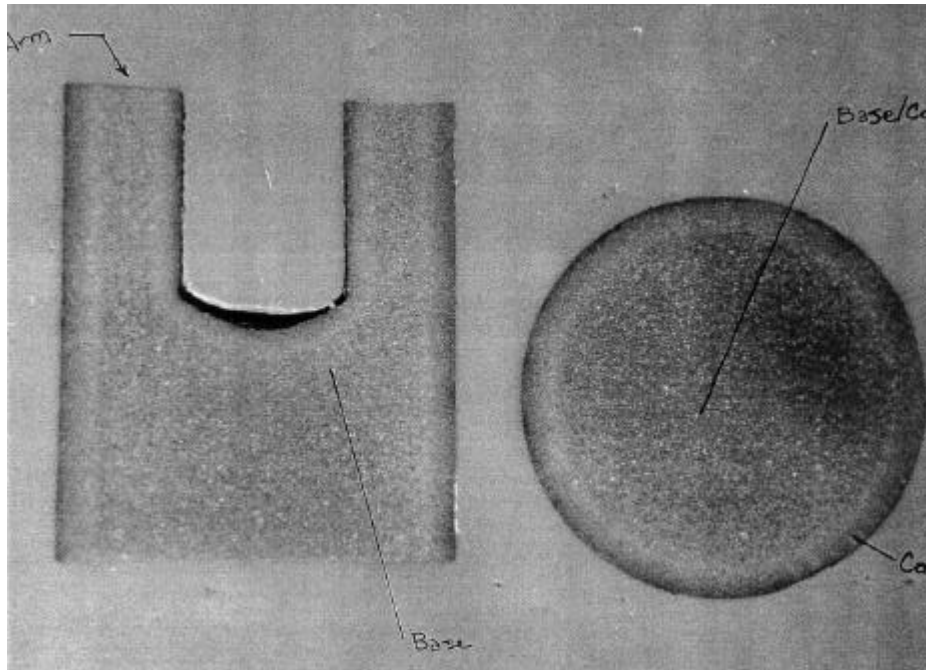
Figure E-17: Views of the longitudinal and transverse cross-sections taken through the intact dowel pin showing the carburized case at both the outside diameter of the pin and within the drilled hole.

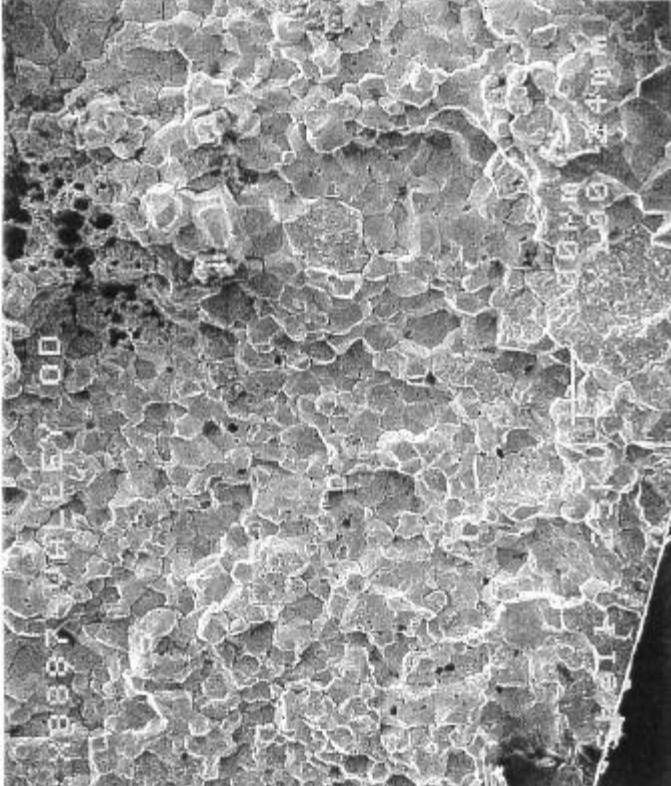
Figure E-20: 400X magnification SEM fractograph of the dowel pin shows details of the intergranular “rock candy” fracture surface at the outside diameter of the dowel pin, a characteristic of hydrogen embrittlement failure mode.

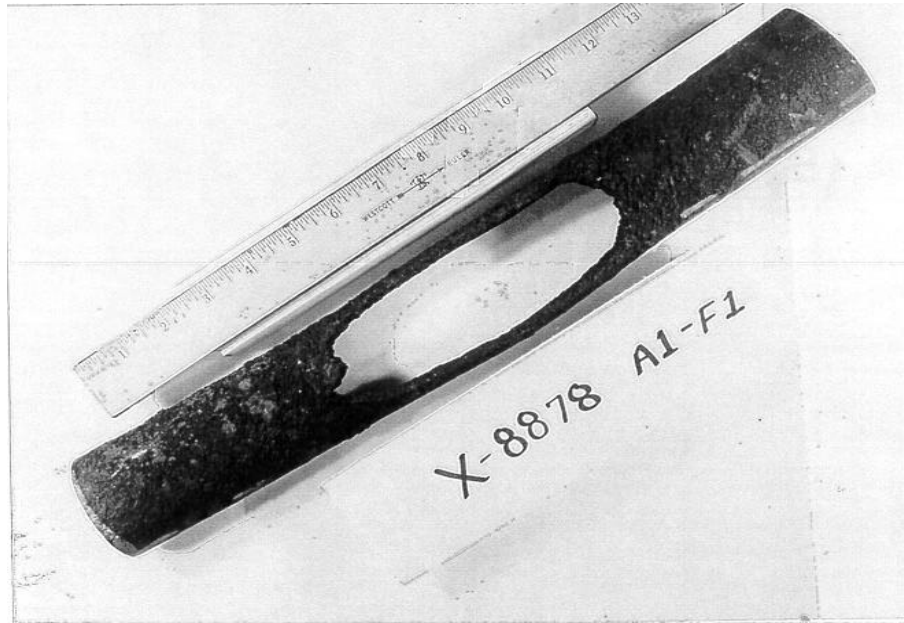
Figure E-21: A view of pipe section X-8878, one of four pipe sections removed from OP-III in addition to the Clow check valve for laboratory analysis as possible sources of the initial flammable gas leak.

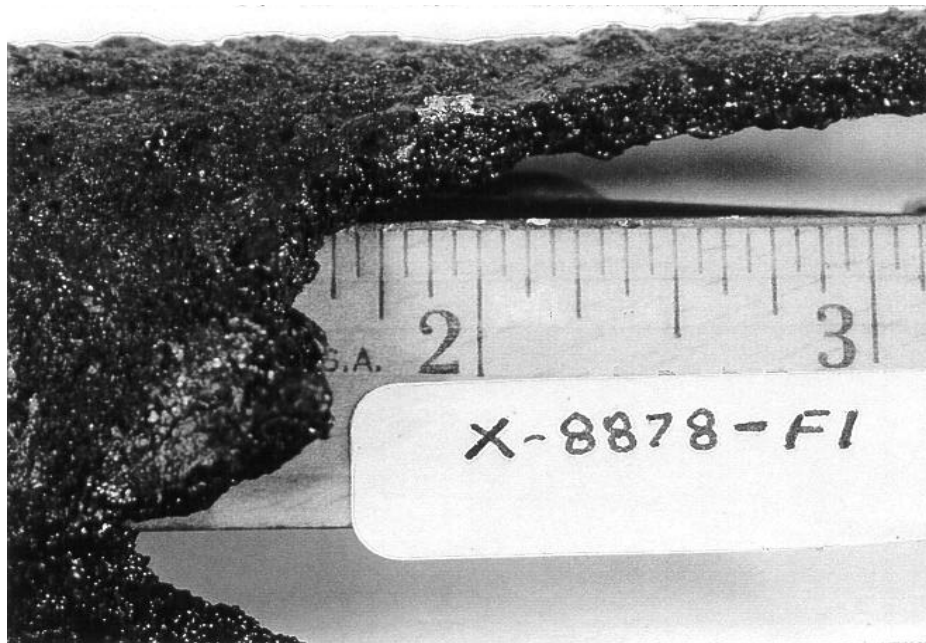
Figure E-22: At higher magnification, this macrograph shows the high temperature oxidation and fire damage around the opening in the pipe section. Laboratory analysis of this and each of the other three pipe sections revealed similar fire-induced failure modes, indicating that none were the likely source of the initial flammable gas leak.
